# TREE CONSERVATION REPORT V3.0

2104 Roger Stevens Drive

**Dendron Forestry Services**

April 15, 2025

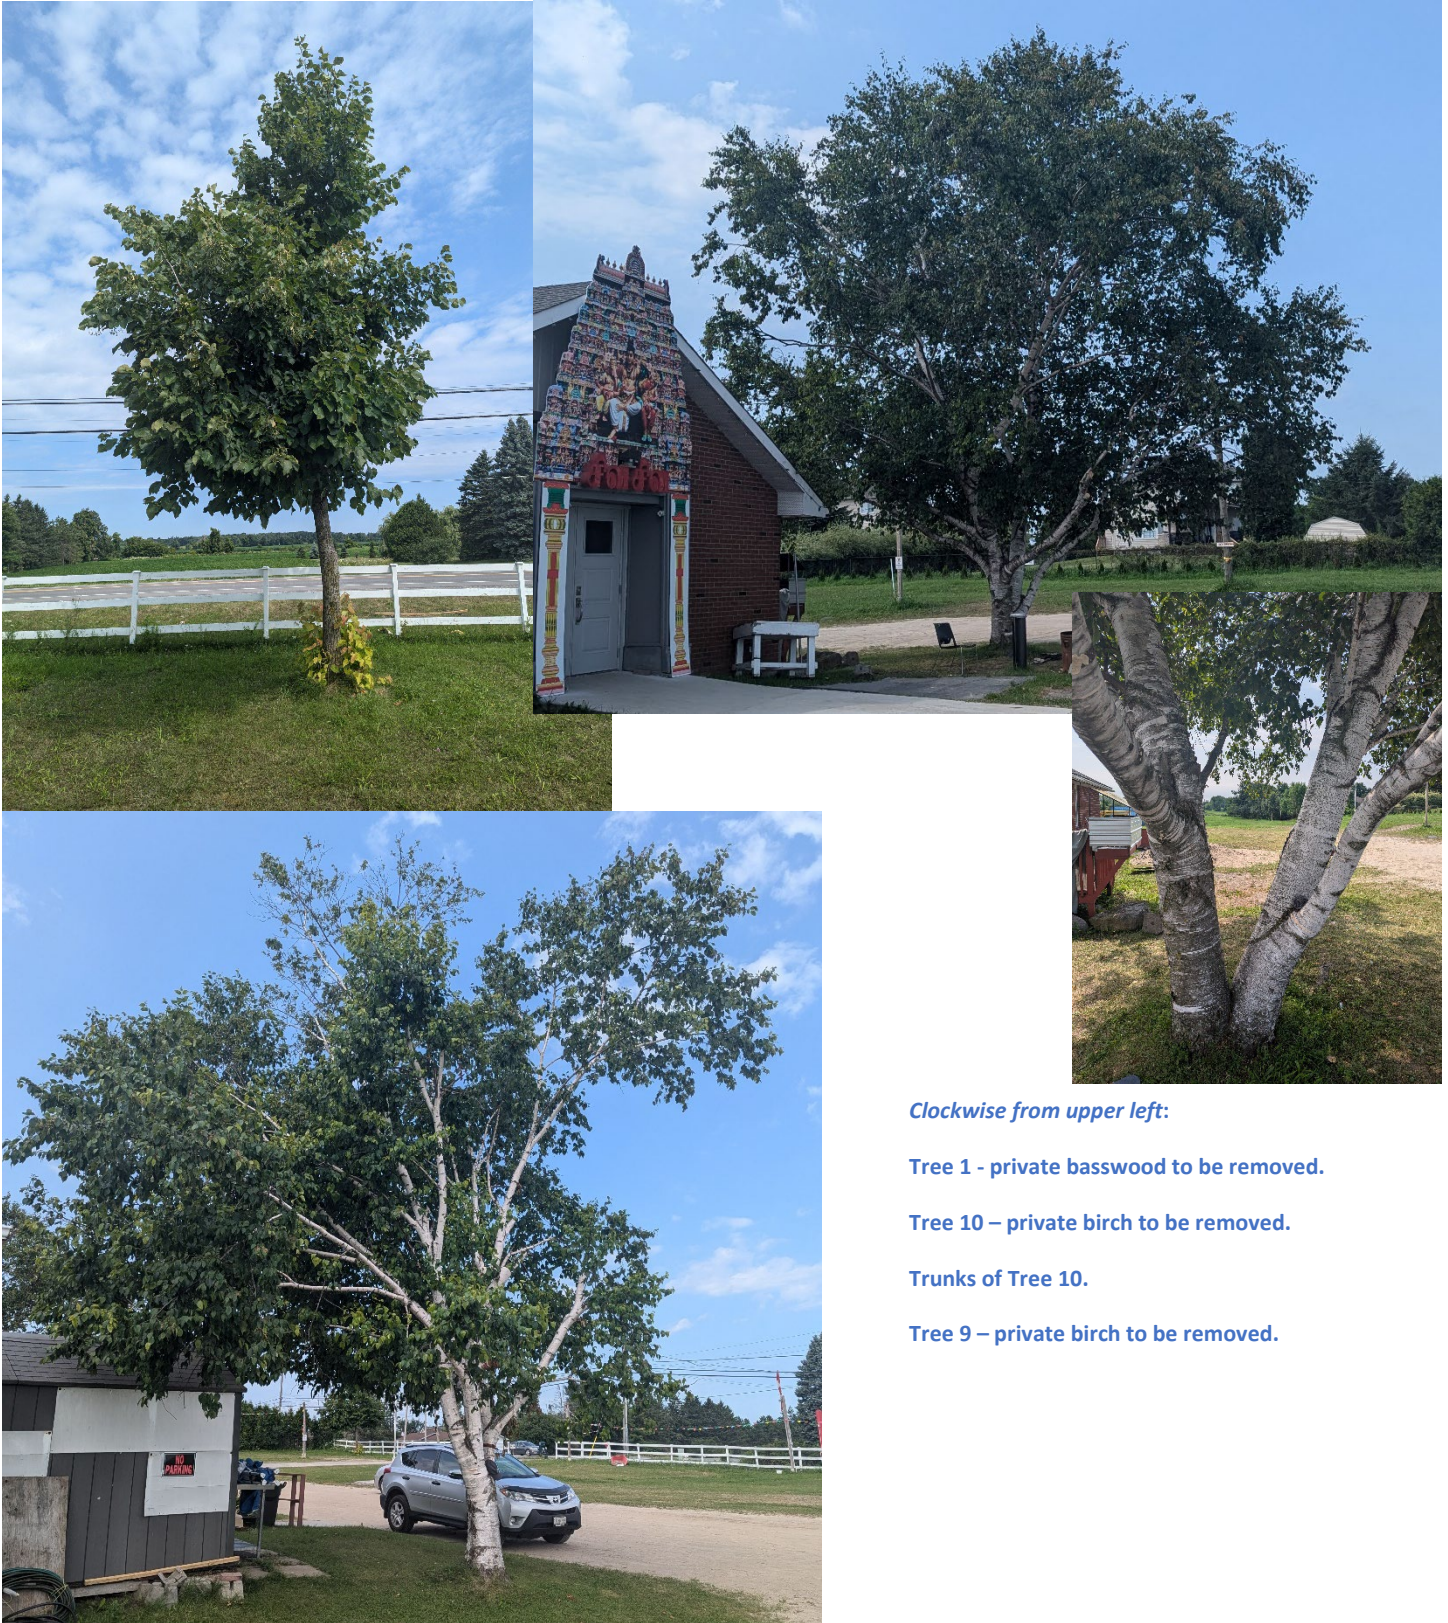
Tree 1 - private basswood to be removed.

Tree 10 – private birch to be removed.

Trunks of Tree 10.

Tree 9 – private birch to be removed.
