Report

Trail Road Battery Energy Storage System (BESS)
Fluvial Geomorphology Assessment

H375035-0000-2B0-066-0001

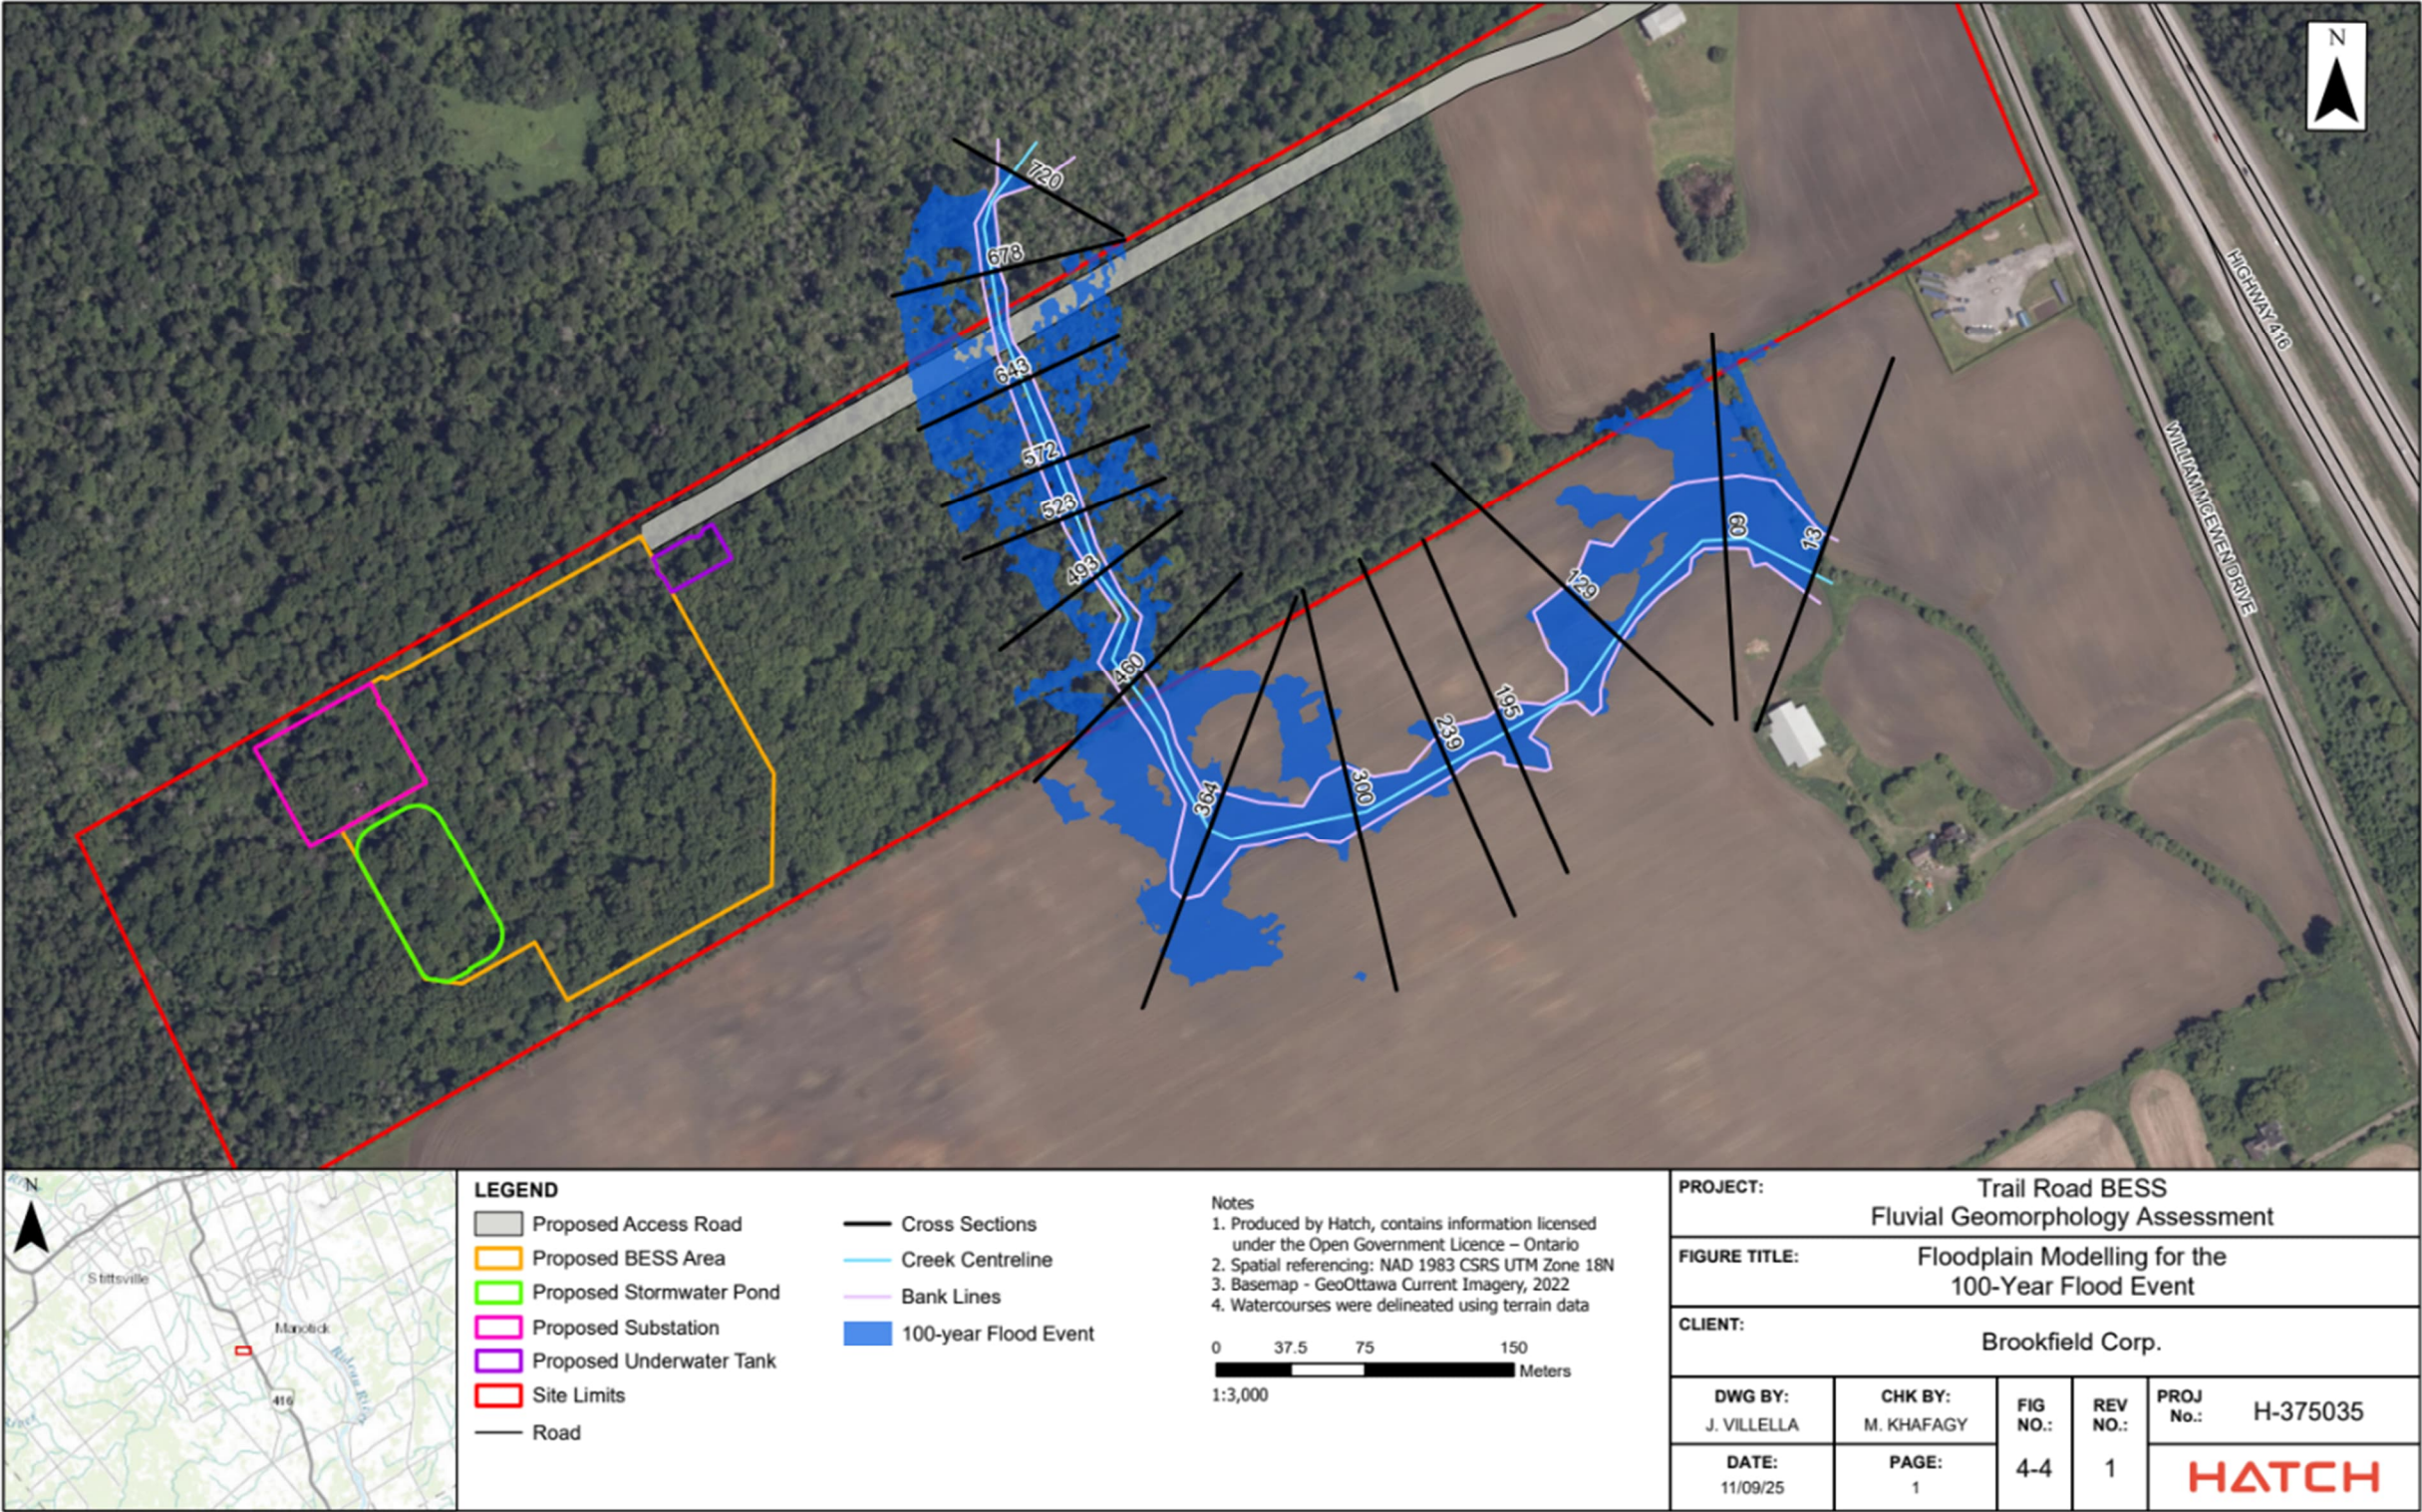
Figure 4-4: Results of Trail Road Creek Floodplain) Modelling for the 100-year Flood Event

The results of the 100-year flood events at the Creek are shown in Figure 4-4 below.

- HEC-RAS 1D hydraulic modelling was performed to estimate floodplain extents under various design flow scenarios. The 100-year floodplain delineation supported the erosion hazard assessment and confirmed no encroachment into the proposed development footprint.

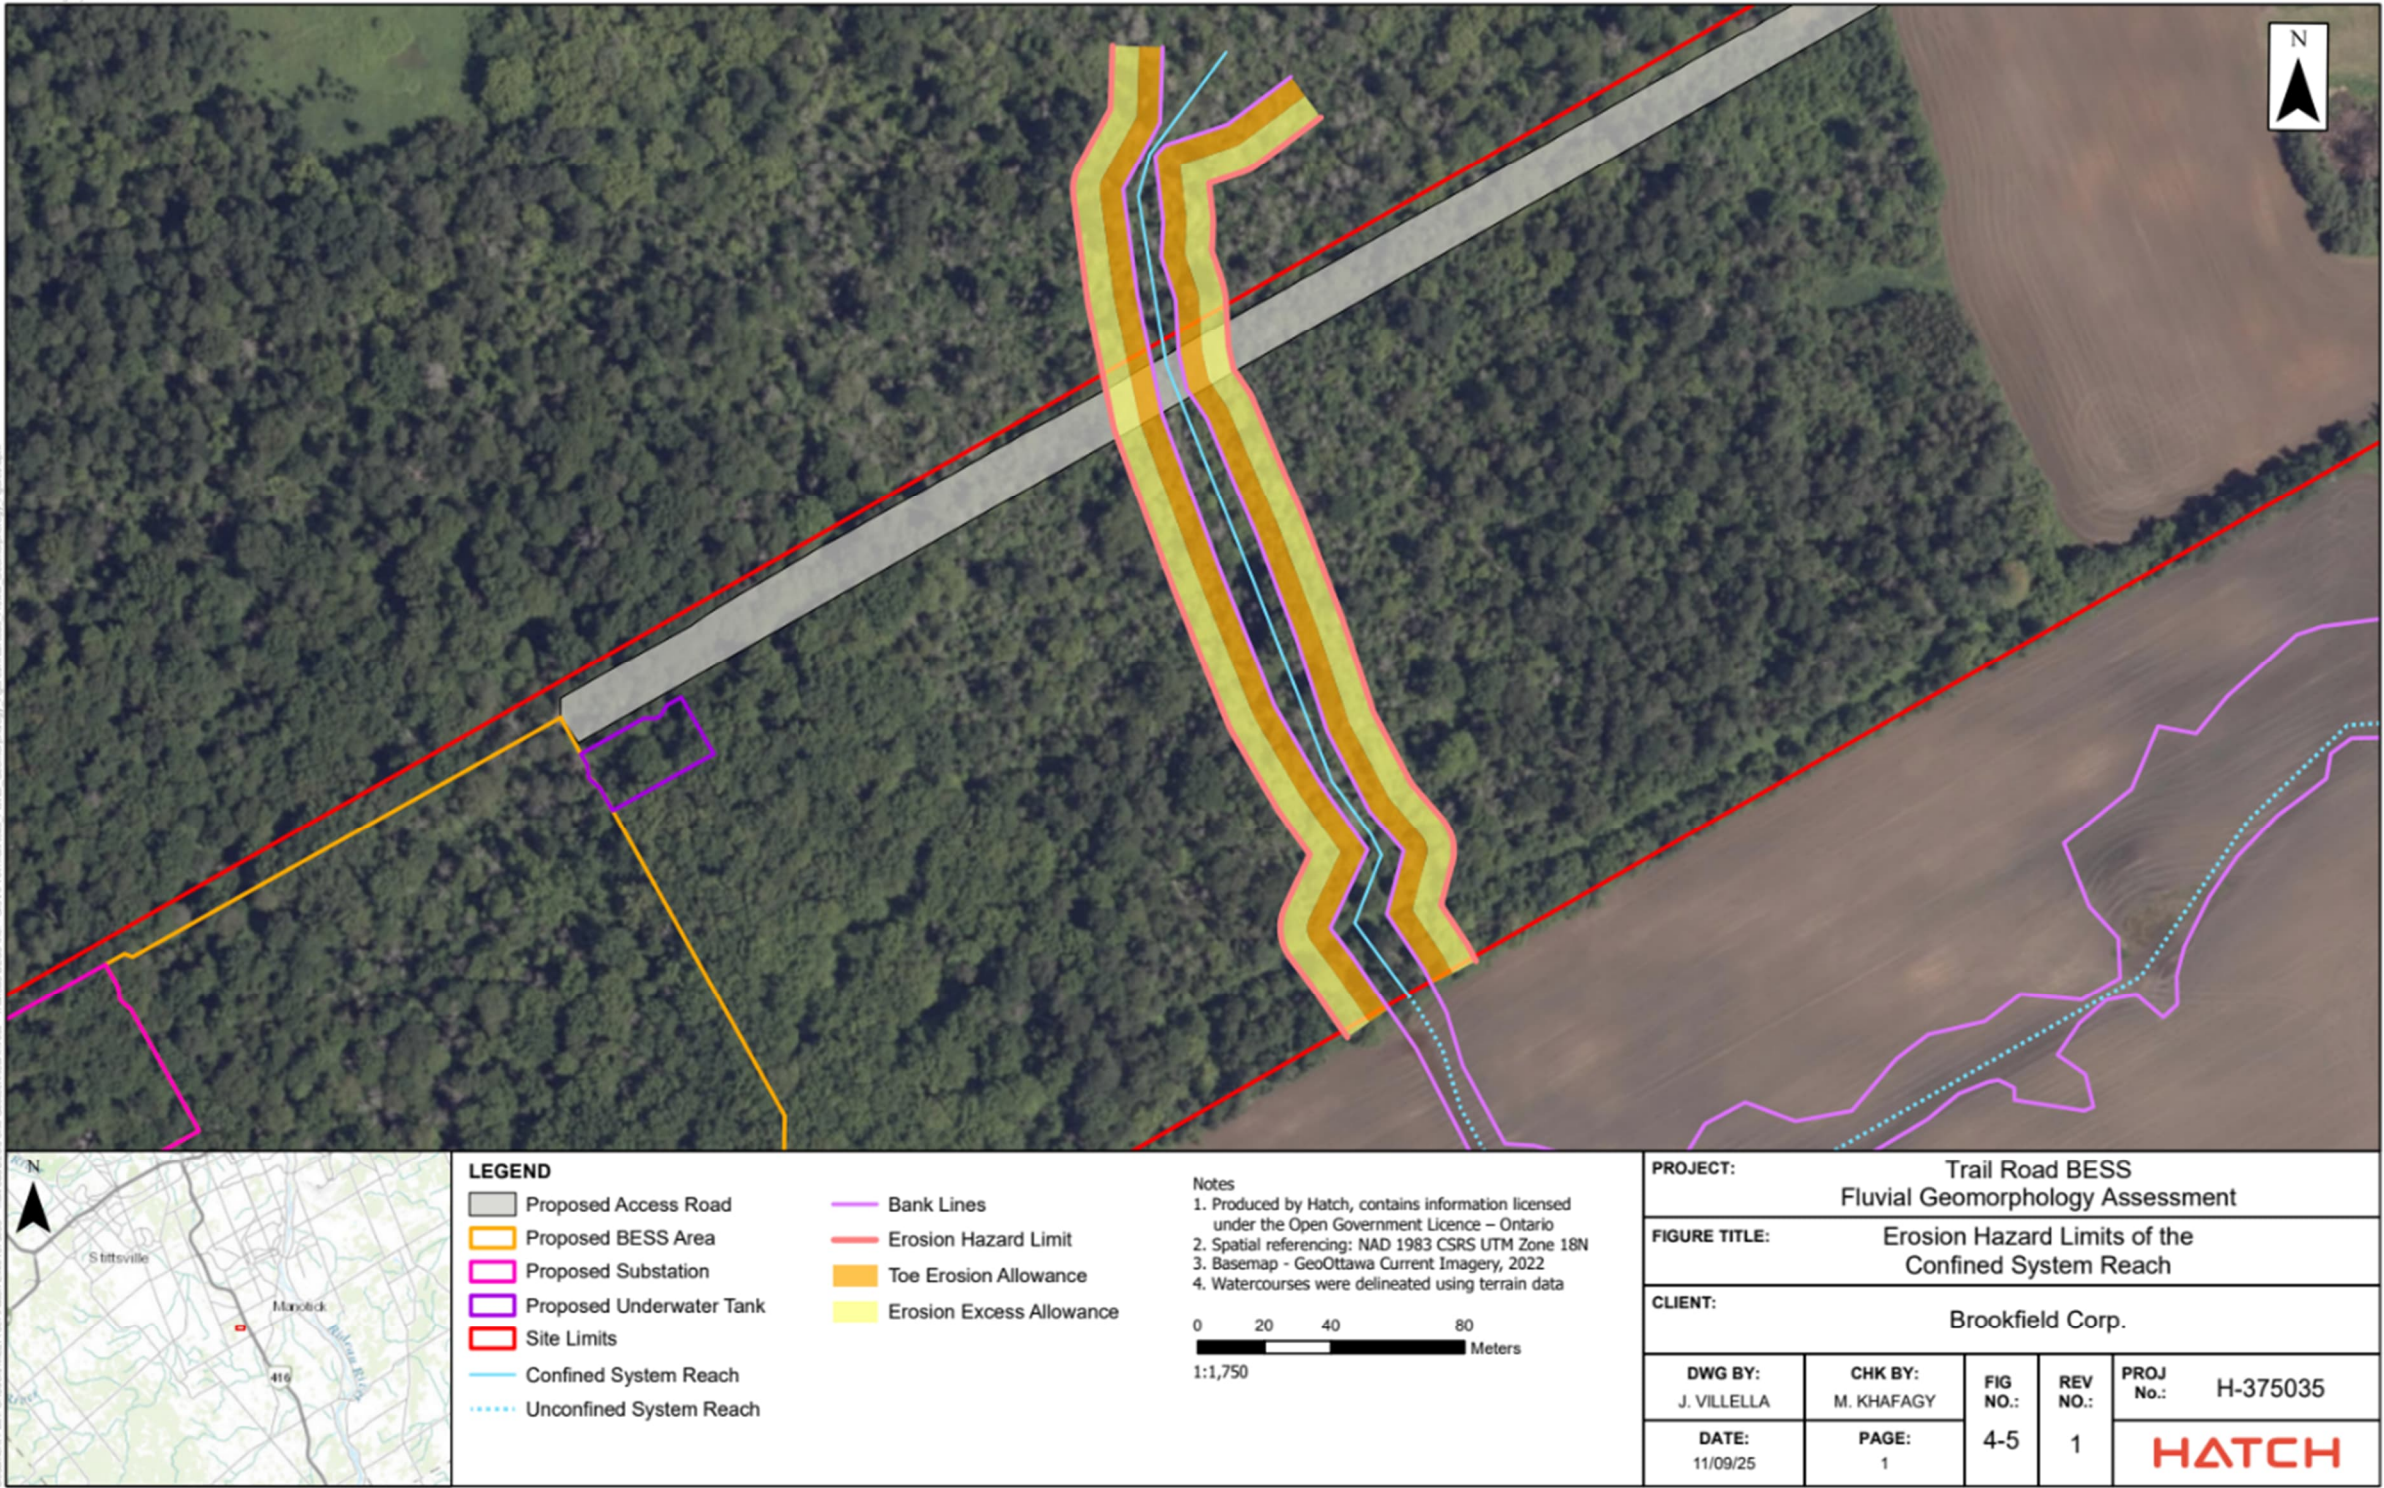
Figure 4-5: Erosion Hazard Limit of the Confined System Reach

An appropriate approach is to delineate the erosion hazard for the confined systems following MNR Erosion Hazard Limit Technical Guide (2002), where the erosion hazard is comprised of three main components: 1) the toe erosion allowance; 2) the stable slope allowance; and 3) the erosion access allowance. The toe Erosion Allowance represents the potential for channel migration at the base of the valley slope. A toe erosion allowance of 7 m was applied following the MNR Technical Guide (2001). Stable Slope Allowance is to address potential long-term slope instability, where the stable slope allowance is determined based on geotechnical criteria. Based on field observations and desktop review, the Creek within the study area exhibits a shallow bankfull depth of approximately 15 cm, and no defined valley slopes or steep embankments were identified adjacent to the channel. In accordance with the CVC Watershed Planning and Regulation Policies (2010), a stable slope allowance is required only where specific conditions apply, including: slope gradients steeper than 3:1, slope heights equal to or greater than 2 m, visible evidence of slope instability, proximity of bankfull flow to the valley toe of slope (within 15 m), or a known history of slope failure. Not all of these conditions were observed at the subject site.

The proposed development area is located entirely outside the delineated erosion hazard limit associated with the confined system reach of the Creek. As shown in Figure 4-5, there is no overlap between the development footprint and the defined erosion hazard components, including the toe erosion allowance and erosion access allowance. Some considerations should be applied for the proposed service road crossing the Creek and discussed in Section 4.6. This confirms that the development, as currently planned, does not encroach upon areas identified as geomorphologically sensitive or at risk of fluvial erosion.

Therefore, a stable slope allowance is not considered necessary for this reach of the watercourse. Erosion Access Allowance is a minimum access distance is typically applied at the top of the valley slope to allow space for maintenance or future stabilization works. Regarding the erosion access allowance, MNR Technical Guide (2002) guidelines note that for stiff/hard cohesive soil (clays, clay silt) and coarse granular (gravels) tills, a 5 to 8 m erosion access is to be applied. Given the evidence of erosion along the Creek, erosion access allowance of 8 m is recommended.

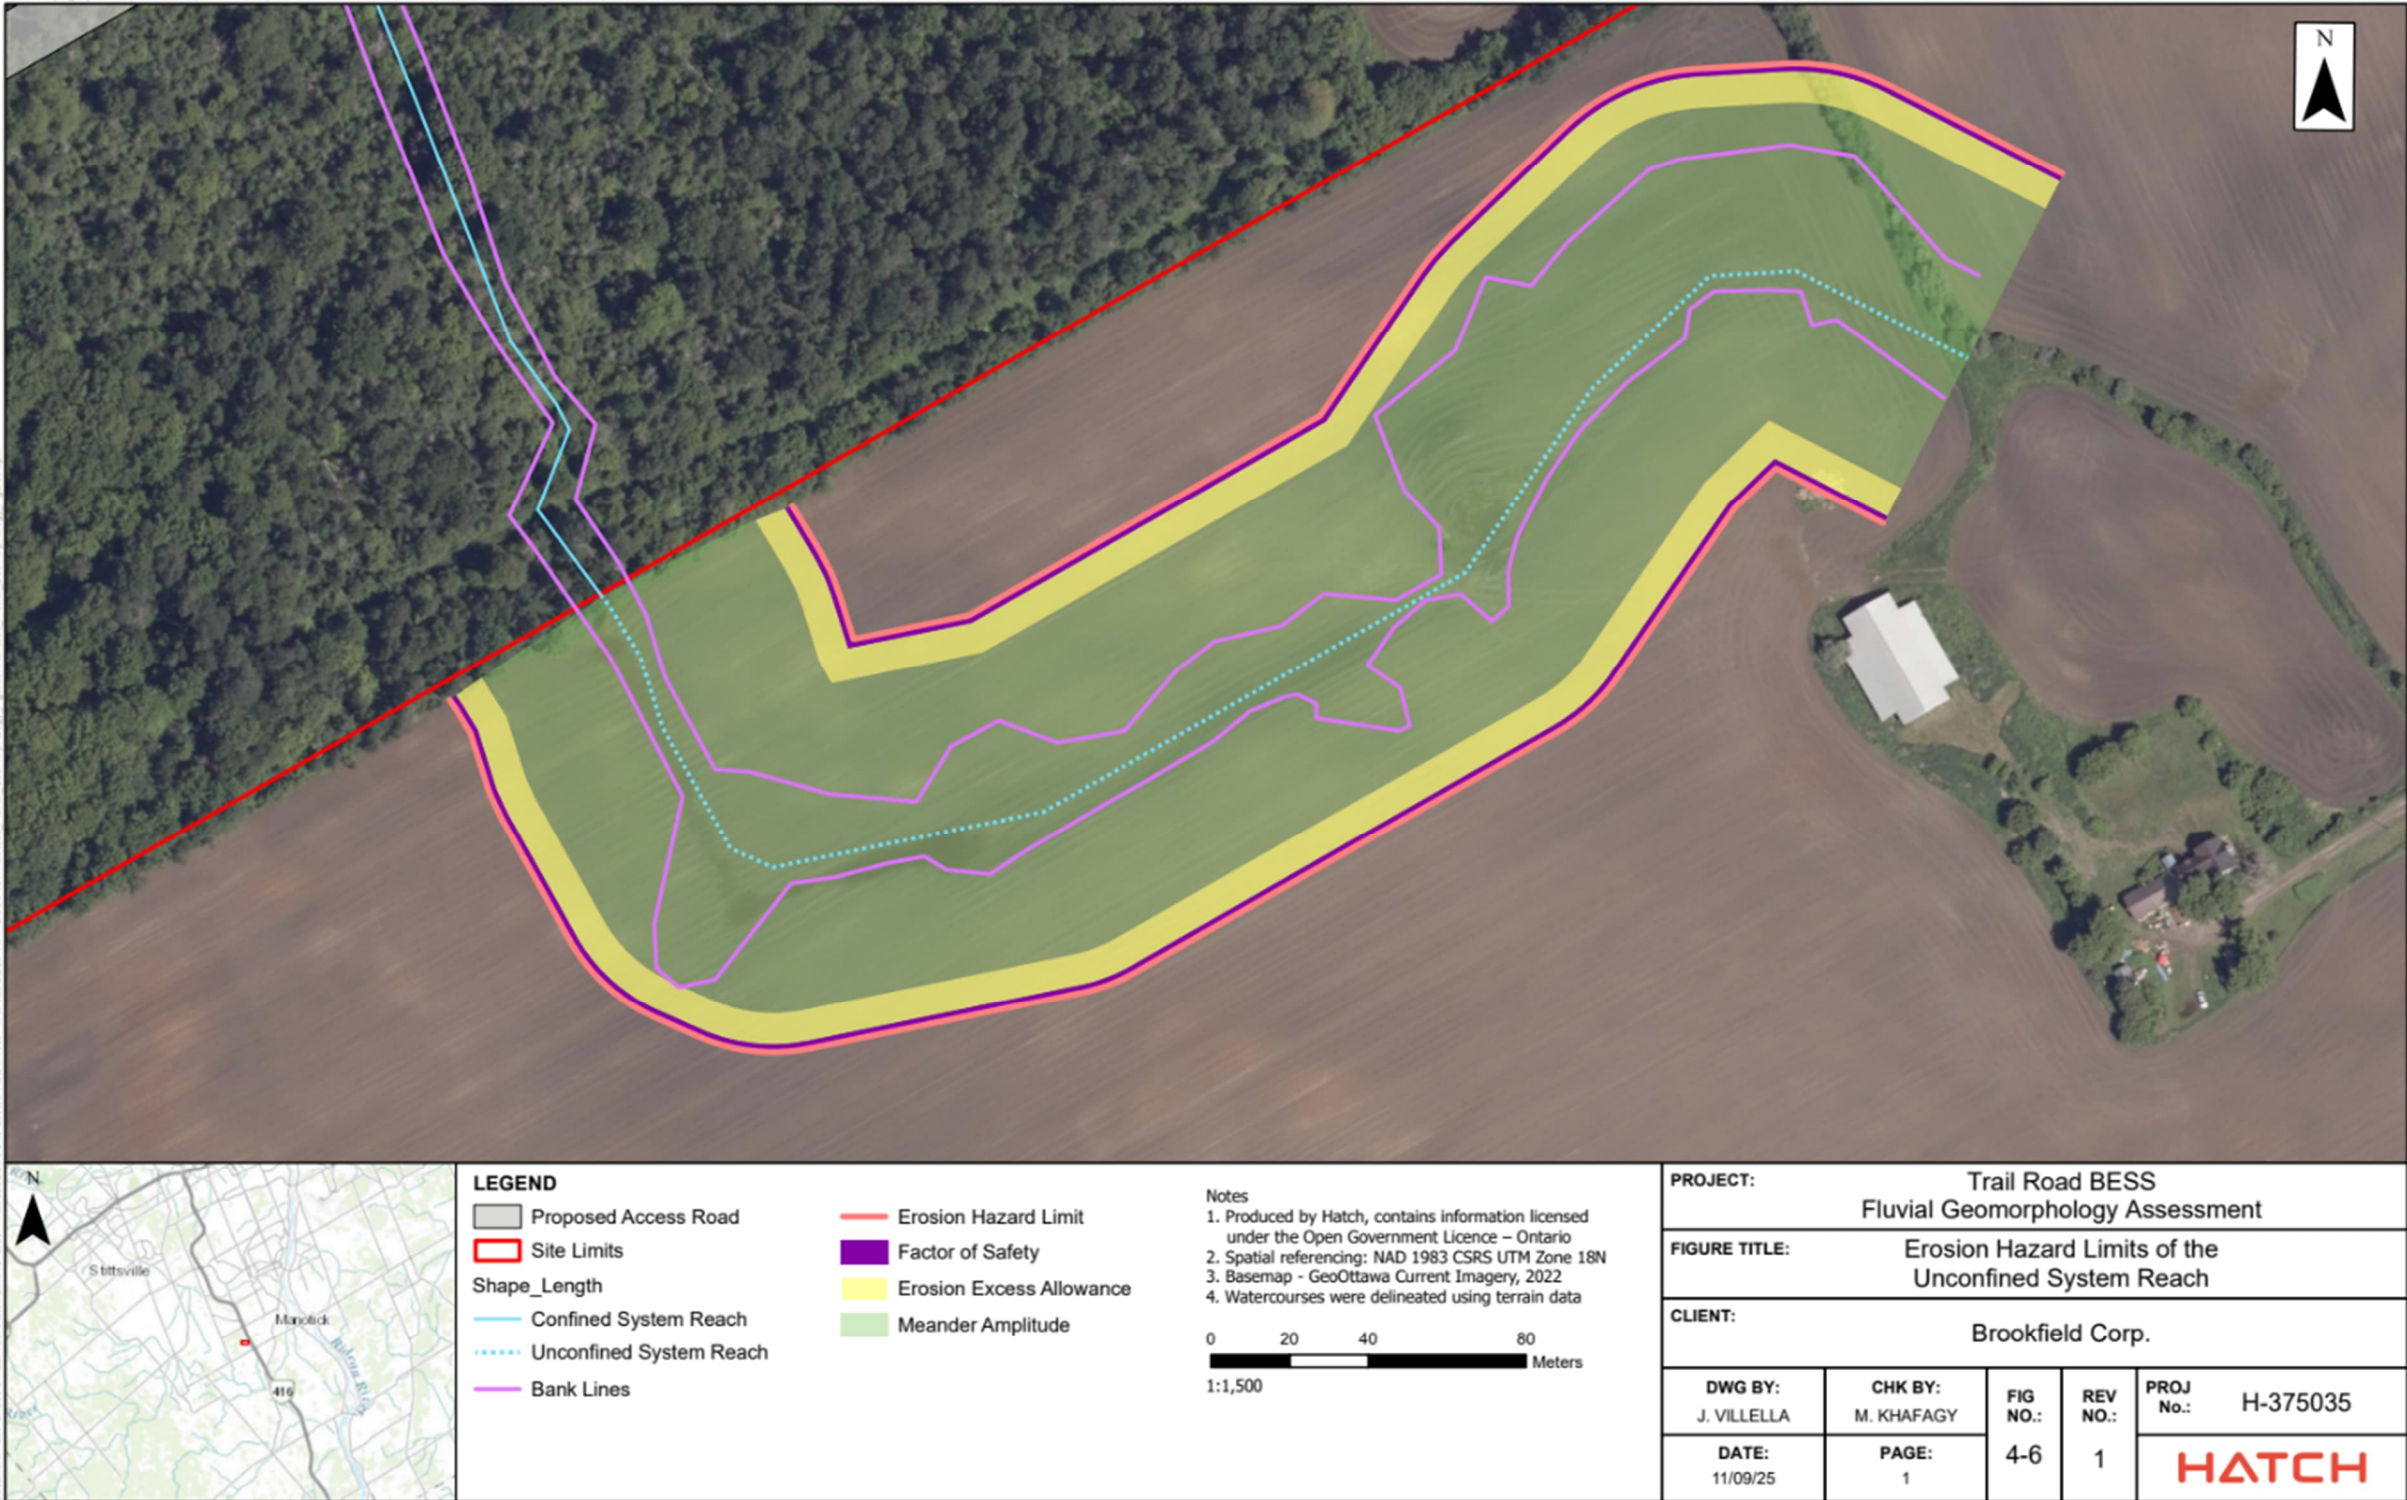
Figure 4-6: Erosion Hazard Limit of the Unconfined System Reach

The downstream reach of the Creek transitions into an unconfined system. In such systems, the erosion hazard is better assessed using a meander belt width approach, which reflects the maximum fixed lateral extent of historical and potential future channel migration. As per MNR Technical Guide (2002), the meander belt width is defined as the summation of meander amplitude and erosion access allowance. In this case, the historical aerial photograph analysis confirms lateral channel migration and expansion of the channel and adjacent wetland features over time. An erosion access allowance of 8 m is recommended for the unconfined system reach. Figure 4-6 shows the erosion hazard limit for both reaches of the Creek (Unconfined System) including the Meander belt Width and erosion access allowance.

An appropriate safety factor can be applied to the Erosion Hazard limit as per guideline recommendations. A 2 m safety factor has been applied to both reaches of the creek (the confined and unconfined systems).

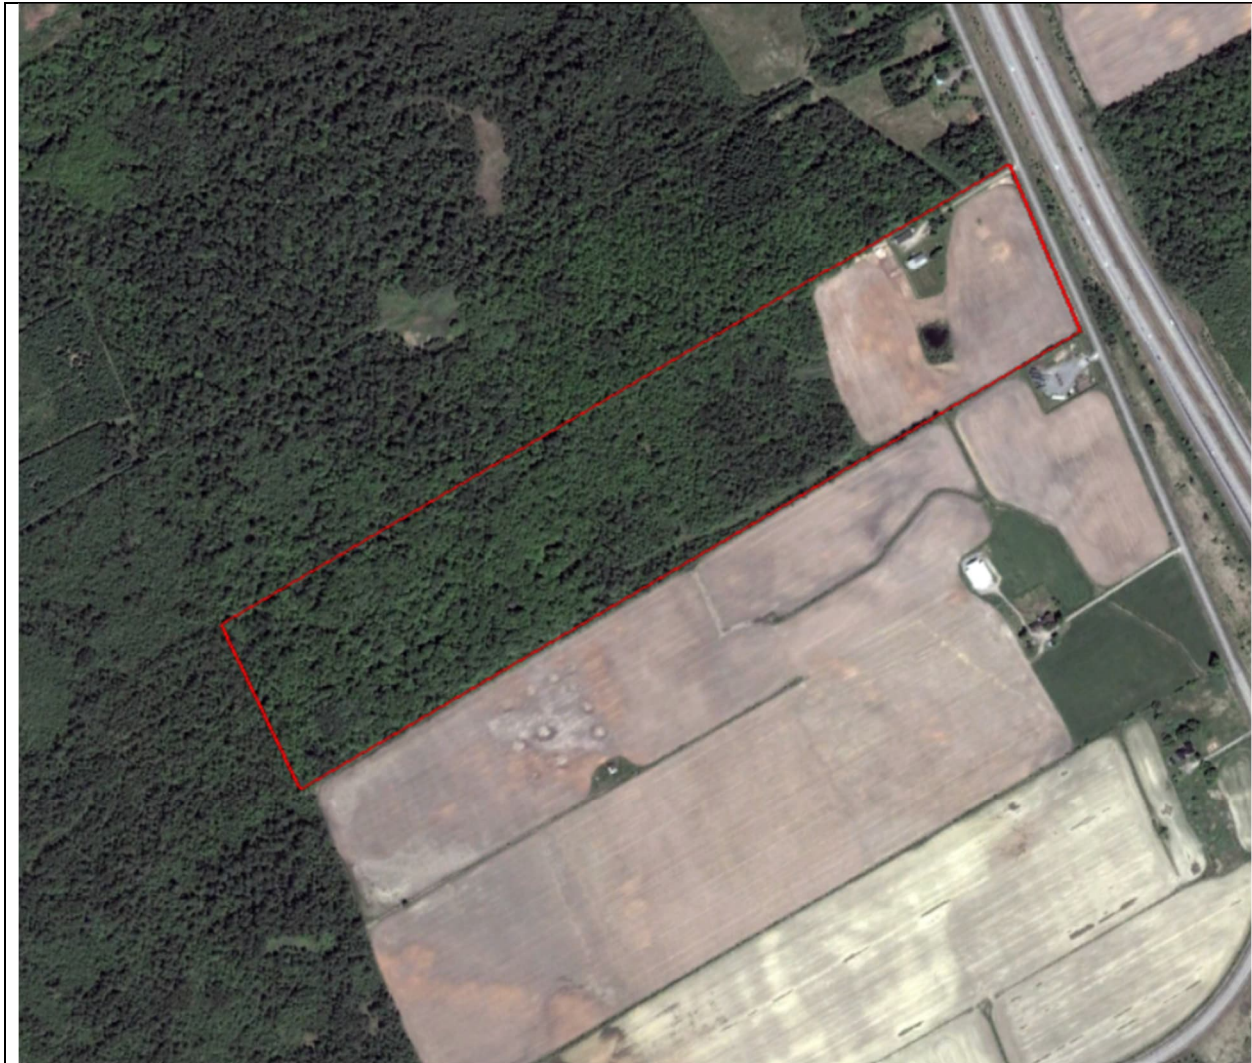
Location: Ottawa, ON
Year: 2012
Scale: 1:14,000
Source: Google Earth Pro
Red Boundary: Site Limits

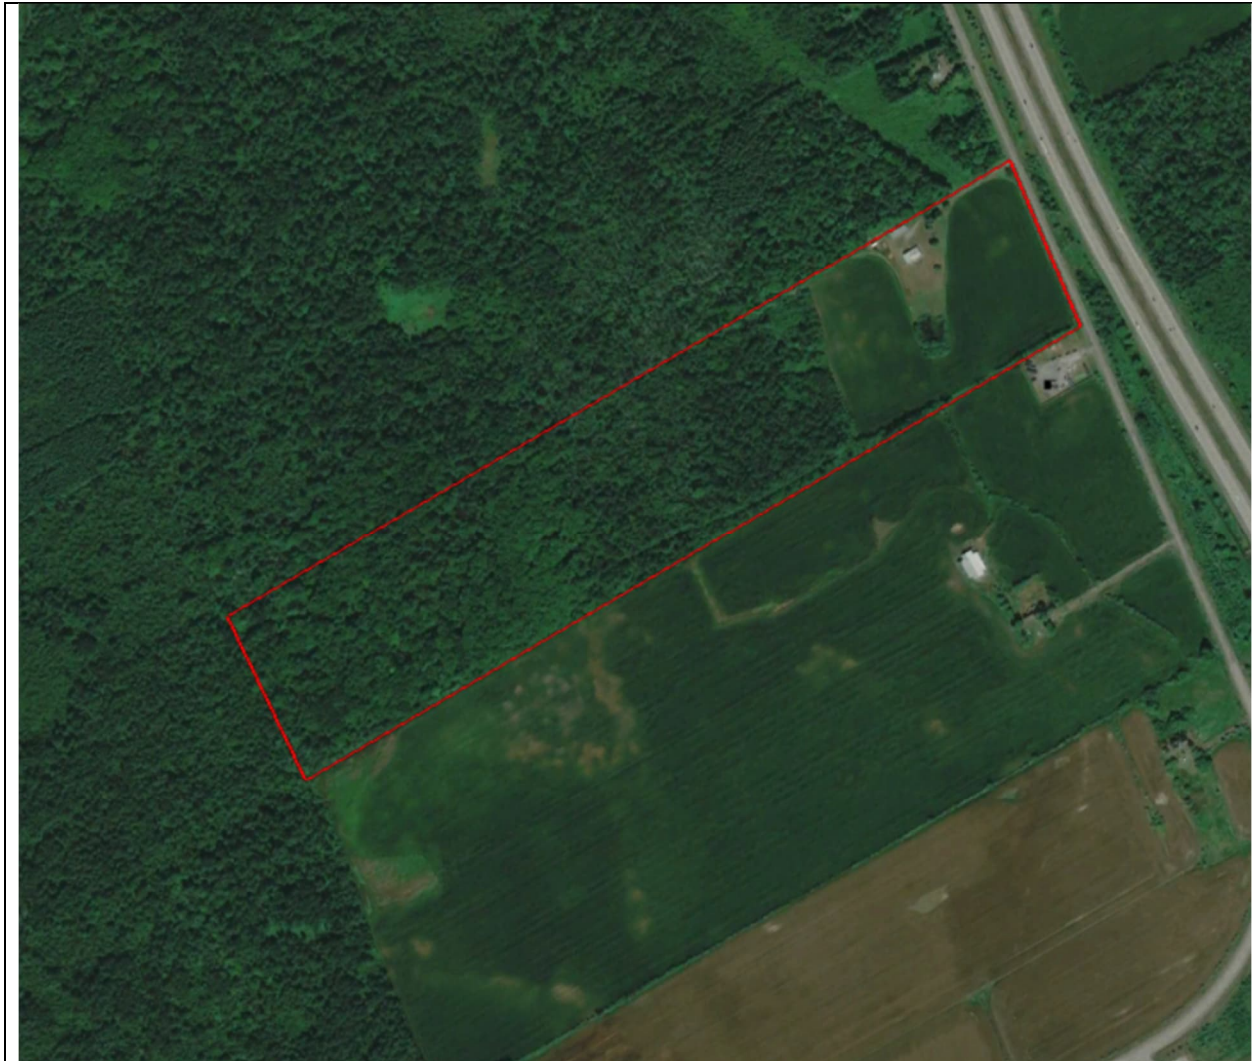
By 2020, the constructed banks are no longer visible, and the condition of the Creek continues to degrade through to 2024. In general, the Creek within the Project site follows a straight alignment; however, no visible changes to the planform of the tributary are observable in all aerial imagery due to tree cover.

Location: Ottawa, ON
Year: 2020
Scale: 1:14,000
Source: Google Earth Pro
Red Boundary: Site Limits

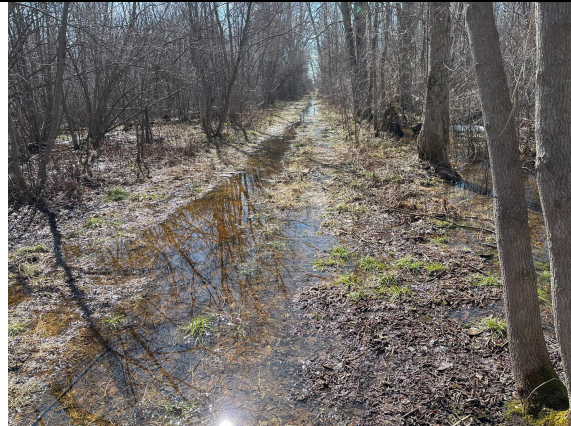
At the north boundary of the Project site, along the property line shared with the adjacent parcel, stagnant water was observed accumulating in a depressed corridor perpendicular to the main Creek alignment as shown in Photo 2 (Appendix B) from location S1. The presence of standing water outside the defined channel zone may also suggest the existence of secondary flow paths or backwater effects during wet periods, although no defined channel is visible in this area.

Photo 2: View looking northeast at the north site boundary (perpendicular to the creek), showing stagnant water on April 7, 2025.

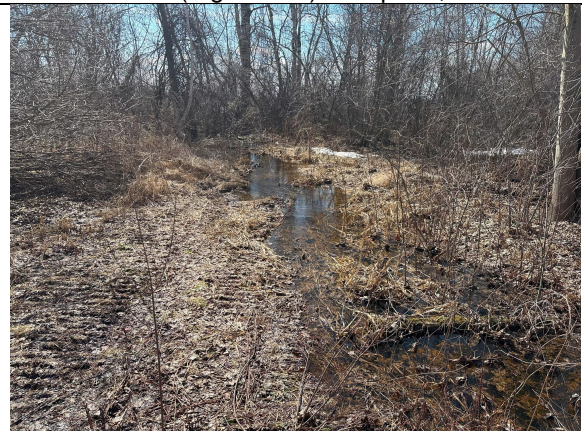
In several locations, including the area shown at location S8 (Photo 16 in Appendix B), evidence of localized channel adjustment and planform variability was observed. The Creek exhibits minor sinuosity, with lateral deflections of the low-flow channel that suggest active, albeit limited, fluvial processes. These deviations in flow alignment are likely the result of small-scale bank erosion and scour occurring along the outer margins of emerging meander features. While the degree of meandering is minimal due to the confined nature of the corridor and limited stream power, these features may represent the early development of a meander belt within the system.

Photo 16: View looking southeast (downstream) at location S8 (Figure 3-1) (minor sinuosity) on April 7, 2025.

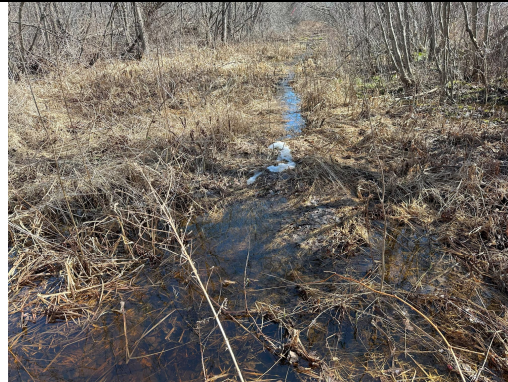
Photo 20: View looking east at the south site boundary from location S9, showing the head of a secondary reach of the creek that initiates on-site and flows eastward on April 7, 2025.
