Phase I Environmental Site Assessment

4405 & 4409 Innes Road Ottawa, Ontario

Report: PE6827-1 November 14, 2024

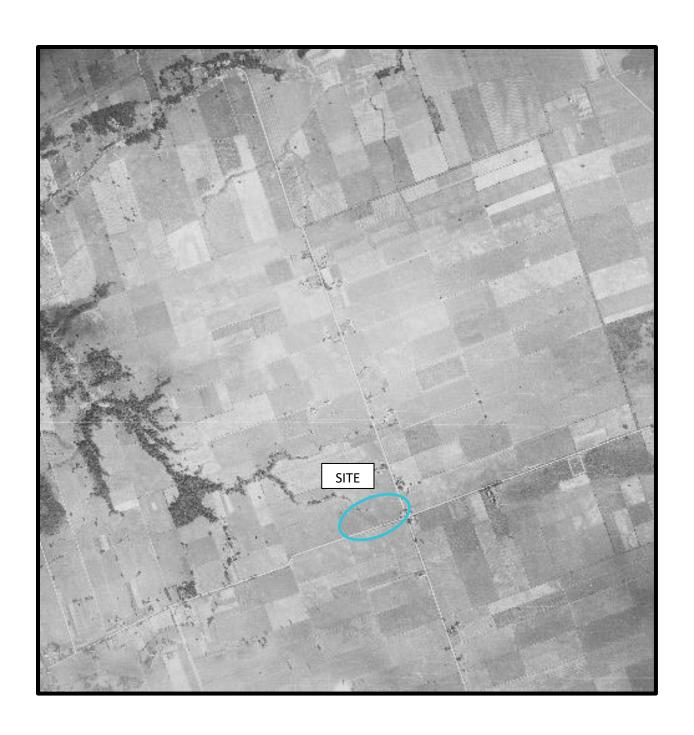
AERIAL PHOTOGRAPH 1946

1946	(Poor Scale) The subject and surrounding properties appear as
	agricultural land, with the exception of some residential dwellings
	along Innes Road and Tenth Line Road.

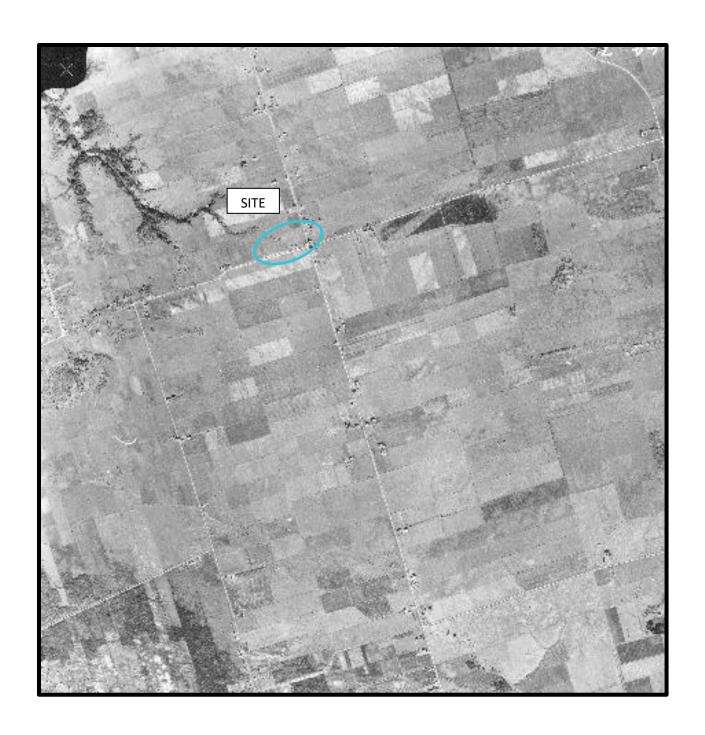
AERIAL PHOTOGRAPH 1960

1960 (Poor Scale, Poor Quality) Two buildings, assumed to be residential dwellings, have been constructed on the subject property. No significant changes have been made to the neighbouring properties since the previous aerial image.

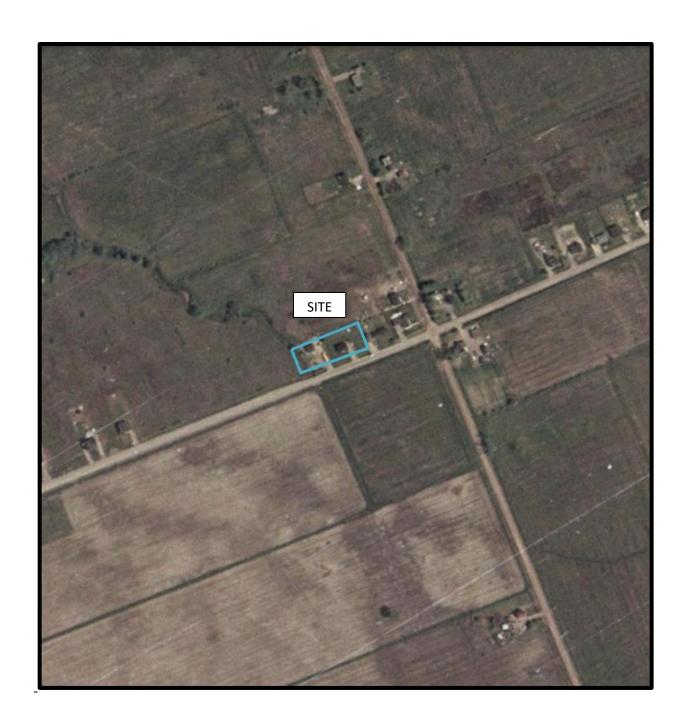
AERIAL PHOTOGRAPH 1976

The subject property appears to be developed with two residential dwellings and associated driveways. No significant changes have been made to the neighbouring properties since the previous aerial image.

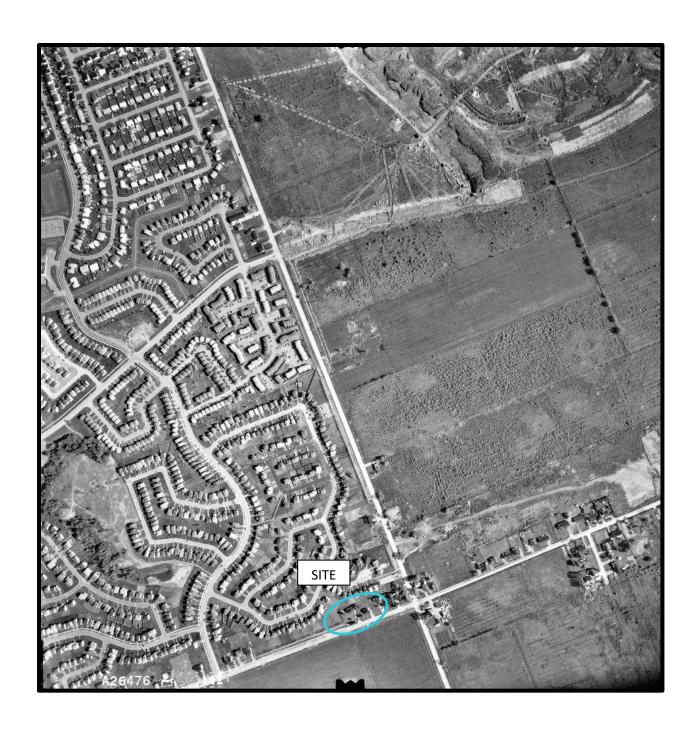
AERIAL PHOTOGRAPH 1984

1984 (Poor Scale) The subject property is unchanged since the previous aerial photograph. Significant residential development has occurred to the northwest of the site. No other changes have been made to the neighbouring properties since the previous aerial image.

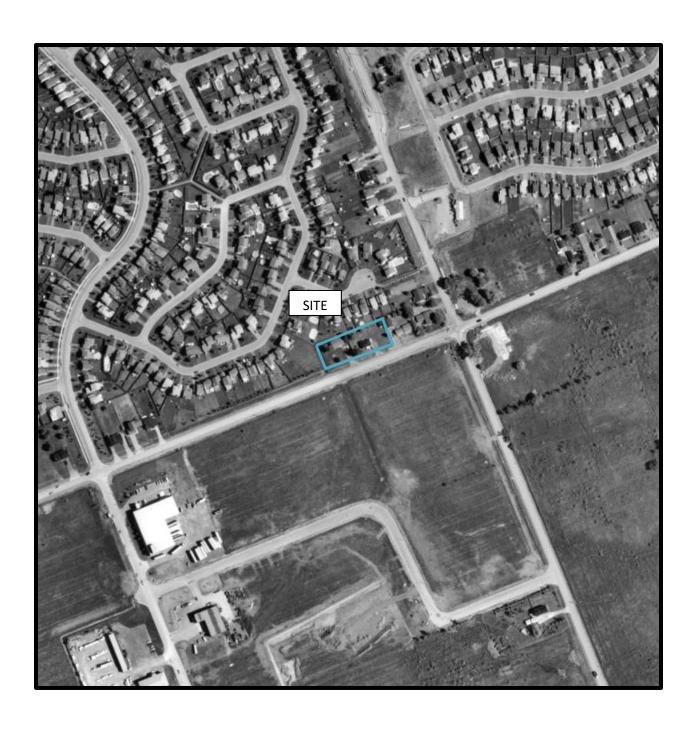
AERIAL PHOTOGRAPH 1991

The subject property is unchanged since the previous aerial photograph. Additional residential dwellings were constructed to the northeast of the site. Several commercial and light industrial buildings have been constructed further southwest. No other changes have been made to the neighbouring properties since the previous image.

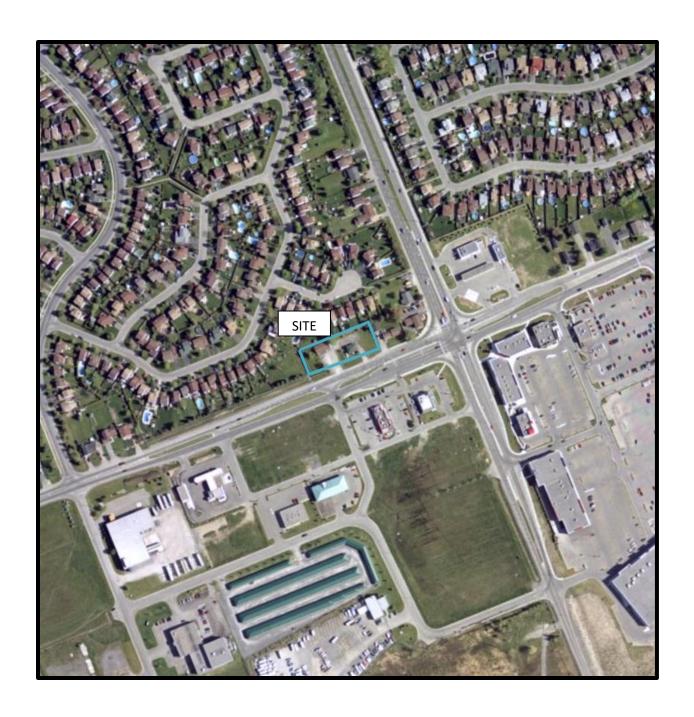
AERIAL PHOTOGRAPH 2002

The subject property is unchanged since the previous aerial photograph. Significant commercial development has occurred to the south, including the addition of an auto repair shop. To the east, a retail fuel outlet was constructed. No other significant changes have been made to the subject or neighbouring properties since the previous aerial image.

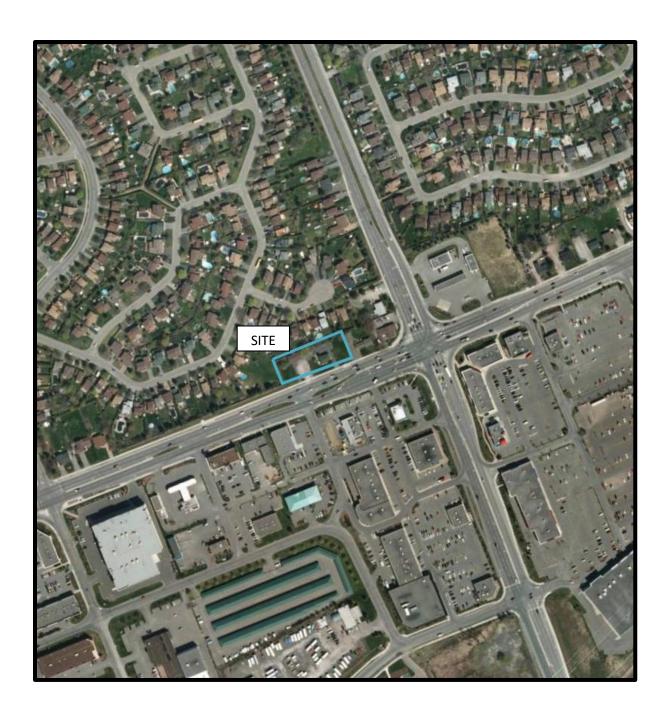
AERIAL PHOTOGRAPH 2011

The subject property is unchanged since the previous aerial photograph. Additional commercial buildings were constructed to the south of the site. No other changes have been made to the surrounding area since the previous aerial image.

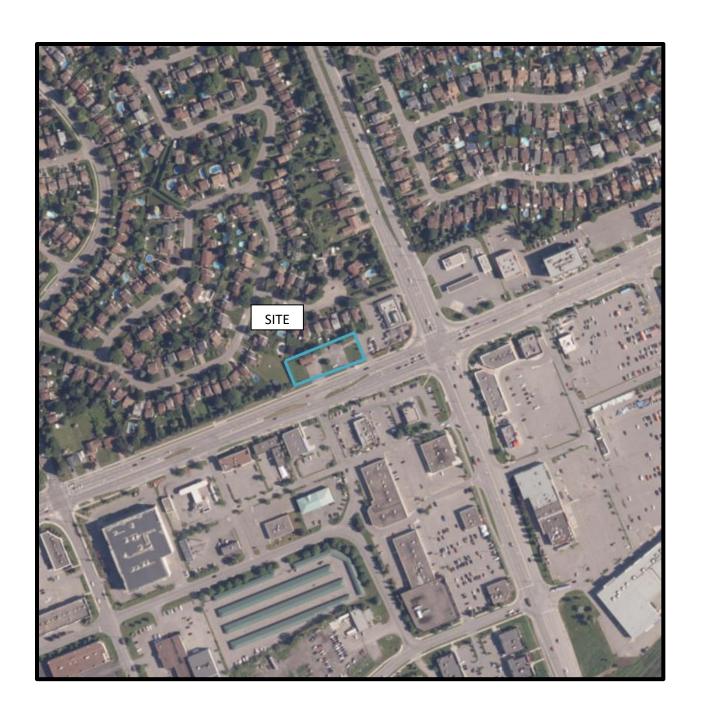
AERIAL PHOTOGRAPH 2022

The residential dwelling on 4409 Innes Road was demolished. The gravel pad at 4405 Innes Road was replaced with a paved parking lot. Three buildings directly to the east of the site were demolished and replaced with the present-day veterinary hospital, pet groomers and associated paved parking lot. No other significant changes have been made to the site or neighbouring properties since the previous aerial photograph.

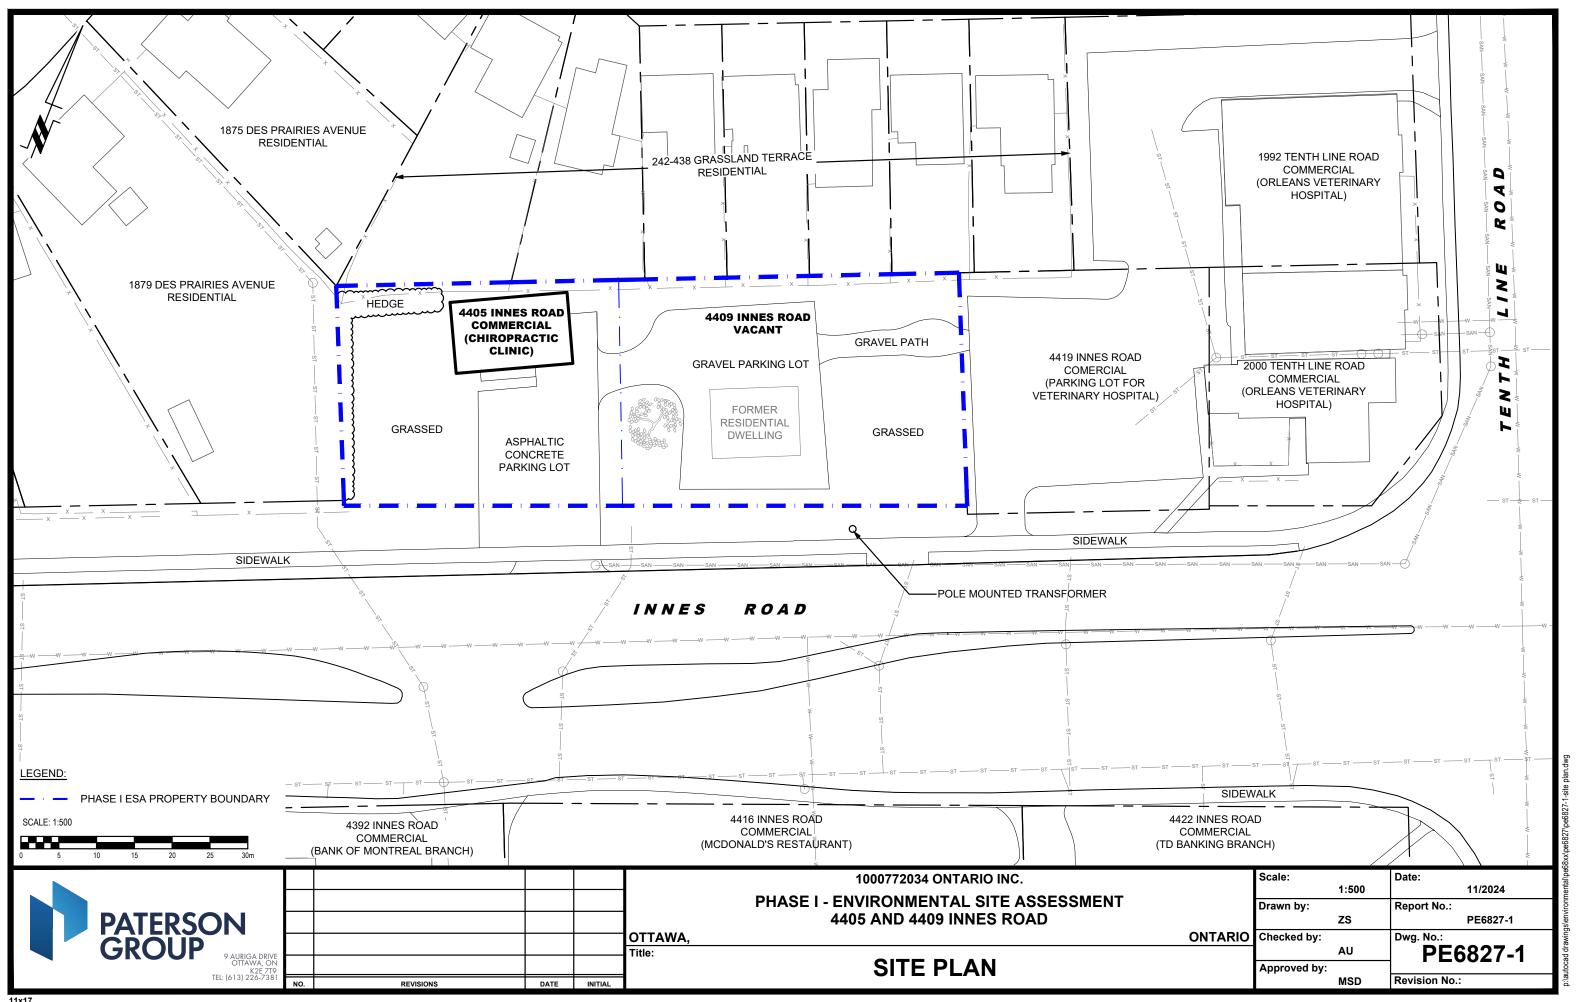
A retail fuel outlet (RFO) is located at 1993 Tenth Line Road, approximately 130m to the east of the site. An auto repair shop is located at 385 Vantage Drive, approximately 140m to the south. Based on the distances from these properties with respect to the subject site, these properties were not considered to pose a potential risk to the Phase I Property. No other concerns were identified with the

current use of the neighbouring lands. Neighbouring land use is shown on Drawing PE6827-1 – Site Plan.
