TREE CONSERVATION REPORT

85 Gemini Way

Tree Conservation Report submitted as Partial Requirements for a Site Plan Control Application, November 28, 2024

Tree Conservation Report – 85 Gemini Way
Map #2 – Proposed Development
Version 1.0, November 28, 2024
For more information, please contact info@dendronforestry.ca

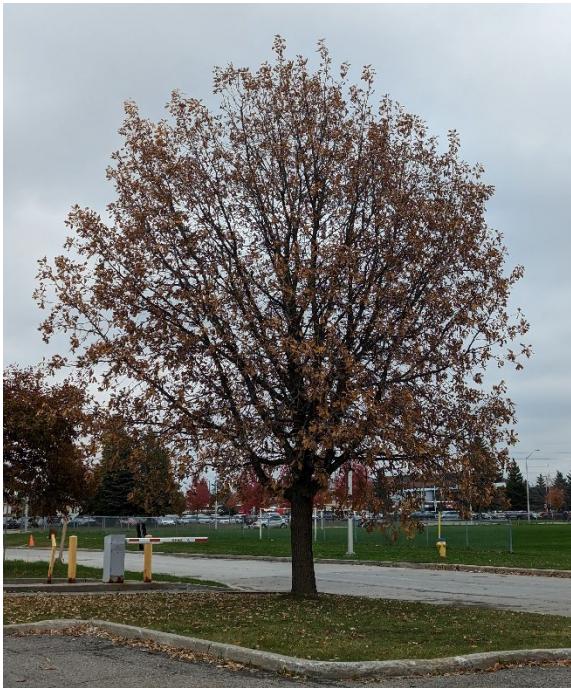
Tree 2 - private oak to be removed.

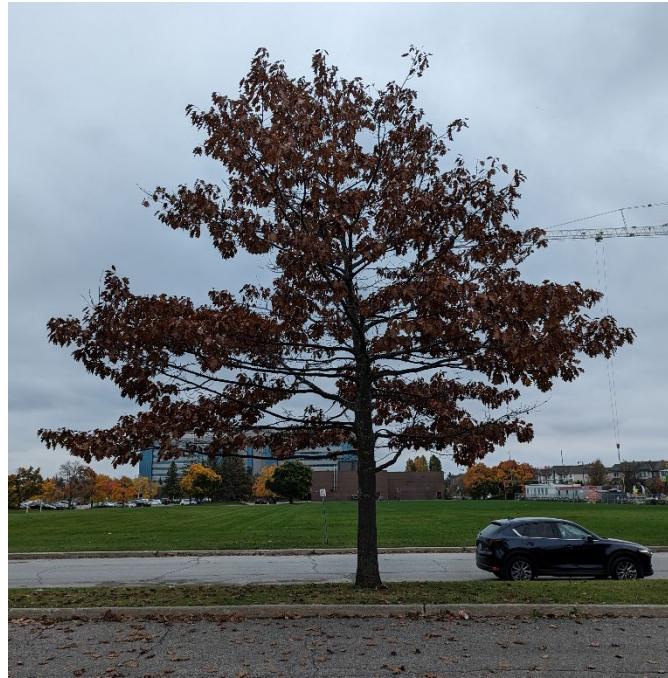
Tree 3 is an oak in good condition. A Tree Protection Area should be installed to ensure that the tree's rooting space is protected to the greatest extent possible.

Tree 3 - private oak to be retained.

Prior to any site works, protective fencing should be installed around the Tree Protection Area as indicated in the attached Tree Information Map and maintained until all construction on site has been completed as per the City of Ottawa Tree Protection Specifications (March 2021).

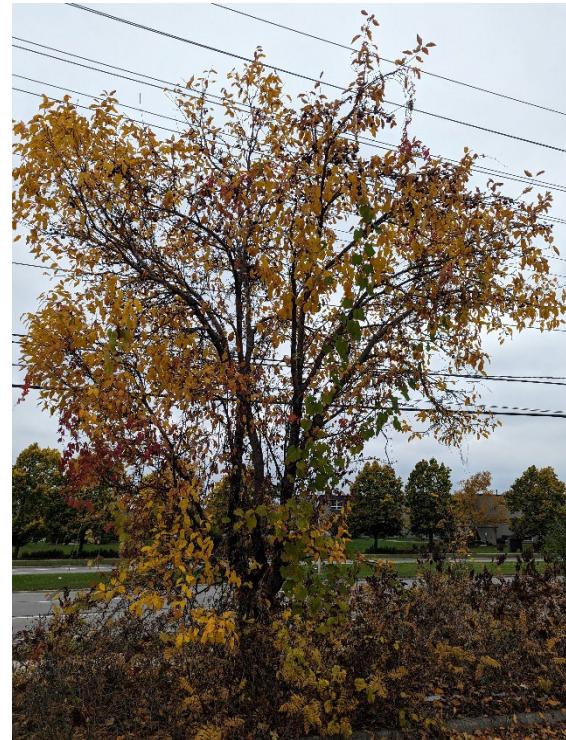
Tree 29 – private crab apple to be removed.
