CM3 Project: SDC1023

**Yard Cleanup – Automotive Fluid Containers and Oil Stained Areas
3210 Albion Road South, Ottawa, Ontario**

1 INTRODUCTION

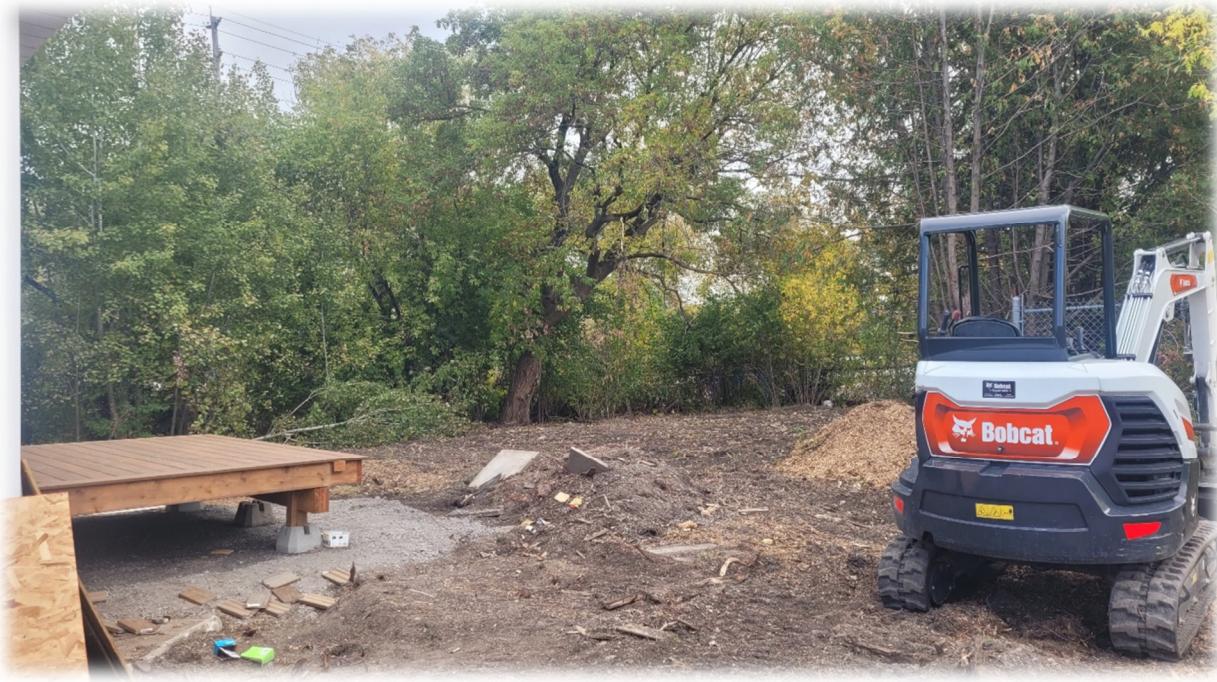
South-East corner of property where small shed with vehicle fluid containers were noted.

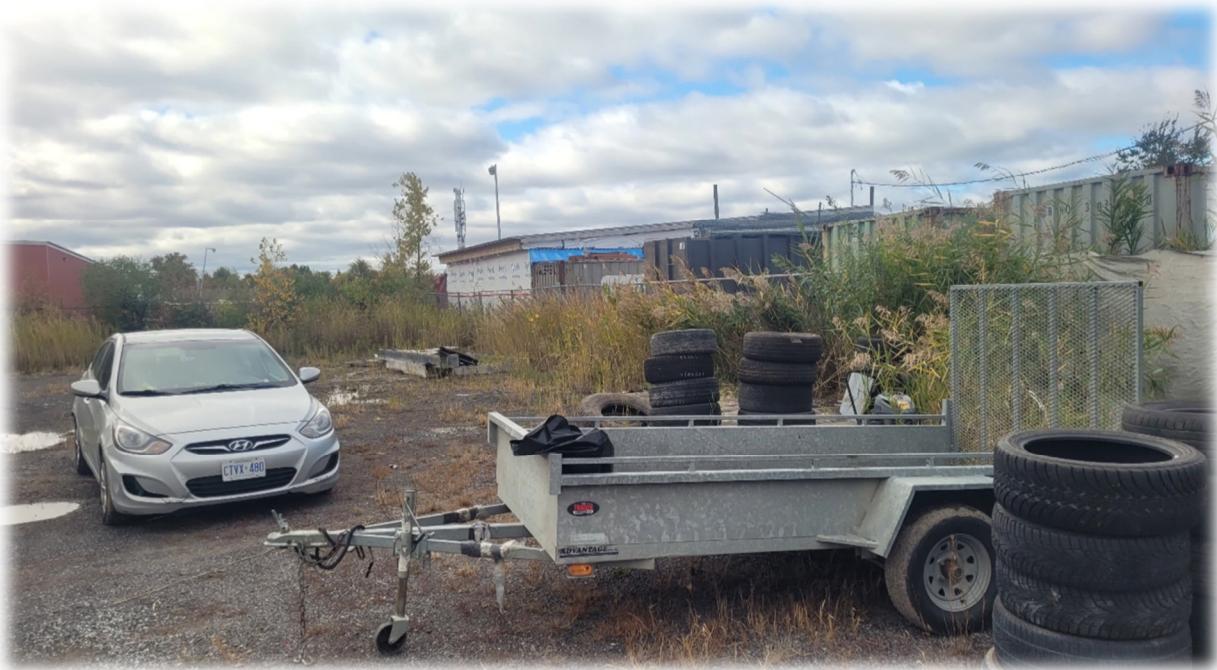
Looking west along north property line where debris and vehicle fluid containers were noted.

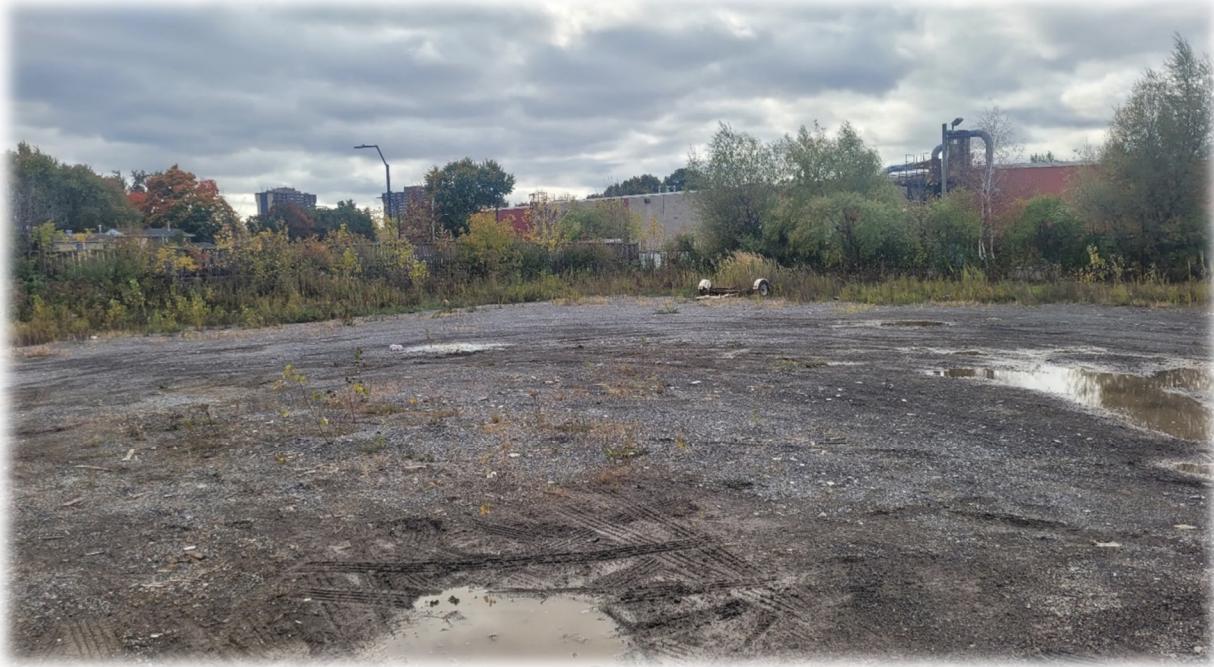
Looking south-west across back lot where oil stained area was located (bottom center of picture and at far south-west corner of property where debris and vehicle fluid containers were located.

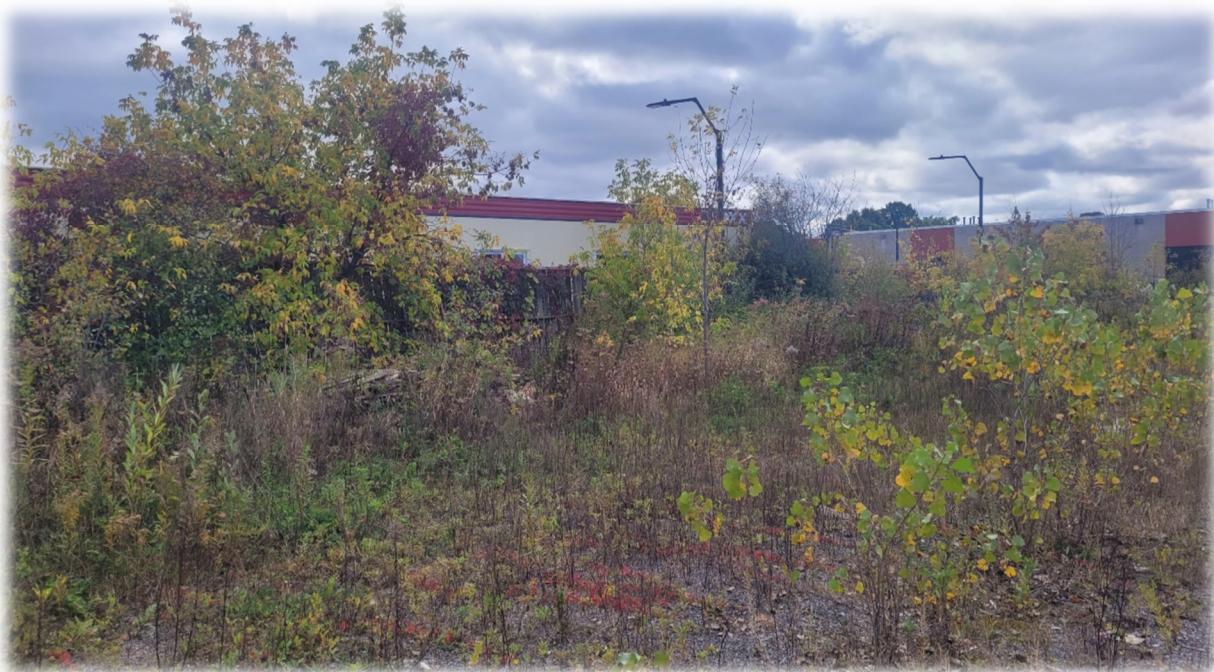
Looking south from rear lot where debris and vehicle fluid containers were noted along south property line in grassed areas.
