STORM & SANITARY SEWER **CCTV INSPECTION REPORT**

Report: HYD-25495

Completion date: September 25th 2025

Project: CCTV - 4000 Riverside Drive , Ottawa

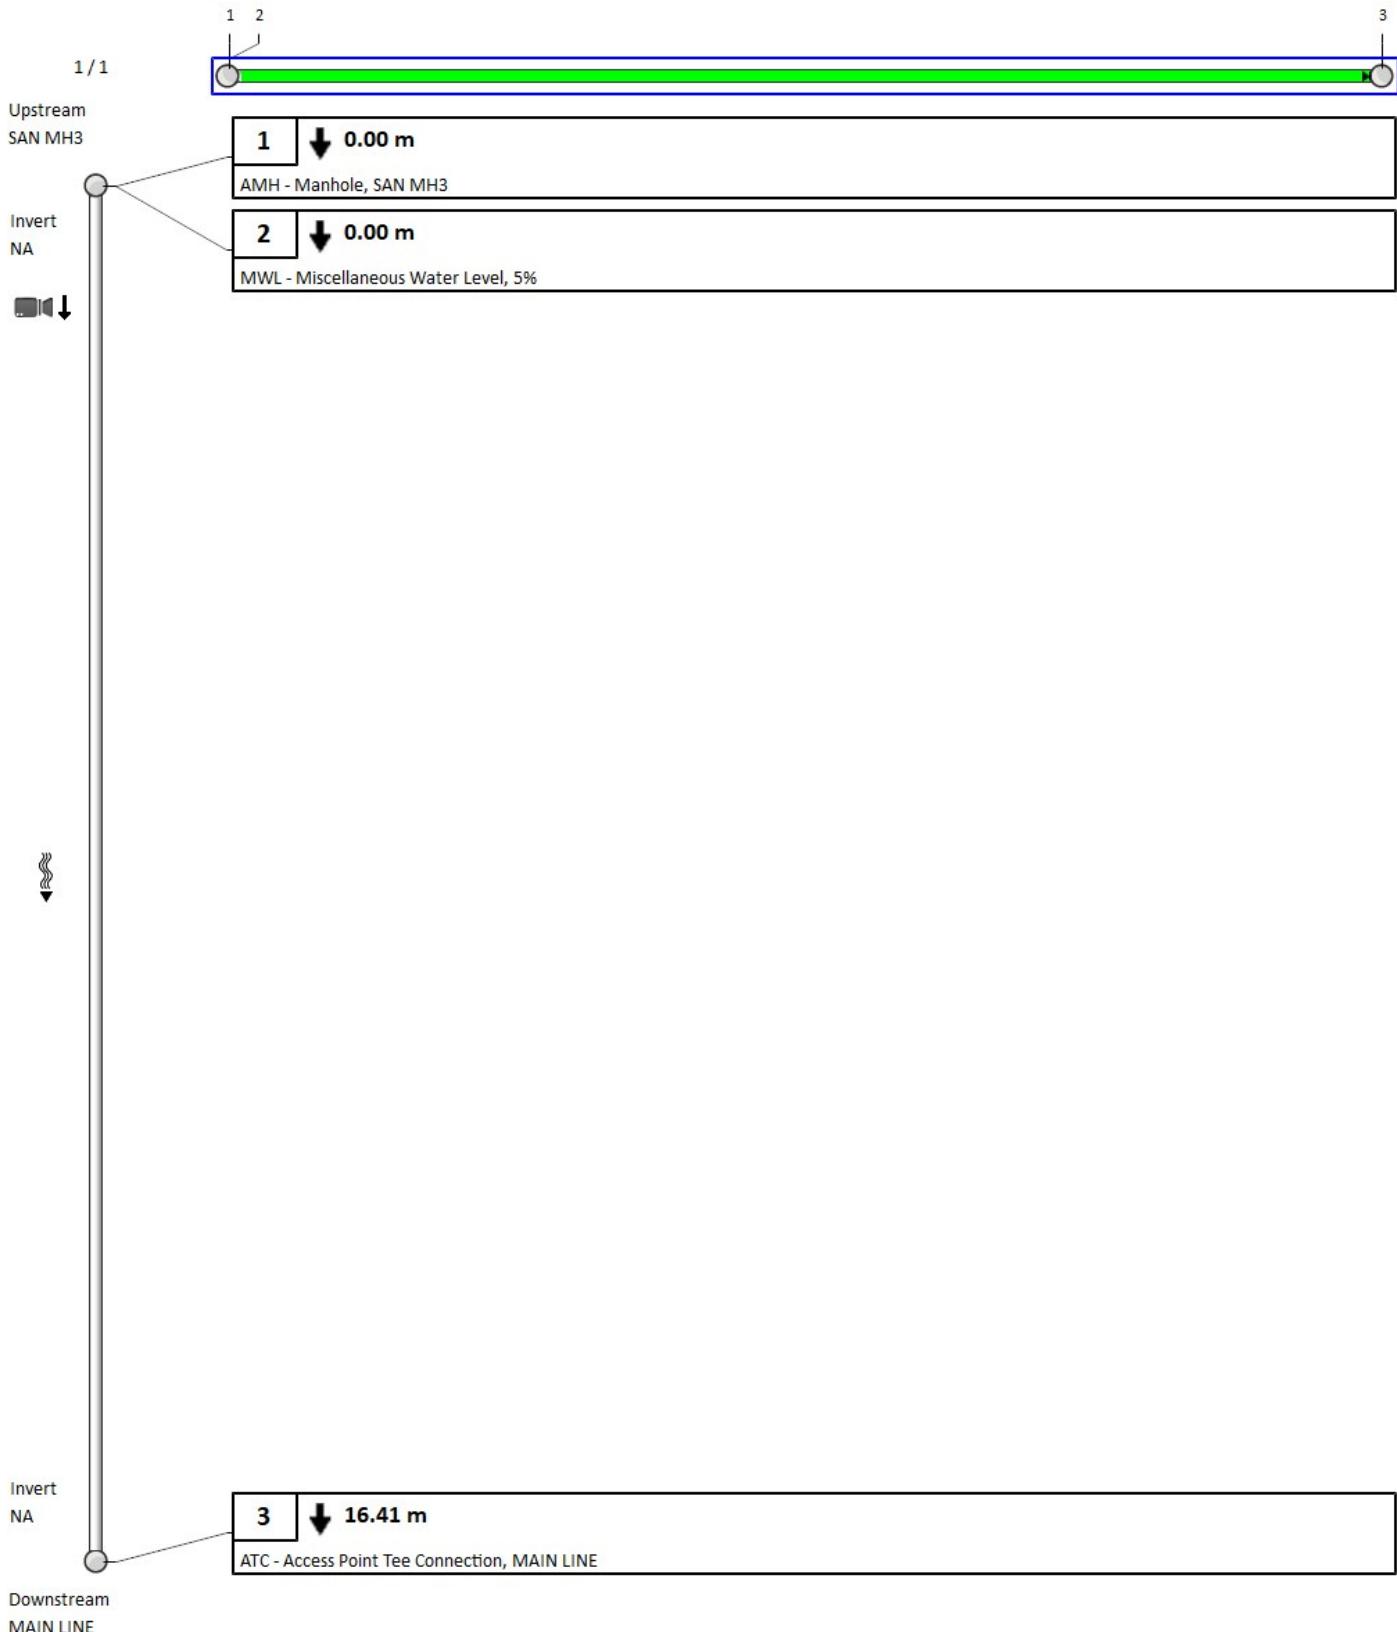
Pipe:	SAN MH3 - MAIN LINE	Direction of inspection:	SAN MH3 --> MAIN LINE
Direction of flow:	SAN MH3 --> MAIN LINE	Direction:	Downstream

Structural rating	O&M rating	Overall rating	Failure
Peak: 0	Peak: 0	Peak: 0	Consequence:
Quick rating: 0000	Quick rating: 0000	Quick rating: 0000	Likelihood: 1
Score: 0	Score: 0	Score: 0	Risk:
Index: 0	Index: 0	Index: 0

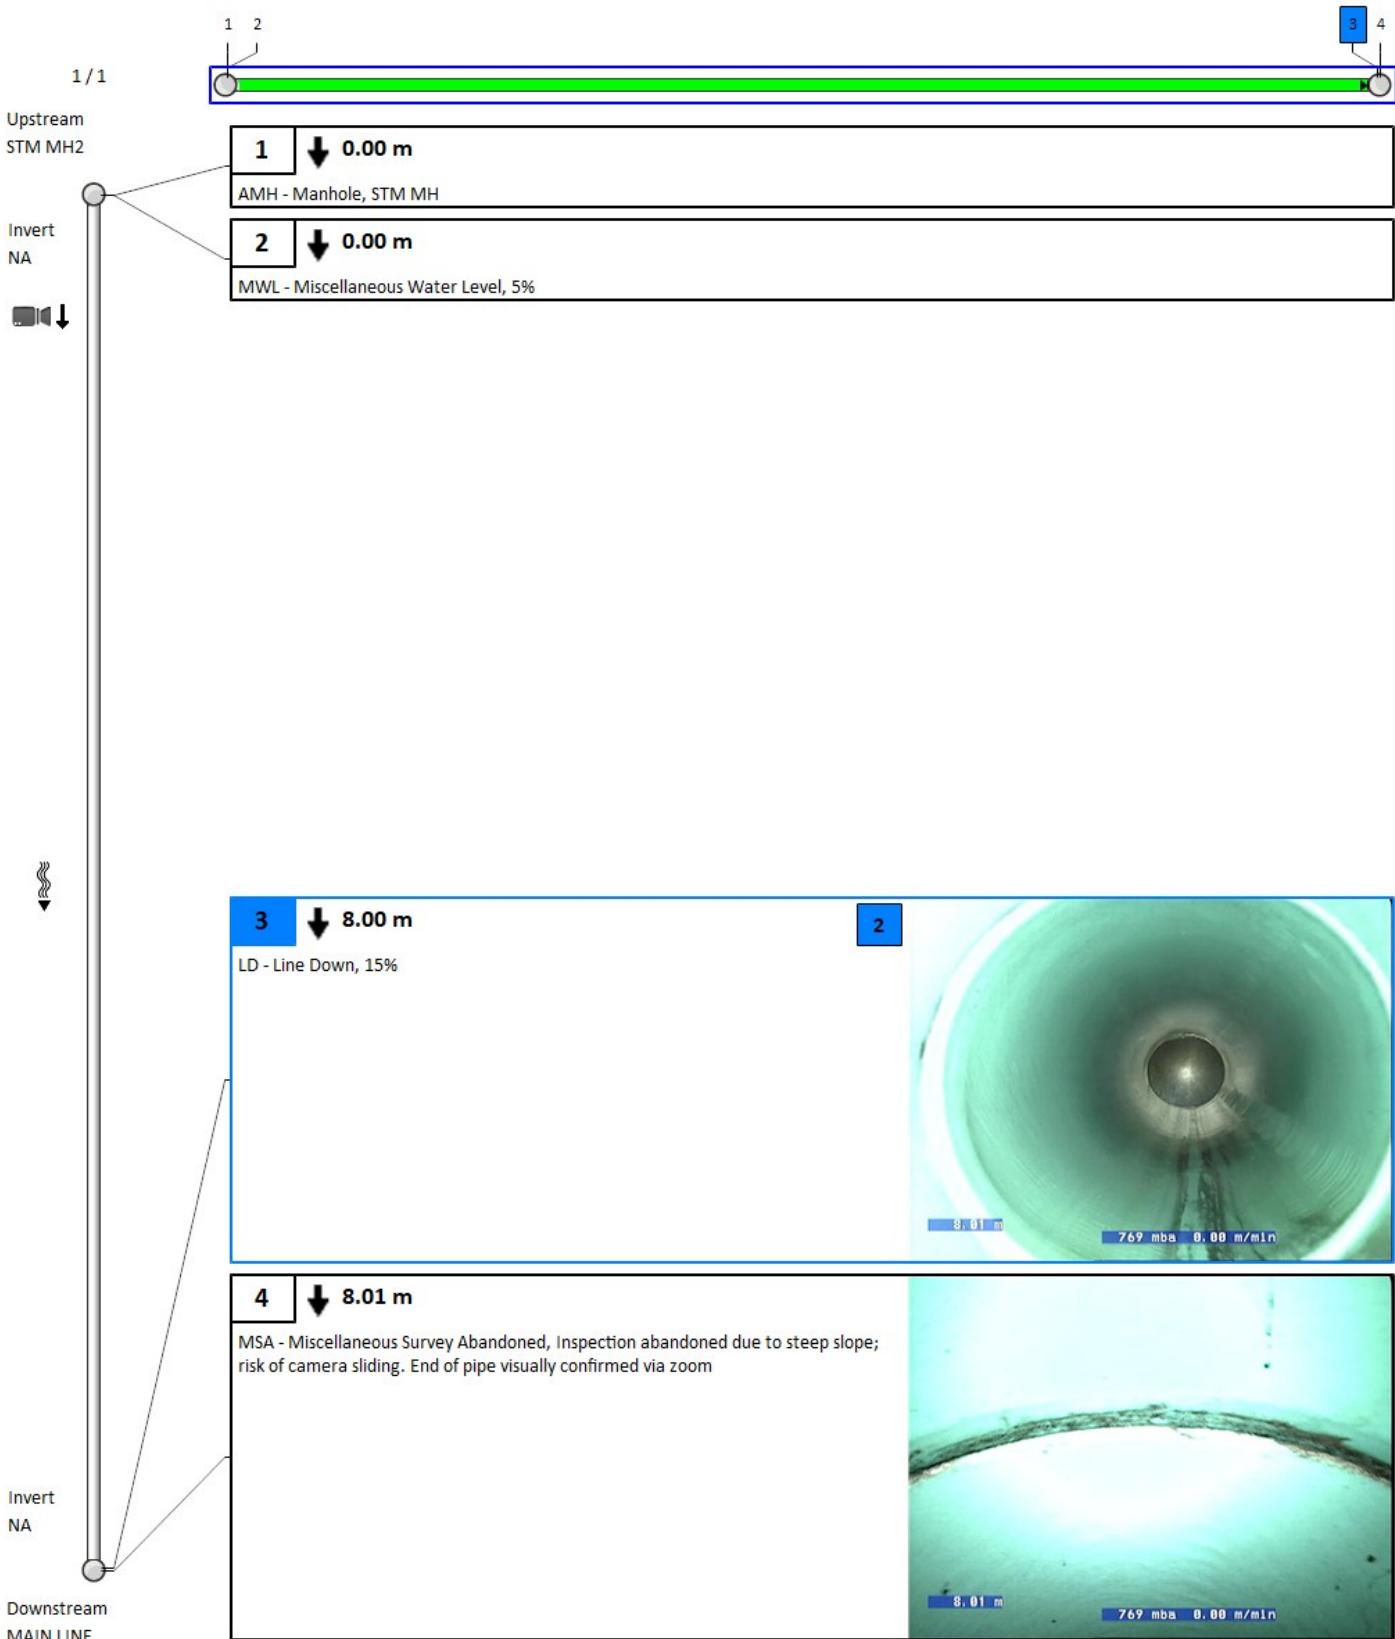
Pipe:	STM MH2 - MAIN LINE	Direction of inspection:	STM MH2 --> MAIN LINE
Direction of flow:	STM MH2 --> MAIN LINE	Direction:	Downstream

Structural rating	O&M rating	Overall rating	Failure
Peak: 0	Peak: 2	Peak: 2	Consequence:
Quick rating: 0000	Quick rating: 2100	Quick rating: 2100	Likelihood: 2.1
Score: 0	Score: 2	Score: 2	Risk:
Index: 0	Index: 2	Index: 2
