## **Phase I - Environmental Site Assessment**

Kanata Highlands, Huntmar Drive  
Ottawa, Ontario

January 31, 2013

Report: PE0846-2

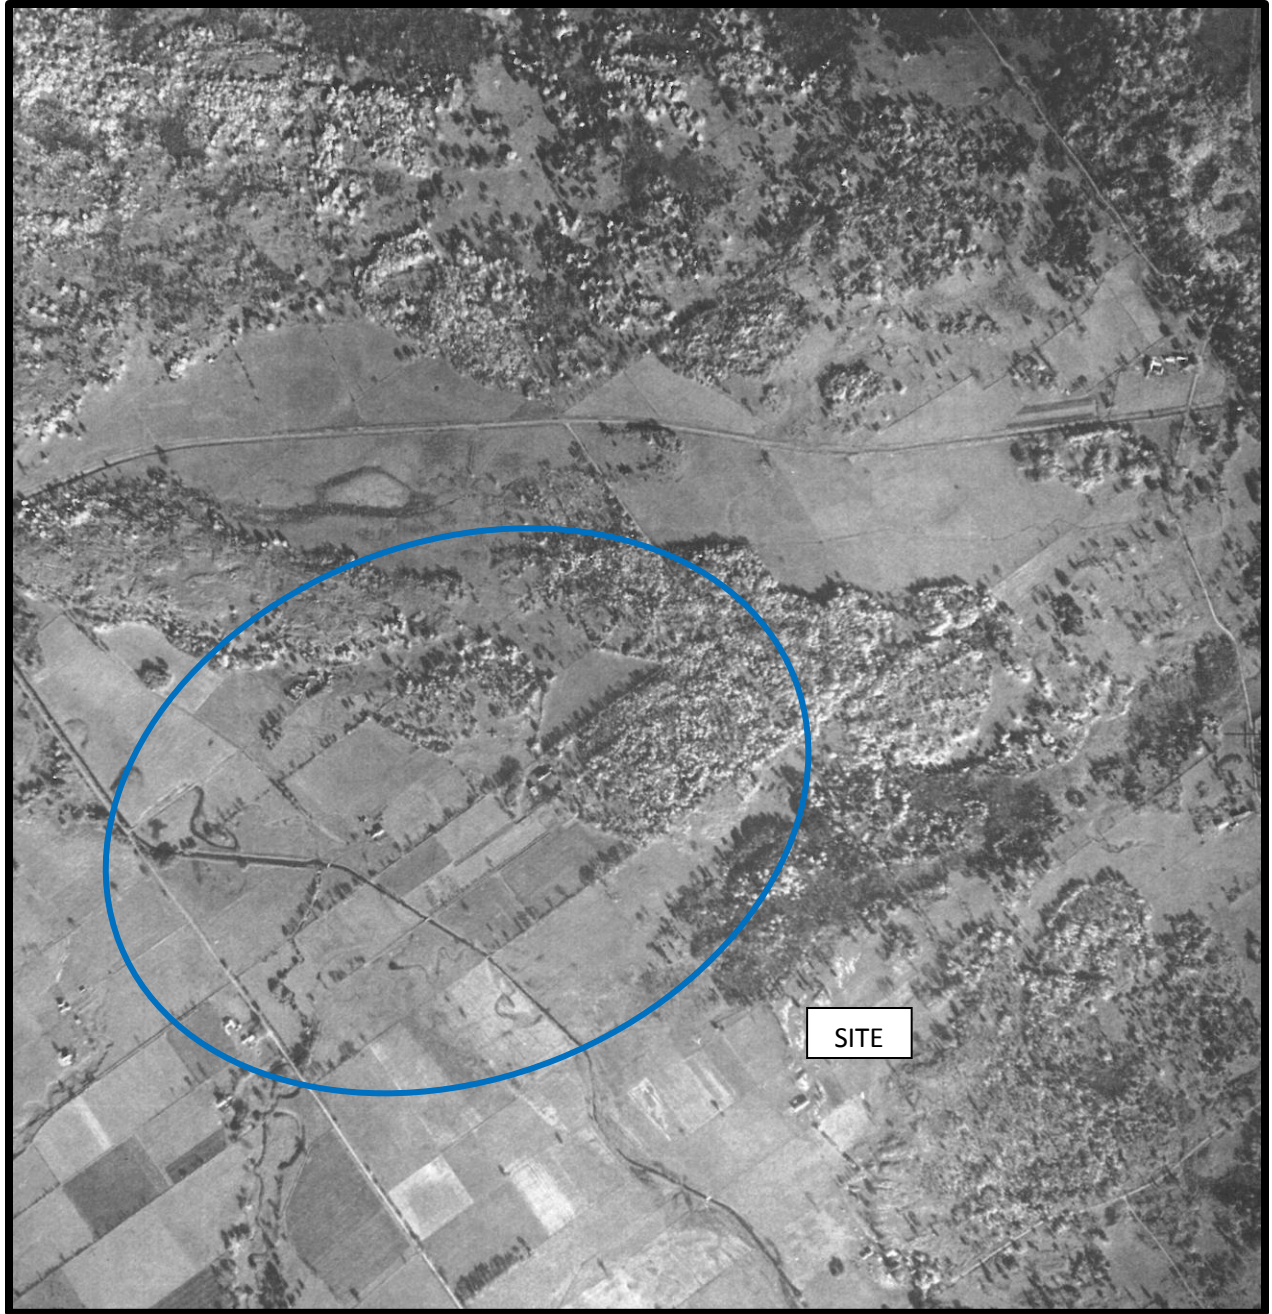
AERIAL PHOTOGRAPH  
1945

| 1945 | The subject site is predominantly agricultural land with some treed areas. There appears to be a few farmsteads located throughout the subject site. Neighbouring properties either are vacant and treed or agricultural land with occasional farmsteads. |

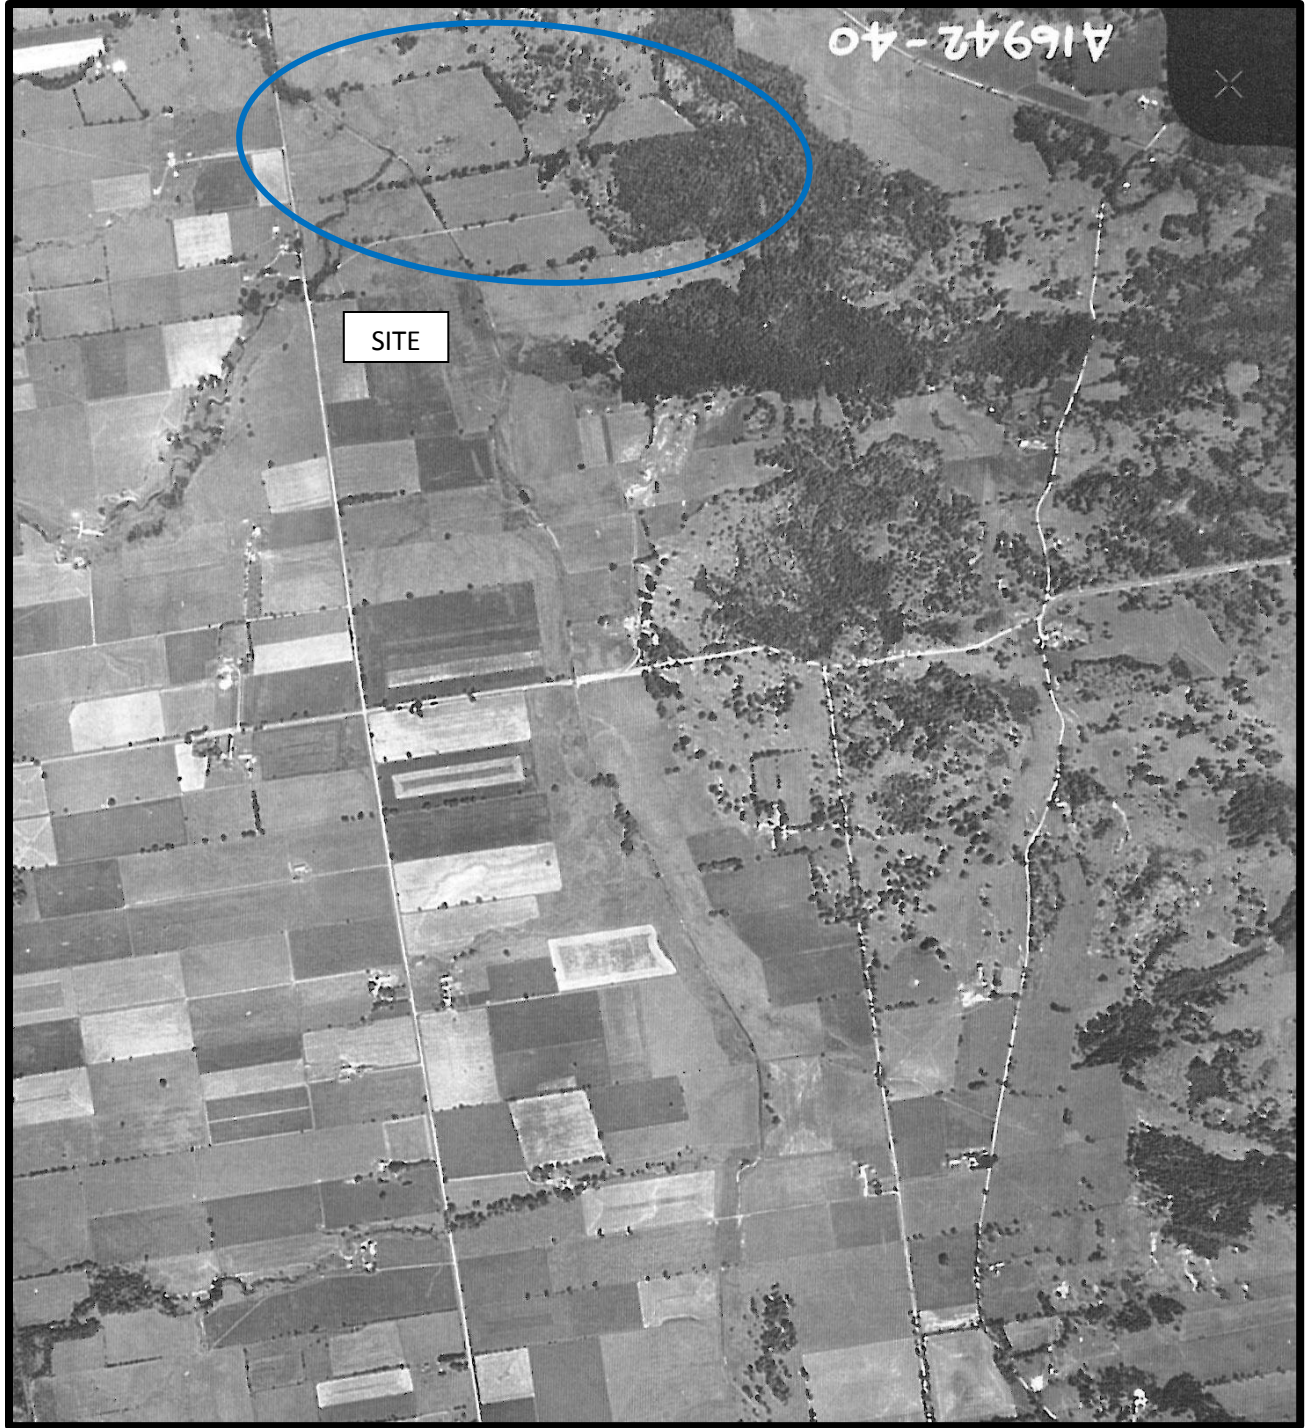
AERIAL PHOTOGRAPH  
1959

| 1959 | No significant changes appear to have been made to the subject site or neighbouring properties. |

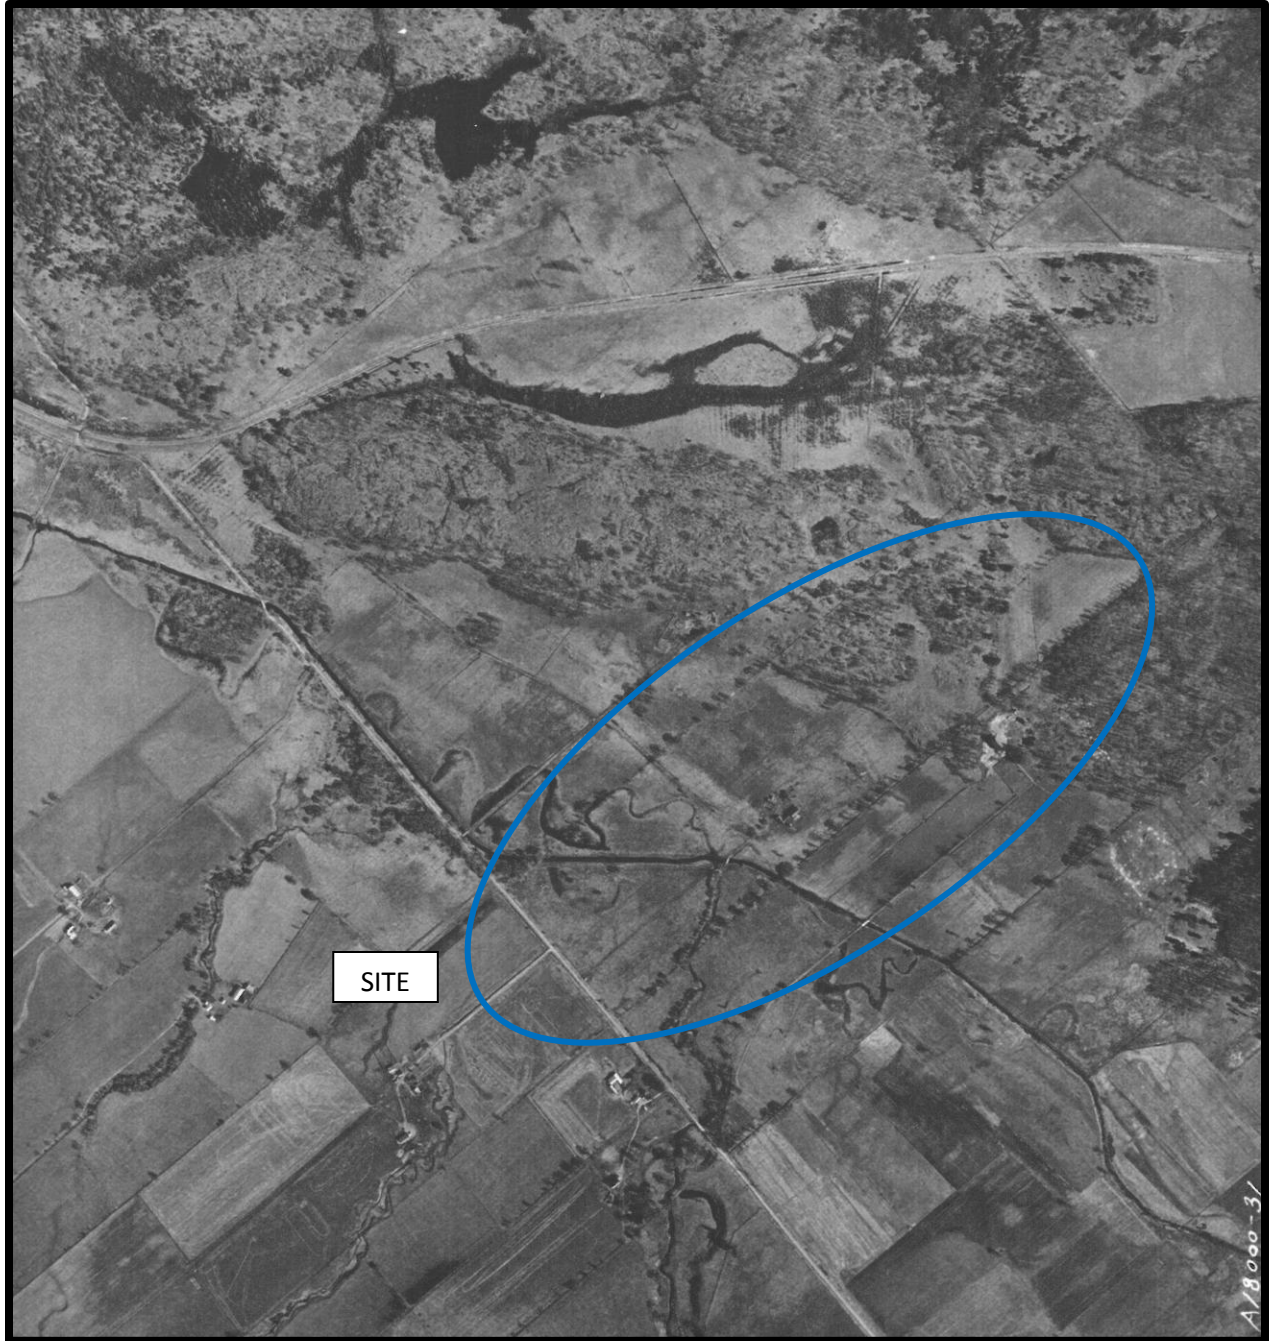
AERIAL PHOTOGRAPH  
1963

| 1963 | The farmsteads on the subject site appear to be in disuse and trees appear to be reclaiming agricultural land. No significant changes appear to have been made to the neighbouring properties. |

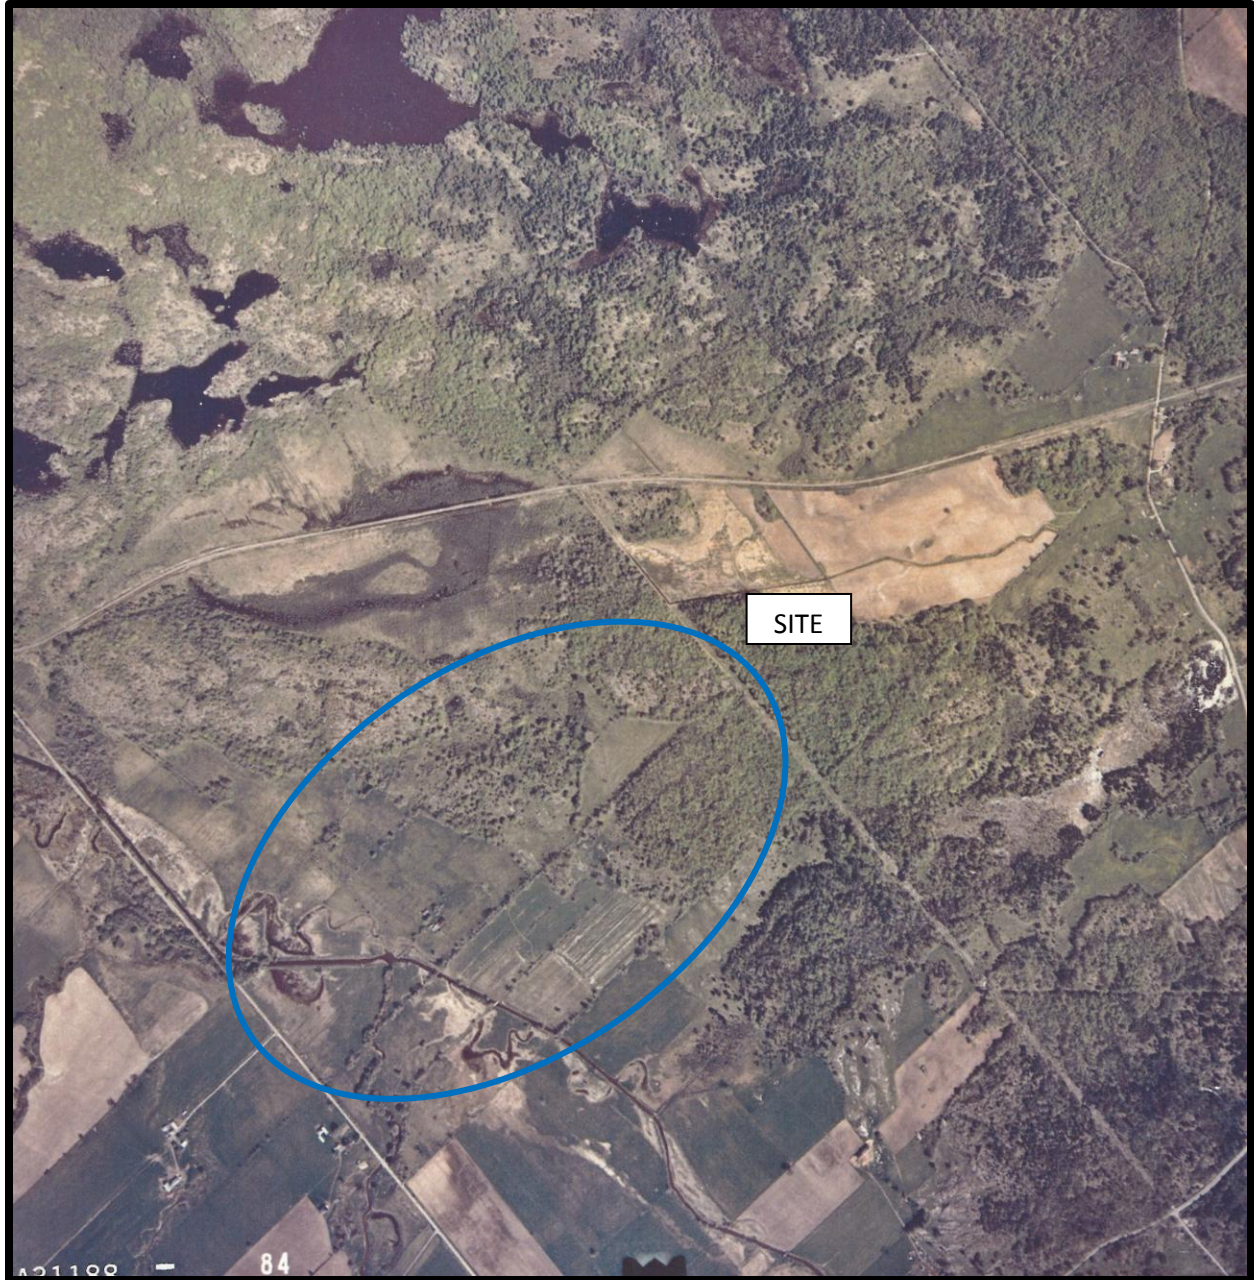
AERIAL PHOTOGRAPH  
1978

| 1978 | No significant changes appear to have been made to the subject site or neighbouring properties. |

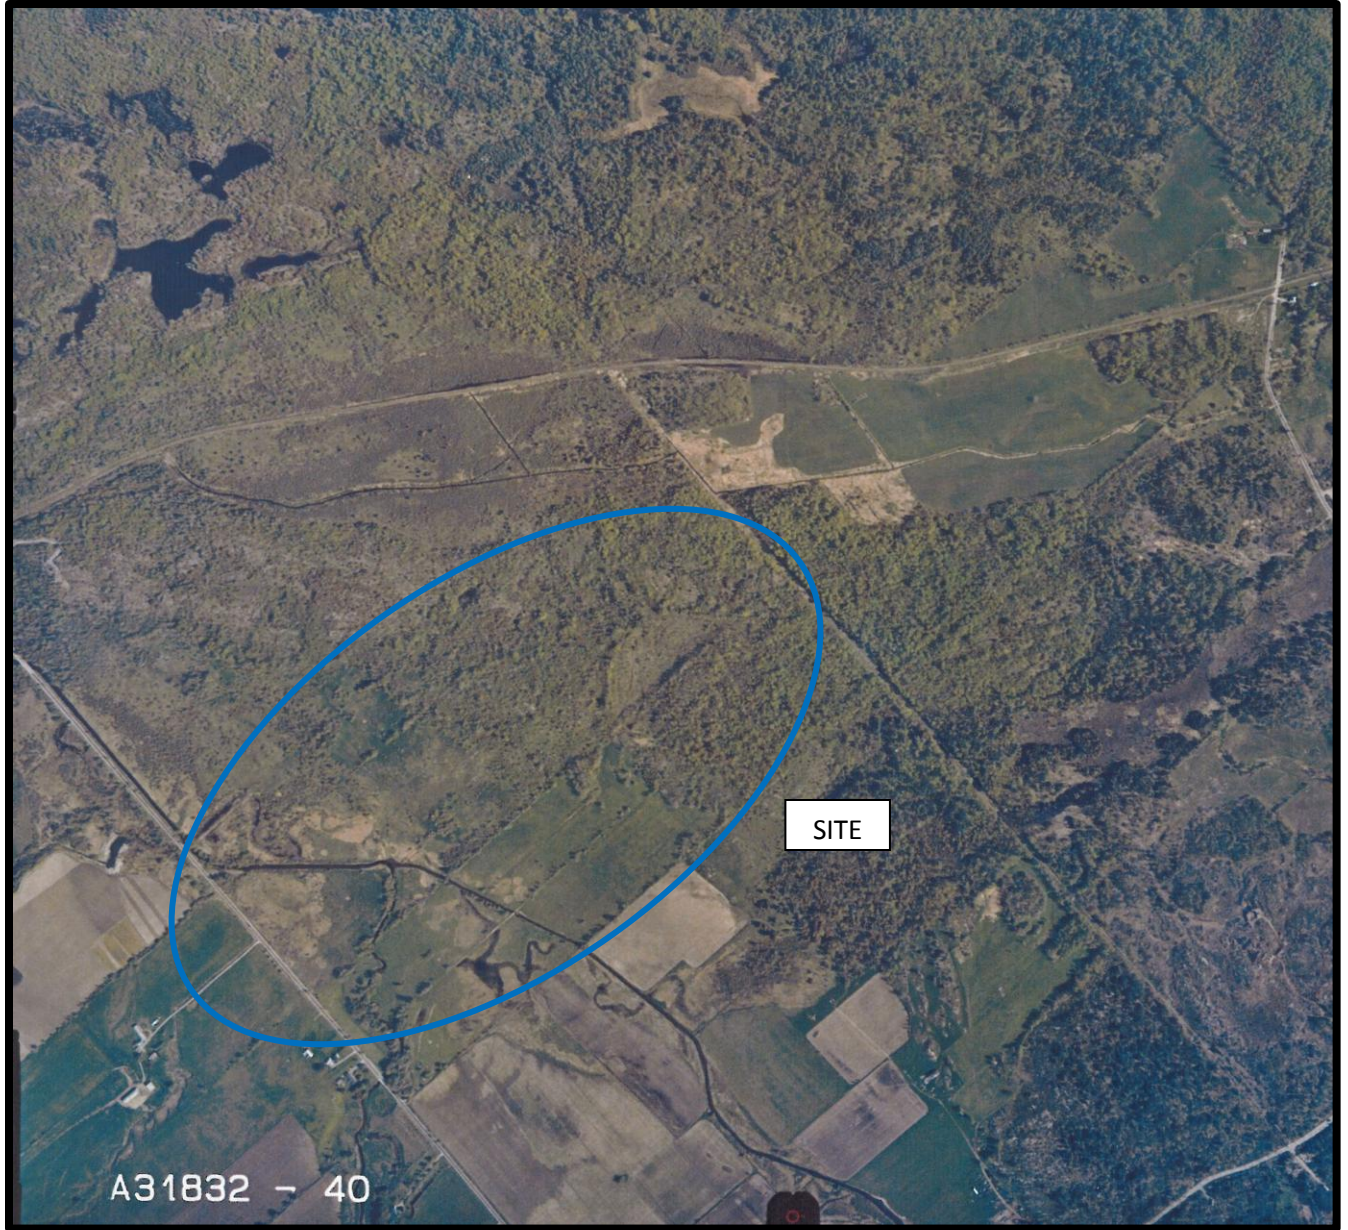
AERIAL PHOTOGRAPH  
2002

| 2002 | No significant changes appear to have been made to the subject site or neighbouring properties. |
