**WILSON COWAN DRAIN FLUVIAL GEOMORPHIC EXISTING CONDITIONS
MINTO MAHOGANY, MANOTICK**

156380-25016-504

Report Prepared for:
MINTO COMMUNITIES INC.

Prepared by:
MATRIX SOLUTIONS INC.

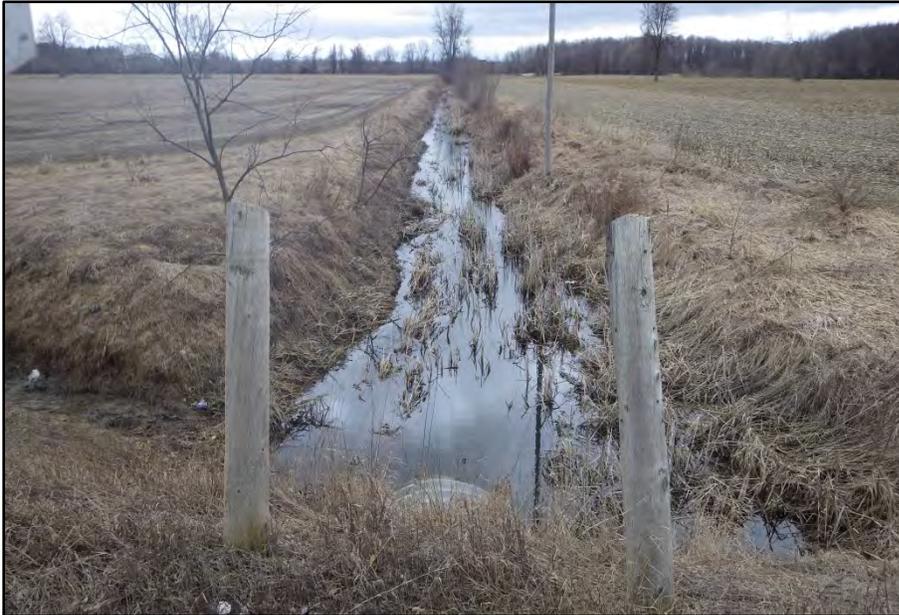
1. WCD-R1: View looking downstream from Century Road. Agricultural fields on both sides of drain. Note presence of instream vegetation.

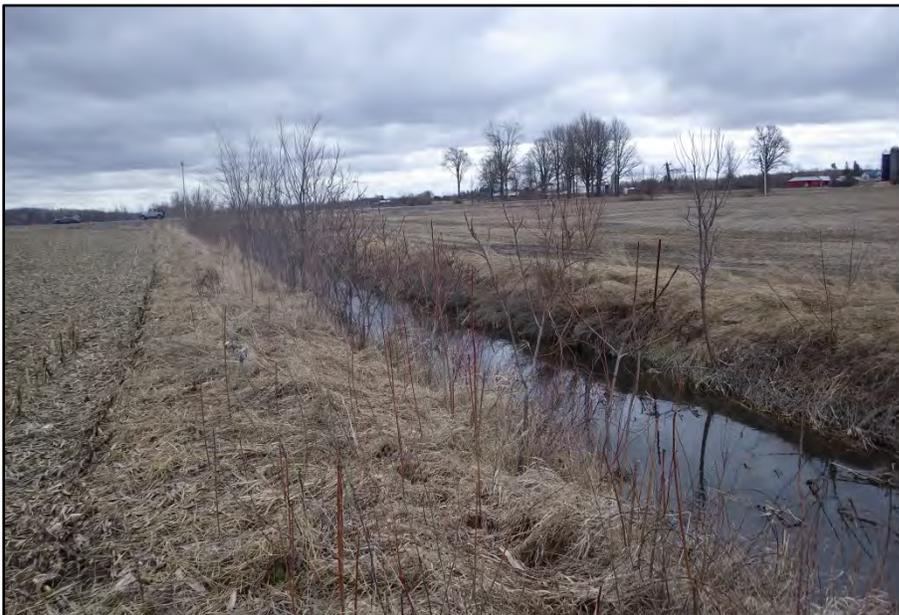
2. WCD-R1: View looking upstream towards Century Road. Riparian zone consists of tall grasses and intermittent shrubs.

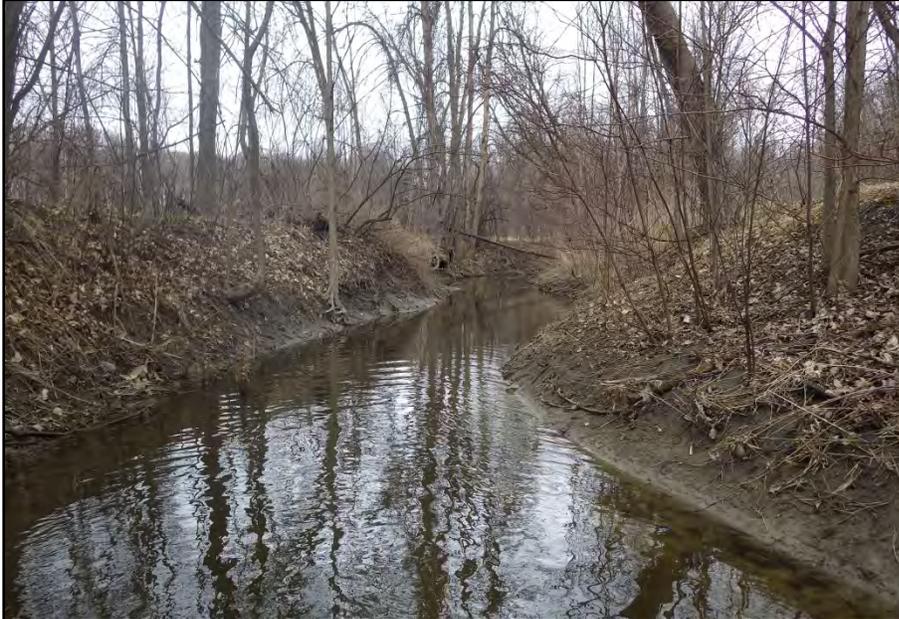
3. WCD-R2: View looking downstream. Riparian zone consists of deciduous trees and grasses. Note the lack of vegetation along both bank toes.

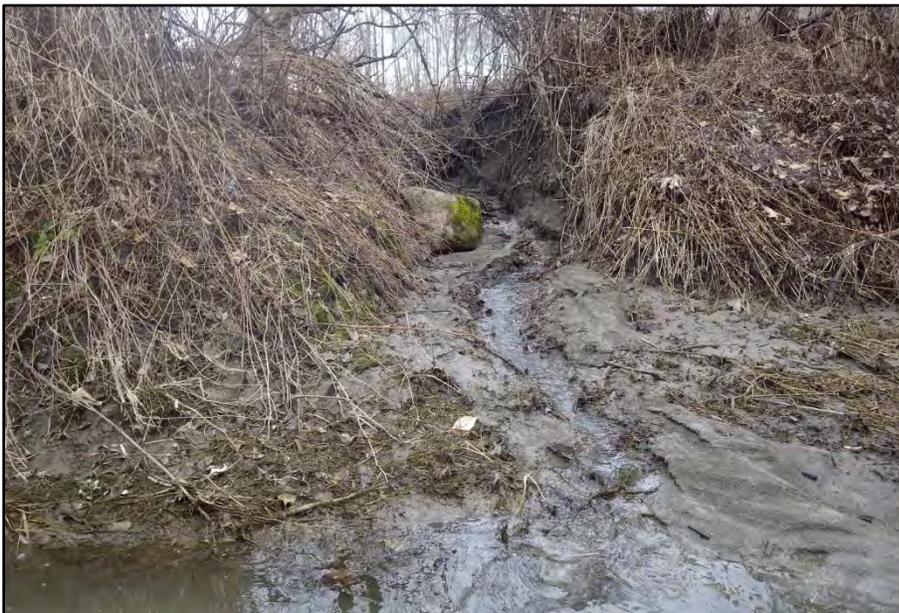
Field observations of channel process noted that both channels exhibited depositional characteristics, with significant sediment inputs from surrounding agricultural lands. In low lying areas, gullying was present along channel banks where sediment heavy surface runoff from agricultural fields has caused the slope failures. These gullies provide significant sediment sources that make up the majority of the bed material through the site, especially in the main branch of the Wilson Cowan Drain. The channel showed no signs of active erosion.

4. WCD-R2: Gully formation originating from agricultural field resulting in sandy depositional feature.

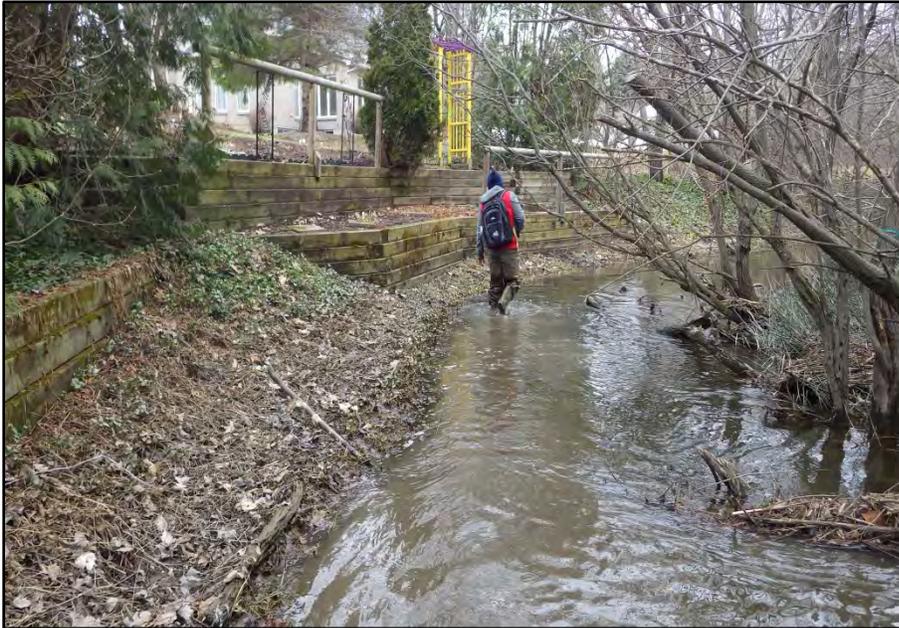
5. WCD-R2: Wooden retaining wall behind houses along Watterson St. No active erosion observed.

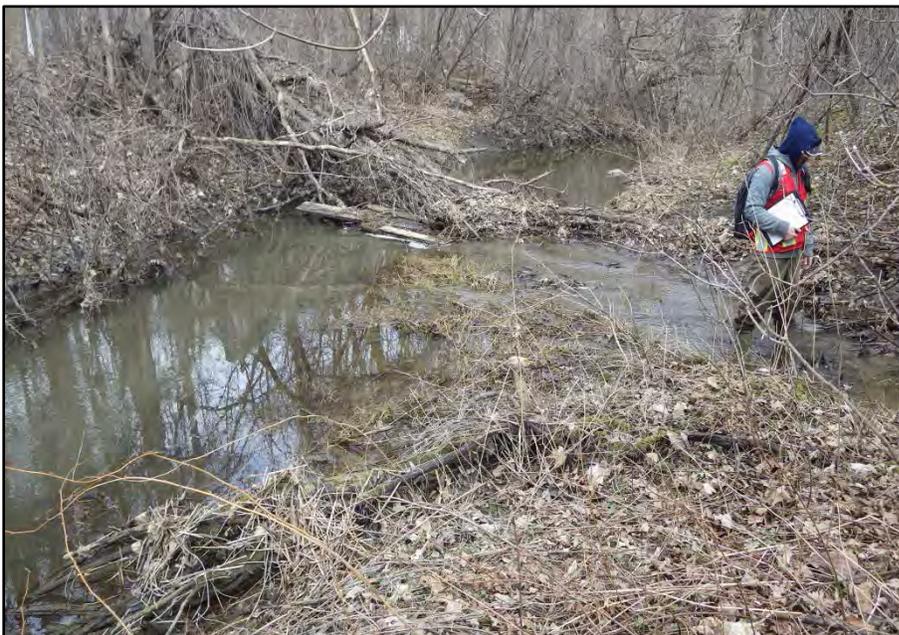
6. WCD-R2: Confluence of tributary (right side of photo) with the main channel of Wilson Cowan Drain.

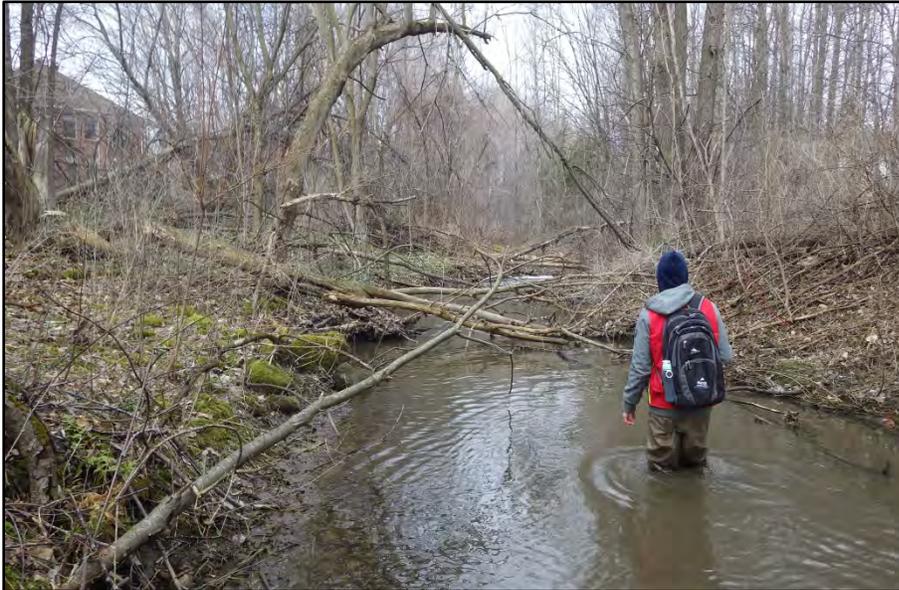
7. WCD-R1: View looking downstream. Some fallen trees, not due to erosion.

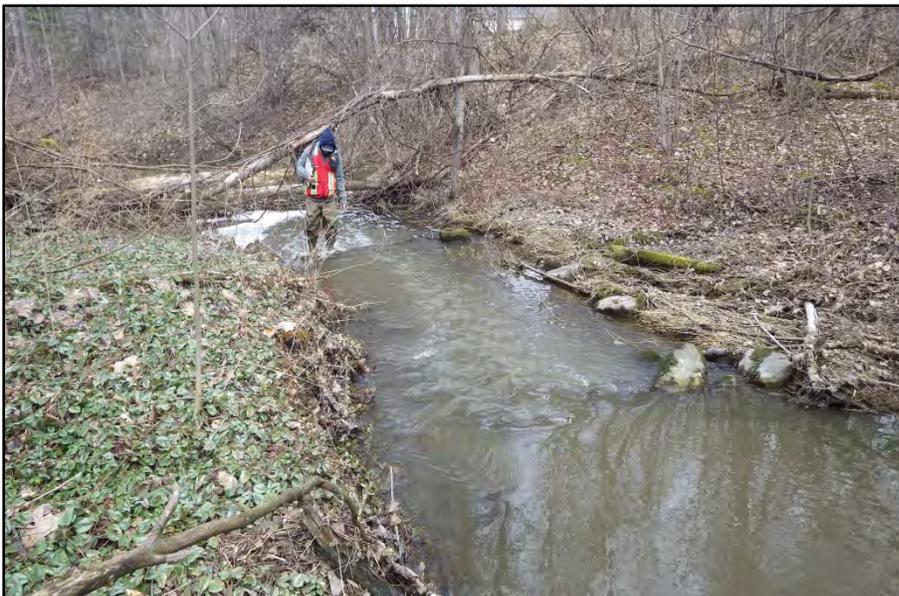
8. WCD-R1: View looking downstream at step-pool formation. Large stones (potentially placed) across channel creating small drop.

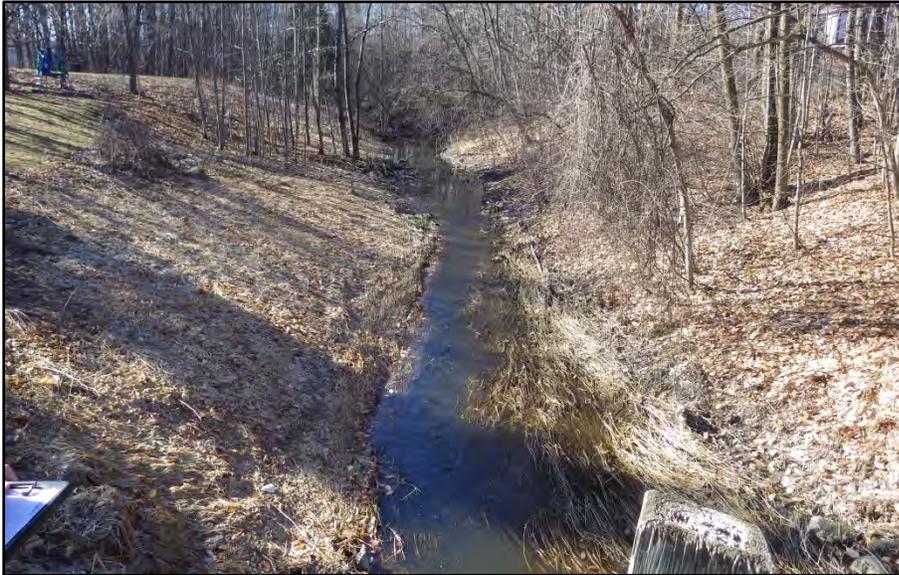
9. WCD-R1: View looking upstream from Watterson St. Large quantities of instream vegetation.

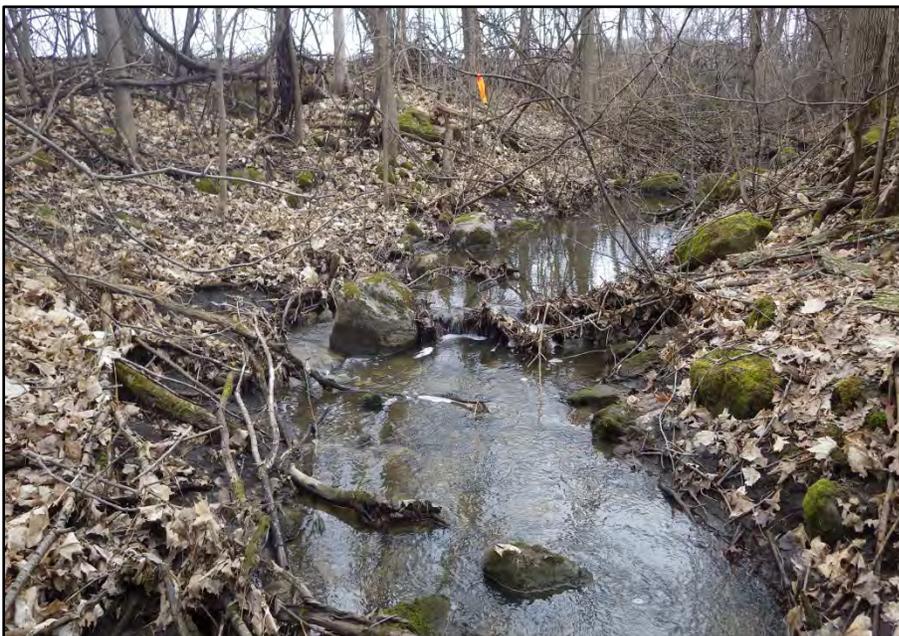
10. WCDT-R1: View looking upstream. Substrate consists of small-large cobble within a riffle-pool sequence.

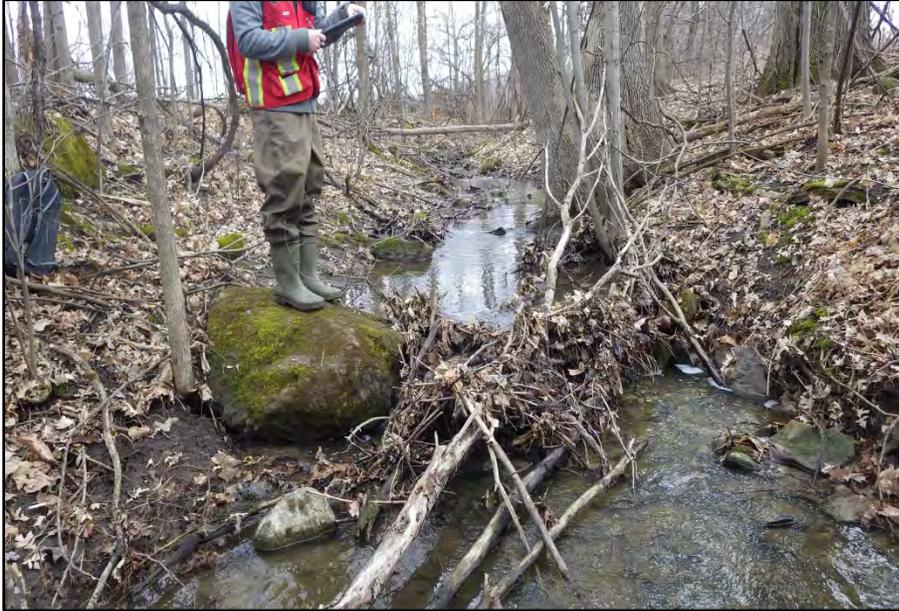
11. WCDT-R1: Woody debris build up in channel.

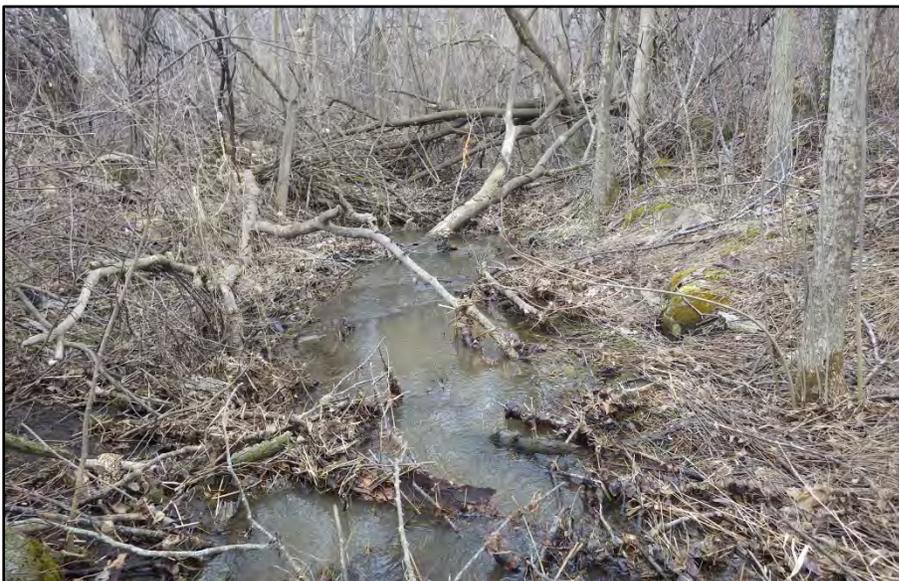
12. WCDT-R1: Tributary within wooded buffer with agricultural fields on both sides.

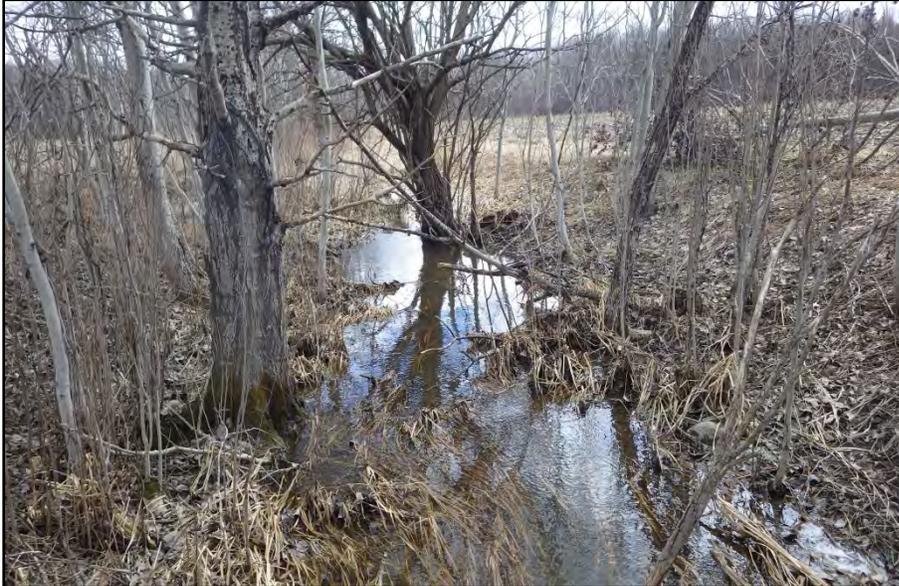
13. WCDT-R2: View looking upstream. Shows transition from agricultural field to beginning of wooded buffer.

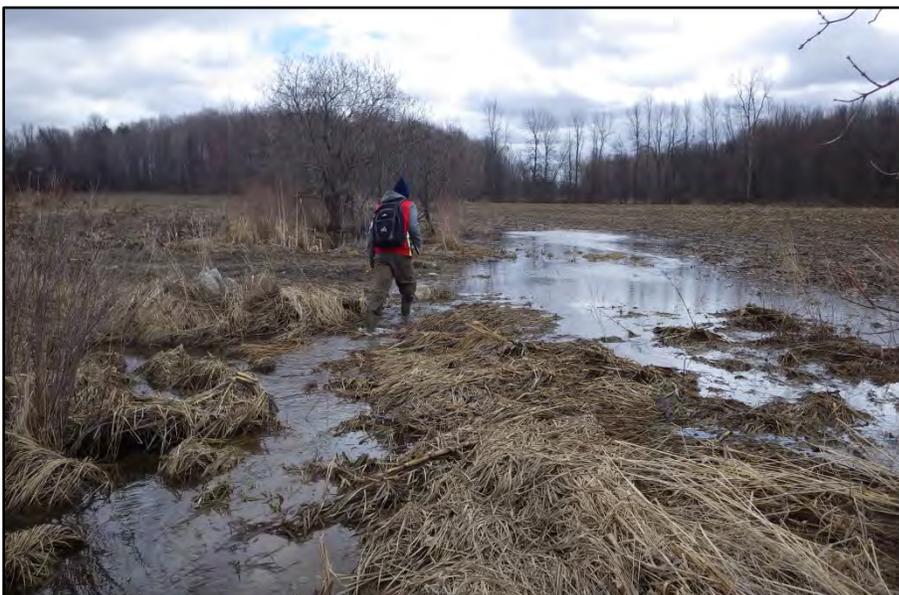
14. WCDT-R2: Channel has lost definition and has much lower grade.

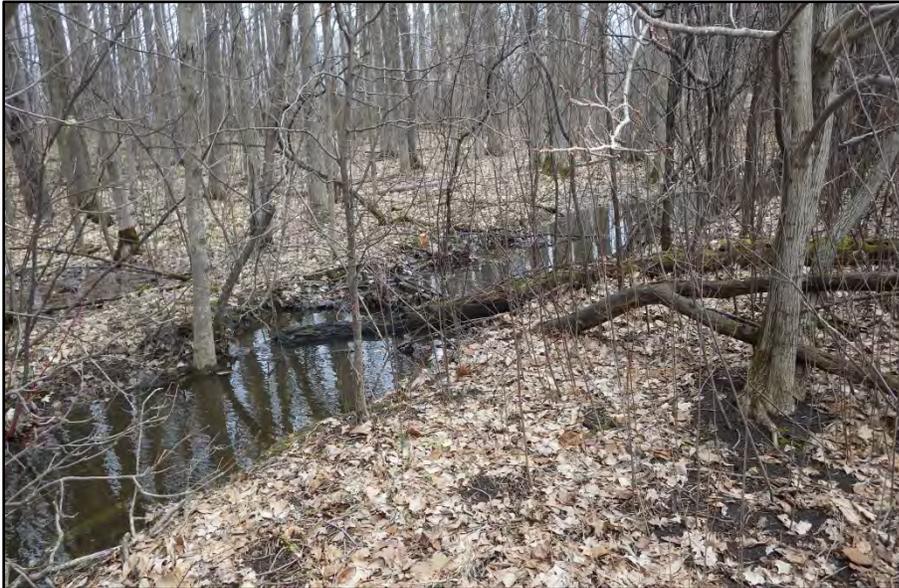
15. WCDT-R3: Where channel enters wooded area it regains some definition.

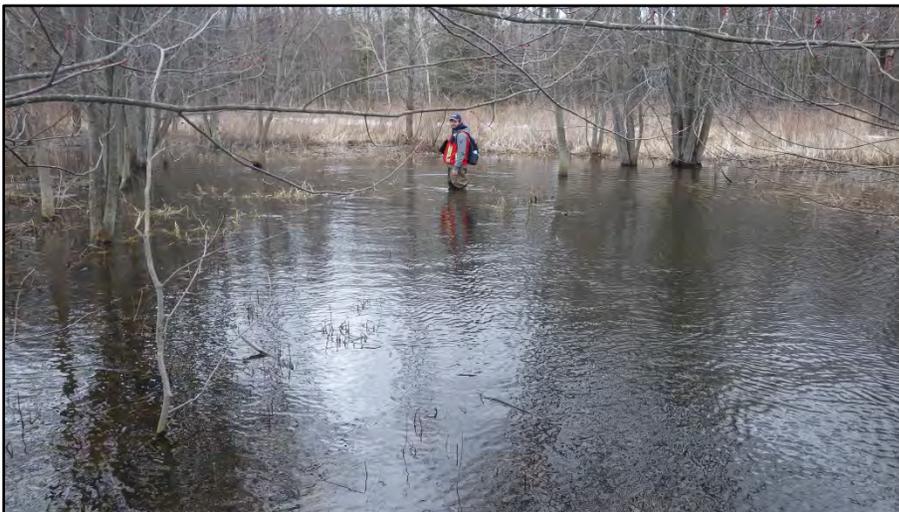
16. WCDT-R3: Water spreads out and creates small pond.

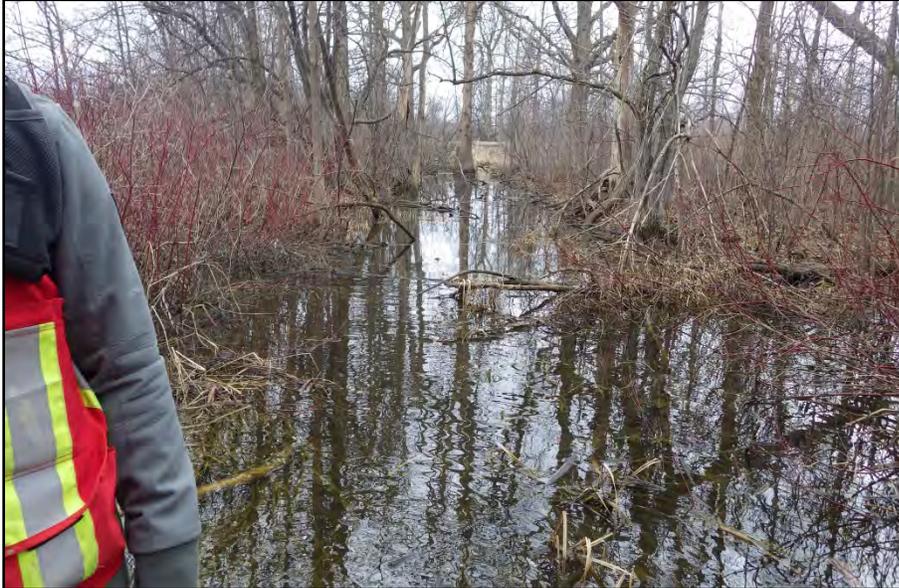
WCDT-R3 begins adjacent to a woodlot with a channel width and depth of 3.3 m and 0.30 m, respectively. In this location the channel did not contain instream vegetation and the beds and banks were composed of highly organic soils and decaying leaves. During the time of the investigation (April 12, 2017), a level of flooding was observed throughout this reach. In some locations large ponds had formed, submerging overbank trees. In the upstream 300 m of channel to Century Rd. East, the flooding expanded to form a 30 m wide pond and no defined channel was observed. No evidence of fluvial processes was observed where a defined channel was present, and EcoTech Environmental Consultants Inc. (2008), observed little to no flow within the channel in May and June 2007, suggest that the channel through this reach is intermittent or ephemeral.

17. WCDT-R3: Channel remains undefined and flooded up to culvert under Century Rd.
