Preliminary Geotechnical Investigation

Proposed Residential Subdivision
1154-1208 Old Montreal Road
Ottawa (Formerly Township of Cumberland), Ontario

OTT-00234493-A0

November 7, 2016

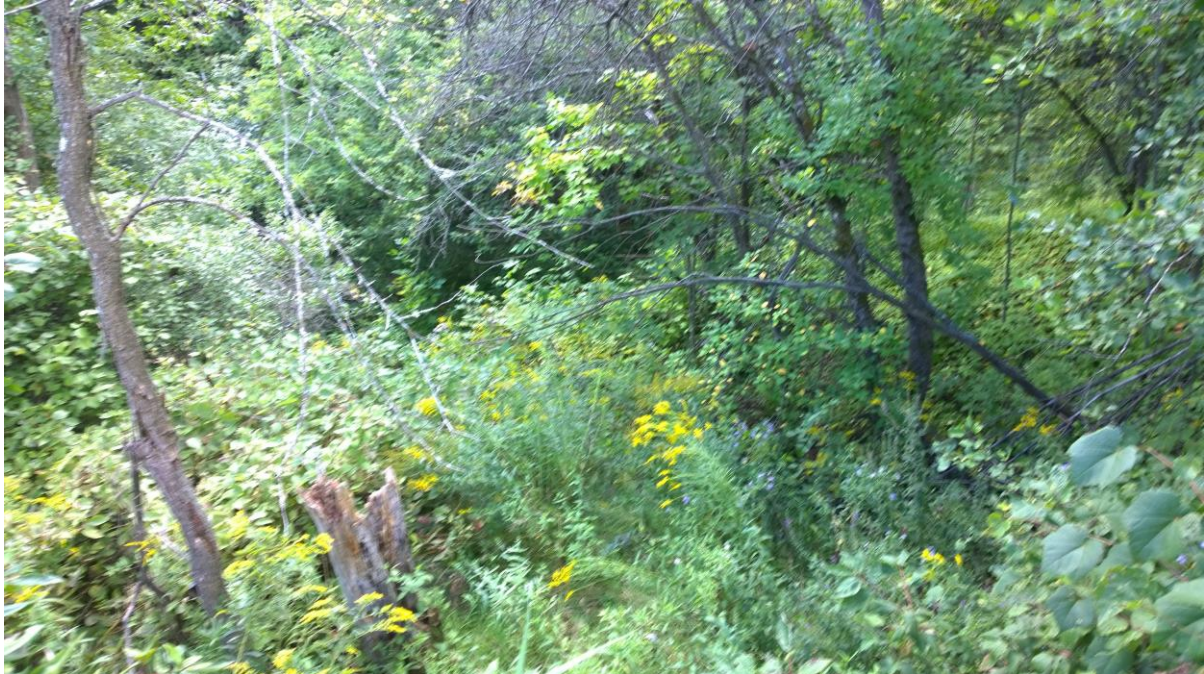
Photograph No. 1
View of creek west of Pedestrian Bridge (Location 1 on Figure 2)

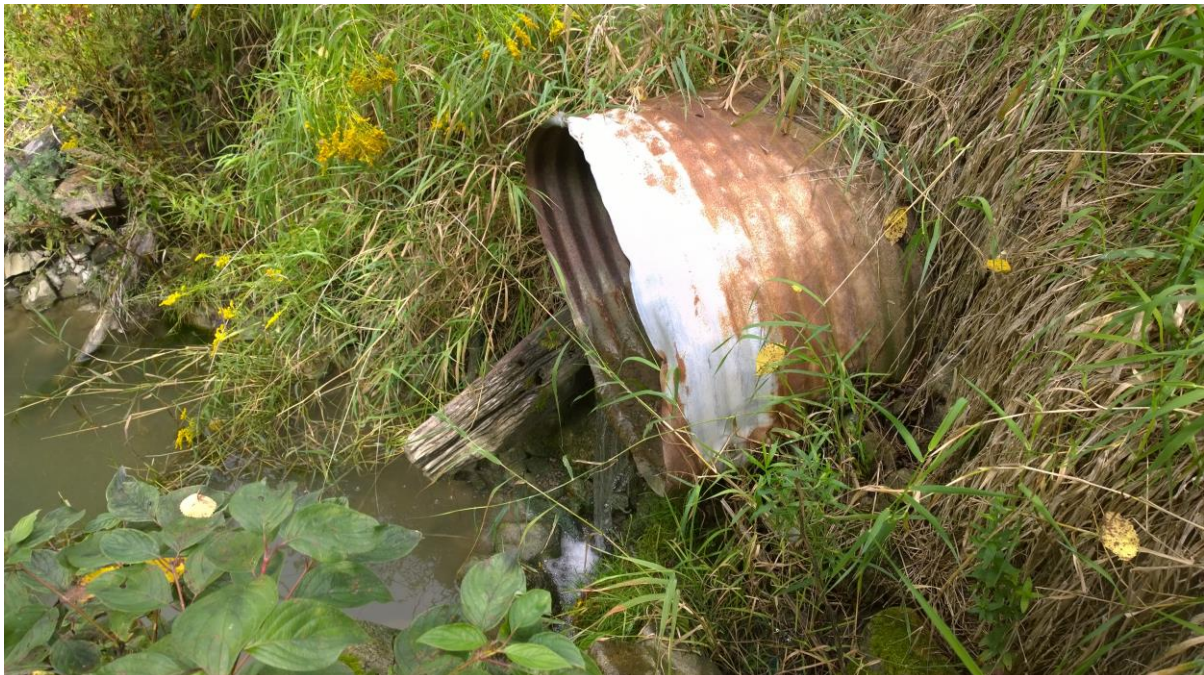
Photograph No. 2:
View of west end of culvert under the roadway (Location 2 on Figure 2)

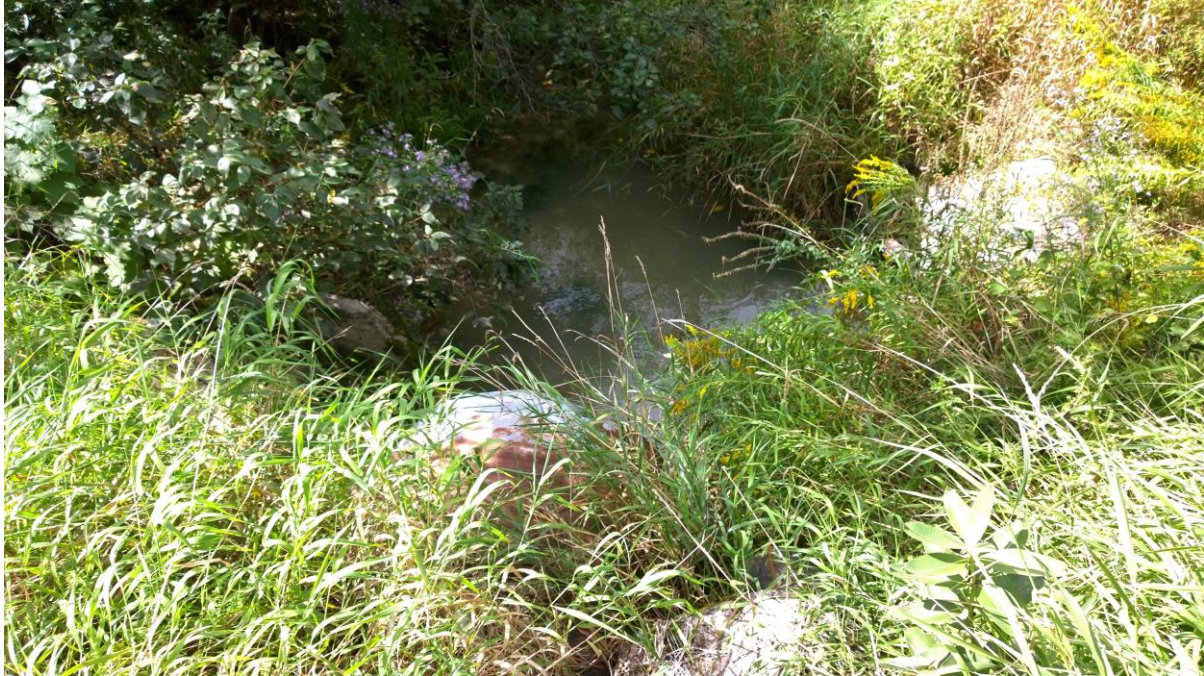
Photograph No. 3
View of creek looking west from pathway (Location 3 on Figure 2)

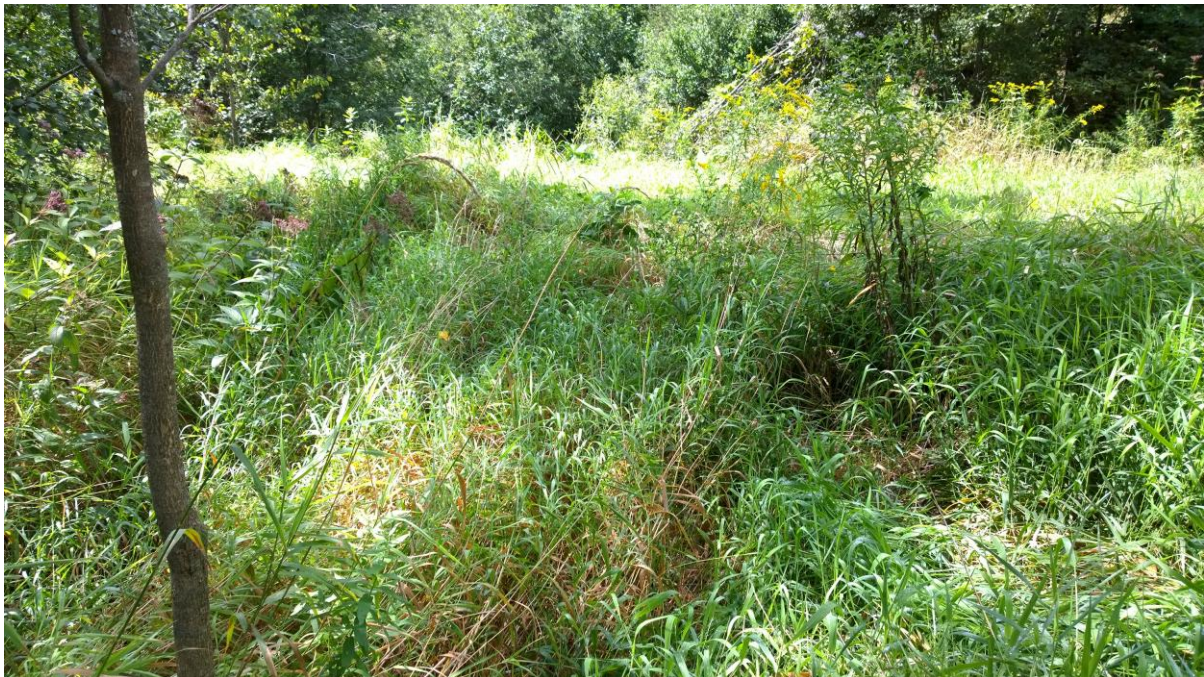
Photograph No. 4
View looking west from east side of pathway near creek (Location 4 on Figure 2)

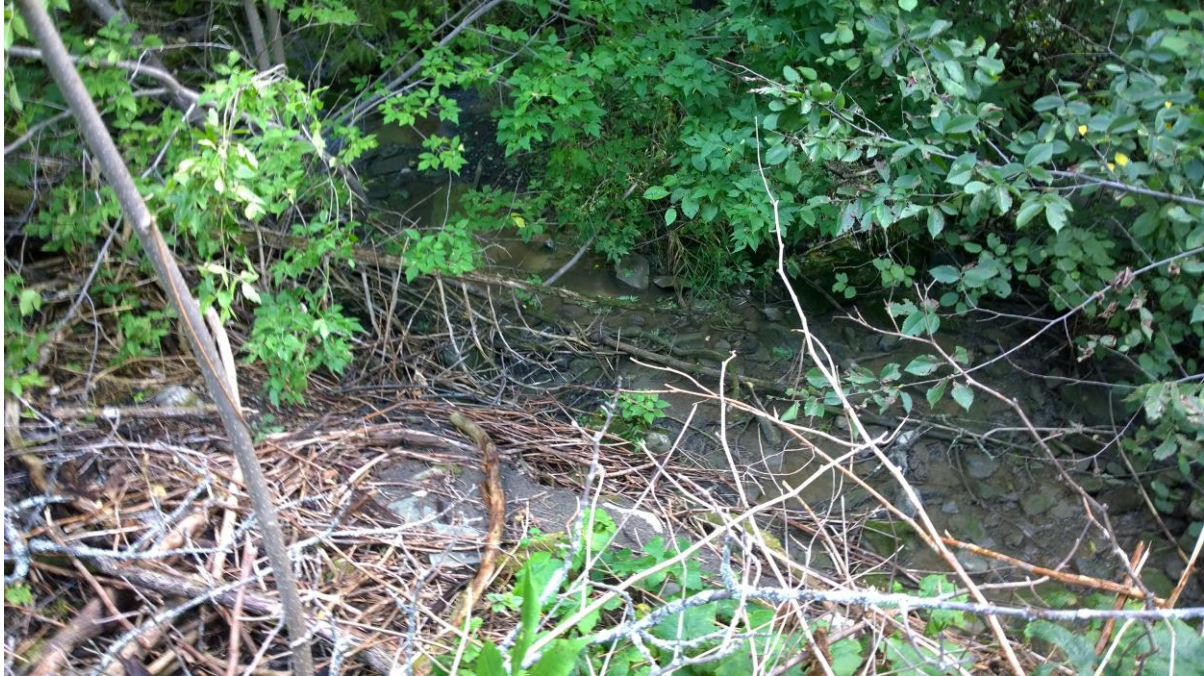
Photograph No. 5
View of creek looking east from Location 5 on Figure 2

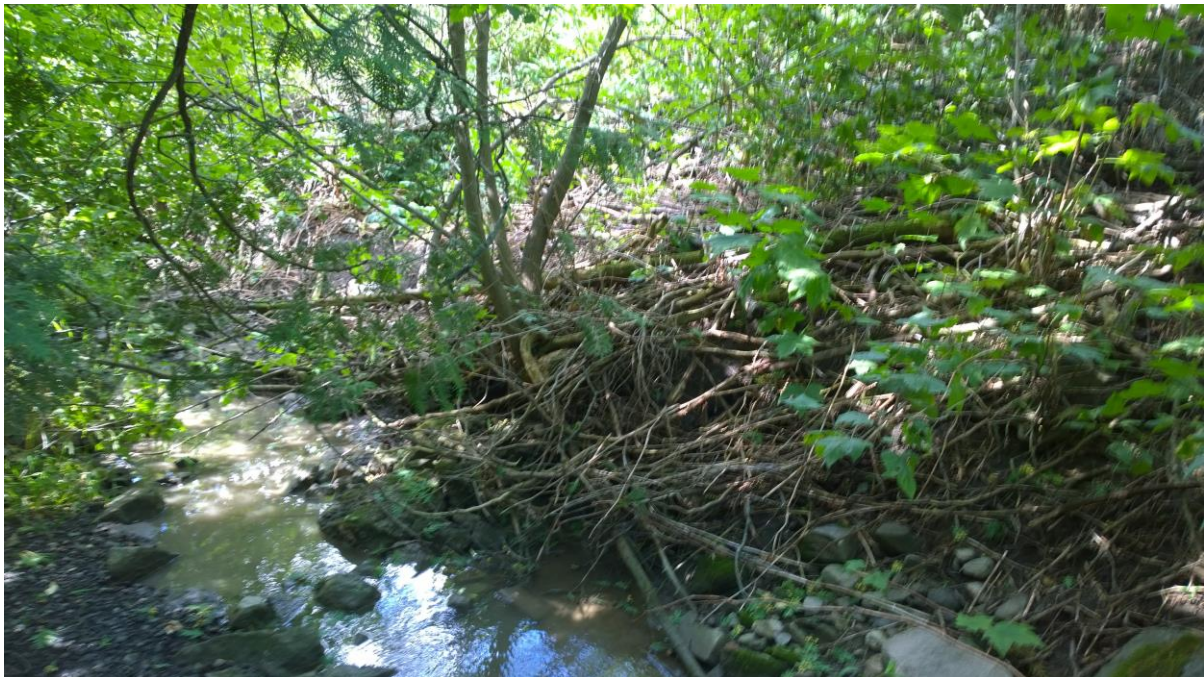
Photograph No. 6:
View along creek bank looking west from north bank at Location 6 on Figure 2

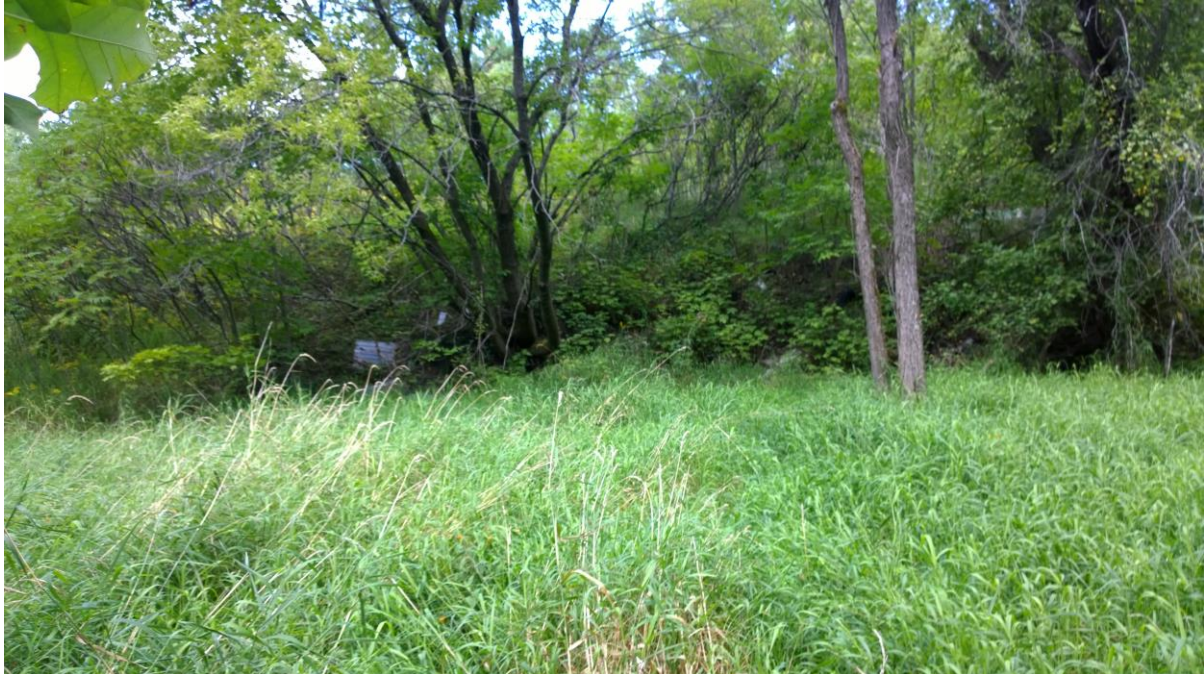
Photograph No. 7

View of creek looking north from south bank of creek at Location 7 on Figure 2

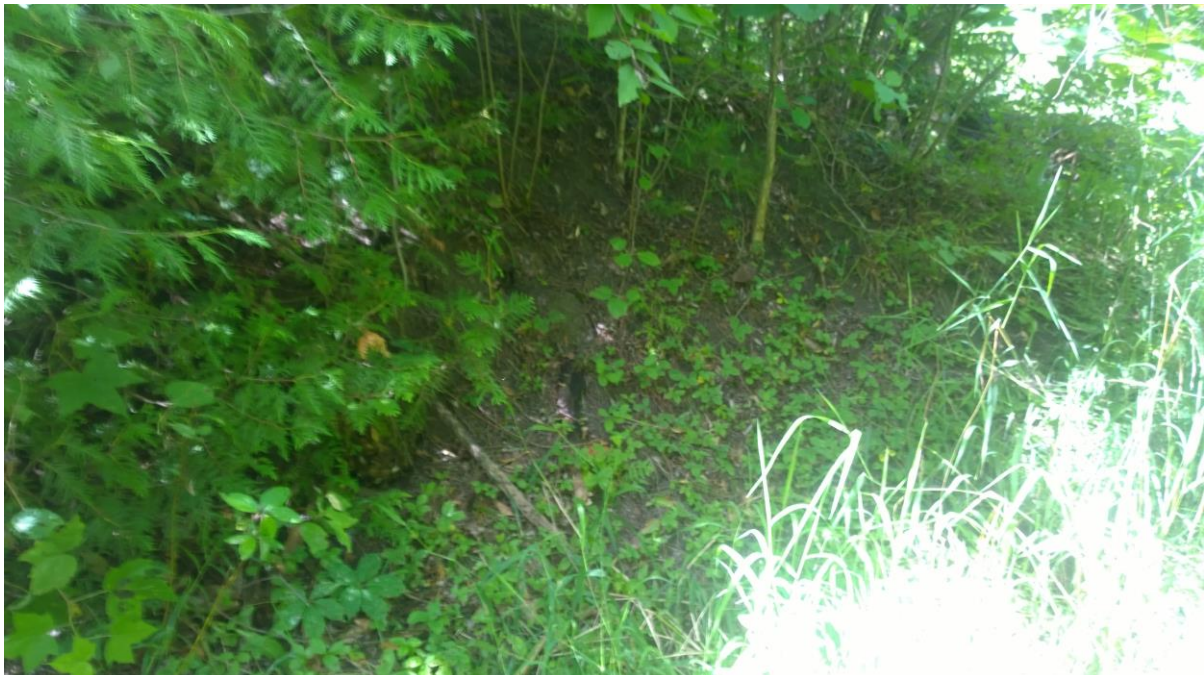
Photograph No. 8

View of toe of slope looking west from Location 8 on Figure 2

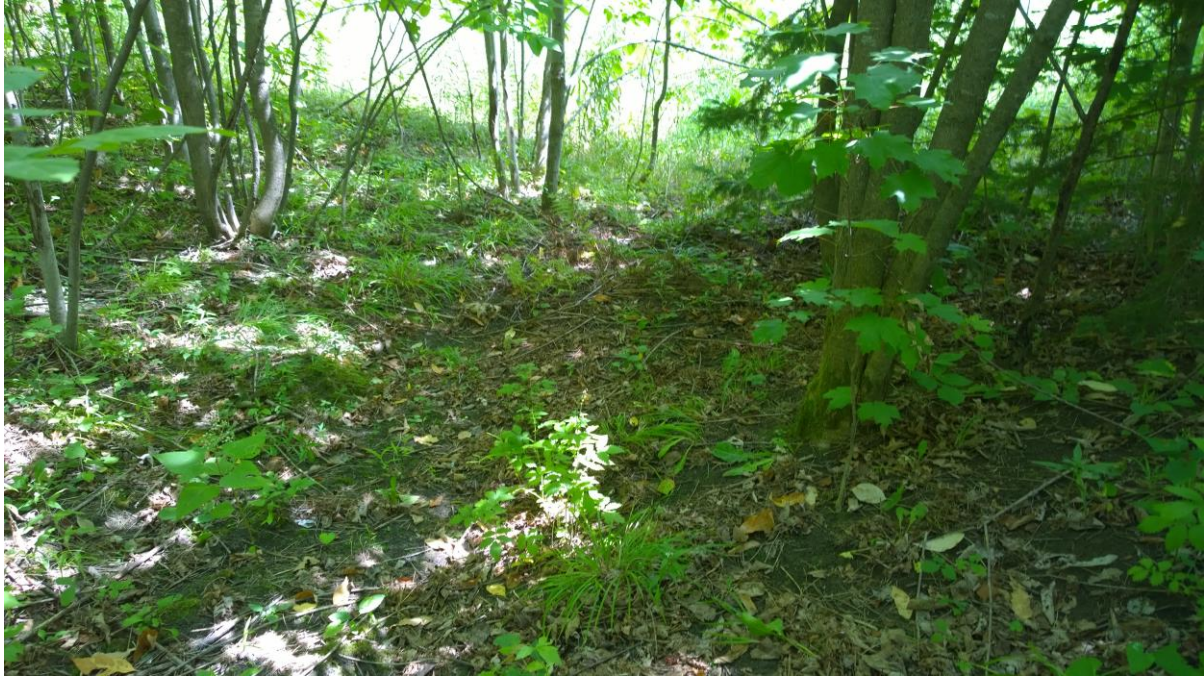
Photograph No. 9
View of creek looking south from Location 9 on Figure 2
