# Phase One Environmental Site Assessment 1154, 1176, 1180, and 1208 Old Montreal Road, Ottawa, Ontario

DCR Phoenix Group of Companies

OTT-00234493-A0

2021-08-27

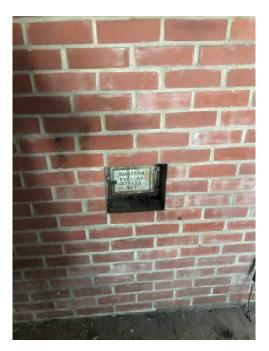
Photograph No. 2

View of former coal chute at 1154 Old Montreal Road.

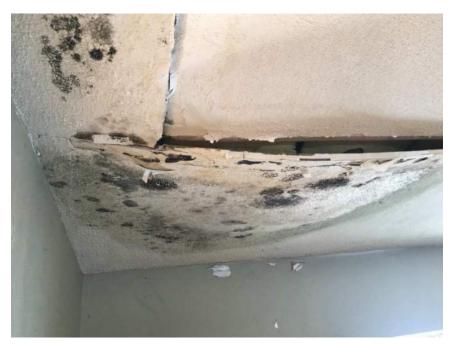
Photograph No. 5

Significant black mould growth and water damage was observed during the site visit in all of the residences.

View of mould and water damage on ceiling of main floor in 1174 Old Montreal Road.

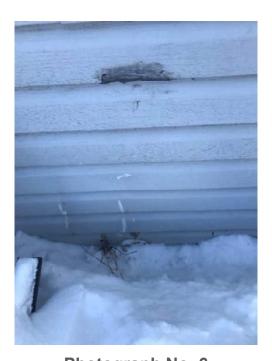
Photograph No. 6

View of location of former fill and vent pipes at 1174 Old Montreal Road.

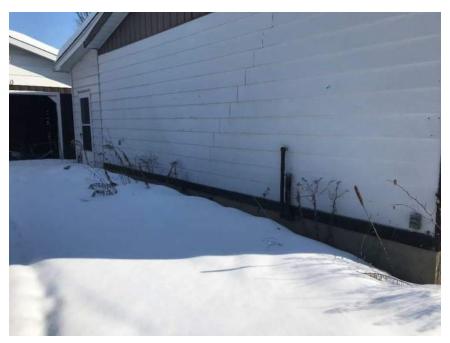
Photograph No. 8

View of fill//vent pipes on the north side of the residence at 1180 Old Montreal Road.

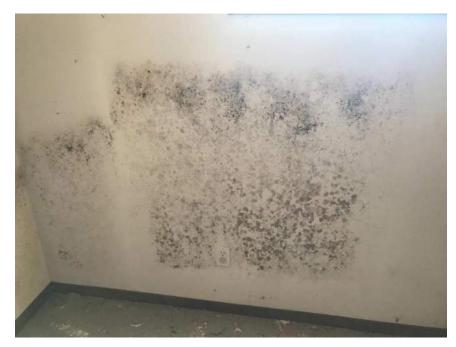
Photograph No. 9

View of black mould on the walls of 1180 Old Montreal Road.

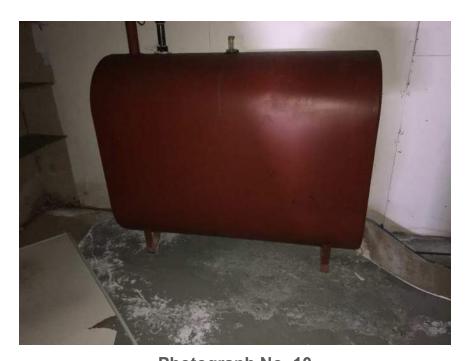
Photograph No. 10

- A heating oil tank in the basement of 1180 Old Montreal Road. The tank was installed above a concrete floor in good condition, and there was no staining in the vicinity of the tank. This represents an APEC (**PCA 3**).

View of the fuel oil AST in the basement of 1180 Old Montreal Road.

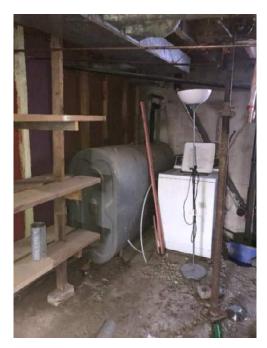
- A heating oil tank in the basement of 1208 Old Montreal Road. The tank was installed above a concrete floor in fair condition. There was some staining observed on the concrete floor below the tank, although the staining appeared to be contained within the building footprint. This represents an APEC (PCA 2).

Photograph No. 14
View of the fuel oil AST at 1208 Old Montreal Road.

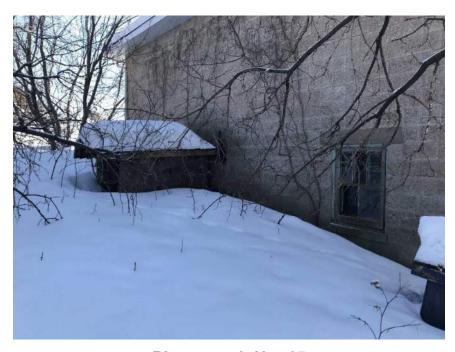
Photograph No. 15

View of vent/fill pipes on the east side of the residence at 1208 Old Montreal Road.
