**Landslide Hazard and Risk  
Assessment**

Final Report

December 13, 2021  
File: 121624058

DCR/Phoenix Group of Companies  
Ottawa, ON

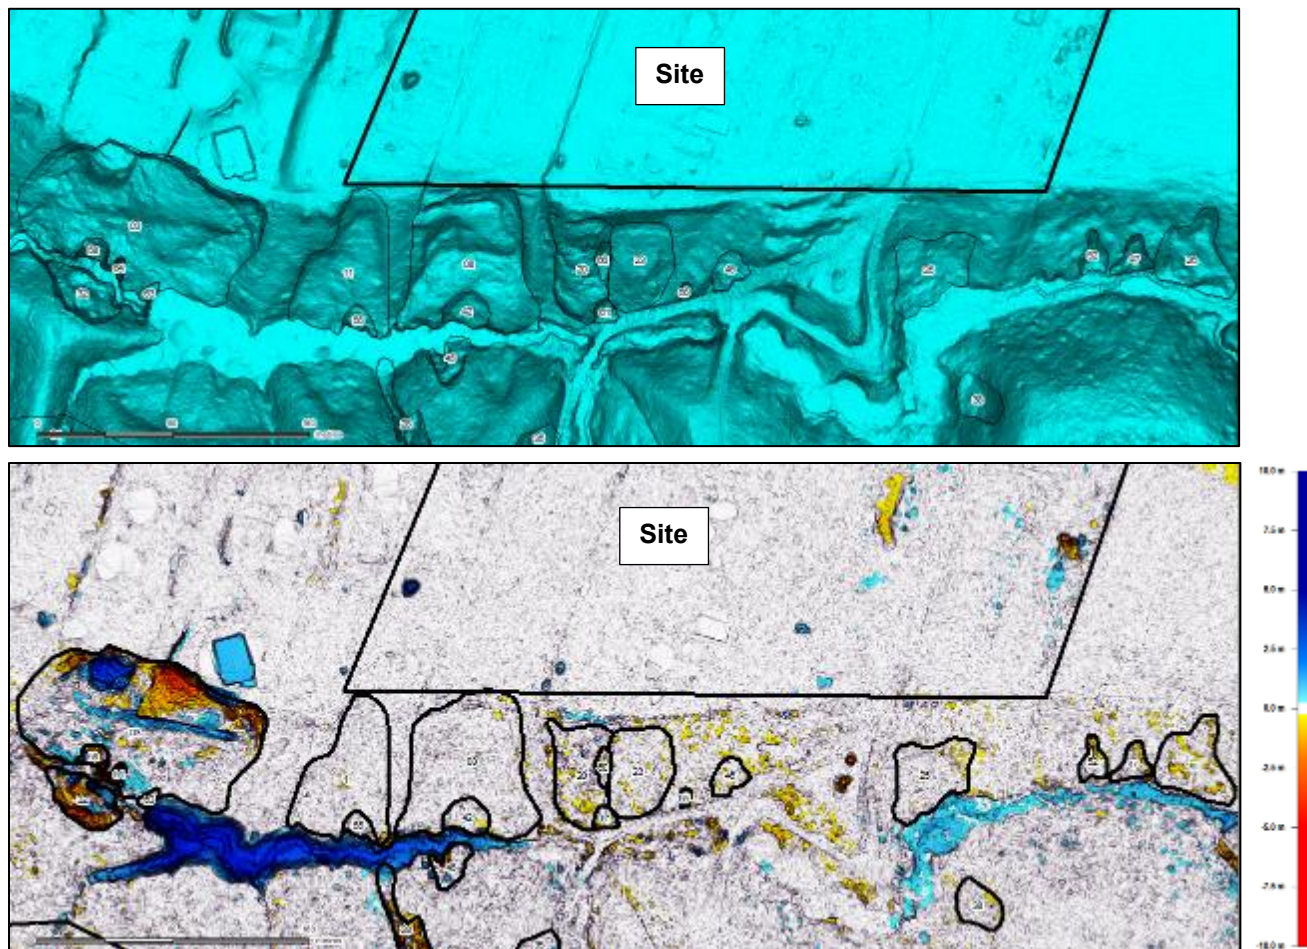
**Figure 3-5 Recorded ground movements along the south-facing slope**

Notes: LiDAR suggest some ground movements within a landslide some 100 m southwest of the site. Three recent failures are present in that same area. The “blue” color along the stream channel, upstream of from the recent landslides corresponds to standing water that has accumulated due to the presence of a beaver dam. Note that some of the negative changes are assumed related to changes in vegetation density (e.g., the “yellow” areas along the south-facing slope), and therefore not representative of actual ground movements.

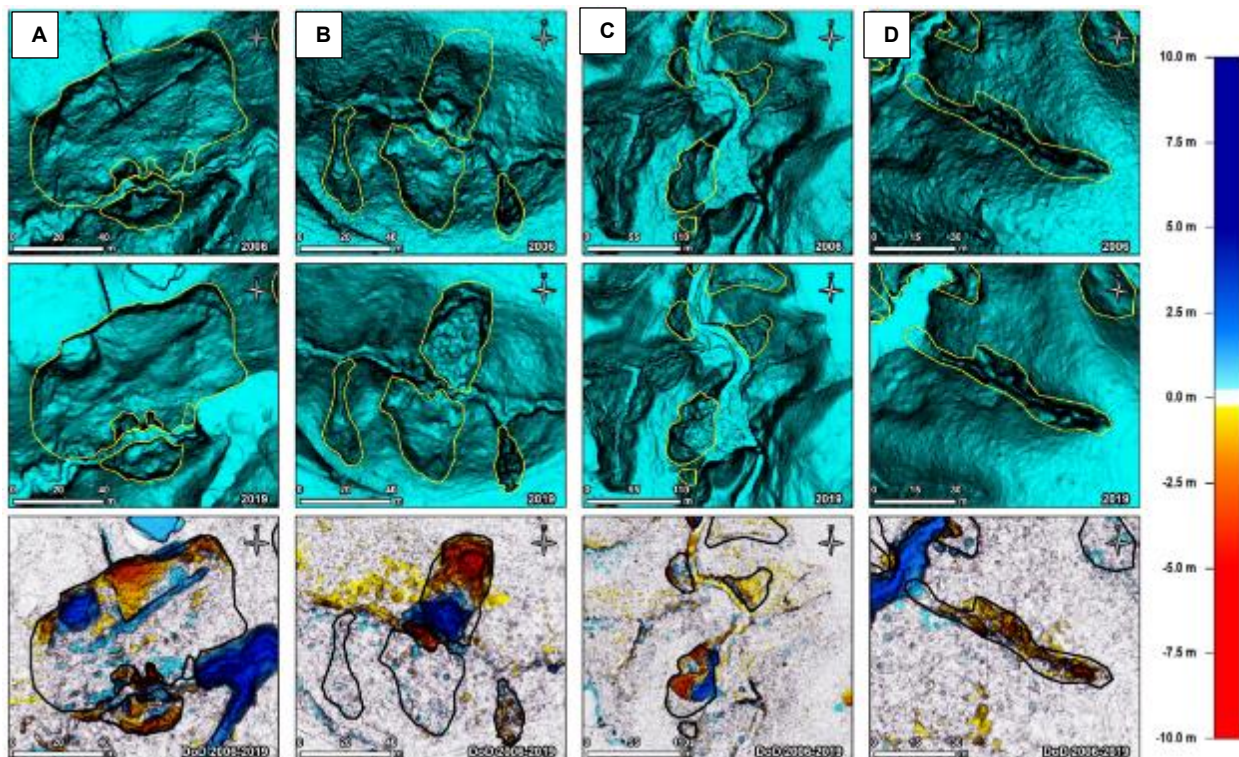
- A Group of landslides showing recent movement (same as displayed in Figure 3.5)
- B Reactivation of a landslide along a tributary gully 200m south of the Site
- C Example of landslides showing recent movement (Cardinal Creek area)
- D Small but active gully that has develop in the clay deposits along a slope across from the site.

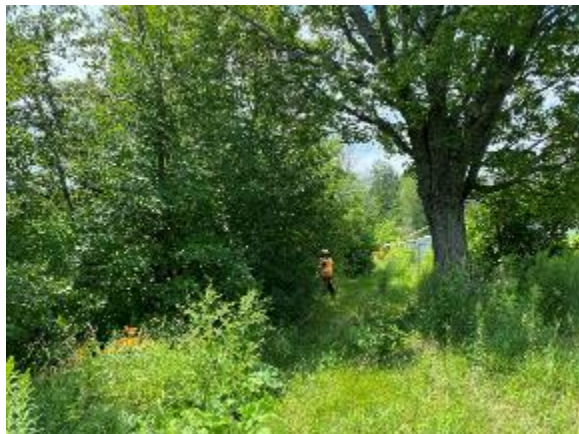
Photo 1: View of upper limit of the south-facing slope at the edge of the plateau (looking west, the slope is on the left).

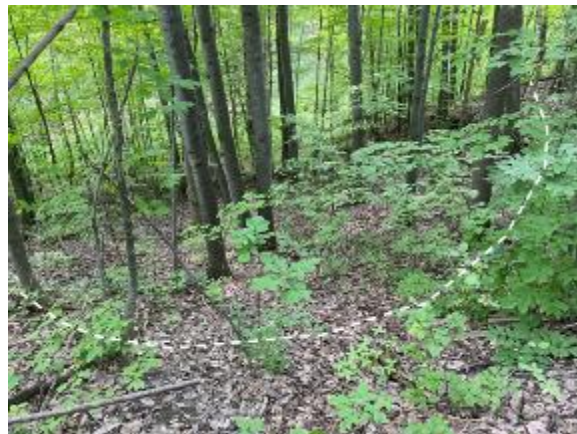
Photo 2: Downslope view of landslide ID 11. Approximate landslide limit in white.

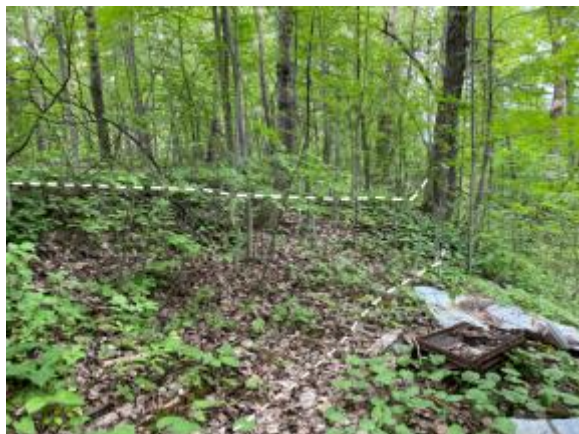
Photo 3: Poorly defined headscarp at landslide ID 11.

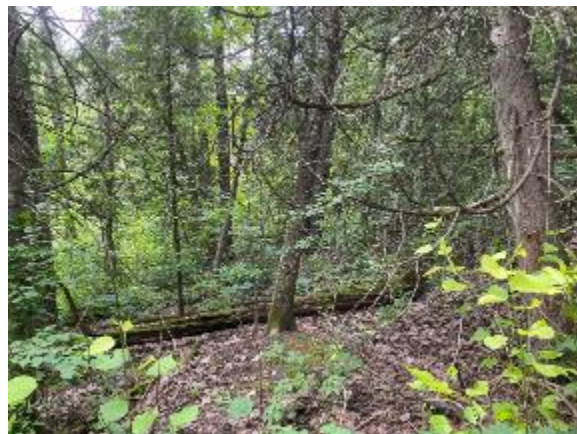
Photo 4: Undulating to hummocky terrain along the base of landslide ID 55. Movement from right to left.

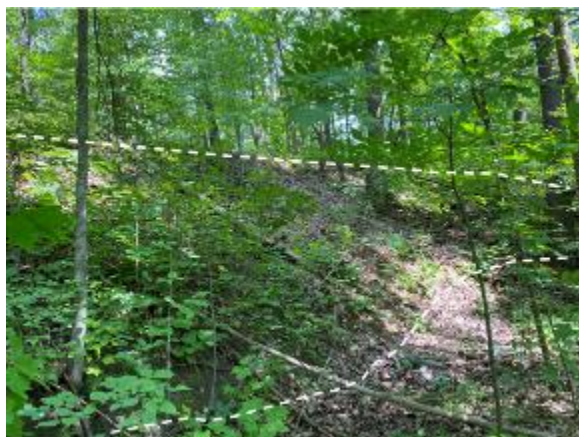
Photo 5: Lateral view of stable headscarp at landslide ID 08. The feature matches the crest of the south-facing slope along the southwest limit of the Site.

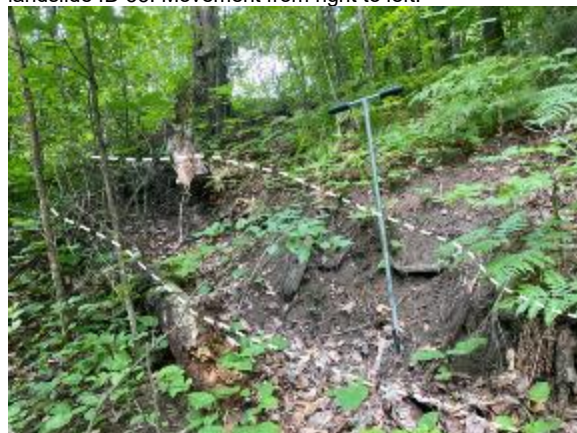
Photo 6: View of a section of the headscarp observed at landslide ID 03, in the area showing movement on the LIDAR change detection.

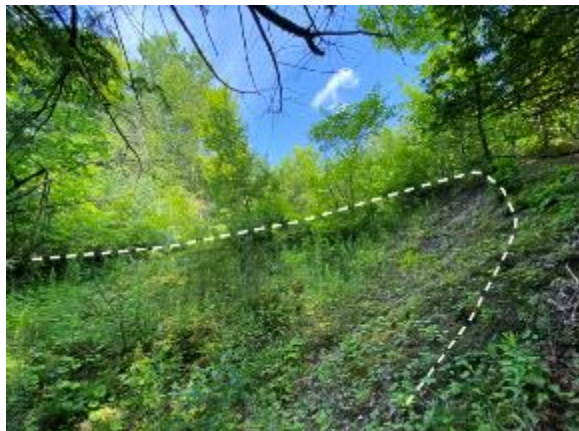
Photo 7: View of the headscarp (white) at landslide ID 14. The landslide is less than 15 years and showing signs of recent movement.

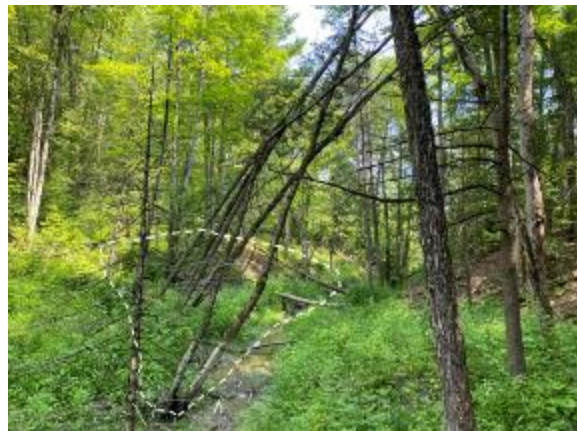
Photo 8: Small landslide (ID 42) along the unnamed creek at the based of the south-facing slope (looking upstream).

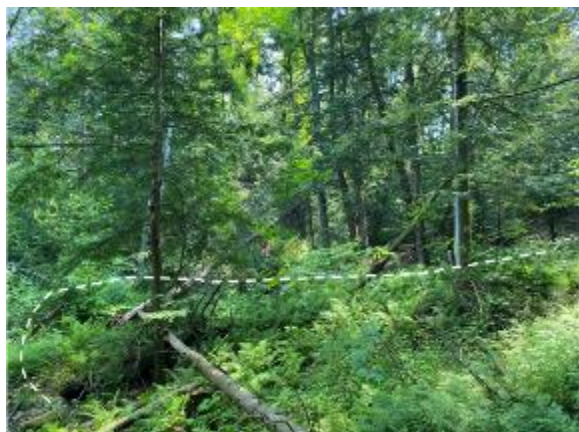
Photo 9: Base of landslide ID 14 showing back-tilted trees (movement from right to left, approximate landslide limit in white).

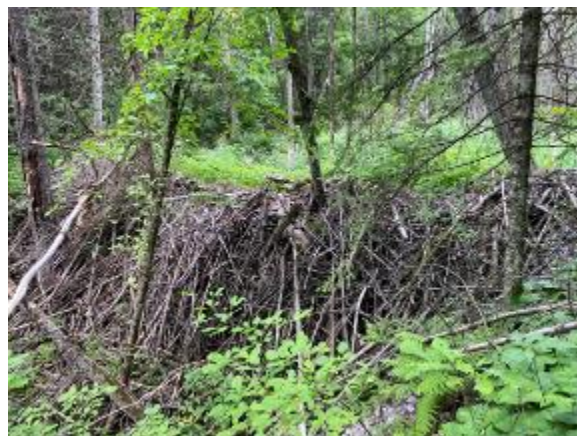
Photo 10: Upstream view of the beaver dam across the unnamed creek.

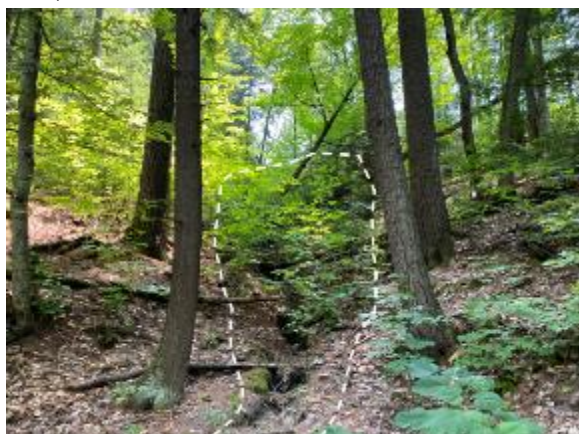
Photo 11: Base of active gully along north-facing slope across from the site (ID 28).

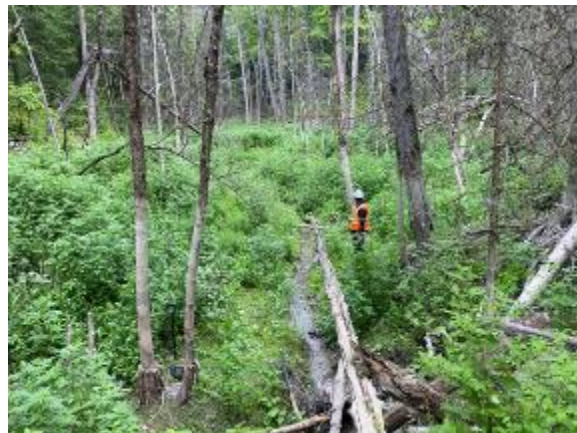
Photo 12: Upstream view of previously flooded area at the base of gully system (south-facing slope on the left side). Note: Maximum water level visible from tree bark.

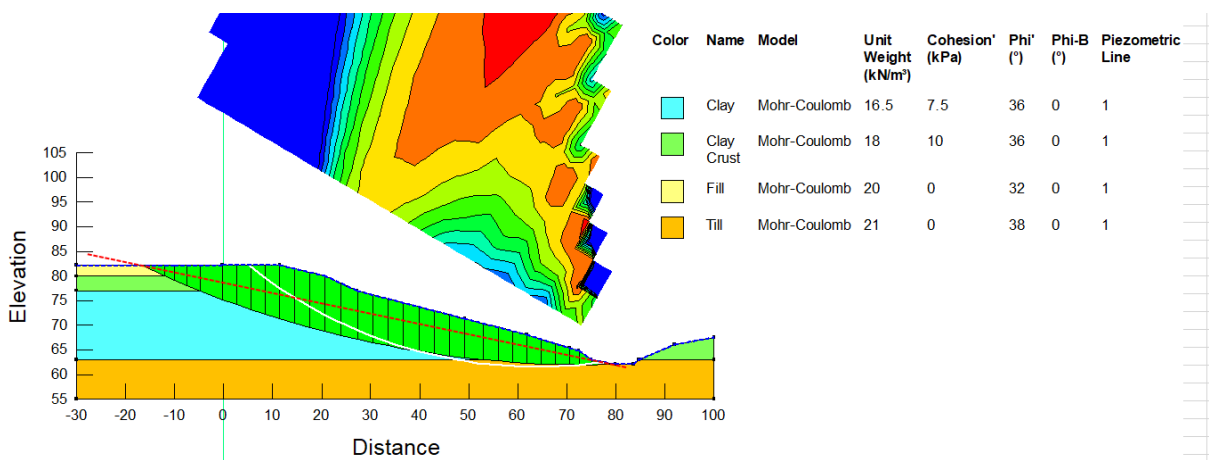
**Figure 6-3 Fahrböschung (11°) of the 1:10,000 return period event (FoS ~1.58)-Section C-C'**

Given the limits of the geotechnical information currently held at the site, using Silva et al (2008), a FoS of 1.58 delimits a zone beyond which the  $PO$  is < 1:10,000 (and Fahrböschung of 11-13° (Figure 6-3)).
