**Headwater Drainage Feature Assessment
Phoenix Homes -
Old Montreal Road**

July 31, 2021

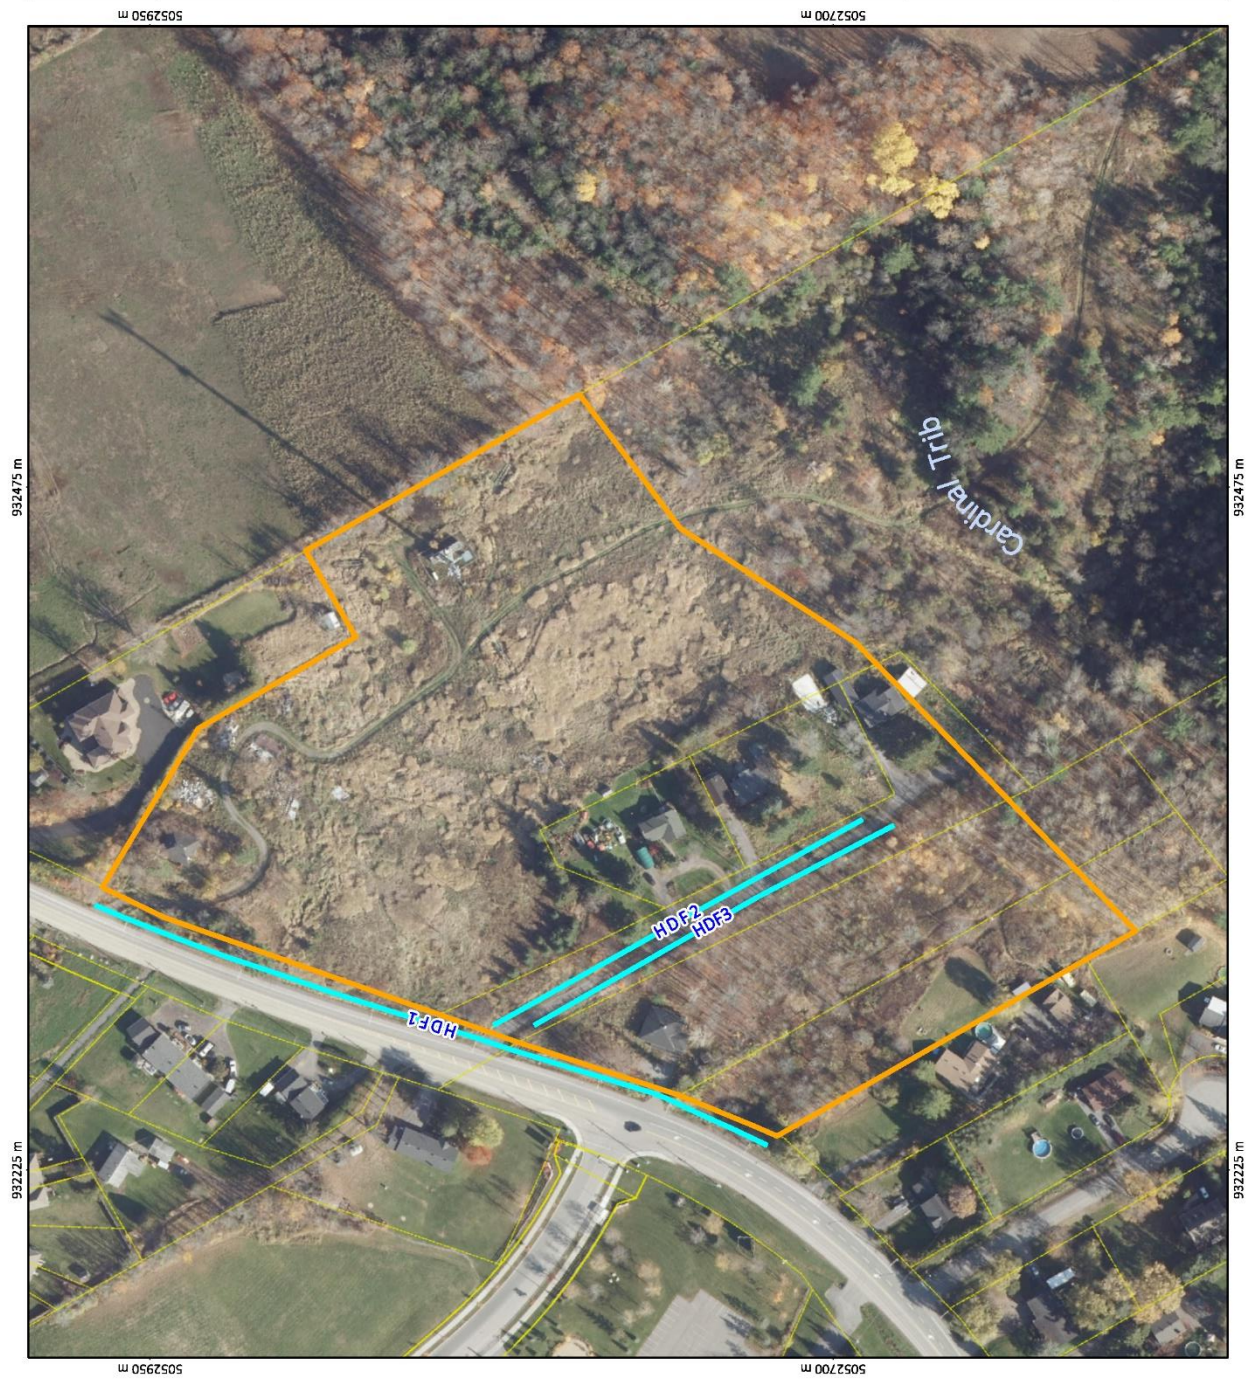
HDFs were reviewed on the Site initially in 2018, then again in 2021. A total of three HDFs were identified and are described in this report (Figure 2). All three features are/were located at the north end of the Site. The southern edge of the Site corresponds with the top of a ravine crossing the Site properties that conveys a tributary to Cardinal creek to the west. The tributary, as a permanent stream, does not meet the definition of an HDF under the HDFA Guidelines. Moreover, it is located outside of the Site area and no HDFs conveyed flows from the rear of the Site flows to that stream. Proposed future development on the Site will adhere to setback requirements as required based on floodplain limits, buffer distances from top-of-bank and/or normal high water mark, and hazard limits. The Cardinal Creek tributary is therefore not addressed further within this report.

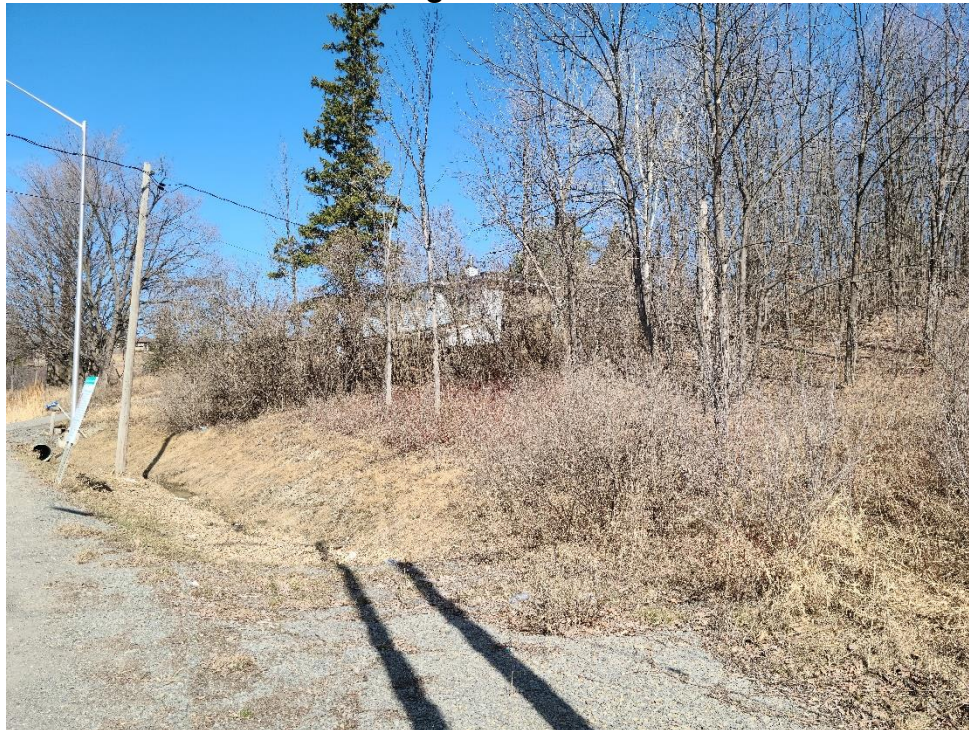
HDF1, the roadside ditch along Montreal Road, conveys road runoff and spring meltwater from the Site and surrounding area to Cardinal Creek ~250 m to the west. The feature has bankfull width of 5.4 m with a wetted width of 100 to 115 cm at the peak of the spring freshet a maximum depth of 17 cm. Flow was 0.32 m/s in the spring of 2018 but was barely detectable in the spring of 2021. No water was observed in the feature beyond the spring freshet. The substrate is muddy with significant grass growth. The left upstream bank (north) is the gravel shoulder to Montreal Road. The right upstream bank is a mix of yards and fields with some trees and shrubs along its length.

HDF1 - Roadside ditch along Old Montreal Road

This feature is a simple roadside ditch with ephemeral hydrology. Its primary function is to collect and convey road runoff. The feature has negligible biological functionality. This feature is likely to remain in place in its current location. Following the HDFA Guide flow chart linking component classification to management directives (Figure 2), this reach:

This chain of classification descriptors leads to a management directive of **Mitigation**. The feature is not required to be maintained per se but if it is to be removed, its functionality must be replicated or enhanced through lot level conveyance measures as part of the site stormwater management system. Any replacement features/systems should be vegetated to mimic online wet vegetation pockets to the extent possible and must convey water to the same final receiver (i.e. Cardinal Creek). As a roadside ditch for a major arterial road, neither this feature nor a future replacement feature/system requires setbacks or a natural channel design.

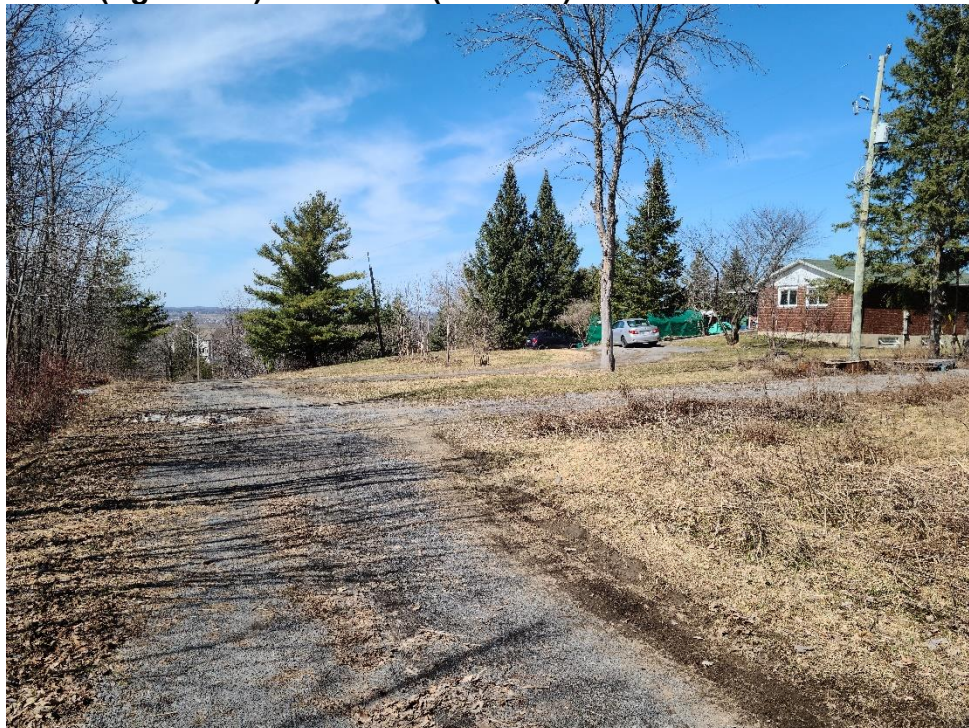
HDF2 and HDF 3 were small swales in 2018 located along the east and west sides respectively of the driveway running up the center of 1180 Old Montreal Road. They conveyed spring runoff norward down the slope. In 2018, both features were both very shallow with no definable banks and both flattened out completely before they reach HDF1 (i.e., had no discernible connection to HDF1). During the spring freshet in 2018, HDF2 had a wetted width of 55 to 110cm with a depth of 1 to 3 cm as it ran south down the length of the driveway. Water from the feature spread out at the bottom end with no detectable depth before, presumably, percolating into the HDF1. The feature was fully grassed with lawn through it and extending to the east. The west edge was the gravel driveway. In 2021 the shape of the feature was still evident though it was completely dry.

During the spring freshet 2018, HDF3 had a wetted width of 40 cm with a depth of 4 to 8 cm (in pockets) as it ran south down the length of the driveway. Water from the feature again spread out at the bottom end with no detectable depth. The feature had a mud and gravel substrate with some portions grassed. Shrubby vegetation grew along the west side; the east edge was the gravel driveway. By the spring of

2021, the length of the feature was inundated with new shrub growth, the channel form along most of its length was no longer evident and no water was present.

HDF2 (right side) and HDF3 (left side)

These reaches do not connect directly to HDF1 may but may direct some spring runoff generally towards that feature and/or provide some opportunity for infiltration Following the HDFA Guide flow chart linking component classification to management directives (Figure 3), these reaches:

This chain of classification descriptors leads to a management directive of **Maintain Recharge**. There is no requirement to retain the feature per se, but the overall water balance for the area must be maintained by providing mitigation measures to infiltrate clean stormwater.
