FINAL REPORT

Phase One Environmental Site Assessment

6305 Ottawa Street West, Ottawa, Ontario

20144864

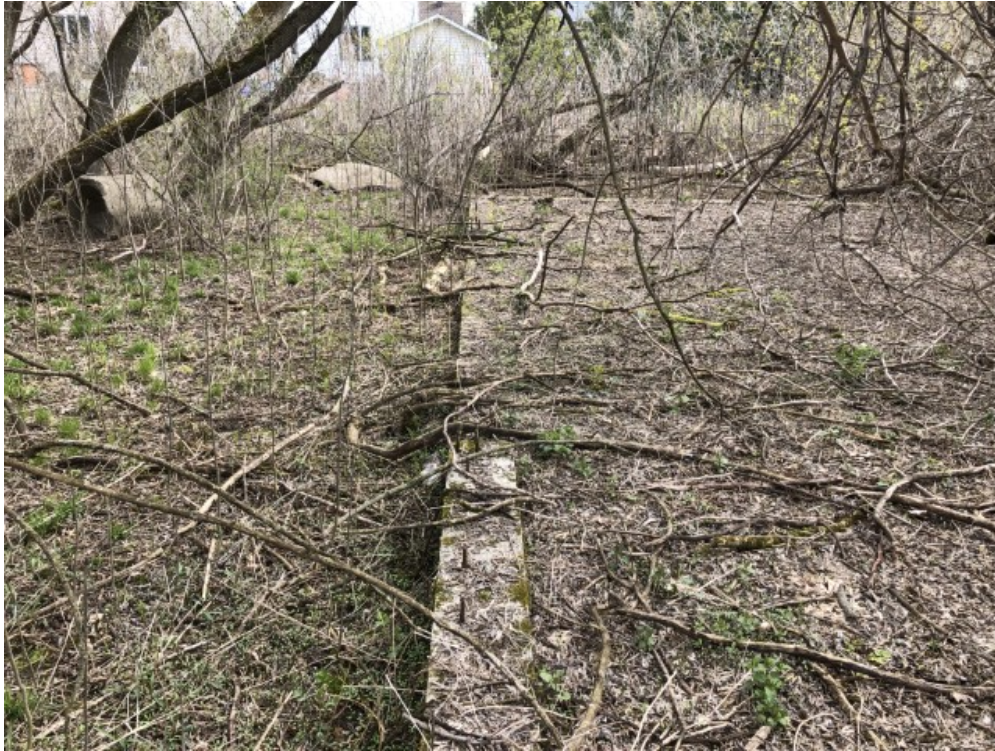
During the Site visit, a paved area and an old concrete foundation one of the former farm related buildings was in the eastern portion of the treed area. An area of metals debris was also observed on the northwest portion of the treed area and other pieces of metal, plastic, paper, concrete and wood debris was scattered in the treed area.

Photo 7: Concrete foundation and concrete debris on the eastern portion of the treed area.

In addition, an area of metals debris is located on the northwest portion of the treed area and small amount of metal, wood, plastic, paper and concrete debris is scattered in the treed area on the Site. Foundation elements and asphalt pavement were noted in the area of the former farm buildings. The presence of this debris and former building elements is not considered to be an on-Site PCA; however, it is considered to be a property management issue and should be removed from the Site prior to development.

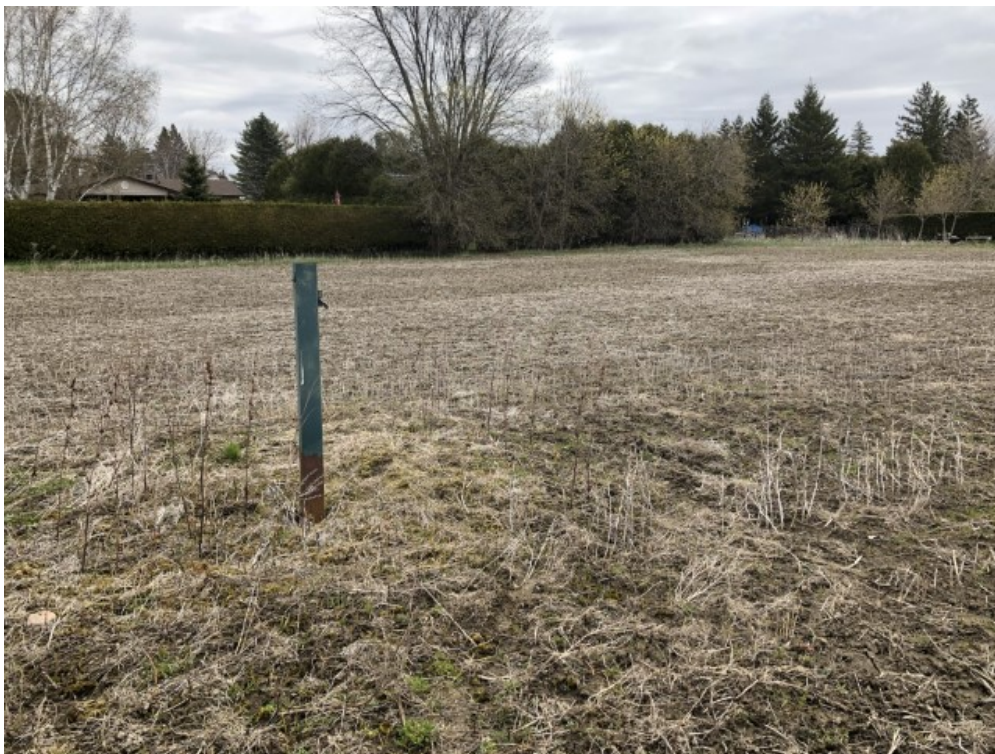
Topic	Conditions	Comment / Source
Water Wells on Site (location, stratigraphy of the overburden, from ground surface to bedrock, depth to bedrock, depth to water table, drilling date, use)	A multi-level well was installed on the southeast portion of the Site in April 2010 for hydrogeological purposes. The shallow well was completed in the overburden to a depth of 1.52 mbgs and the deeper was completed in bedrock to a depth of 4.24 mgs. The water levels in July 2010 were 2.54 and 2.26 mbgs, respectively. These wells were present on the Site at the time of the Site visit.	Site Observations and 2010 Hydrogeological Investigation
Water Wells on the Neighbouring Properties (location, stratigraphy of the overburden, from ground surface to bedrock, depth to bedrock, depth to water table, drilling rate, use)	Based on the ERIS report, there are 67 water wells within the Phase One Study Area. Details of these water wells are provided in the ERIS report in Appendix B. At the time of the Site visit one monitoring well was located to the west of the northern portion of the Site. This well was completed on the adjacent property as part of the 2010 Hydrogeological Investigation. Two newer standpipes were also present on this adjacent property on the south portion of the property.	ERIS Report, 2010 Hydrogeological Investigation and, Site Observations

Photo 12: Monitoring wells located on the southeast corner of the Site looking southeast.
