Marlborough Creek Erosion Mitigation Assessment

6038 Ottawa Street

Ottawa (Richmond), Ontario

GEO Morphix Project No. 25011

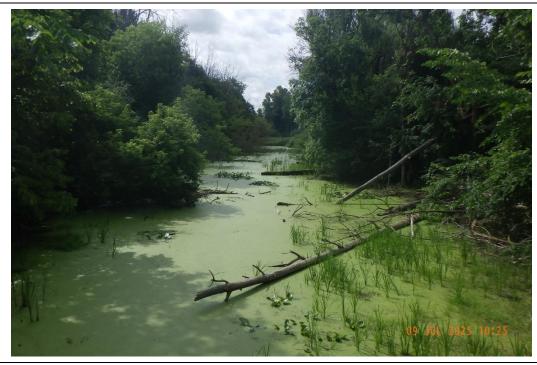
Photo 1 irlborough Cree Peach: MC1

Photograph taken facing upstream from Ottawa street box culvert of reach MC1. Note the fallen trees in the channel and dense floating rooted aquatic vegetation.

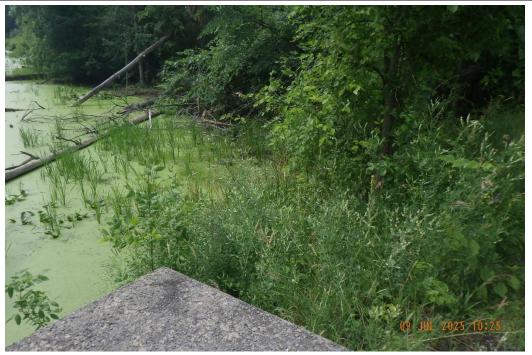
Photograph taken facing upstream from Ottawa street box culvert of reach MC1. Photo showing left bank of channel.

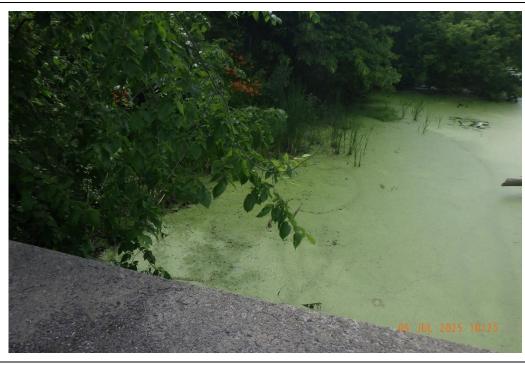
Photo 3 arlborough Cree

Photograph taken facing upstream from Ottawa street box culvert of reach MC1. Photo showing right bank of channel.

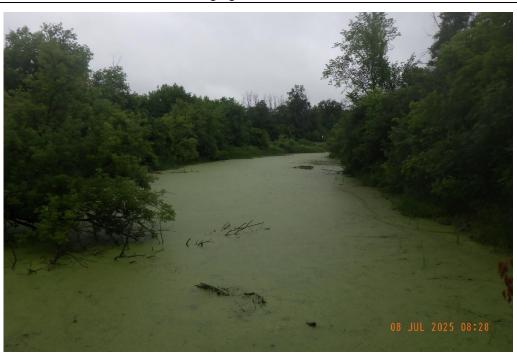
Photo 4
larlborough Creek

Photograph taken facing downstream from Ottawa Street box culvert of reach MC2. Channel exhibits no flow, lack of riffle-pool morphology, and dense floating rooted aquatic vegetation.

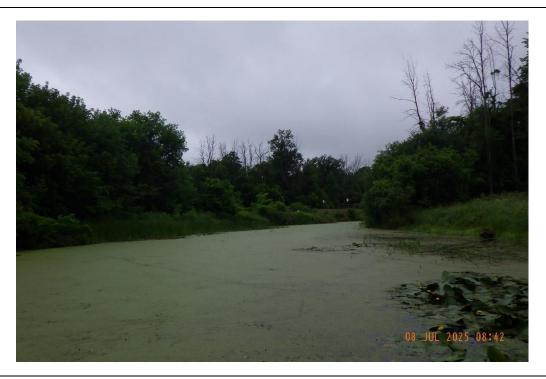
Photo 5

Photograph taken facing downstream along reach MC2. Channel is relatively straight with industrial land use near right bank of reach.

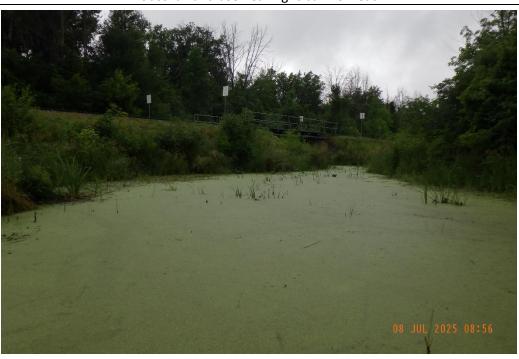
Photo 6 arlborough Creek Beach: MC2

Photograph taken facing downstream along reach MC2. Note photo is taken at single bend in channel before entering reach MC3.

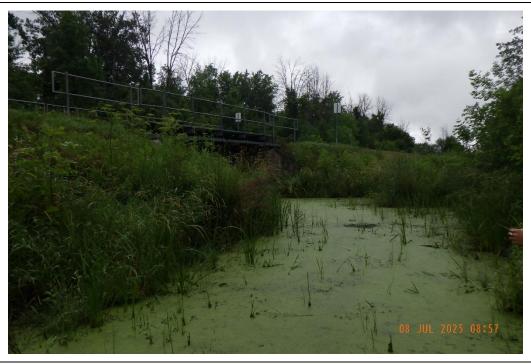
Photo 7 larlborough Cree

Photograph taken facing downstream along MC2. Note the CN railway marks the reach break between MC2 and MC3.

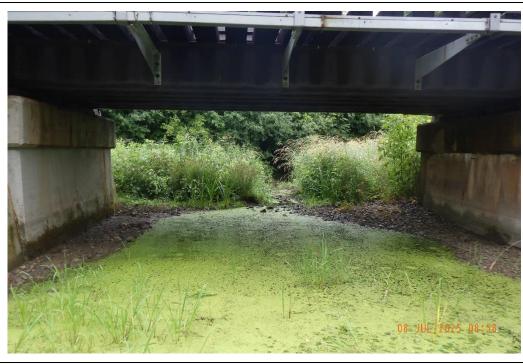
Photo 8 arlborough Creek

Photograph taken facing downstream under CN railway bridge marking reach break between MC2 into MC3. Note the reduction in channel width and depth from reach MC2 into MC3.

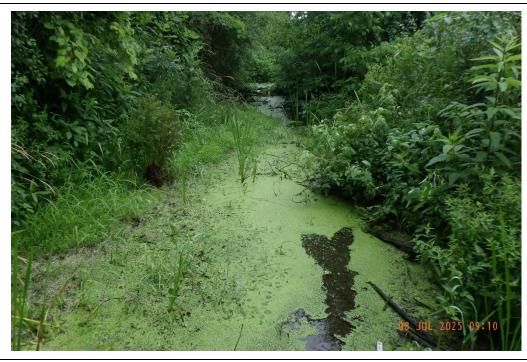
Photo 9 Irlborough Cree Reach: MC3

Photograph taken facing downstream along reach MC3. A small riffle with flowing water was observed at the upstream extent of the reach.

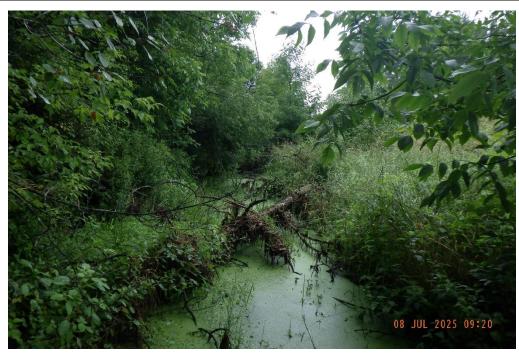
Photograph taken facing downstream along reach MC3. Straightened channel had few fallen trees and heavily vegetated banks with some encroachment into channel.

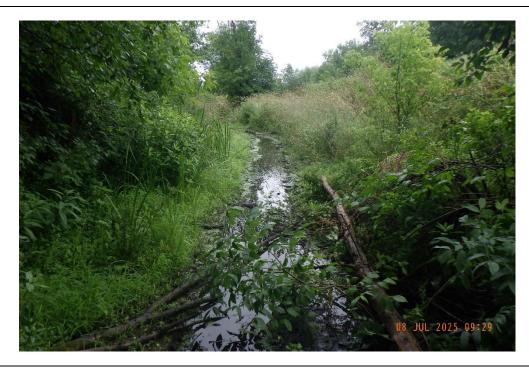
Photo 11 arlborough Cree Reach: MC3

Photograph taken facing downstream along reach MC3. Channel becomes less vegetated and covered near downstream end of reach. The railway embankment located along MC3's right bank was composed of cobbles, with cobbles of similar shape and size found embedded within the channel bed and bank sediments.

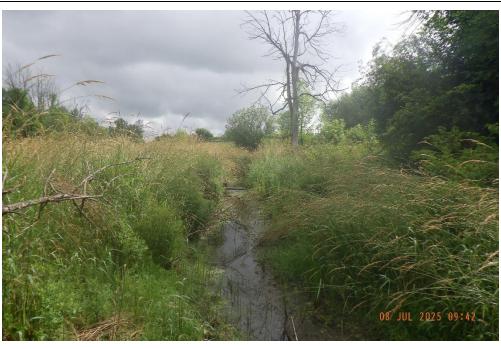
Photo 12 arlborough Creek Reach: MC3

Photograph taken facing downstream along reach MC3. Near the downstream end of the reach the dominant channel riparian vegetation transitions from trees and shrubs to tall grasses and herbaceous plants.

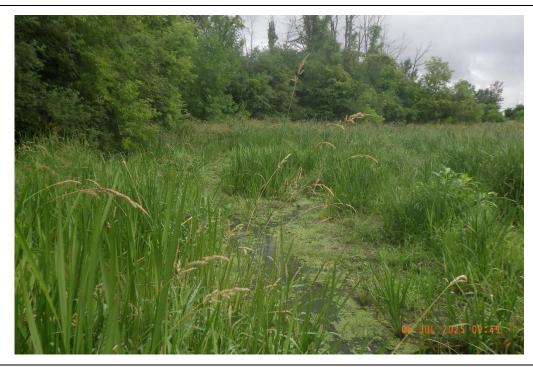
Photo 13 arlborough Creel Reach: MC3

Photograph taken facing downstream along reach MC3. The downstream end of the reach widens and enters large floodplain, channel exhibits swamp/wetland like characteristics with no flow, dense vegetation, and no defined channel.

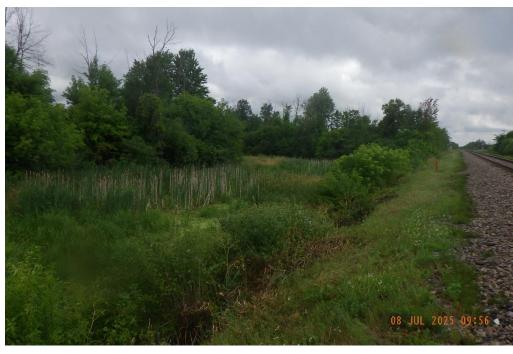
Photo 14 Marlborough Creek Peach: MC4

Photograph taken facing downstream at reach MC4. Note CN railway along right bank. Upstream end of reach exhibits swamp/wetland like characteristics.

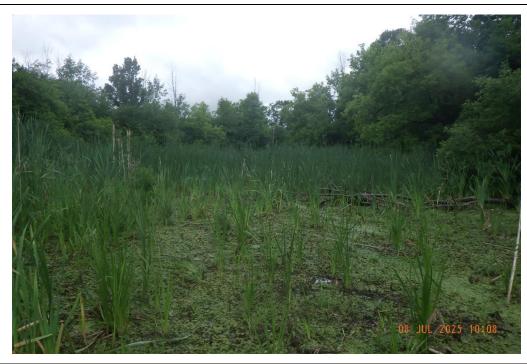
Photo 15

Photograph taken facing downstream along reach MC4. Channel is heavily vegetated by cattails and european frogbit. Stagnant water and a deep layer of unconsolidated fine sediments were present throughout the extent of the reach.

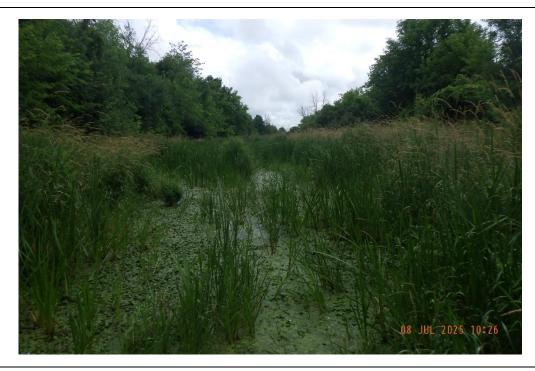
Photo 17
arlborough Cree

Photograph taken facing downstream along reach MC4. No signs of erosion or bank failures along the channel. Heavily vegetated channel and banks.

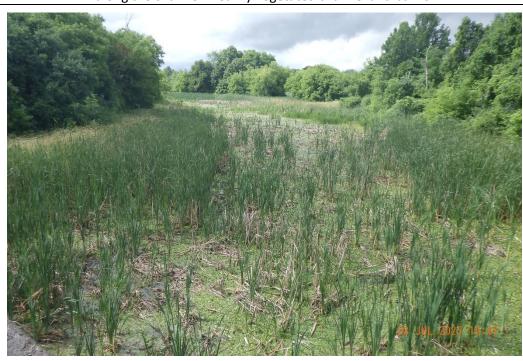
Photo 18 Iarlborough Creek

Photograph taken facing upstream of reach MC4. Photo taken from Eagleson Road which delineates reach break between MC4 and MC5.

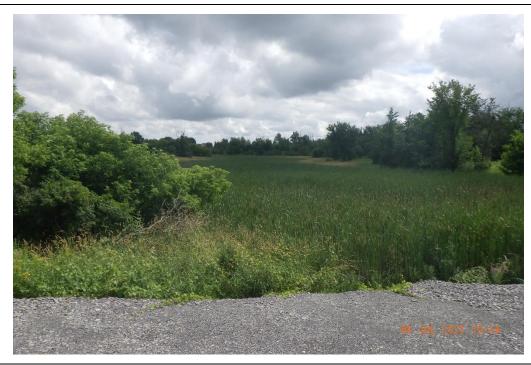
Photo 19
arlborough Cree

Photograph taken facing upstream of reach MC5. Photo taken from Eagleson Road. Reach has the densest vegetation and widest channel of all assessed reaches.

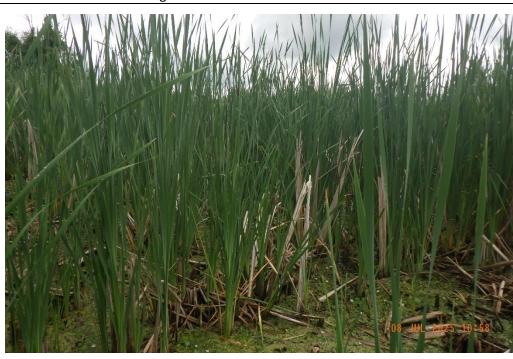
Photo 20 larlborough Creek

Photograph taken facing upstream along reach MC5. Reach has dense instream vegetation comprised of cattails and european frogbit. Riparian vegetation is comprised of trees, shrubs, and grasses.

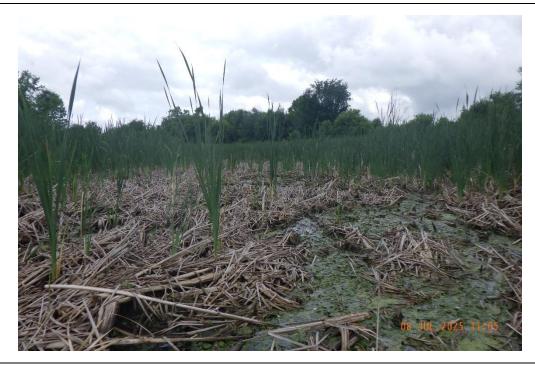
Photo 21 arlborough Cree

Photograph taken facing upstream along reach MC5. Open area of channel near the downstream end of reach, with no velocity and low gradient.

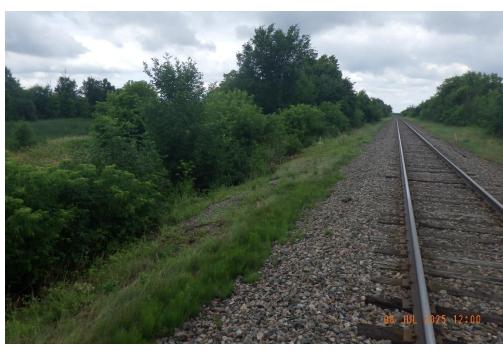
Photo 22 larlborough Creek

Photograph taken facing upstream of reach MC5. CN railway runs along a portion of the right channel bank. Channel is located on left side of photo.

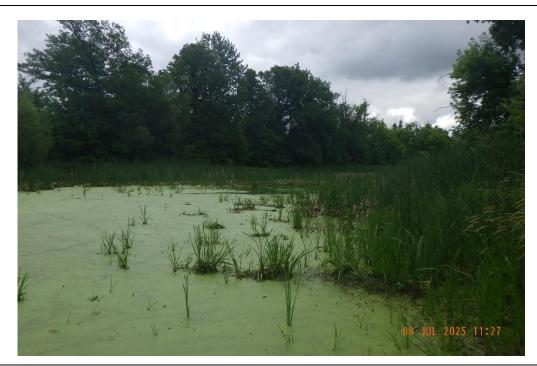
Photograph taken facing upstream at reach MC6. Start of MC6 and end of MC5, dominant aquatic vegetation changes from cattails to duckweed resulting in more open channel.

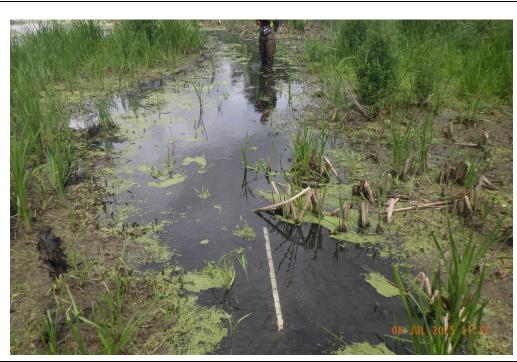
Photograph taken facing upstream along reach MC6. Small riffle present at the beginning of reach,; one of few instances of riffle-pool morphology along the entirety of creek.

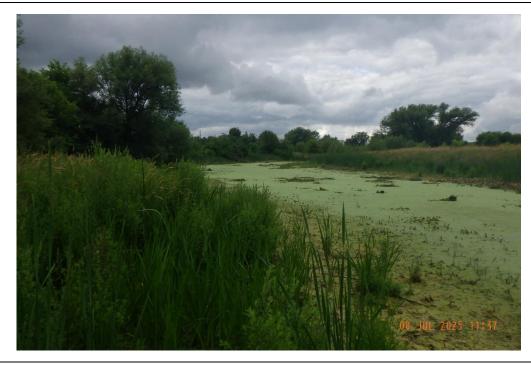
Photo 25 farlborough Cree

Photograph taken facing upstream along reach MC6. The channel is bordered by agricultural land on both banks.

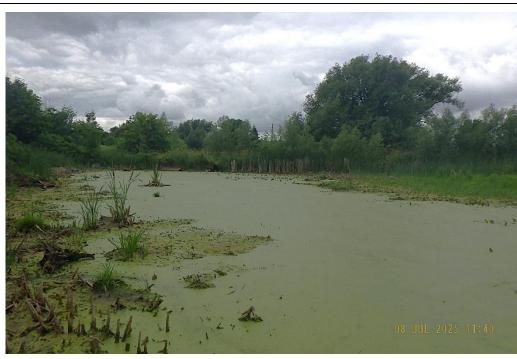
Photograph taken facing upstream along reach MC6. The reach is dominated by floating rooted aquatic vegetation. No flow observed and no erosion present as reach has stable banks and low bank angles. The riparian zone at the downstream portion of the reach is bordered by an agricultural access road.

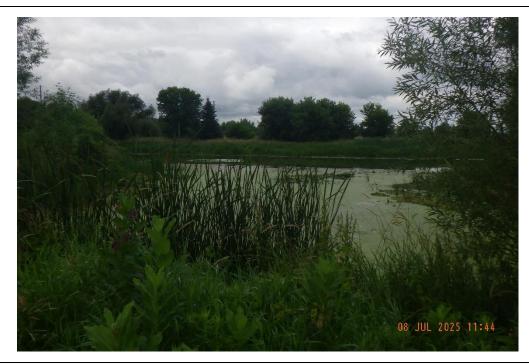
Photo 27 Iarlborough Cree

Photograph taken facing upstream at reach MC6. Confluence of Marlborough creek with Jock River, photo taken on agricultural access road which creek flows under.
