FINAL REPORT

Phase One Environmental Site Assessment

6305 Ottawa Street West, Ottawa, Ontario

Golder Associates Ltd.

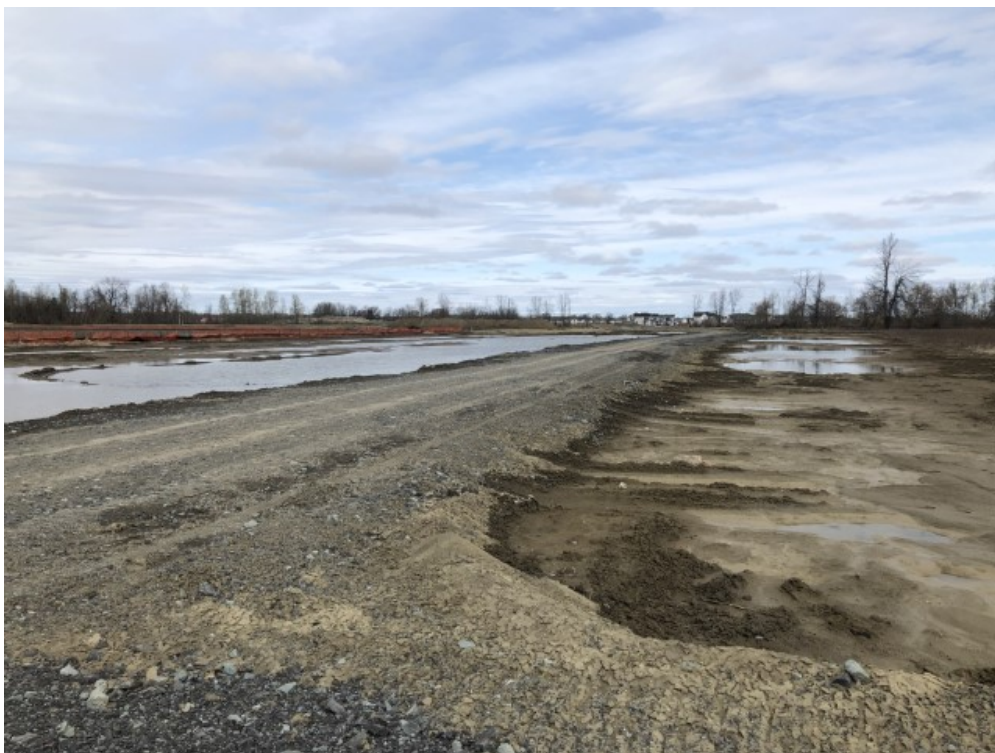
West: Vacant land undergoing residential development. Similar to the lands to the southwest of the Site, some piles of material were present on these lands; however, the fill is likely the material stripped from the property itself associated with the ongoing residential development and therefore no considered to be a PCA. Large areas of standing water was also noted in some of the areas that had been stripped.

Photo 4: Looking northwest at the residential development occurring on the adjacent lands west of the Site includes the fill piles and standing water.

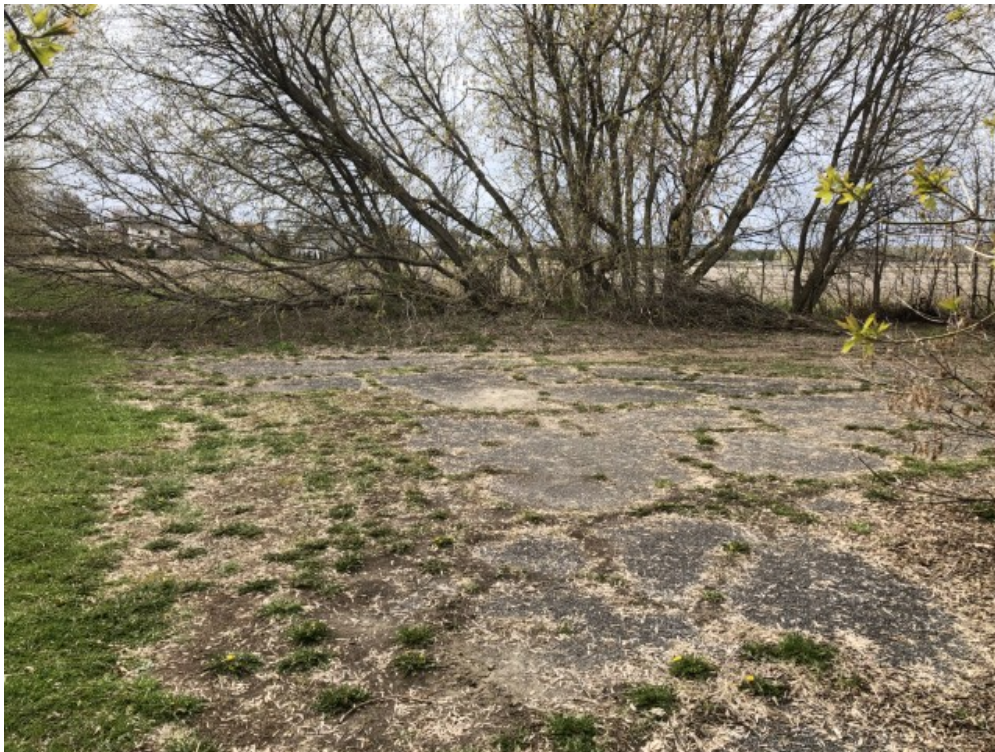
Photo 6: Paved area on the eastern portion of the treed area.

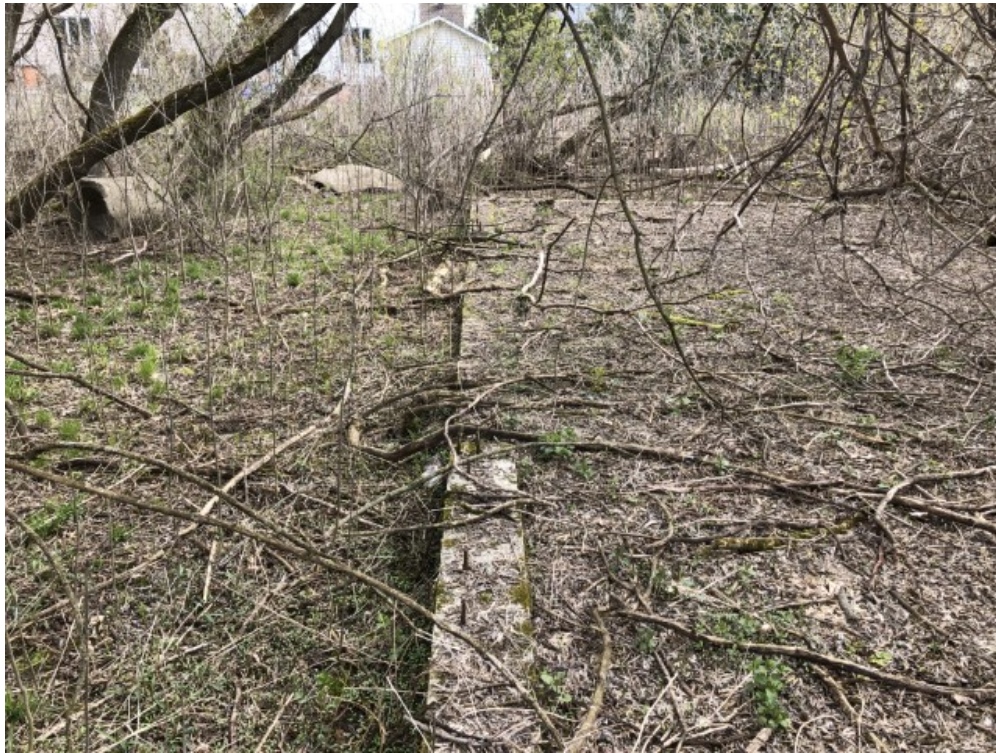
During the Site visit, a paved area and an old concrete foundation one of the former farm related buildings was in the eastern portion of the treed area. An area of metals debris was also observed on the northwest portion of the treed area and other pieces of metal, plastic, paper, concrete and wood debris was scattered in the treed area.

Photo 7: Concrete foundation and concrete debris on the eastern portion of the treed area.

In addition, an area of metals debris is located on the northwest portion of the treed area and small amount of metal, wood, plastic, paper and concrete debris is scattered in the treed area on the Site. Foundation elements and asphalt pavement were noted in the area of the former farm buildings. The presence of this debris and former building elements is not considered to be an on-Site PCA; however, it is considered to be a property management issue and should be removed from the Site prior to development.

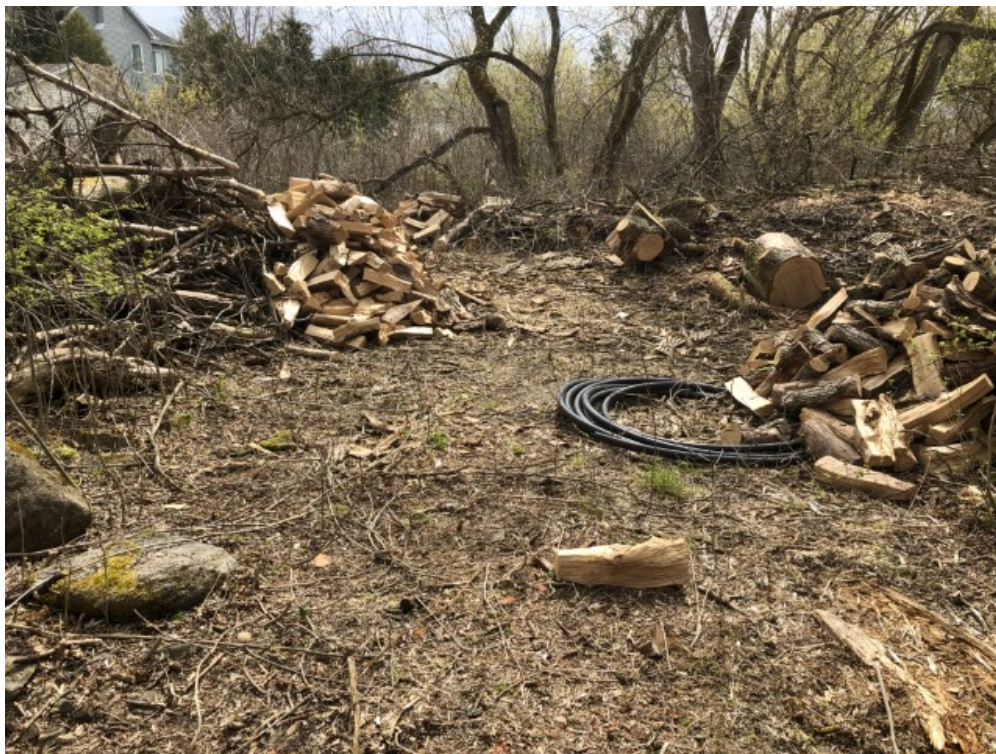
Photo 8: One of many piles of firewood in the treed area.

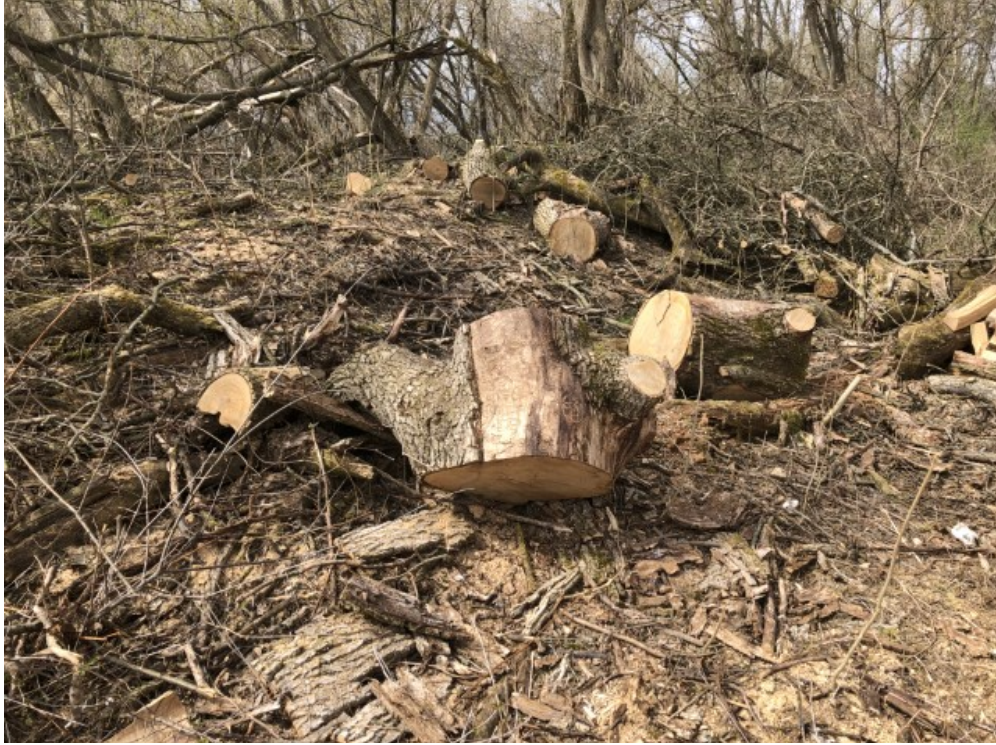
Topic	Conditions	Comment / Source
Fill Materials	Additionally, there appeared to be a pile wood waste on the eastern portion of the treed area. It is possible that some fill material is present within this pile, but it appeared to mostly contain wood waste. Furthermore, the Site Representative indicated that there is no fill material on the Site.	Site observations and Site Representative

Photo 9: Photo of the pile of wood waste located on the easternmost portion of the treed area.

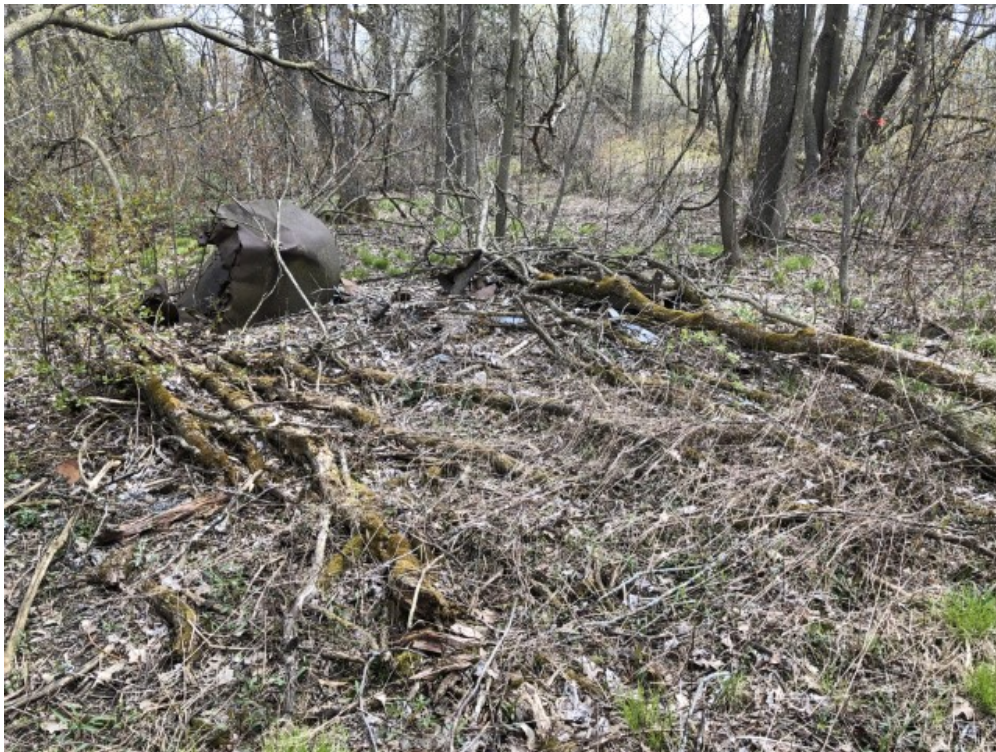
Topic	Observations	Source
Areas Where Fill and/or Debris Materials Appear to Have Been Placed	<p>An area of metal debris was observed in the northwest portion of the treed area. Other small amounts of metal, plastic, paper and concrete debris was scattered throughout the treed area. Small amount of metal, plastic and paper debris was observed in various locations throughout the treed area.</p> <p>There appeared to be a pile wood waste on the eastern portion of the treed area. It is possible that some fill material is present within this pile but it appeared to mostly contain wood waste. Furthermore, the Site Representative indicated that there is no fill material on the Site.</p>	Site observations and Site Representative
Potentially Contaminating Activity	None identified.	Site observations and Site Representative

Photo 10: Area of metal debris located on the northwest portion of the treed area.

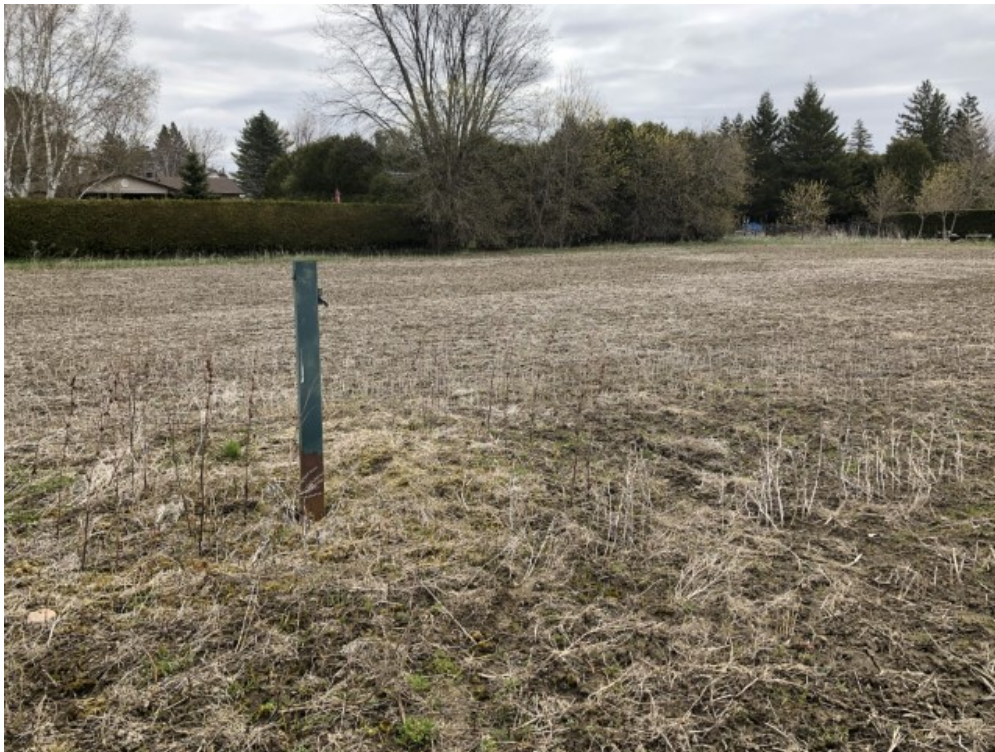
Topic	Conditions	Comment / Source
Water Wells on Site (location, stratigraphy of the overburden, from ground surface to bedrock, depth to bedrock, depth to water table, drilling date, use)	A multi-level well was installed on the southeast portion of the Site in April 2010 for hydrogeological purposes. The shallow well was completed in the overburden to a depth of 1.52 mbgs and the deeper was completed in bedrock to a depth of 4.24 mgs. The water levels in July 2010 were 2.54 and 2.26 mbgs, respectively. These wells were present on the Site at the time of the Site visit.	Site Observations and 2010 Hydrogeological Investigation
Water Wells on the Neighbouring Properties (location, stratigraphy of the overburden, from ground surface to bedrock, depth to bedrock, depth to water table, drilling rate, use)	Based on the ERIS report, there are 67 water wells within the Phase One Study Area. Details of these water wells are provided in the ERIS report in Appendix B. At the time of the Site visit one monitoring well was located to the west of the northern portion of the Site. This well was completed on the adjacent property as part of the 2010 Hydrogeological Investigation. Two newer standpipes were also present on this adjacent property on the south portion of the property.	ERIS Report, 2010 Hydrogeological Investigation and, Site Observations

Photo 12: Monitoring wells located on the southeast corner of the Site looking southeast.
