Landslide Hazard Assessment

Proposed Residential Development

Ottawa, Ontario

Report PG5201-2 Revision 3 dated October 18, 2024

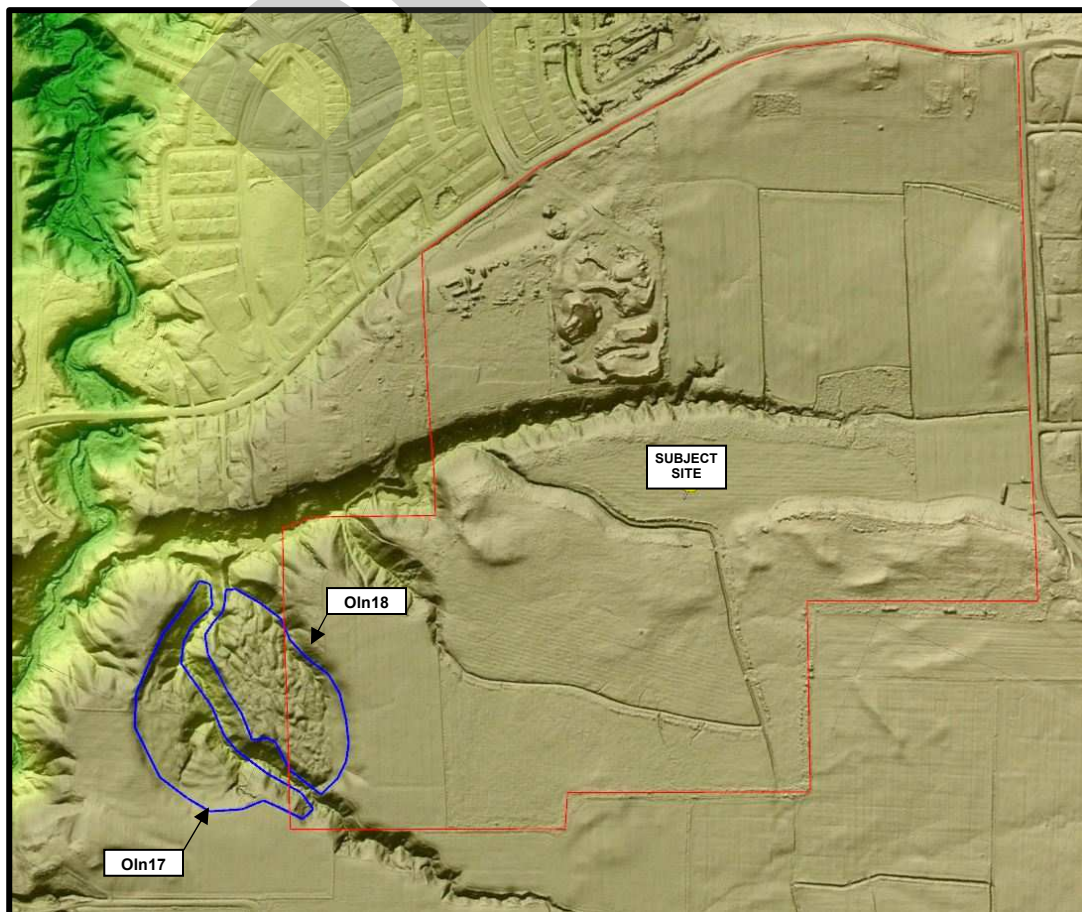
Figure 2 – LiDAR Image of Subject Site and closest landslide and slope failure.

Further to the above-noted large-scale landslides that have occurred within the vicinity of the subject site, recent small-scale and localized slumps have formed in recent years in response to active erosion and sheet drainage. Given the high concentration of local small- and large-scale landslides throughout the area and within the subject site, it is considered appropriate to increase the baseline probability for landslides to occur throughout the subject site by a factor of 2 in Section 4.3 – Hazard Assessment of this report.

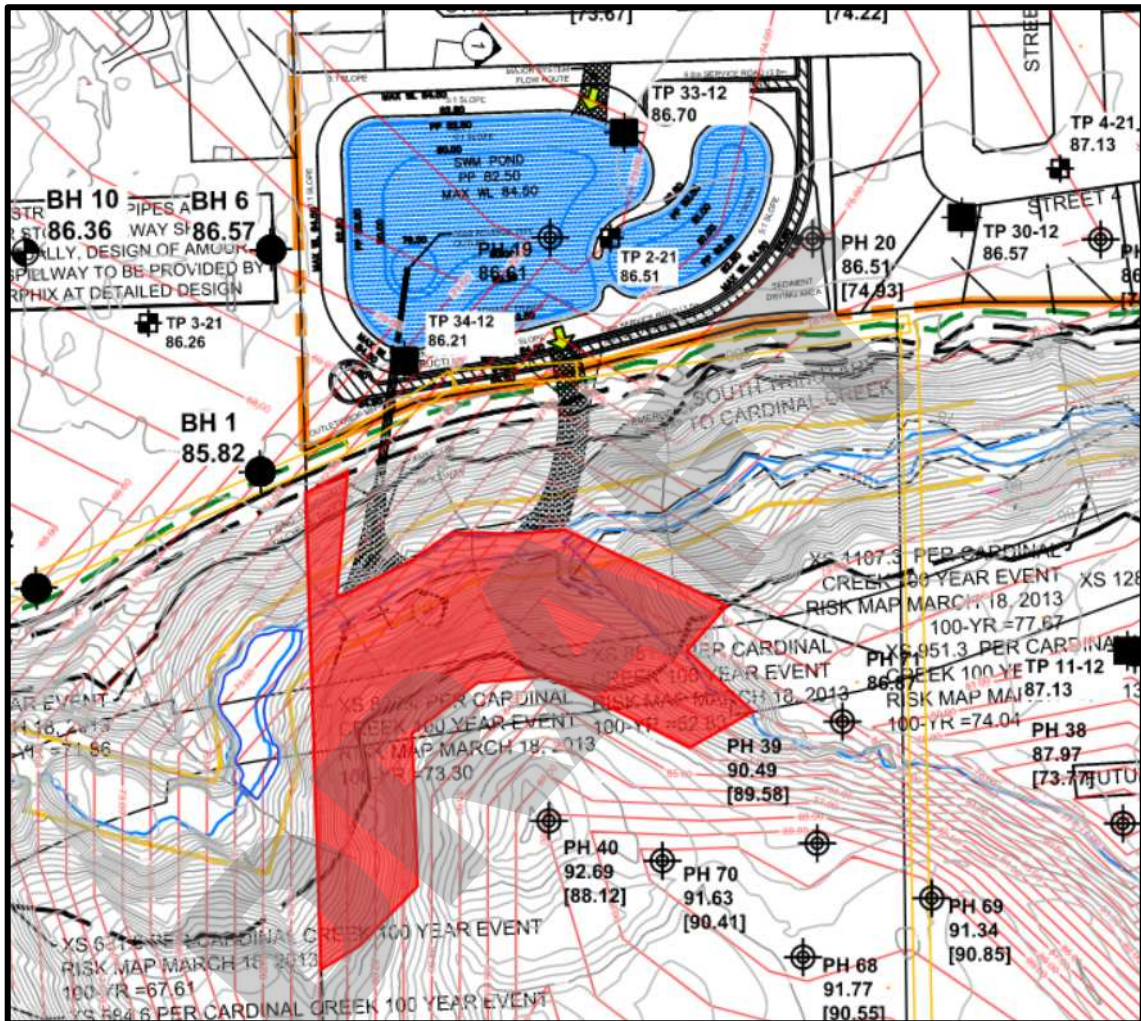
Figure 4 – Area of Subject Site Above 1:10,000-Annual Probability Threshold

Based on our assessment, the probability for a landslide to occur throughout the western portion of the subject site has been estimated to be **1:5,158 per year**. Based on the above, the annual probability of a large landslide occurring at or directly impacting the subject site is estimated to be more than 1:10,000 per year for portions of the subject site where drift thickness exceeds 15 m and topographic relief exceeds 12 m. Based on this, the area of the subject site corresponding to a probability exceeding 1:10,000 is located at the western boundary of the subject site, and as depicted in Figure 4 below.

Based on our review, pre-development and post-development conditions throughout this portion of the subject site are such that the probability for a landslide to occur is considered to be more than 1:10,000 per year.
