re: Slope Stability Assessment of Existing Slope Failure
Existing Residential Dwelling
1320 Grand-Chêne Court – Ottawa, Ontario
to: Tamarack Homes – Mr. Mike Green – mike.green@taggart.ca
to: HP Urban Inc. - Mr. Peter Hume - peter.hume@hpurban.ca
to: DSEL - Mr. Braden Kaminski - Bkaminski@dsel.ca
date: November 13, 2023
file: PG5201-MEMO.03

**GEOTECHNICAL INVESTIGATION
EXISTING RESIDENTIAL DWELLING
1320 GRAND-CHENE COURT**

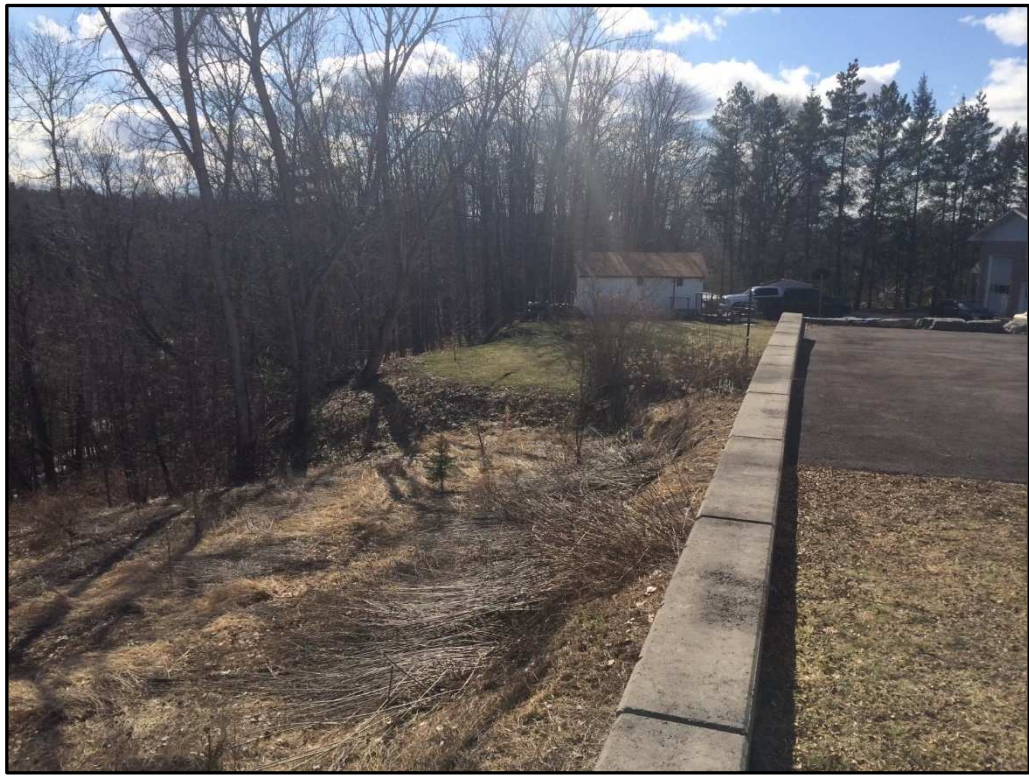
Photo 1: Photograph of failure observed along the top of slope at the property site. Photo taken from 1325 Grand Chêne Court. Photograph provided by the property owner.

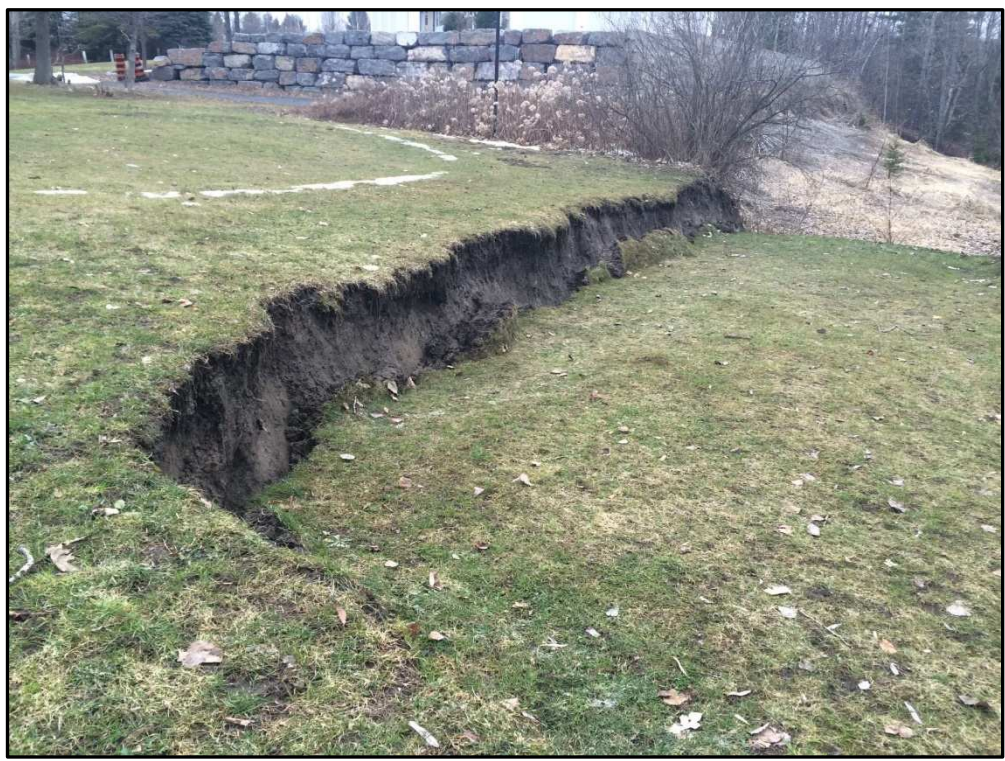
Photo 2: Photograph of failure observed along the top of slope at the property site. Photo taken from the southwest portion of the subject site. Photograph provided by the property owner.

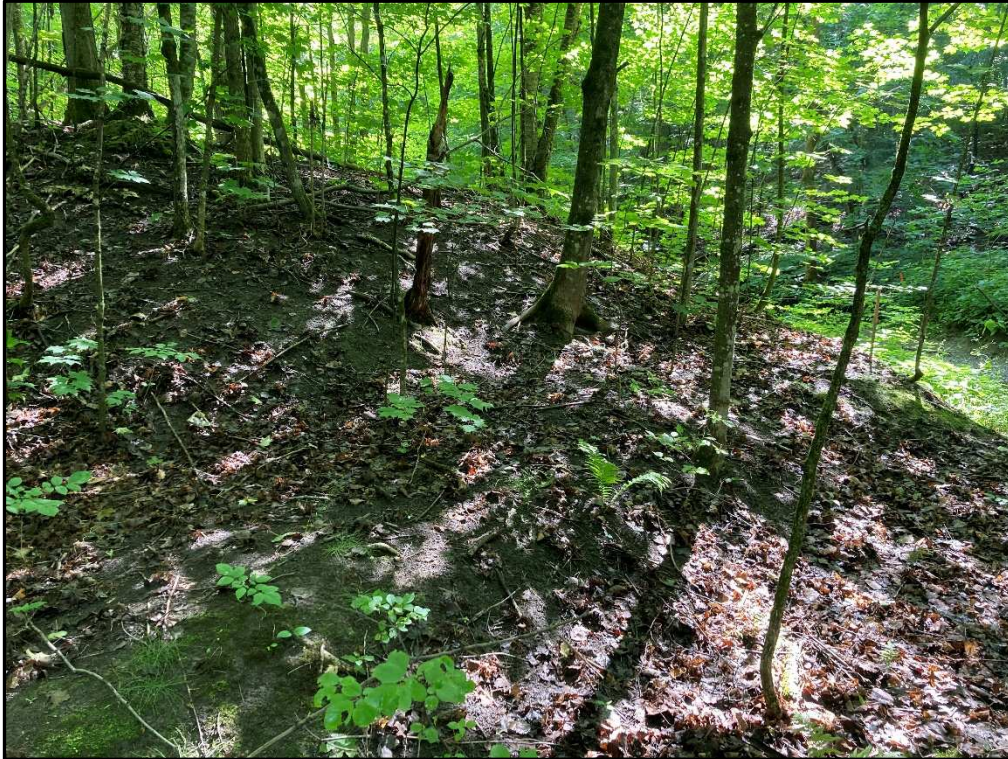
Photo 3: Photograph along the slope face, facing northeast. The photograph depicts the presence of mature vegetation. The face of slope can be observed to consist of brown silty clay.

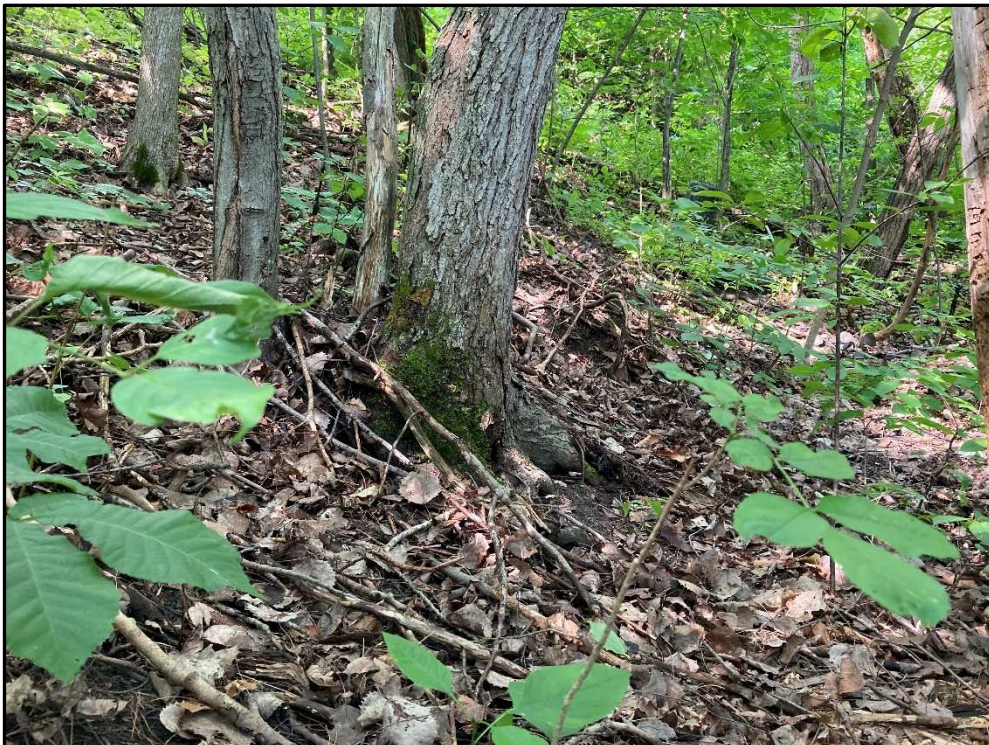
Photo 4: Photograph of the face of slope indicating the presence of mature vegetation. The face of slope is observed to consist mostly of brown silty clay.

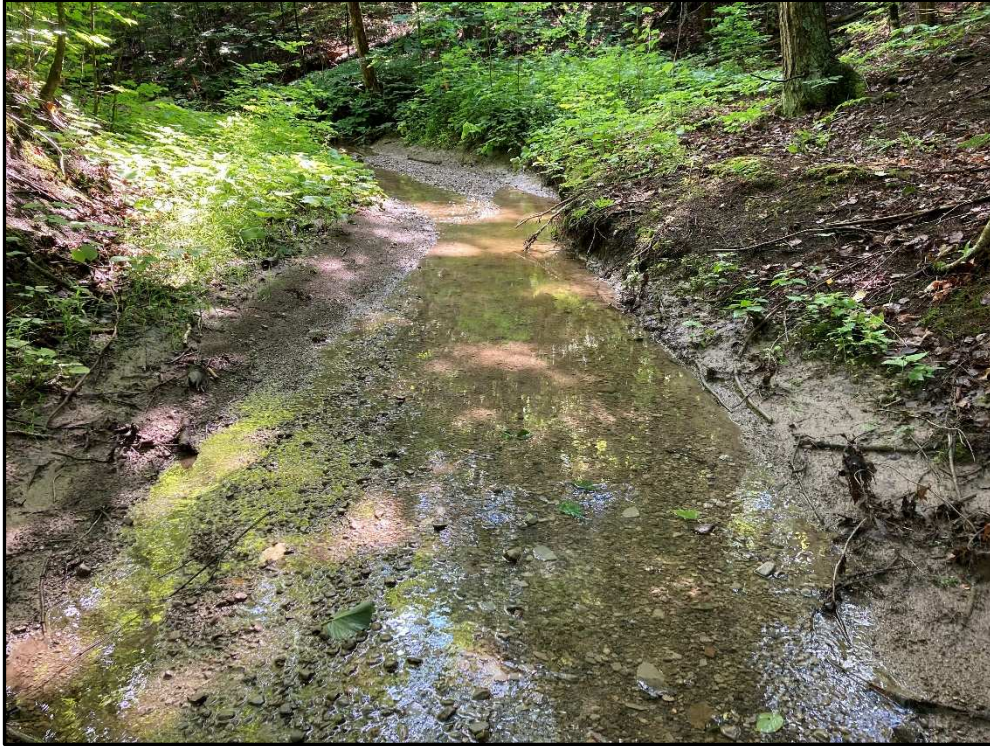
Photo 5: Photograph of the toe of slope and along the north tributary to Cardinal Creek. The toe of slope is observed to consist of grey silty clay with minor signs of erosion.

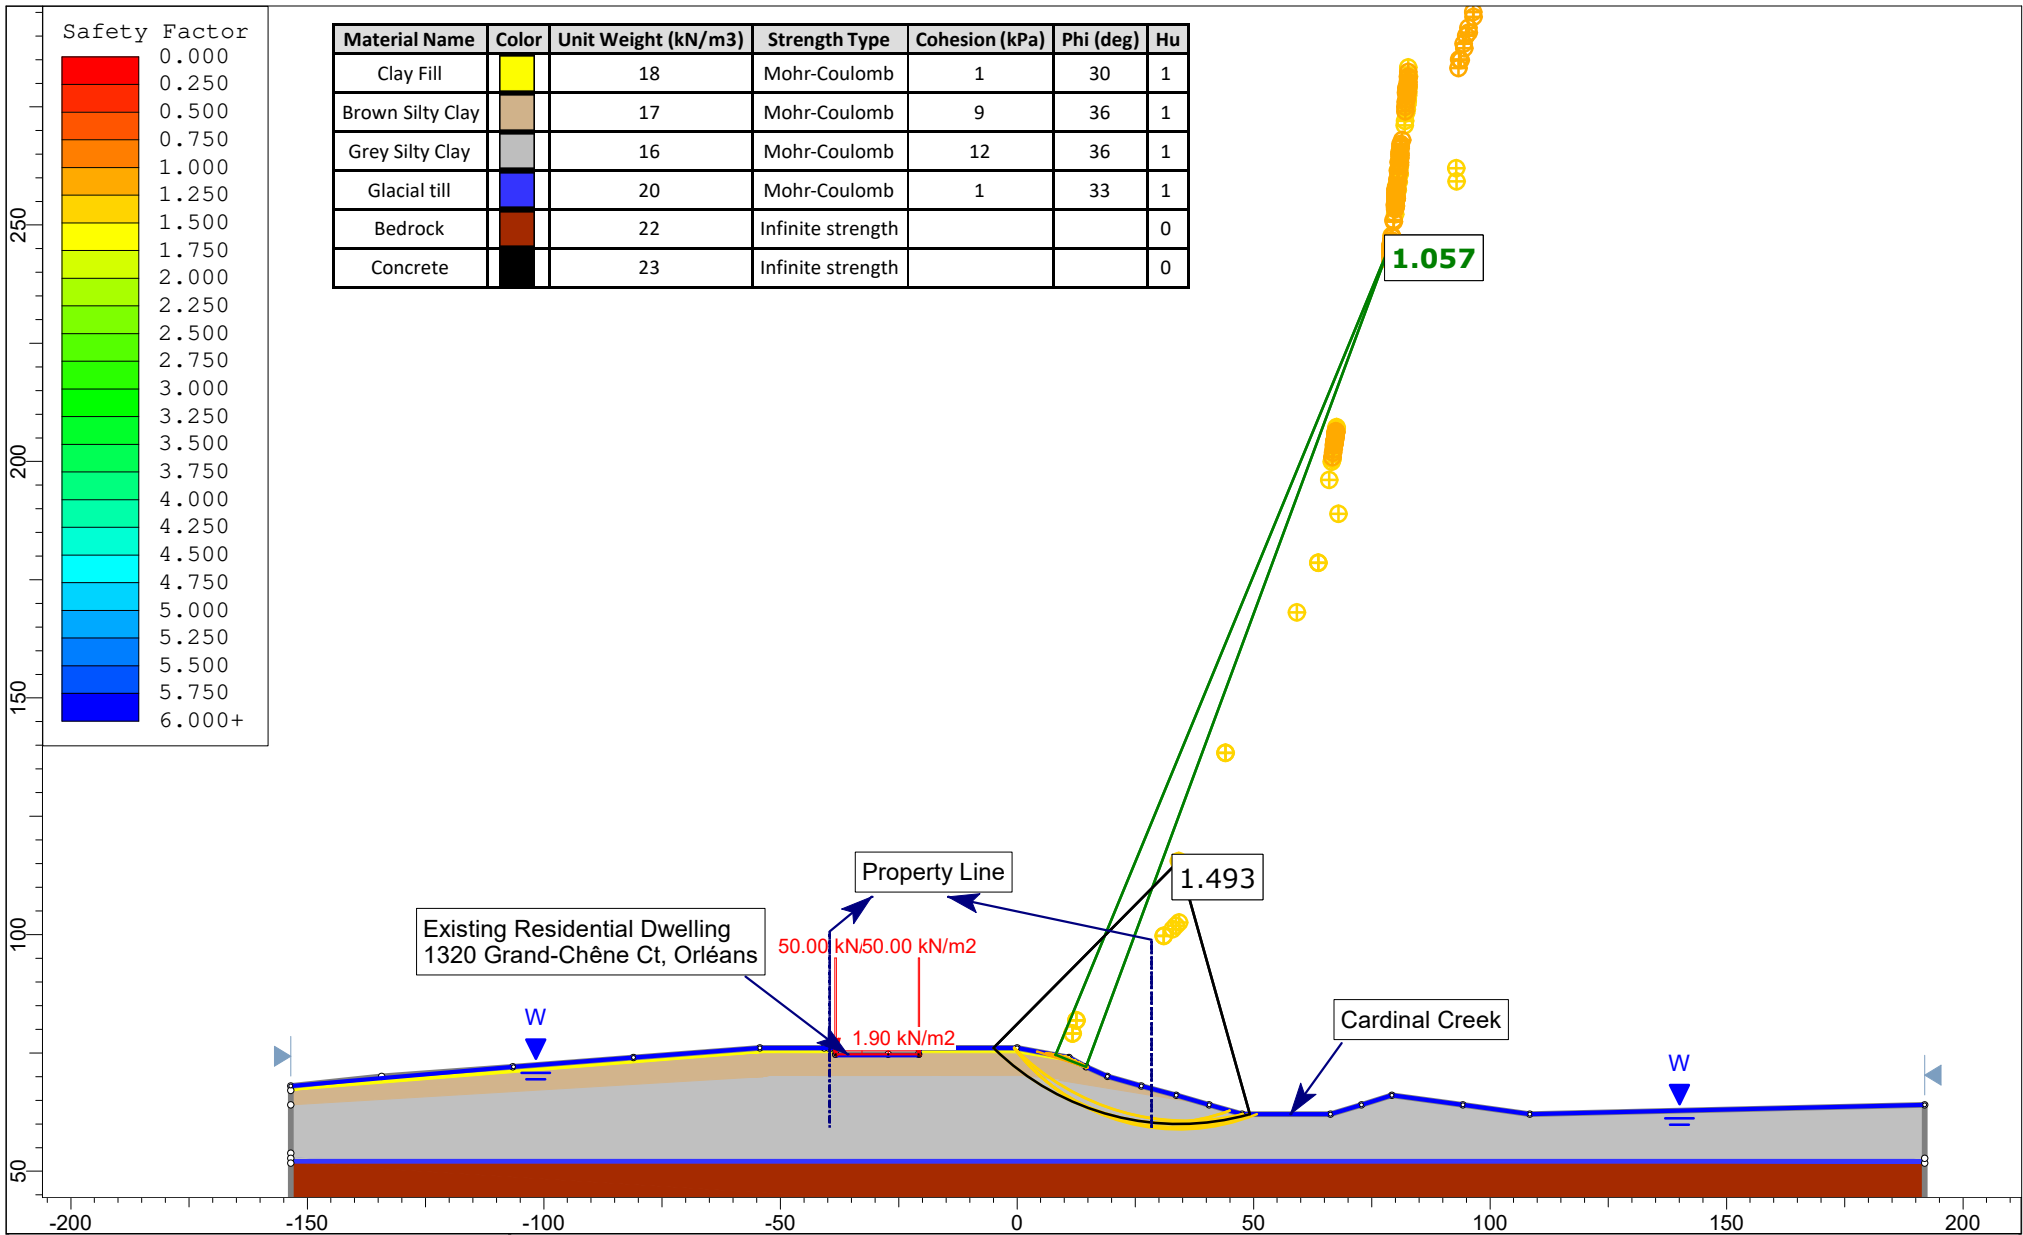
Project		PG5201- 1320 Grand-Chene Ct, Orleans	
	Cross Section	PP	Scenario	Static Condition
	Drawn By	EA	Company	Tamarack Homes
	Date	8/31/2023	File Name	Geotechnical Investigation
	SLIDEINTERPRET 9.025

The results for the slope stability analysis at Section A are shown in Figure 1A, attached to the present memo report. The factor of safety was found to be less than 1.5 and mostly affecting the infilled portion of the slope. The lower factor of safety can be attributed to increased grade raise and surcharge along the top of the slope. Based on our review, the above-mentioned lowest factor of safety generally coincided with the location of the observed existing failure surface at the top of slope.

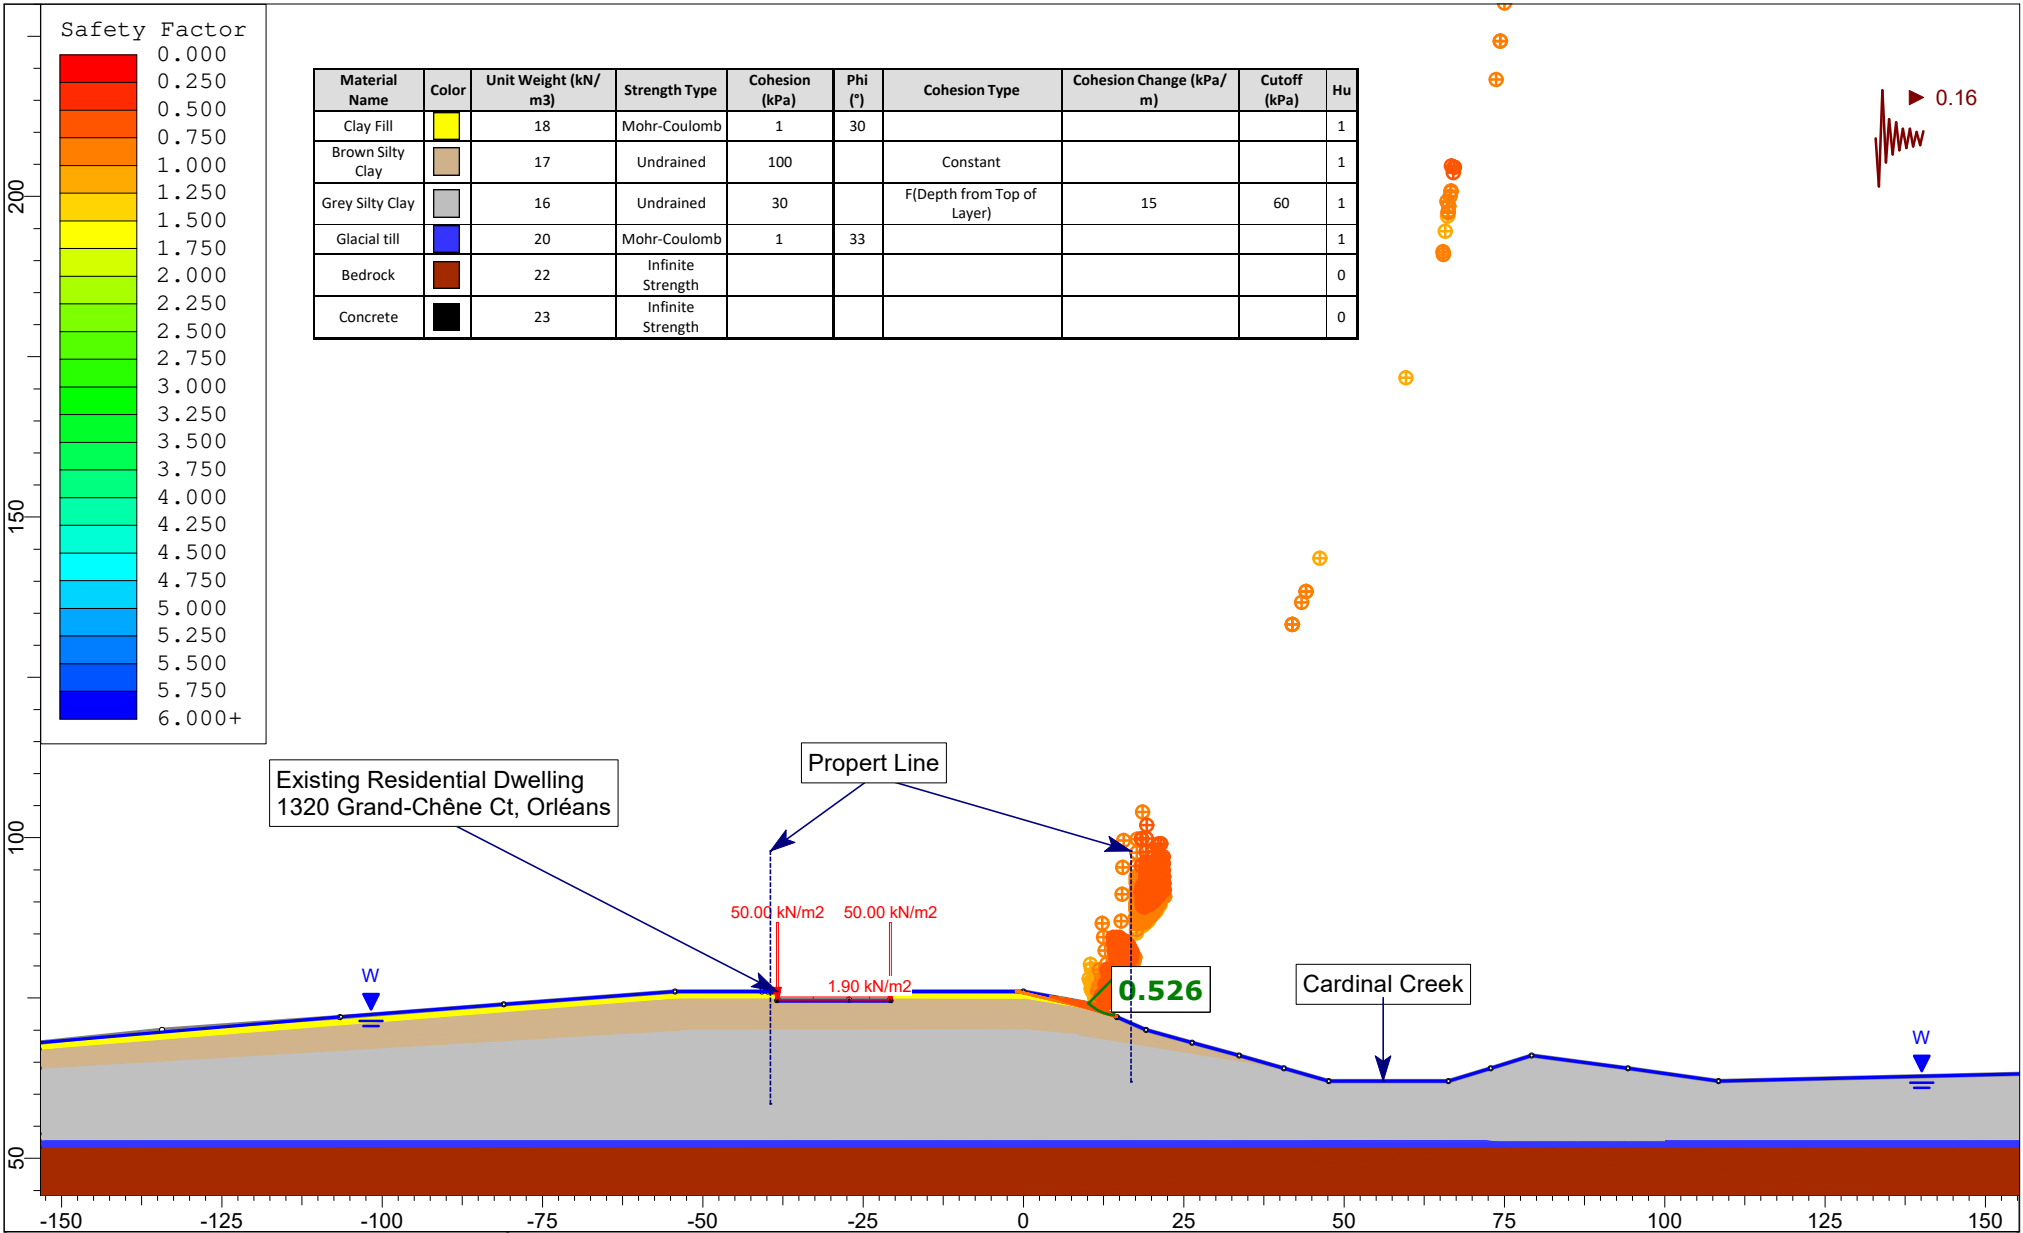
Project		PG5201 - 1320 Grand-Chene Ct, Orleans	
	Cross Section	PP	Scenario	Seismic Condition
	Drawn By	EA	Company	Tamarack Homes
	Date	11/16/2023	File Name	Geotechnial Investigation

The cross-section models the pre-existing condition before the development of the failure at the top of slope. The results of the analysis including seismic loading are shown in Figure 1B attached to the present memo report. The factor of safety was found to be less than 1.1 along the top of slope and within the fill material. However, a factor of safety of 1.1 is present within the native overburden.

Based on the results, a limit of hazard lands setback should have been assigned to the subject lot and uncontrolled placement of fill along the top of slope and settlement sensitive structures should have not been allowed to prevent future slope failures.

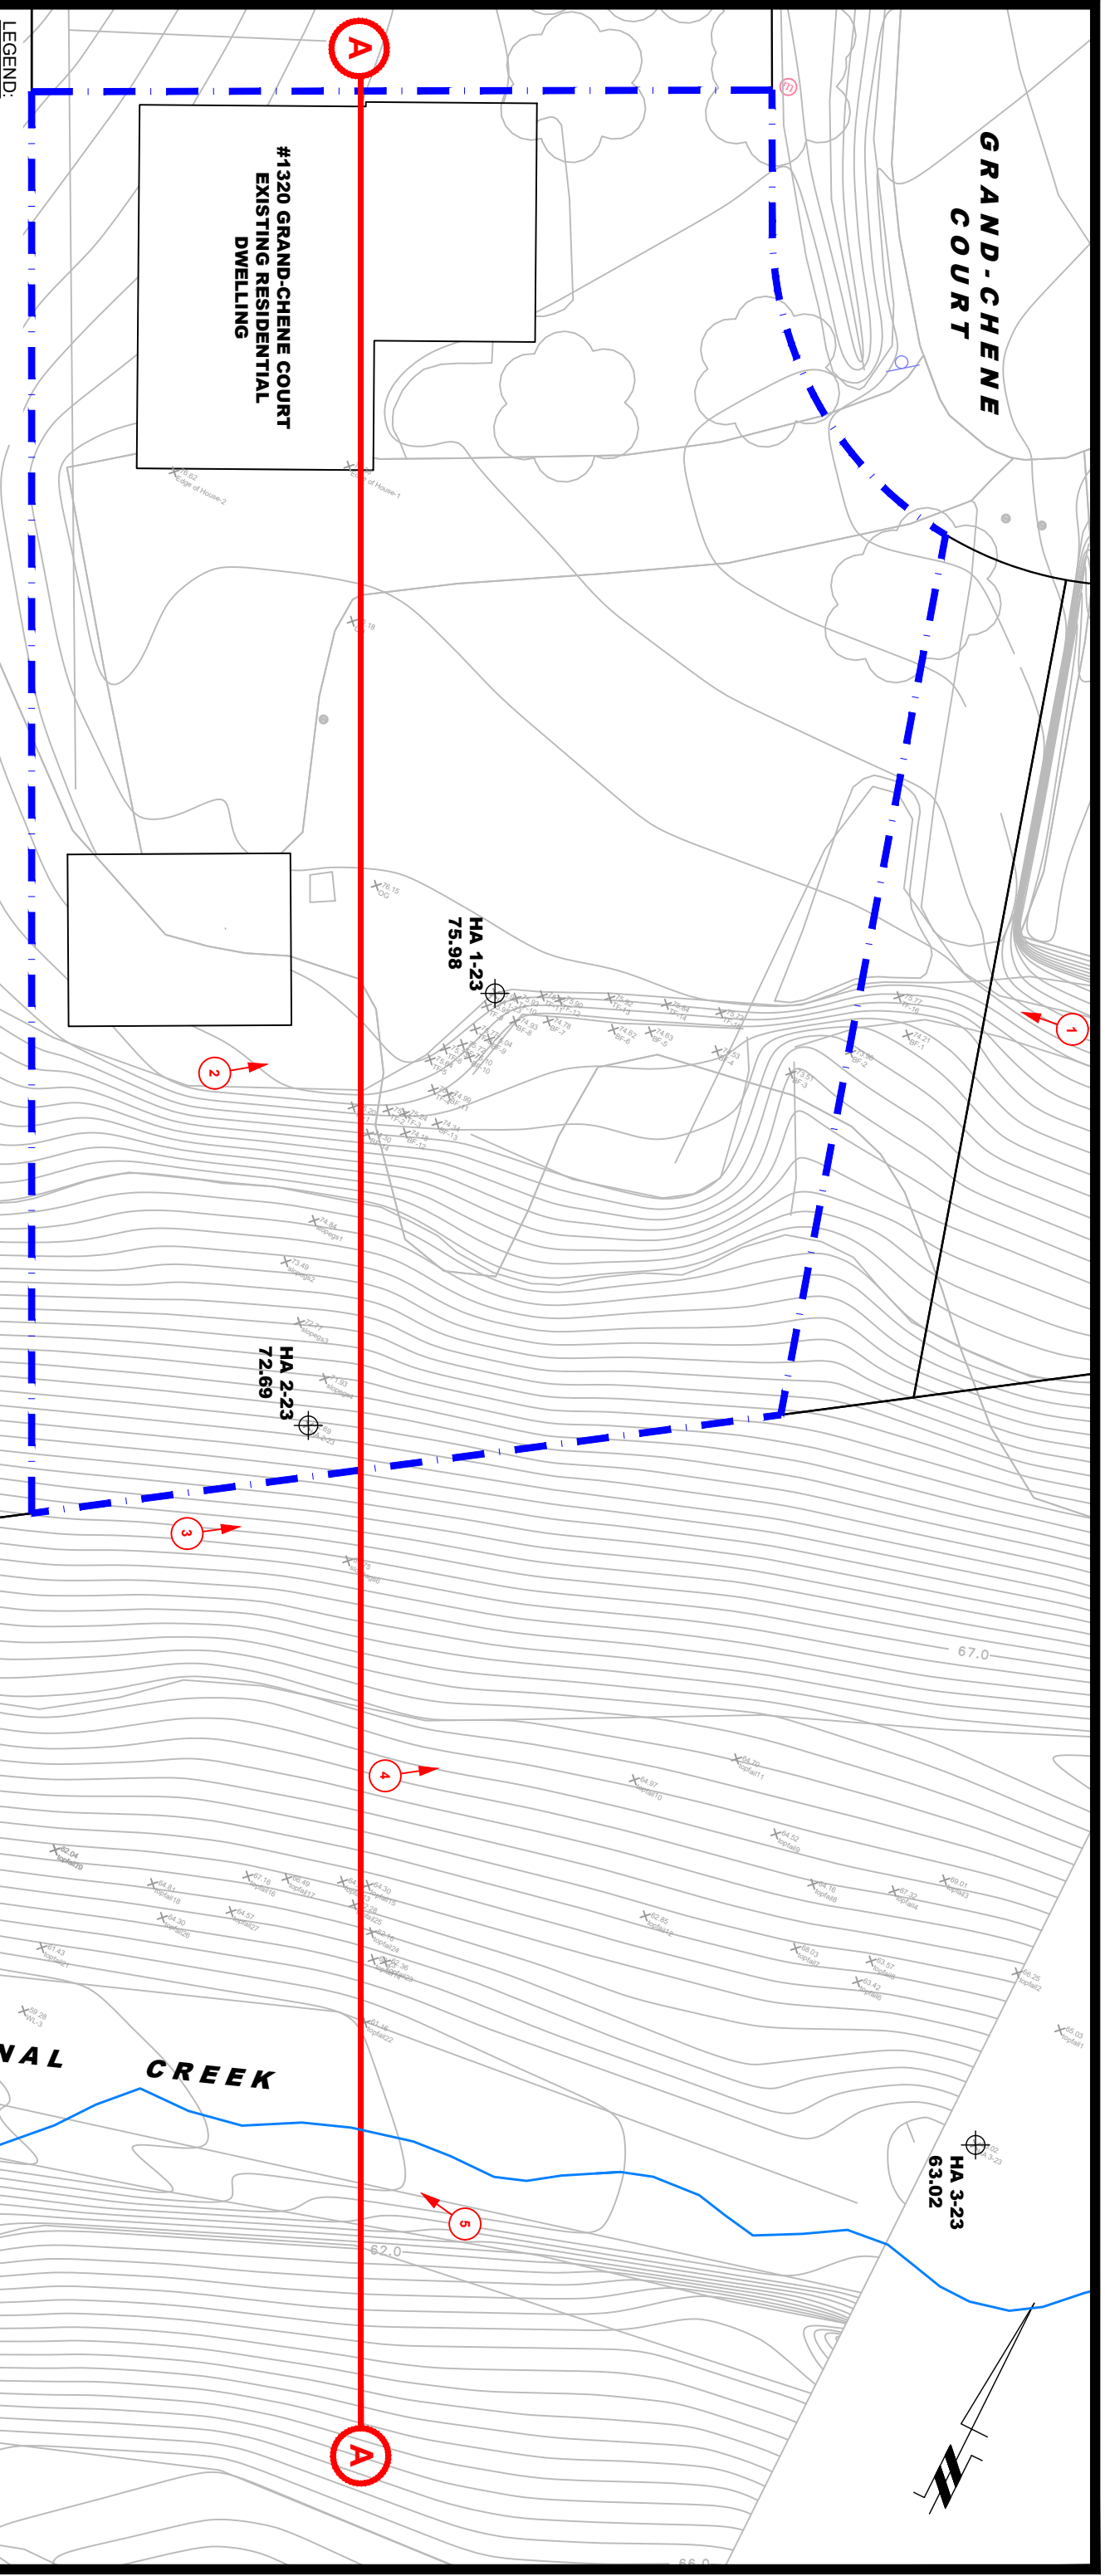
TEST HOLE LOCATION PLAN

The top of the slope failure was observed throughout the rear-yard of 1320 Grand-Chêne Court and along the top of the existing slope. The area was surveyed in the field and may be observed on Drawing PG5201-6 - Test Hole Location Plan attached to this report by the topographic shots labeled “TF-xx” and “BF-xx” denoting the top and bottom of the face of the failure, respectively. The height of the face of the failure is approximately between 400 mm and 1.2 m high across its footprint.

Additional slip surfaces were also visible along the bottom of the slope and coinciding with the watercourse within the tributary and are identified on the Drawing PG5201-6 - Test Hole Location Plan as topographic shots labeled as “topfailx”. The ground surface throughout the portion of the slope failure located within the rear-yard of 1320 Grand-Chêne Court was relatively flat at the time of our review.
