Geotechnical Investigation

Proposed Residential Development

4386 Rideau Valley Drive
Ottawa, Ontario

Report PG5828-1 Revision 5 dated July 19, 2024

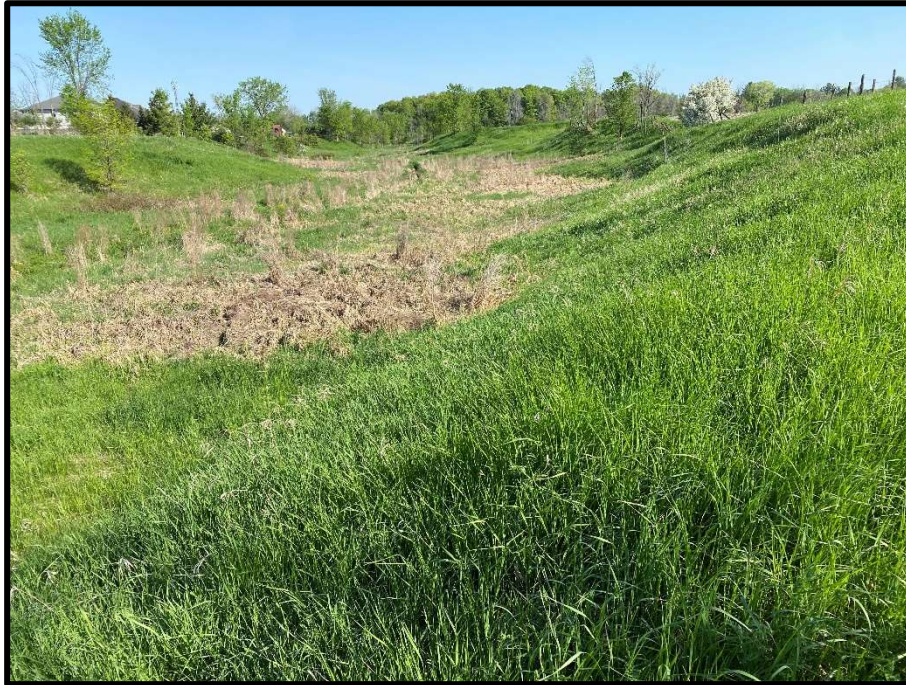
Photo 1: Area located at the bottom of the slope along the south-west portion of the subject site. Area is well vegetated and sloped gradually towards the valley floor.

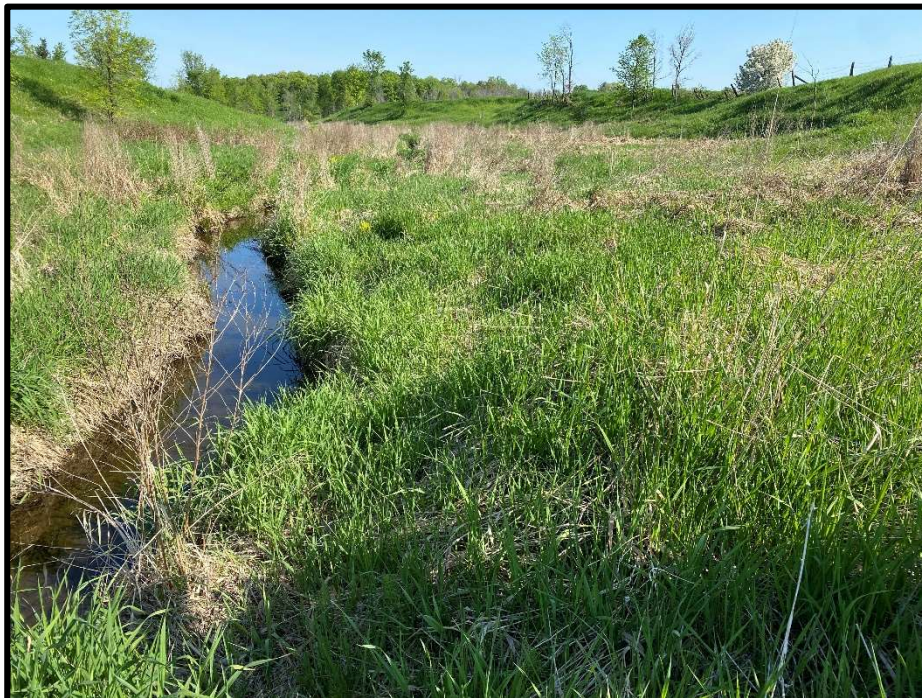
Photo 2: Area along Wilson Cowan Drain and south-west portion of the subject site. Area appeared to be well vegetated and did not appear to be eroded at the time of site visit. Water throughout Wilson Cowan Drain appeared to be flowing very slowly and/or ponding.

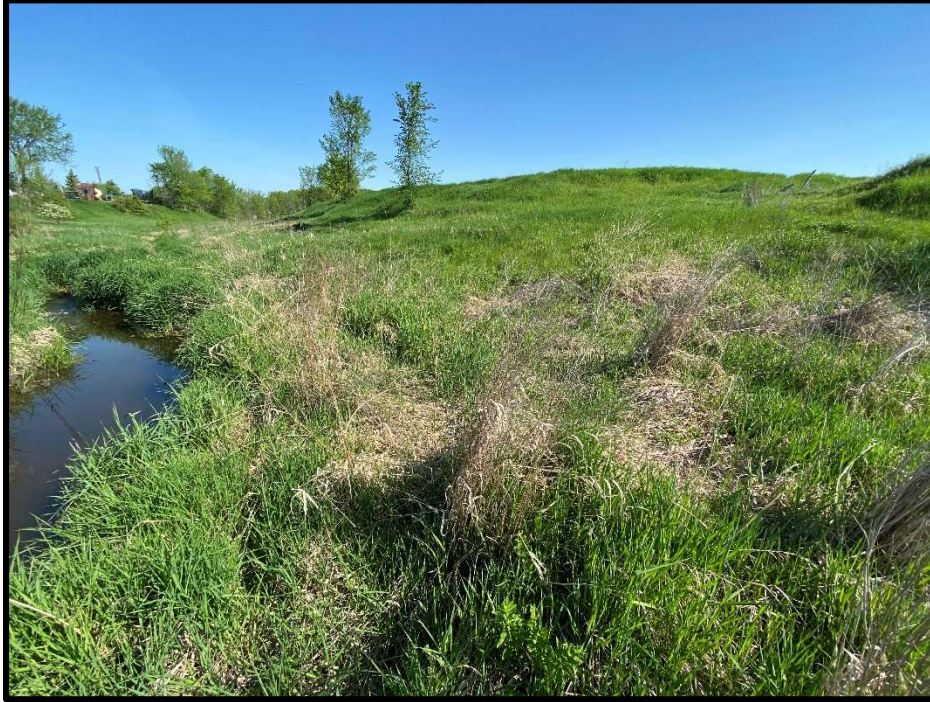
Photo 3: Area along Wilson Cowan Drain and south-west portion of the subject site. Area appeared to be well vegetated and did not appear to be eroded at the time of site visit. Gradual slope observed from subject site to the valley floor.

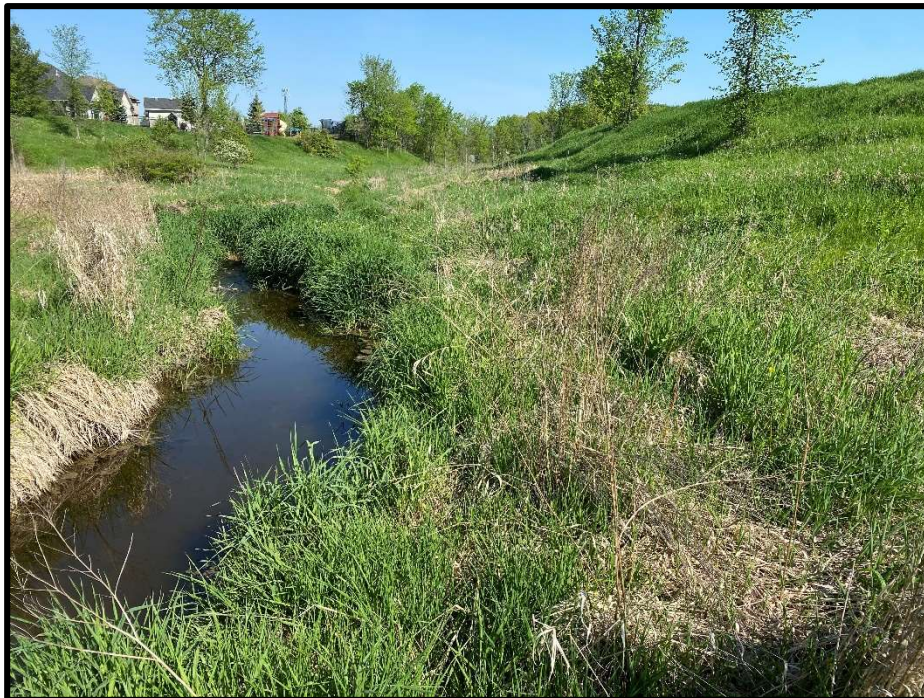
Photo 4: Area along Wilson Cowan Drain and south-west portion of the subject site. Area appeared to be well vegetated and did not appear to be eroded at the time of site visit. Water throughout Wilson Cowan Drain appeared to be flowing very slowly and/or ponding.

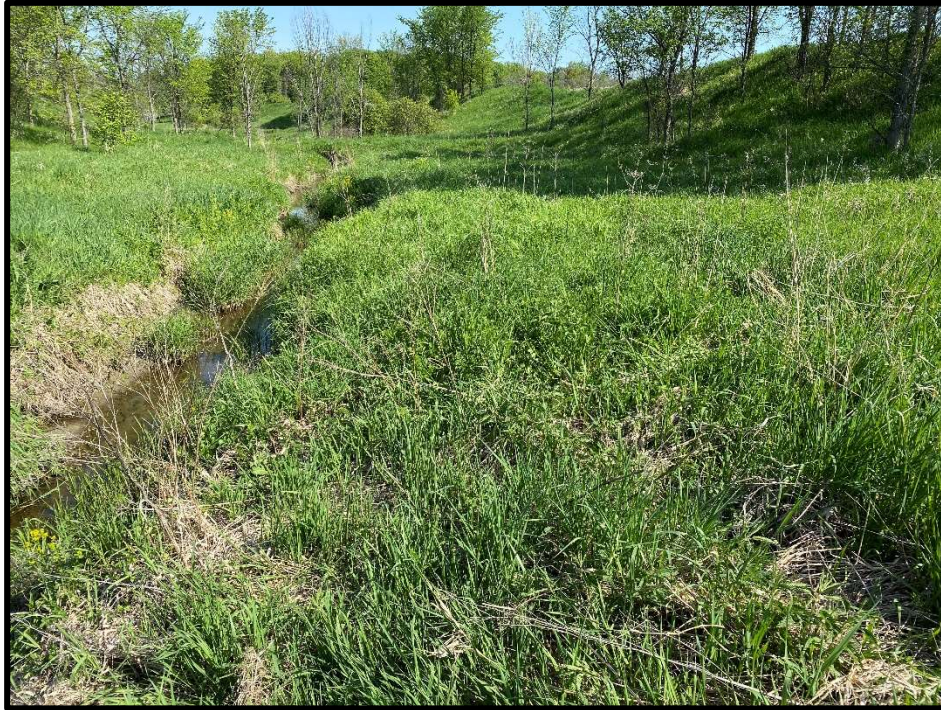
Photo 5: Area along Wilson Cowan Drain and south-west portion of the subject site. Area appeared to be well vegetated and did not appear to be eroded at the time of site visit. Water throughout Wilson Cowan Drain appeared to be flowing very slowly and/or ponding.

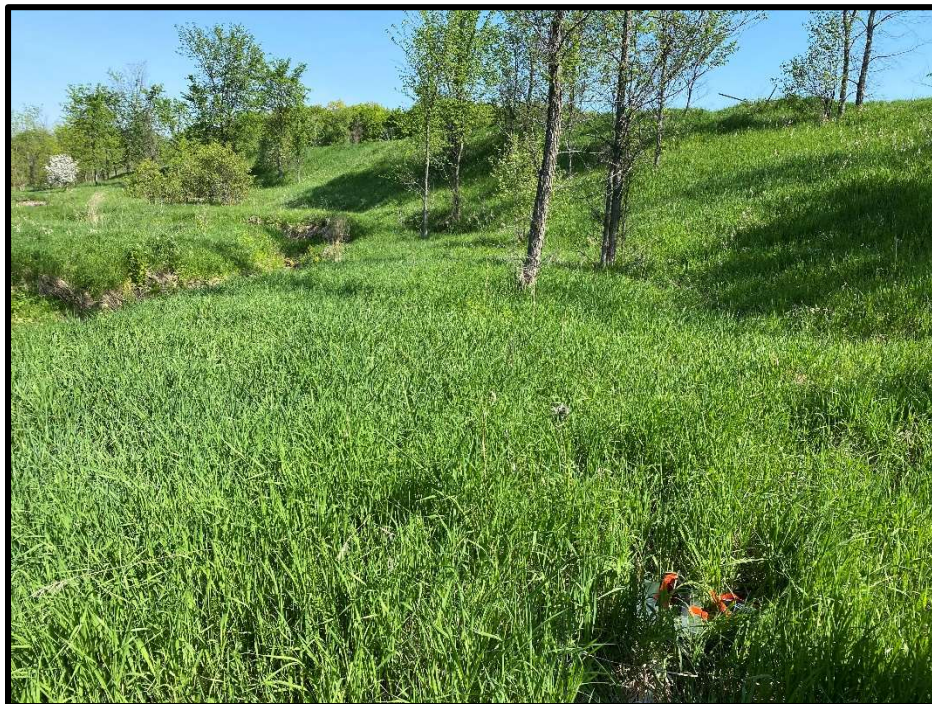
Photo 6: Area along Wilson Cowan Drain and west portion of the subject site. Area appeared to be well vegetated and did not appear to be eroded at the time of site visit. Gradual slope observed from subject site to the valley floor.

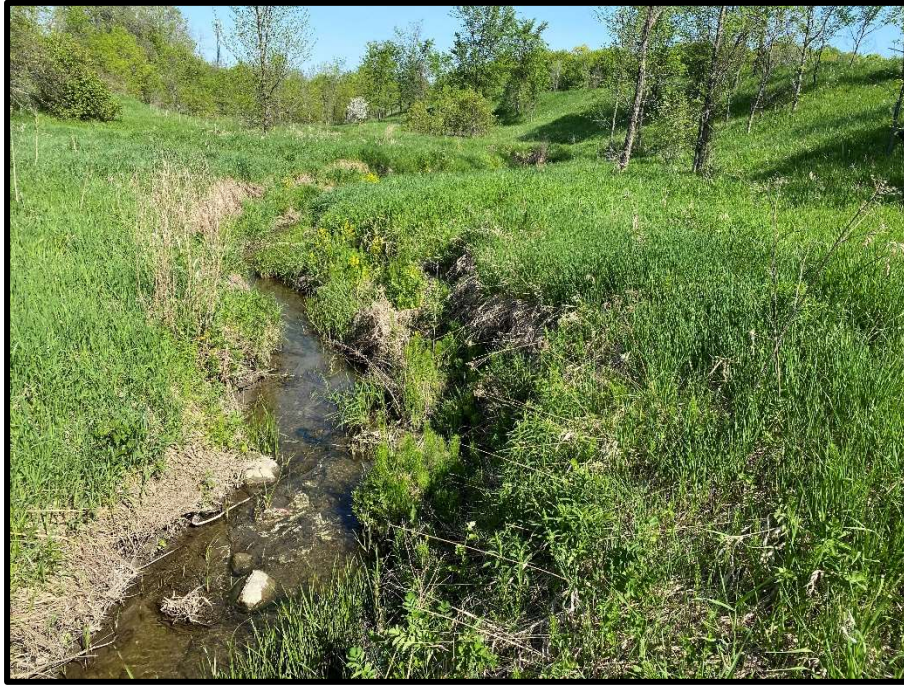
Photo 7: Area along Wilson Cowan Drain and west portion of the subject site. Area appeared to be well vegetated with a slightly steeper bank along Wilson Cowan Drain at the time of site visit. Gradual slope observed from subject site to the valley floor. Active erosion was not observed.

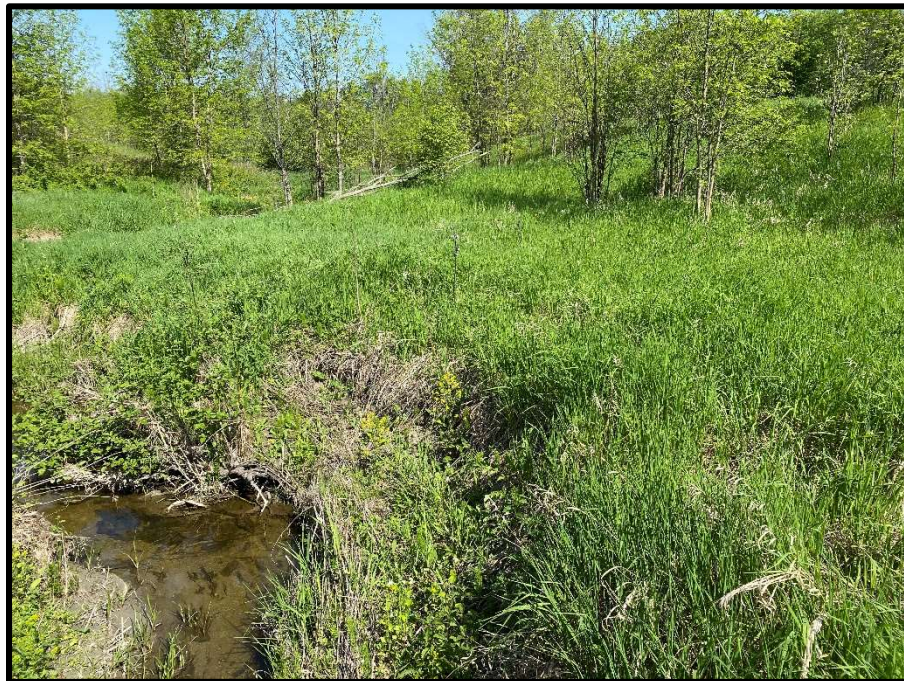
Photo 8: Area along Wilson Cowan Drain and west portion of the subject site. Area appeared to be well vegetated with a slightly steeper bank along Wilson Cowan Drain at the time of site visit. Gradual slope observed from subject site to the valley floor. Active erosion was not observed.

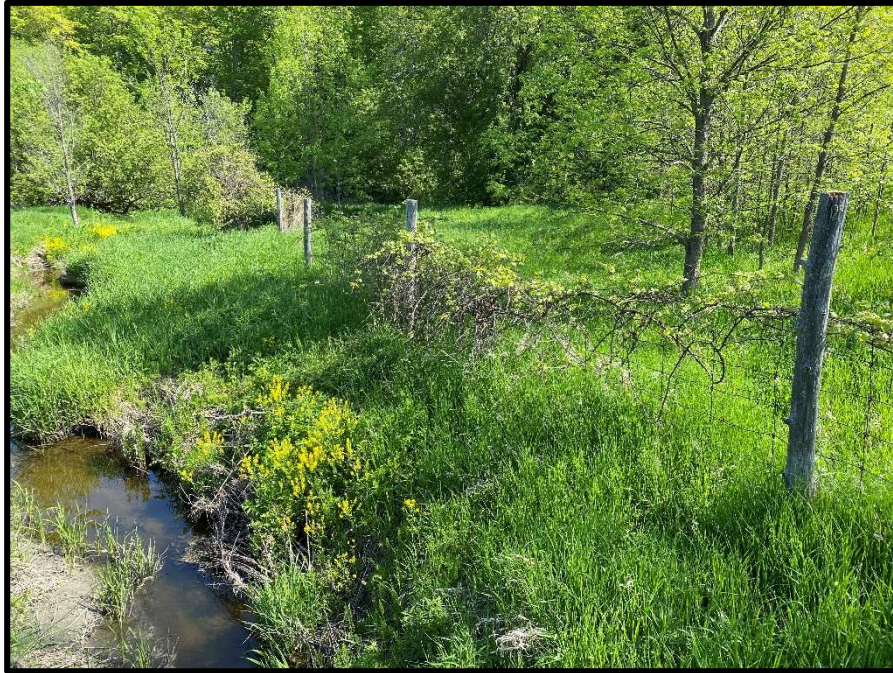
Photo 9: Area along Wilson Cowan Drain and north-west portion of the subject site. Area appeared to be well vegetated with a gentle flow throughout Wilson Cowan Drain at the time of site visit. Gradual slope observed from subject site to the valley floor.

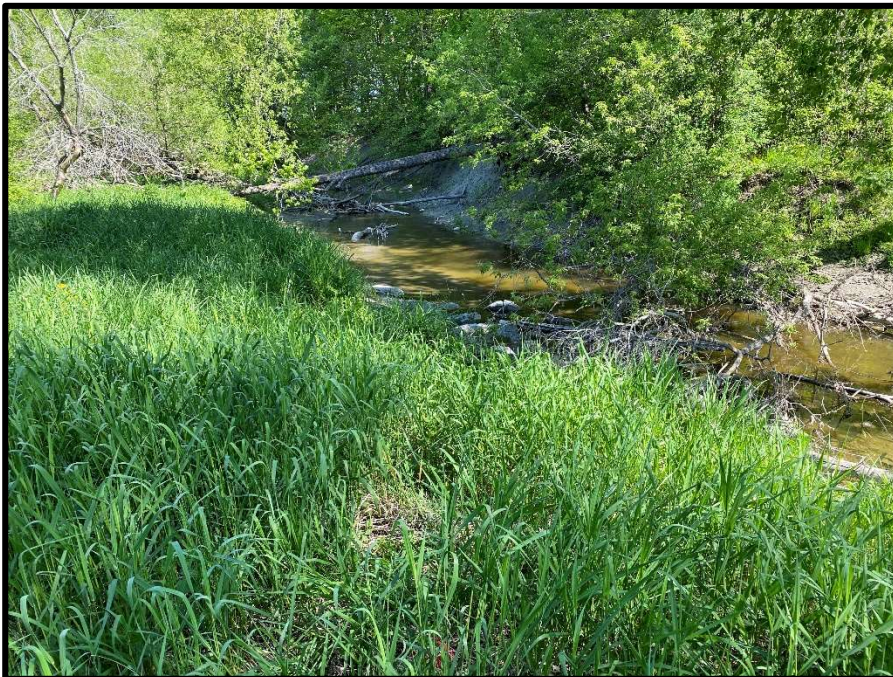
Photo 10: Area of intersection of Wilson Cowan Drain along west portion of subject site and Mud Creek. Area of Mud Creek appeared to have banks exposed to streams flow. Mature trees noted to have previously fallen across creek alignment. Some over-steepening of banks also observed at the time of site visit.

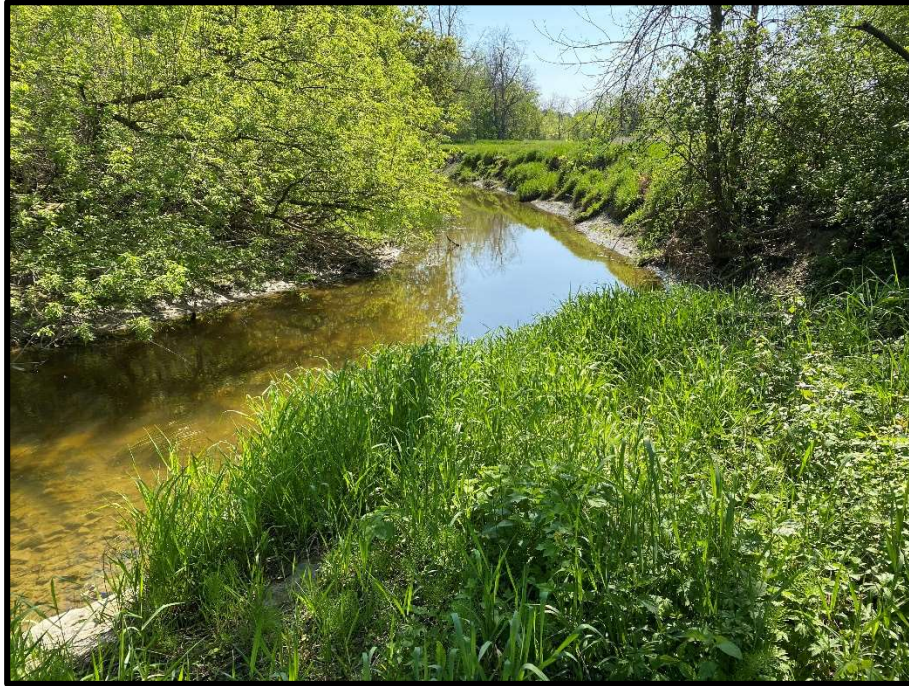
Photo 11: Area of Mud Creek along north-west portion of subject site. Area appeared to have banks exposed to streams flow and lack of well rooted vegetation along bank. Some oversteepening of banks also observed. Creek appeared to be flowing very slowly at the time of site visit.

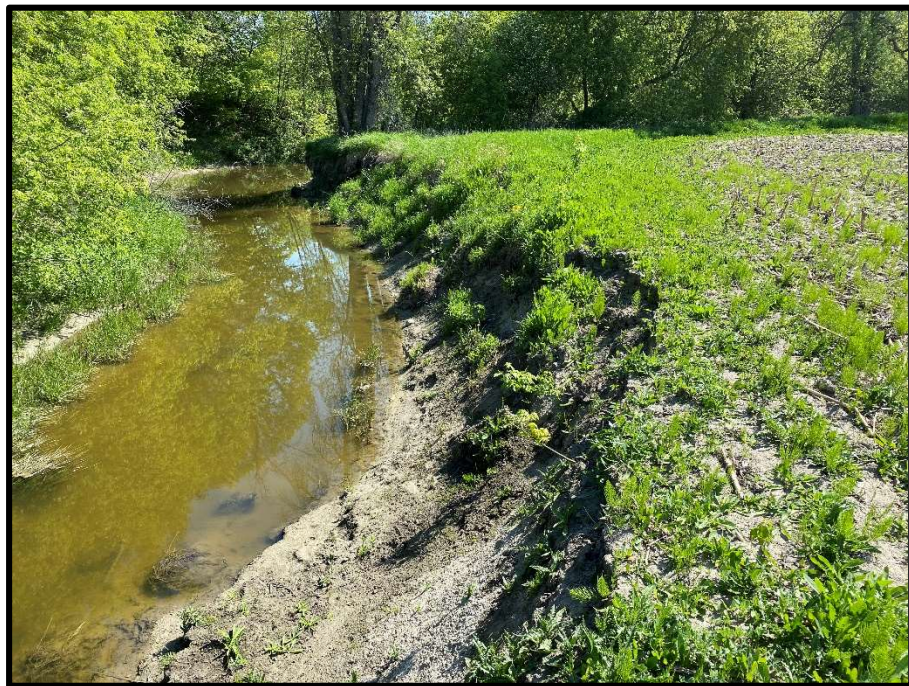
Photo 12: Area of Mud Creek along north-west portion of subject site. Area appeared to have banks exposed to streams flow and along with slumping and oversteepening of banks at the time of our site visit.

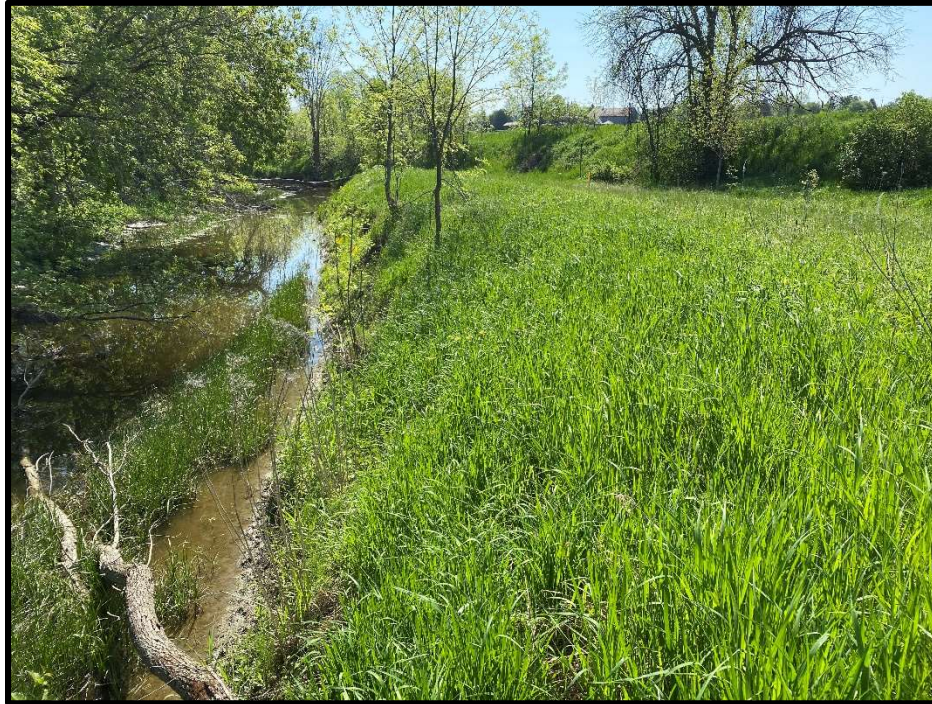
Photo 13: Area of Mud Creek along north-west portion of subject site. Area of valley floor appeared to have well rooted vegetation with relatively steep banks along creek. No active erosion observed along photographed portion of creek at the time of site visit.

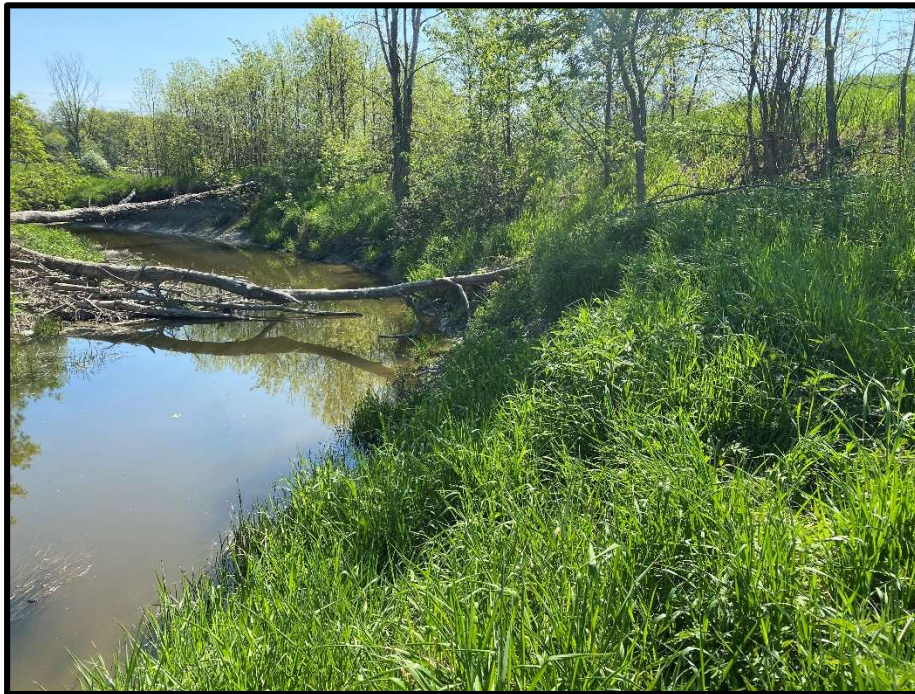
Photo 14: Area of Mud Creek along north-west portion of subject site. Area of valley floor appeared to have well rooted vegetation with relatively steep banks along creek. Some active erosion and fallen trees observed along photographed portion of creek.

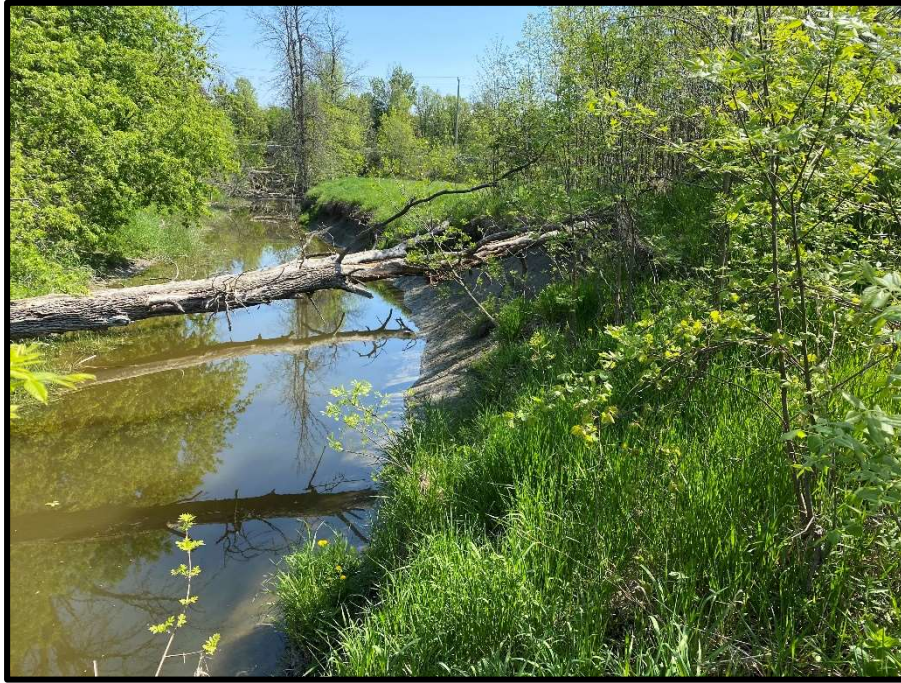
Photo 15: Area of Mud Creek along northern portion of subject site. Photographed area appeared to have banks exposed to streams flow along with slumping and undercutting of banks at the time of our site visit.

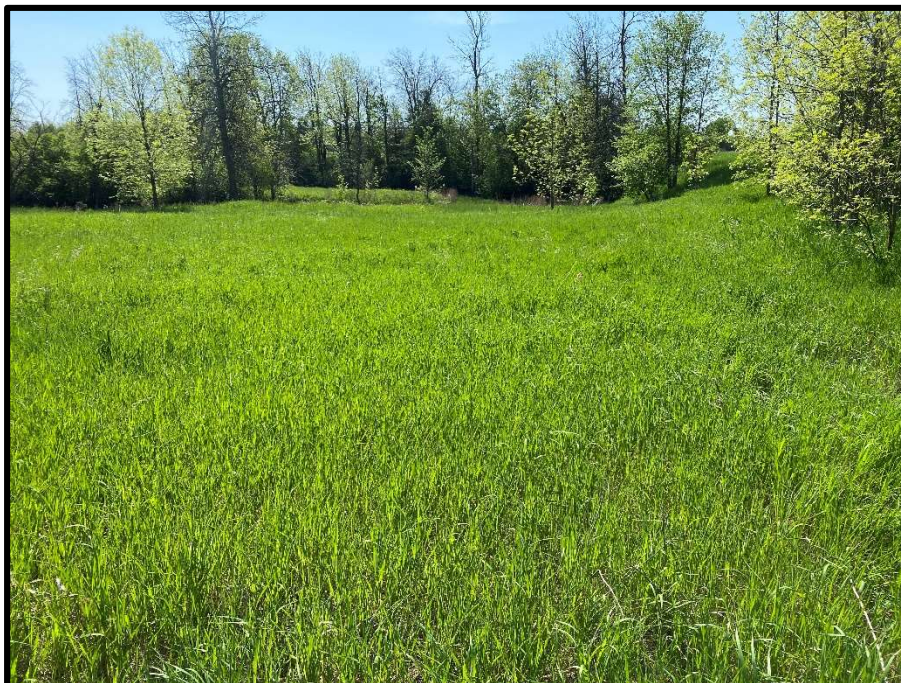
Photo 16: Area of Mud Creek valley floor along north-east portion of subject site. Photographed area appeared to contain well rooted vegetation and mature trees.

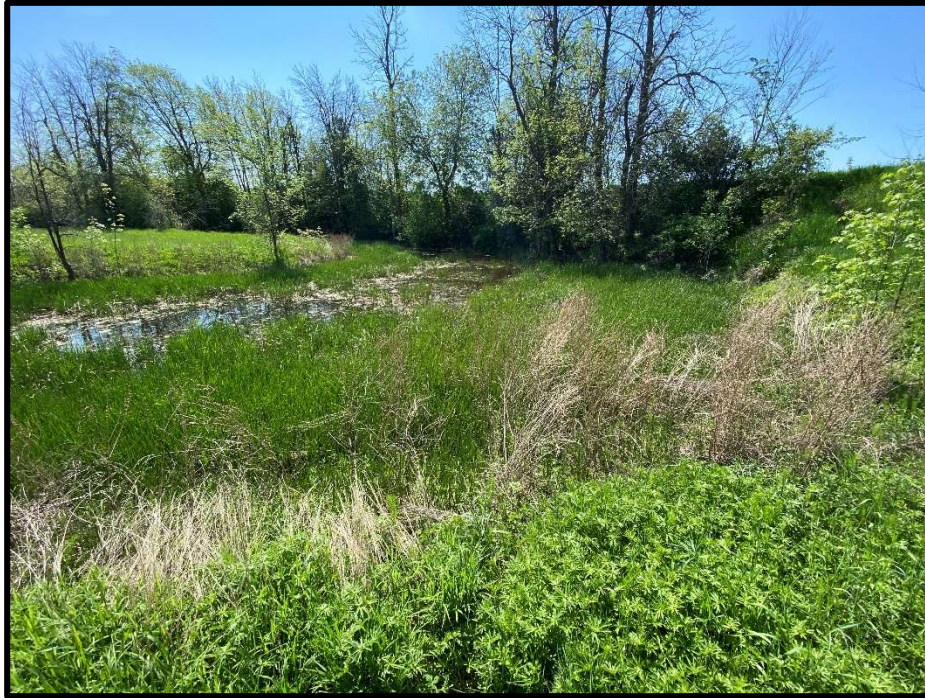
Photo 17: Area of Mud Creek valley floor along north-east portion of subject site. Photographed area appeared to contain well rooted vegetation and mature trees. No erosion observed along toe of slope at time of site visit.

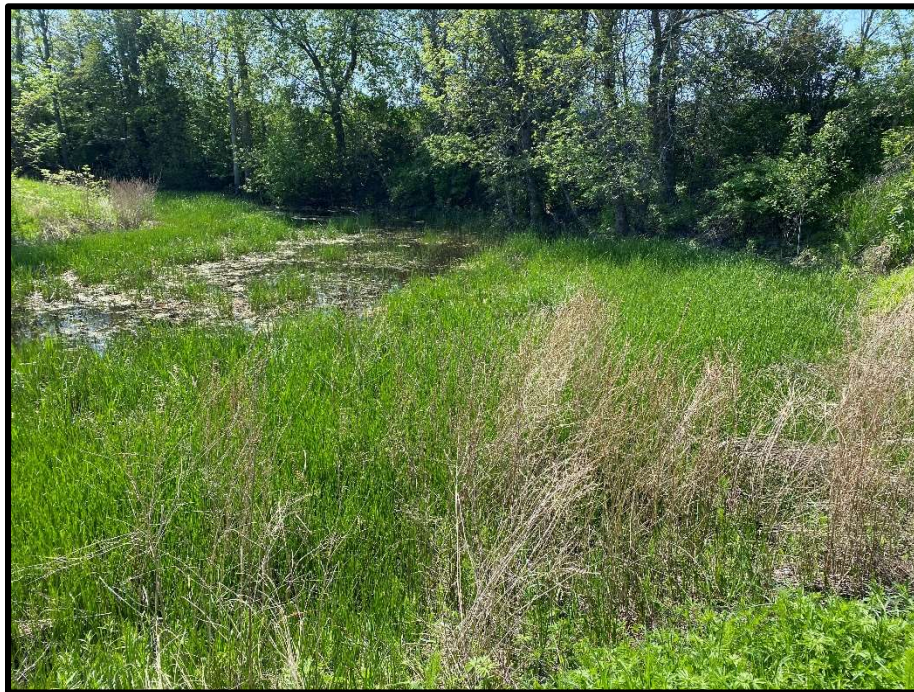
Photo 17b: Close-up of Photo 17 - Area of Mud Creek valley floor along north-east portion of subject site. Photographed area appeared to contain well rooted vegetation and mature trees. No erosion observed along toe of slope at time of site visit.

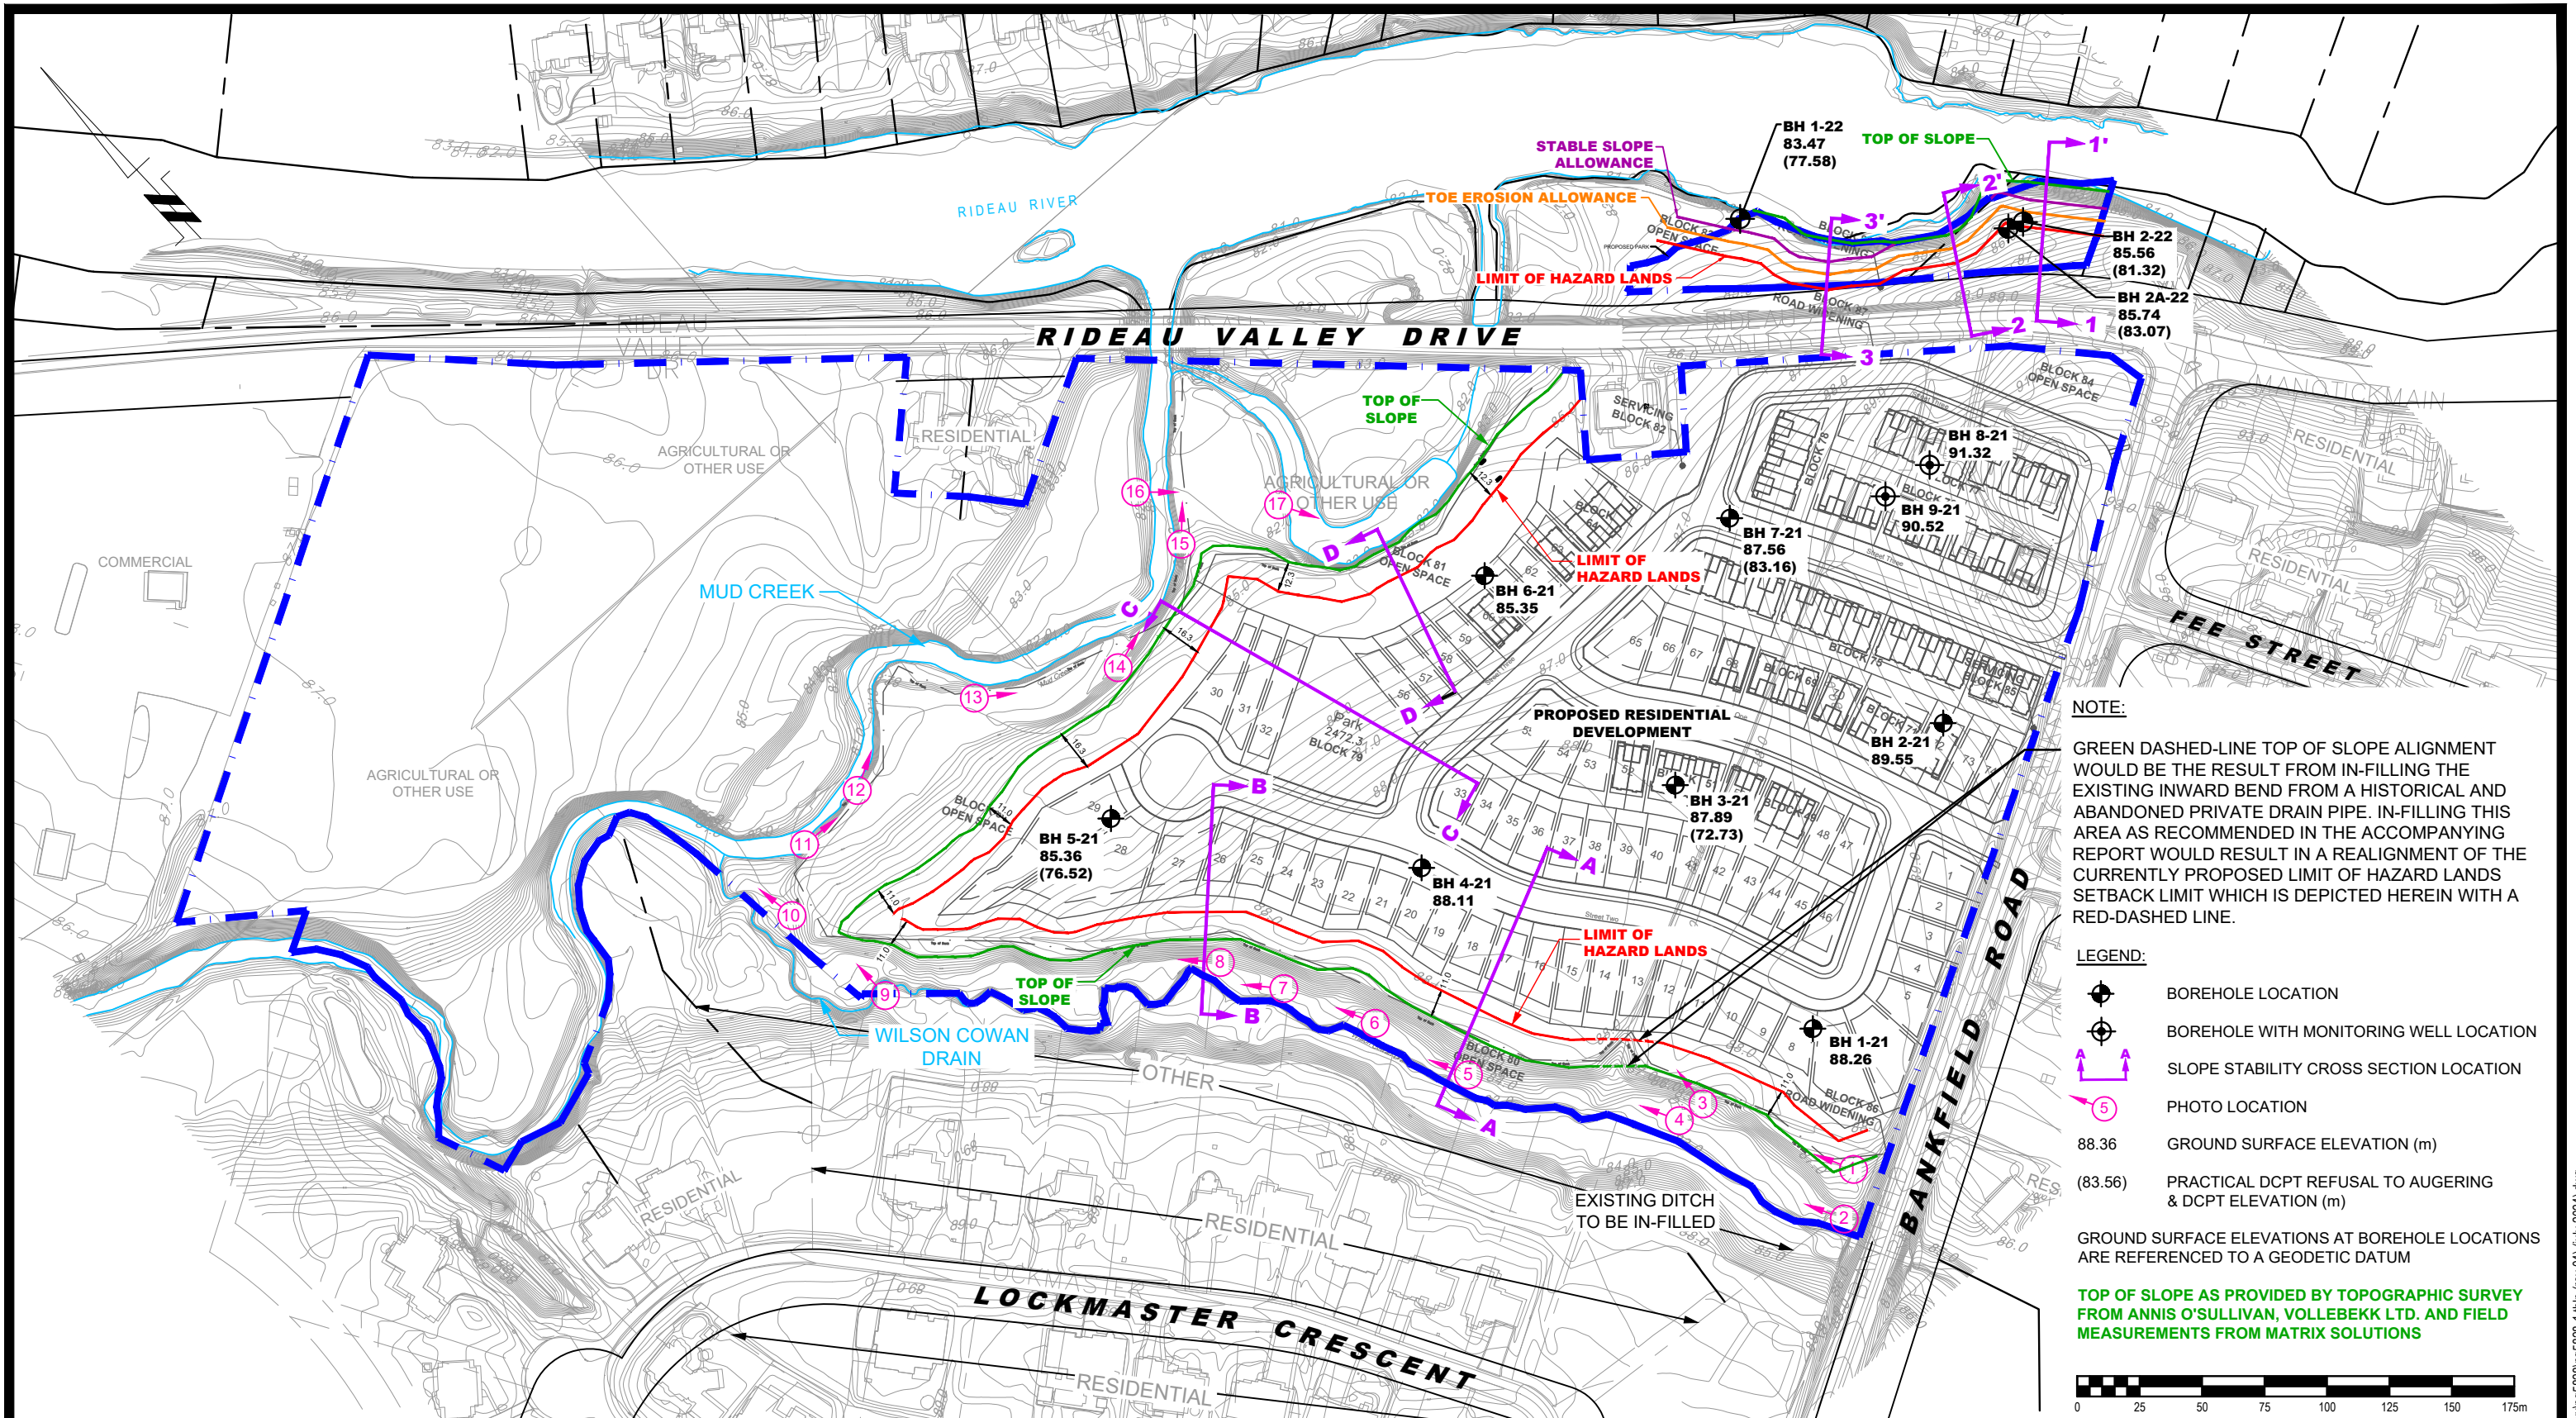
NOTE:
 GREEN DASHED-LINE TOP OF SLOPE ALIGNMENT WOULD BE THE RESULT FROM IN-FILLING THE EXISTING INWARD BEND FROM A HISTORICAL AND ABANDONED PRIVATE DRAIN PIPE. IN-FILLING THIS AREA AS RECOMMENDED IN THE ACCOMPANYING REPORT WOULD RESULT IN A REALIGNMENT OF THE CURRENTLY PROPOSED LIMIT OF HAZARD LANDS SETBACK LIMIT WHICH IS DEPICTED HEREIN WITH A RED-DASHED LINE.
