FLUVIAL GEOMORPHIC AND EROSION HAZARD ASSESSMENT STINSON LANDS OTTAWA, ONTARIO

Prepared for: NOVATECH ENGINEERING AND CONSULTANTS LTD.

Prepared by: MATRIX SOLUTIONS INC., A MONTROSE ENVIRONMENTAL COMPANY

Version 1.0 April 2024 Guelph, Ontario

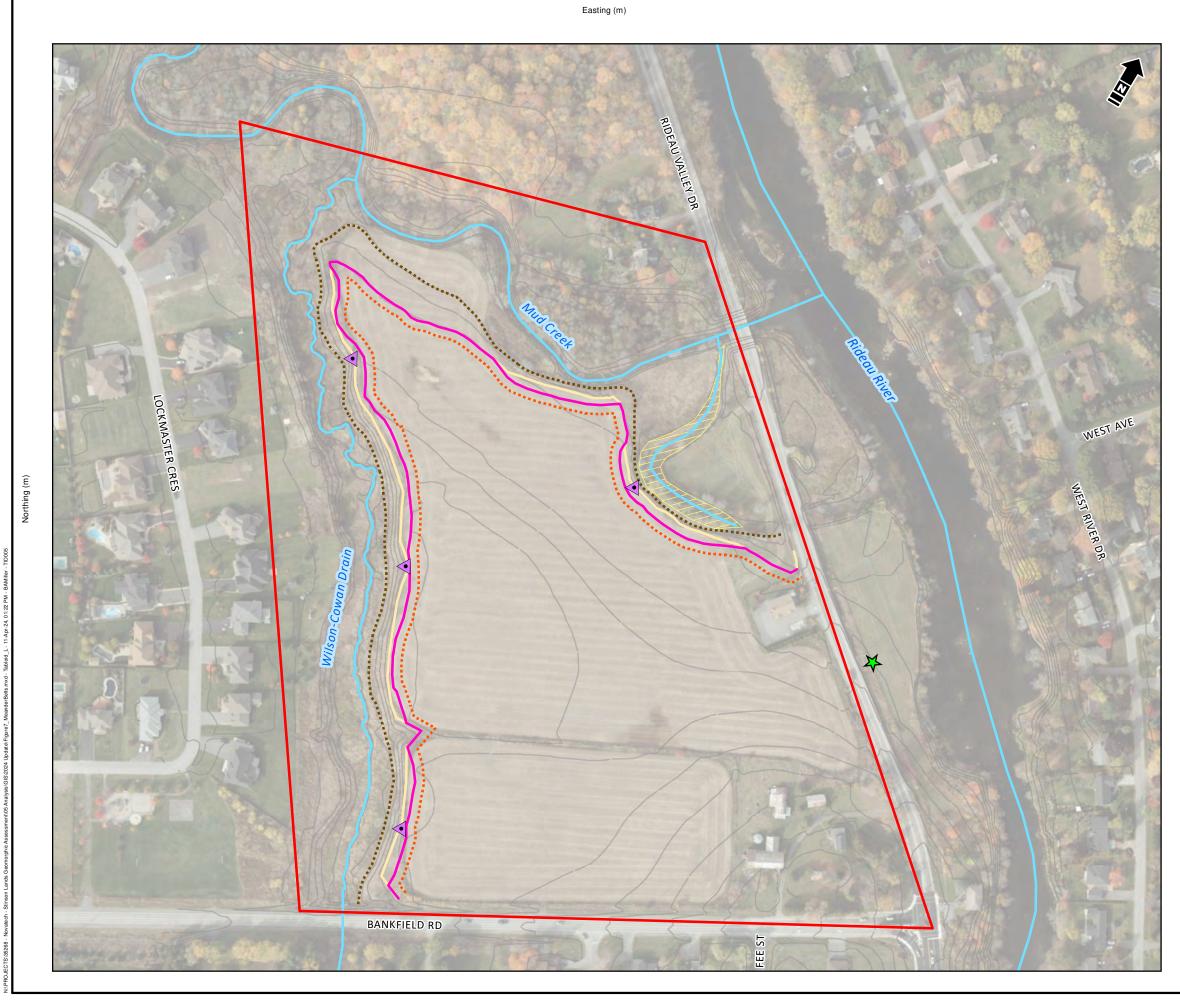
For this confined setting, Figure 8 presents the combined erosion hazard limit, whereby a single polyline captures the greater of the physical top-of-slope, long-term stable top-of-slope (3:1 setback), and segments that include a 5 m toe erosion allowance. For the purpose of this study a 3:1 stable slope was assumed per the technical guide, and a 6 m erosion access allowance applied to the stable slope setback per the MNRF technical guide (2002b) to determine the final erosion hazard limit. It should be noted that a detailed slope stability assessment was competed by Paterson Group (2023), and their stable slope projections should be utilized in the delineation of the erosion hazard limit for development planning, with inclusion of the toe-erosion allowance presented here at areas where the toe of slope is within 15 m of the active channel.

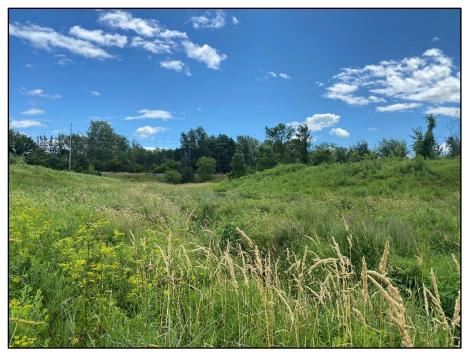
5. Wilson Cowan Drain - Looking upstream, despite being well vegetated, the channel maintains it's definition along the reach

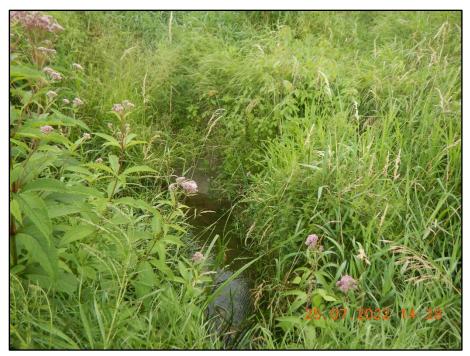
6. Wilson Cowan Drain - Facing downstream, the reach showed consistent signs of erosion in the form of steep outside meander banks, slumped banks, and failed banks

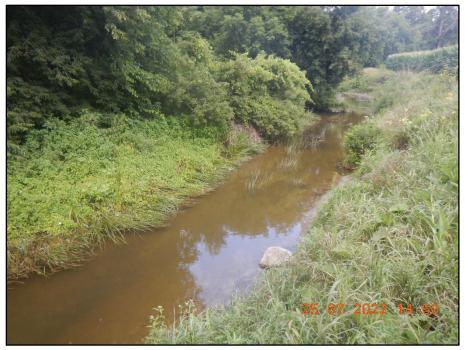
7. Mud Creek – Facing downstream, the creek shows low flow velocities at time of visit with established in stream vegetation with step outer meander bends and point bars established on the inside of beds

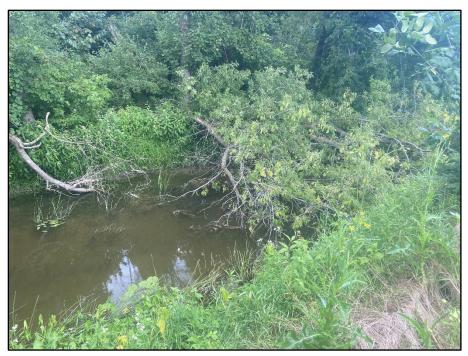
8. Mud Creek – Facing downstream, creek shows evidence of erosion and widening with many downed and leaning trees

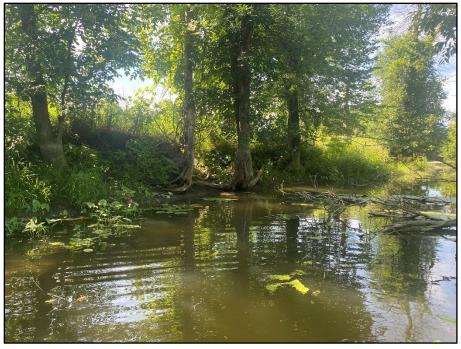
9. Mud Creek – Facing upstream, creek banks commonly show exposed tree roots

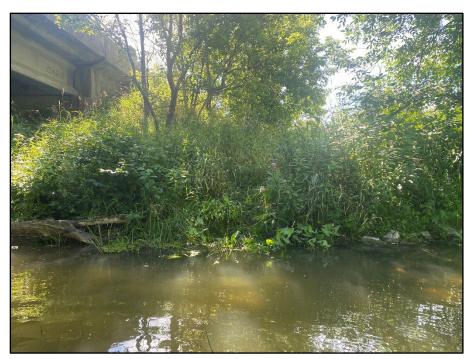
10. Mud Creek – Facing parallel to Rideau Valley Drive N, inlet location from the Oxbow feature into Mud Creek with an approximate 1 – 1.5 m elevation change

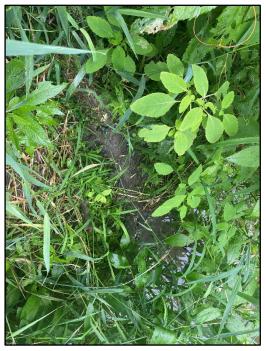
12. Oxbow Feature – Facing down, elevated area separating the standing water in the Oxbow and Mud Creek has a clear and define flow path but was above the water level at the time of the field visit

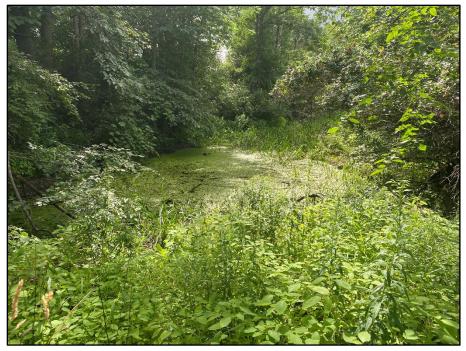
13. Oxbow Feature – Facing downstream, the depression maintained standing water at the time of the site visit, with saturated and unconsolidated soil underneath

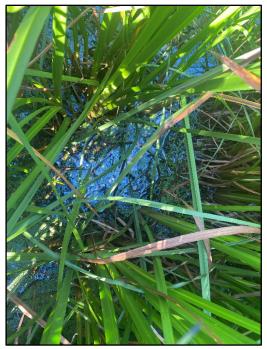
15. Oxbow Feature – Facing down, water surfaces in parts of the oxbow show pollution in the form of mineral staining

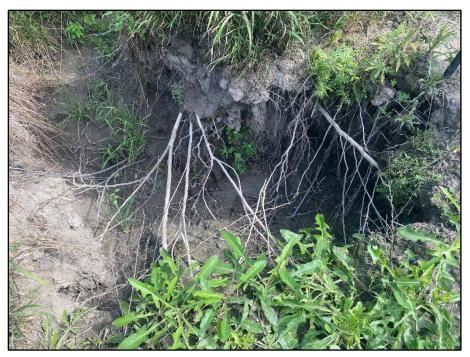
16. Mud Creek– Drainage from the adjacent field has resulted in a significant washout along the southern bank of Mud Creek
