# **Geotechnical Investigation**

## **Proposed Residential Development**

4386 Rideau Valley Drive  
Ottawa, Ontario

Report PG5828-1 Revision 4 dated April 4, 2024

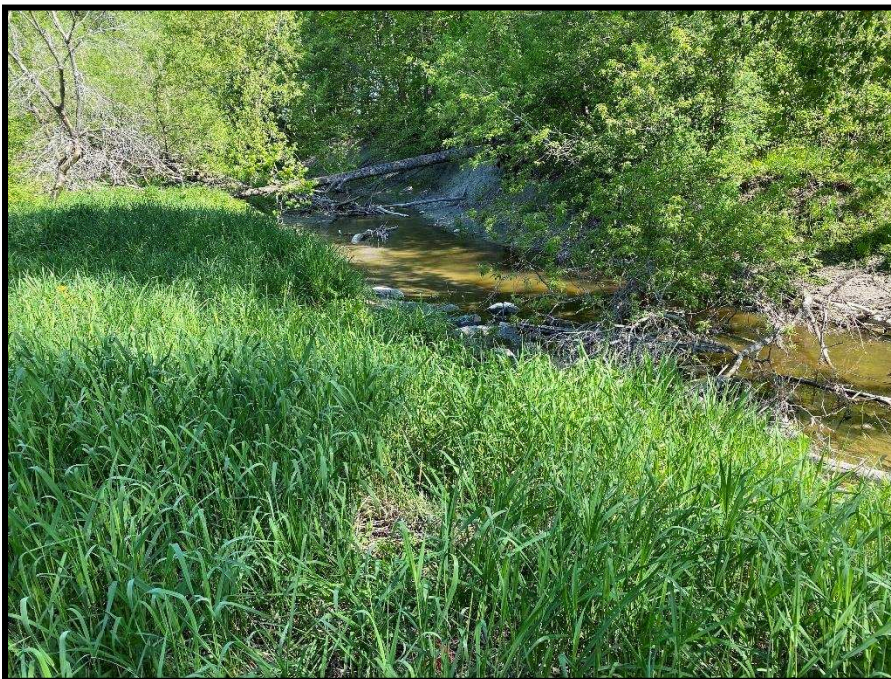
Photo 10: Area of intersection of tributary along west portion of subject site and Ruisseau Mud Creek. Area of Ruisseau Mud Creek appeared to have banks exposed to streams flow. Mature trees noted to have previously fallen across creek alignment. Some over-steepening of banks also observed at the time of site visit.

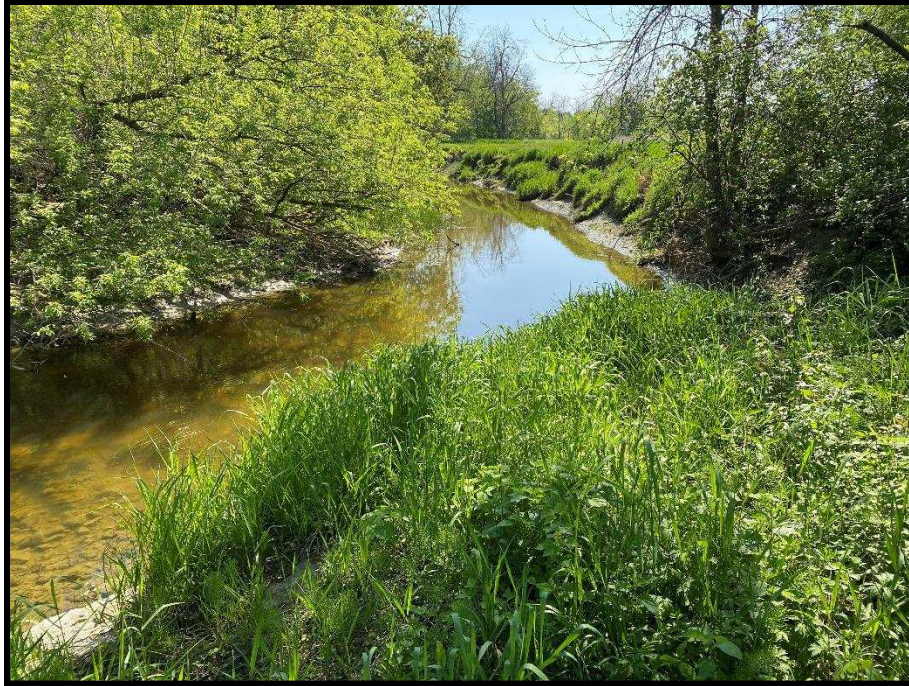
Photo 11: Area of Ruisseau Mud Creek along north-west portion of subject site. Area appeared to have banks exposed to streams flow and lack of well rooted vegetation along bank. Some oversteepening of banks also observed. Creek appeared to be flowing very slowly at the time of site visit.

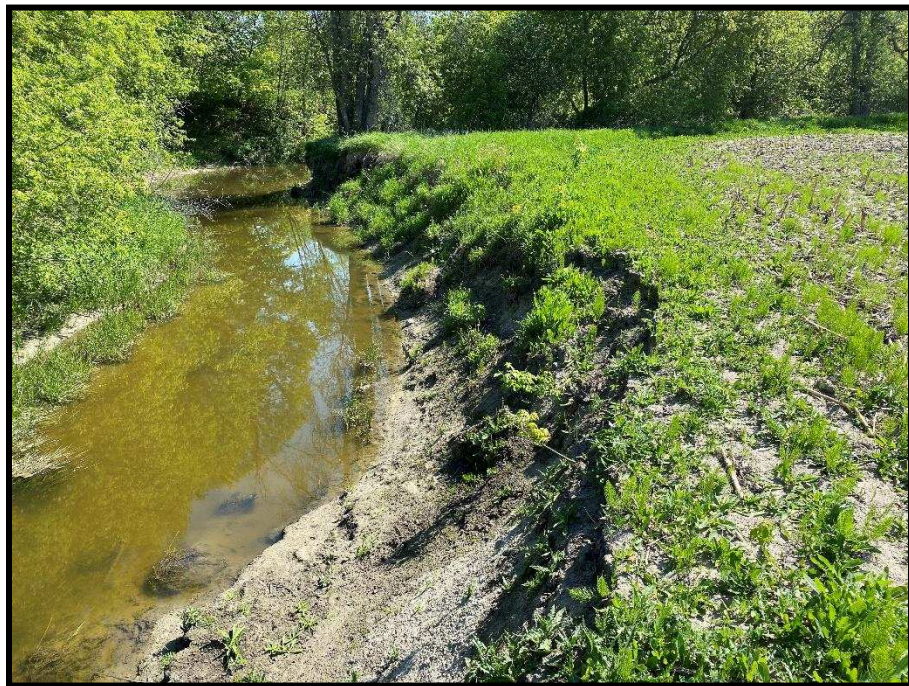
Photo 12: Area of Ruisseau Mud Creek along north-west portion of subject site. Area appeared to have banks exposed to streams flow and along with slumping and oversteepening of banks at the time of our site visit.
