Geotechnical Investigation

Proposed Residential Development

4386 Rideau Valley Drive
Ottawa, Ontario

Report PG5828-1 Revision 2 dated October 14, 2022

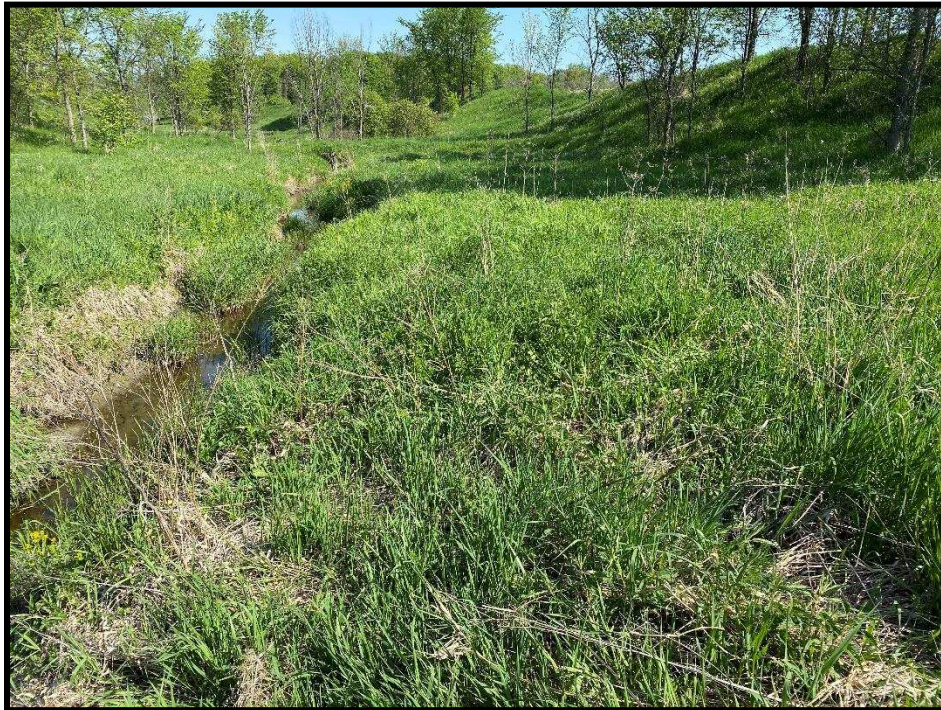
Photo 5: Area along creek tributary and south-west portion of the subject site. Area appeared to be well vegetated and did not appear to be eroded at the time of site visit. Water throughout creek tributary appeared to be flowing very slowly and/or ponding.

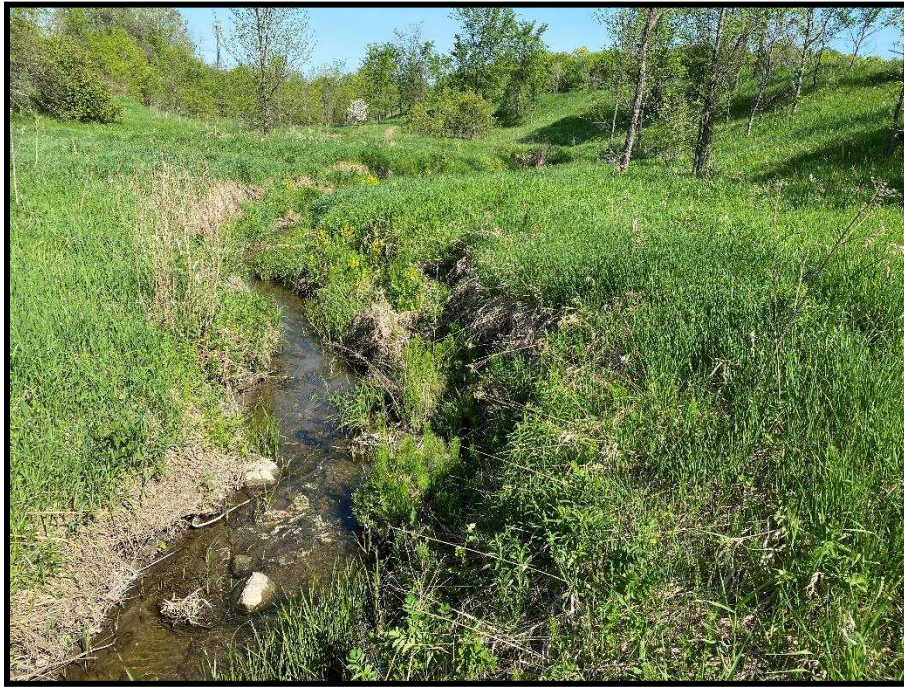
Photo 7: Area along creek tributary and west portion of the subject site. Area appeared to be well vegetated with a slightly steeper bank along the tributary at the time of site visit. Gradual slope observed from subject site to the valley floor. Active erosion was not observed.

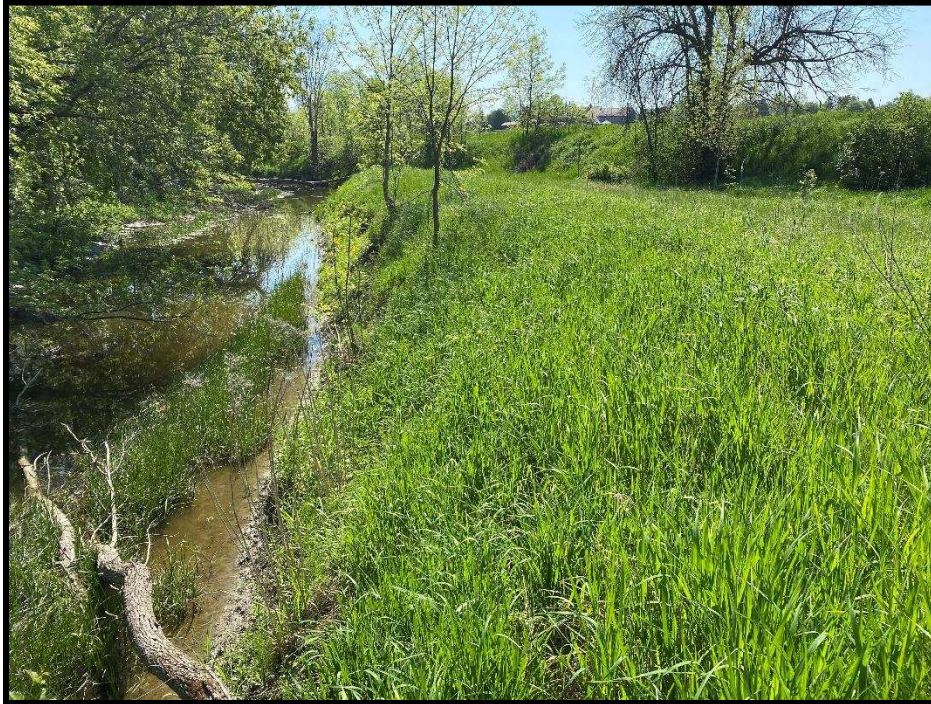
Photo 13: Area of Ruisseau Mud Creek along north-west portion of subject site. Area of valley floor appeared to have well rooted vegetation with relatively steep banks along creek. No active erosion observed along photographed portion of creek at the time of site visit.

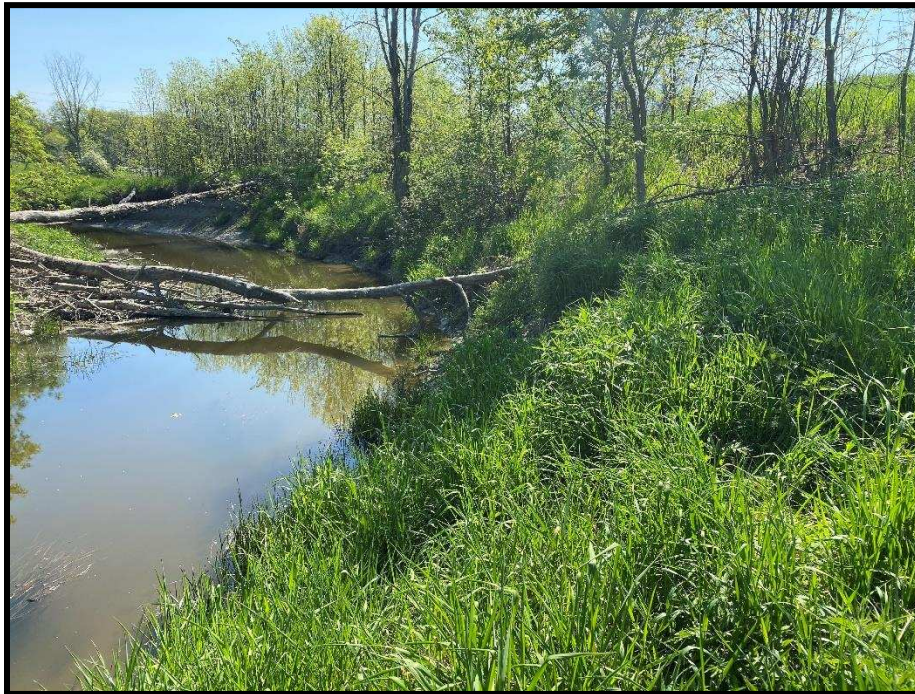
Photo 14: Area of Ruisseau Mud Creek along north-west portion of subject site. Area of valley floor appeared to have well rooted vegetation with relatively steep banks along creek. Some active erosion and fallen trees observed along photographed portion of creek.
