PATERSON GROUP

July 5, 2022
PG5828-LET.01 Rev. 1

Subject: **Slope Stability Assessment
Proposed River Park
4386 Rideau Valley Drive - Ottawa, Ontario**

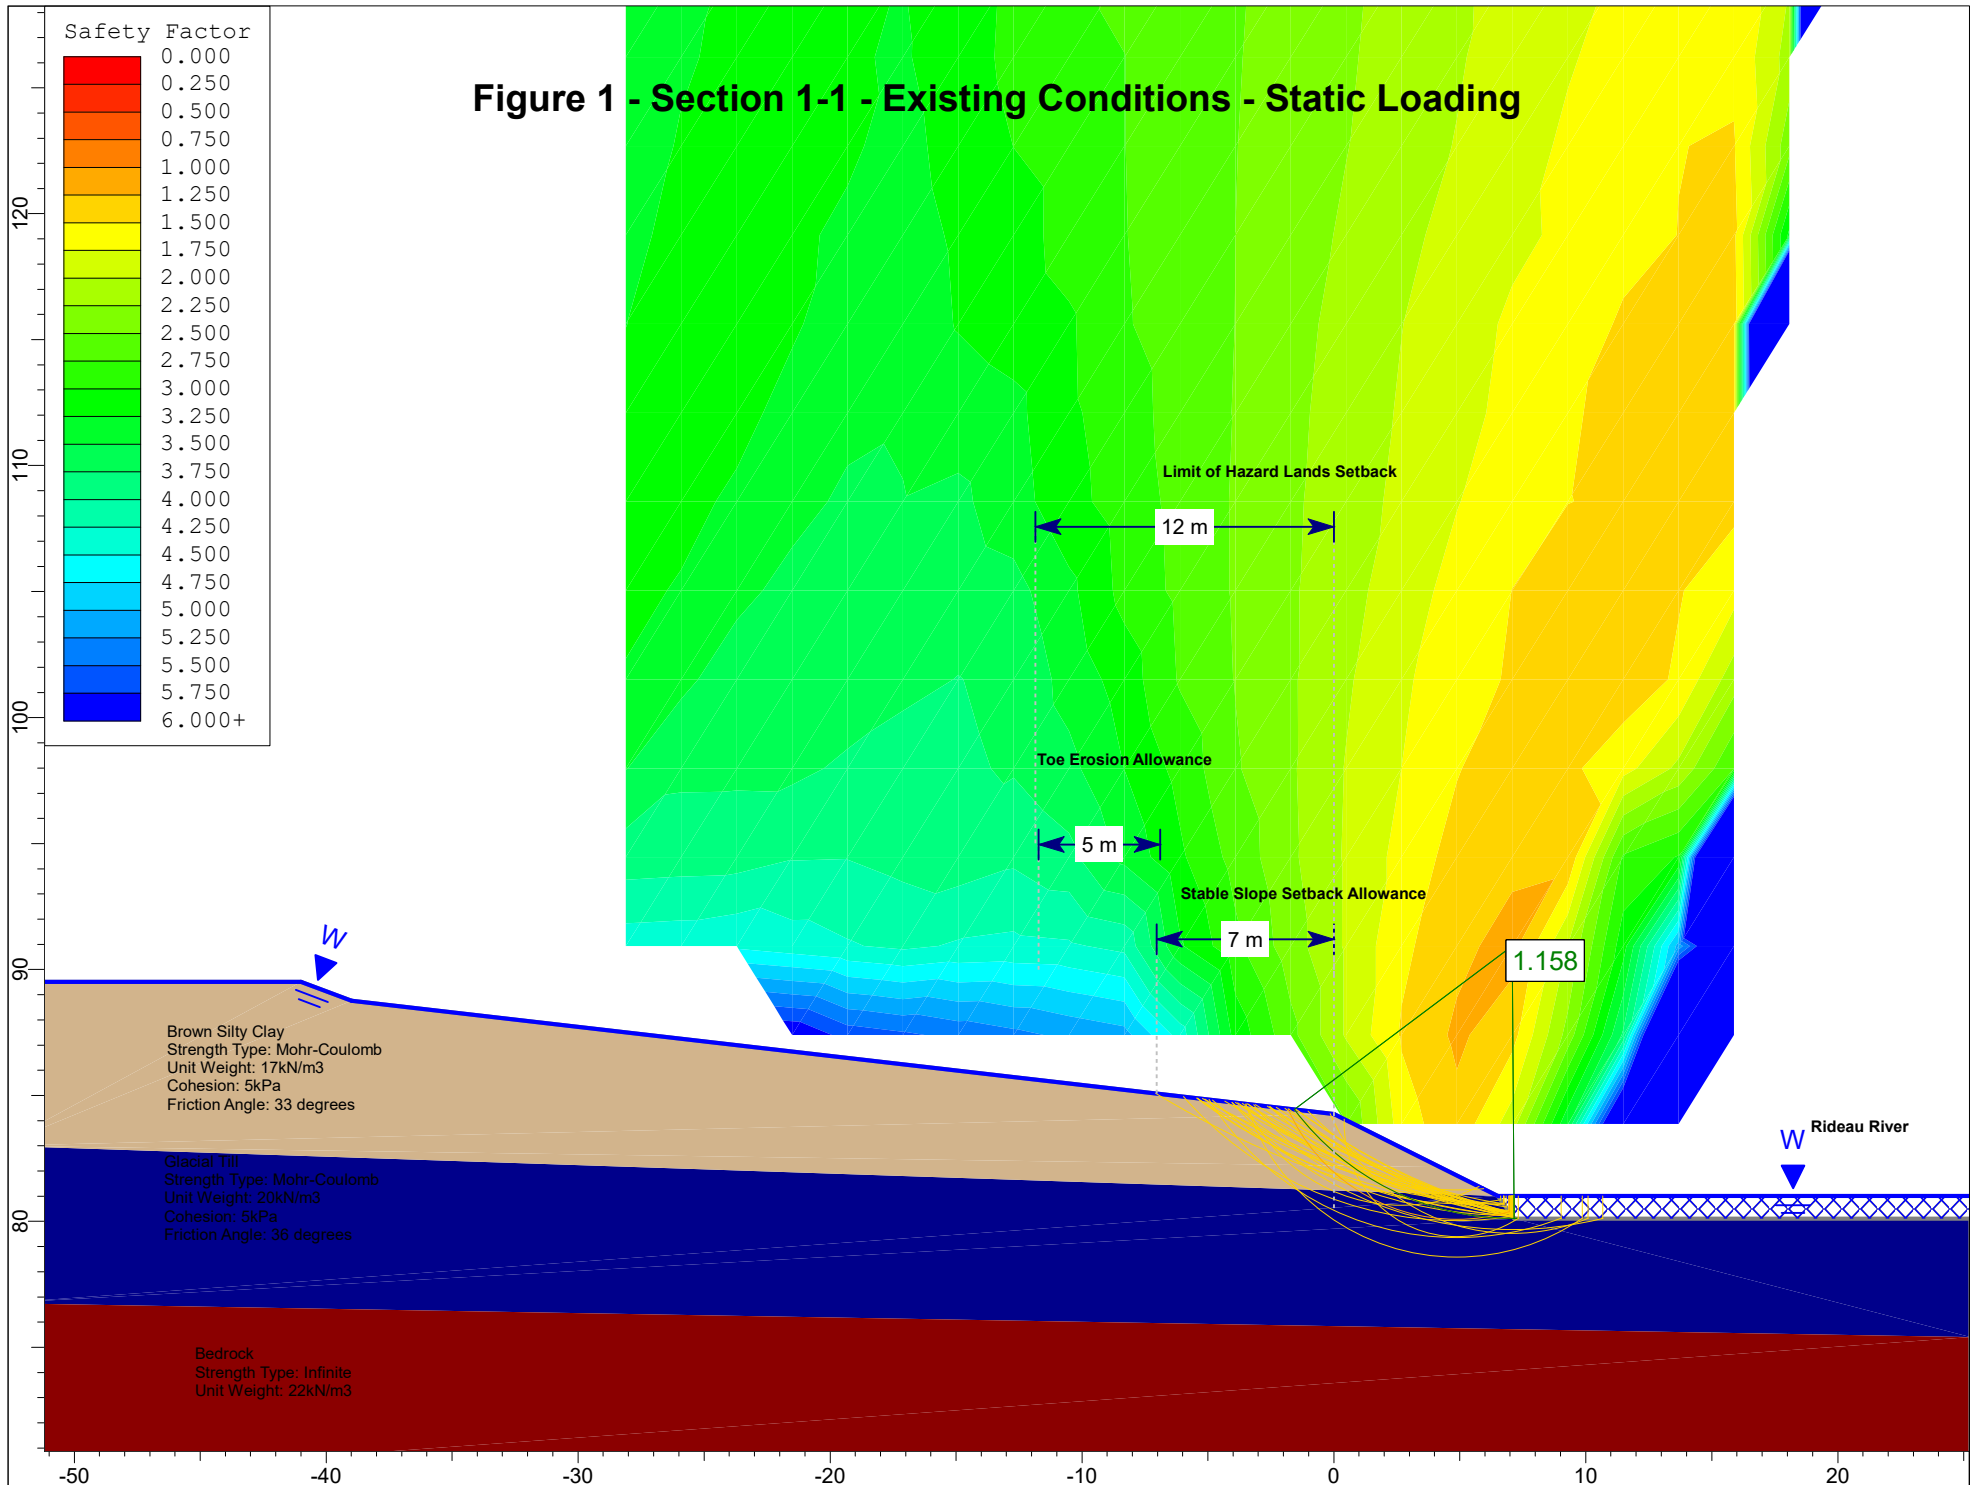
Figure 1 - Section 1-1 - Existing Conditions - Static Loading

The results are shown in Figures 1, 3, and 5. The results indicate a slope with a factor of safety of 1.16, 1.66, and 0.4 at Sections 1, 2, and 3, respectively. Based on these results, a stable slope setback varying between 7 and 9 m from the top of the slope are required for sections 1-1 and 3-3 to achieve a factor of safety of 1.5 for the limit of the hazard lands in the park area. Section 2-2 will not require a stable slope allowance.

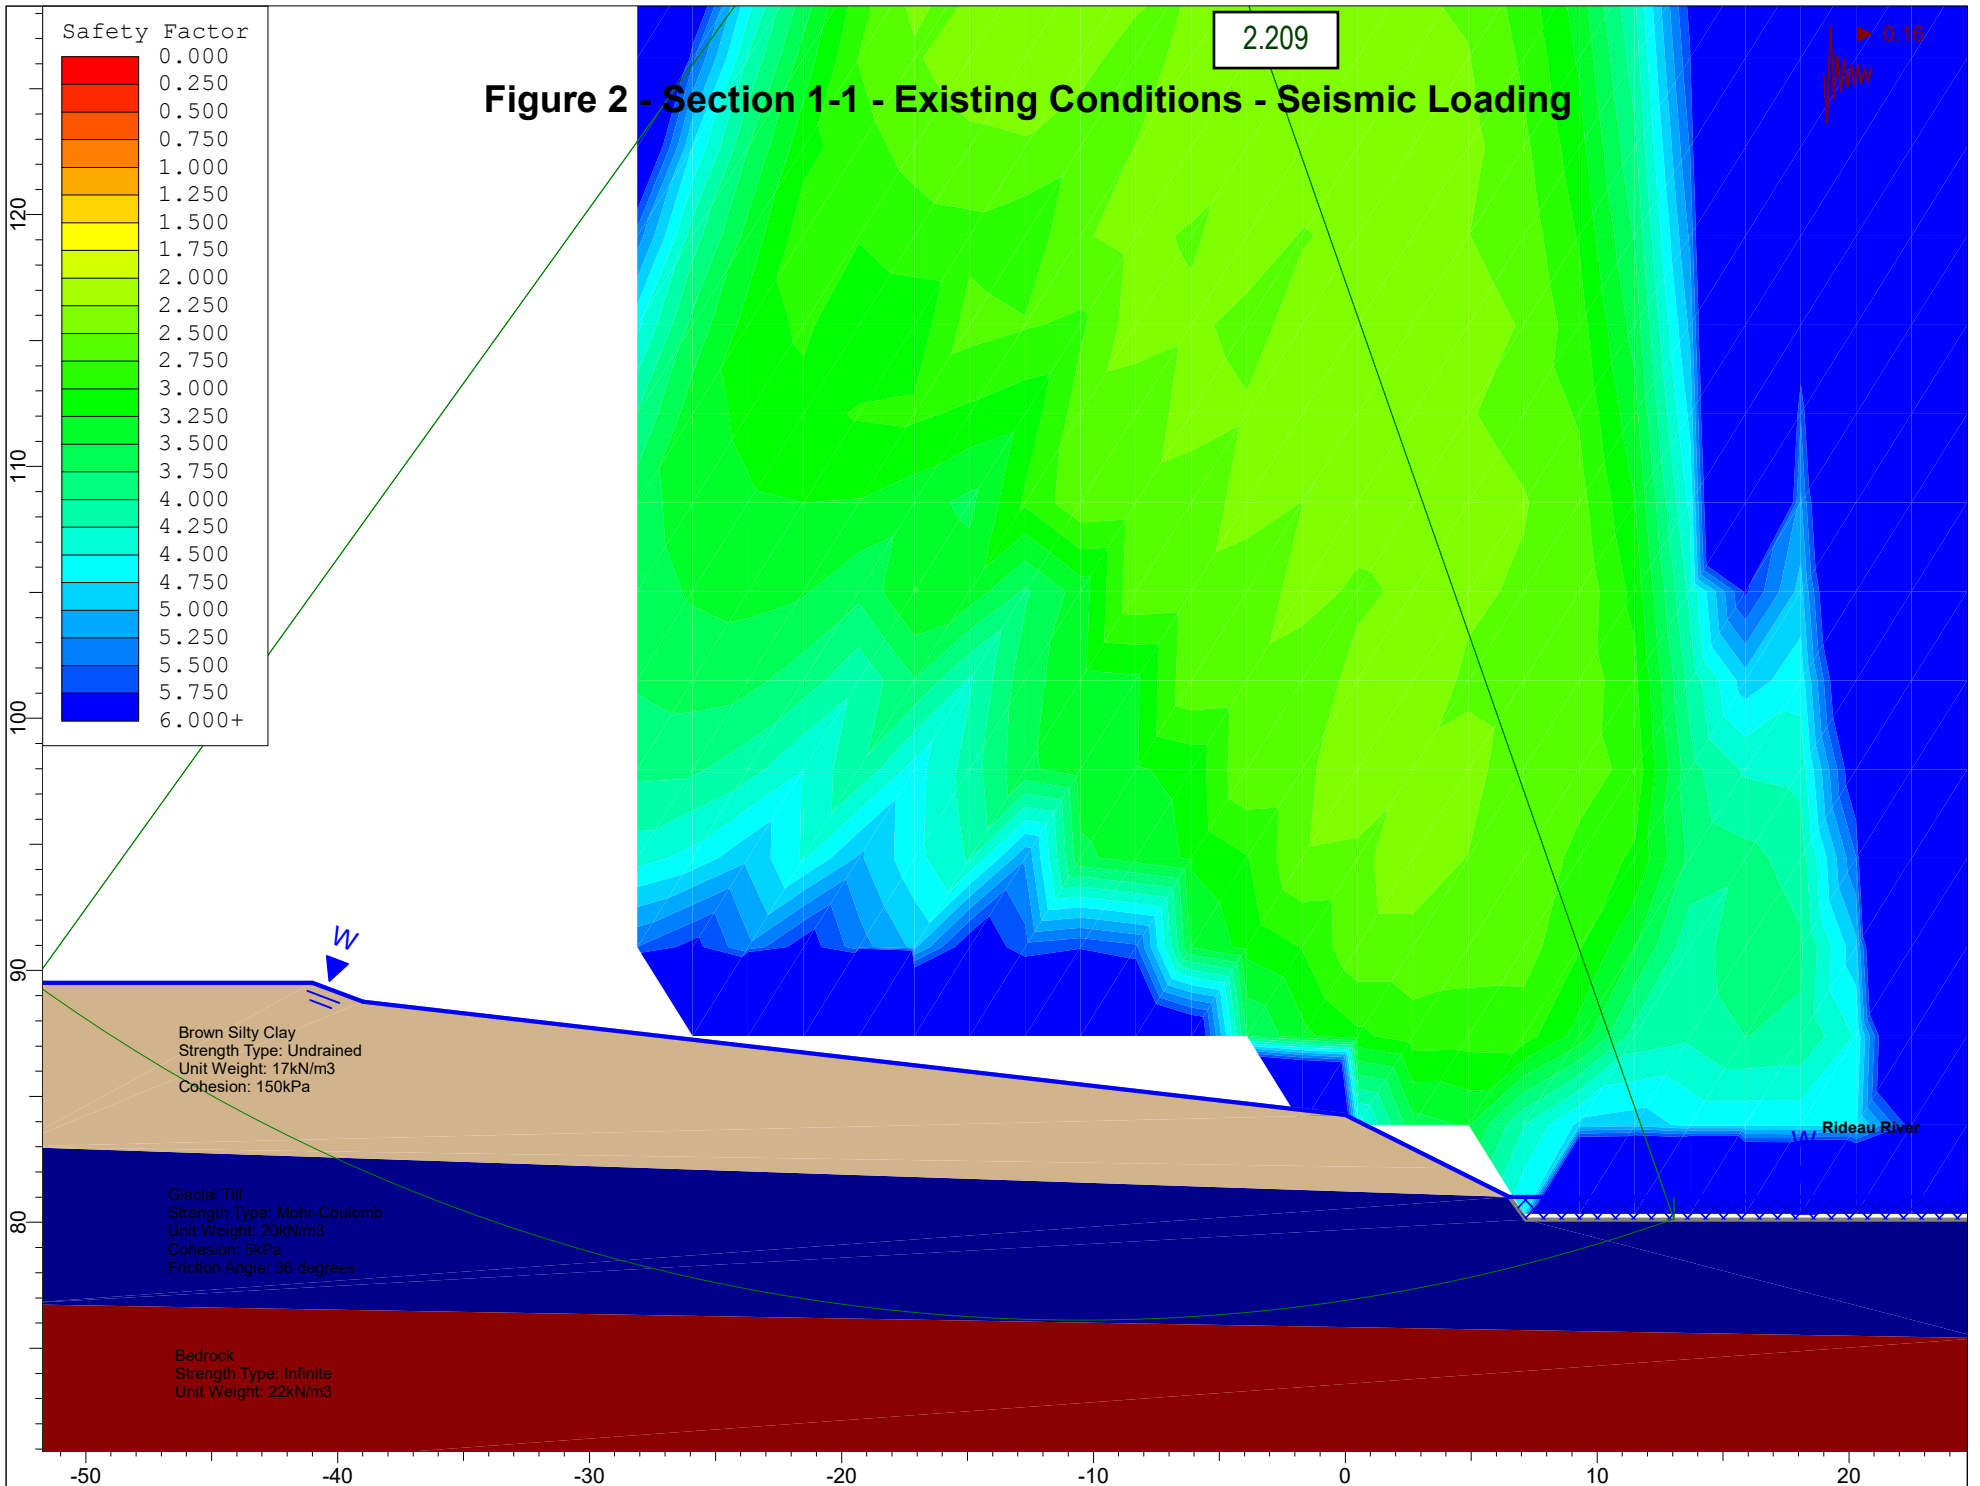
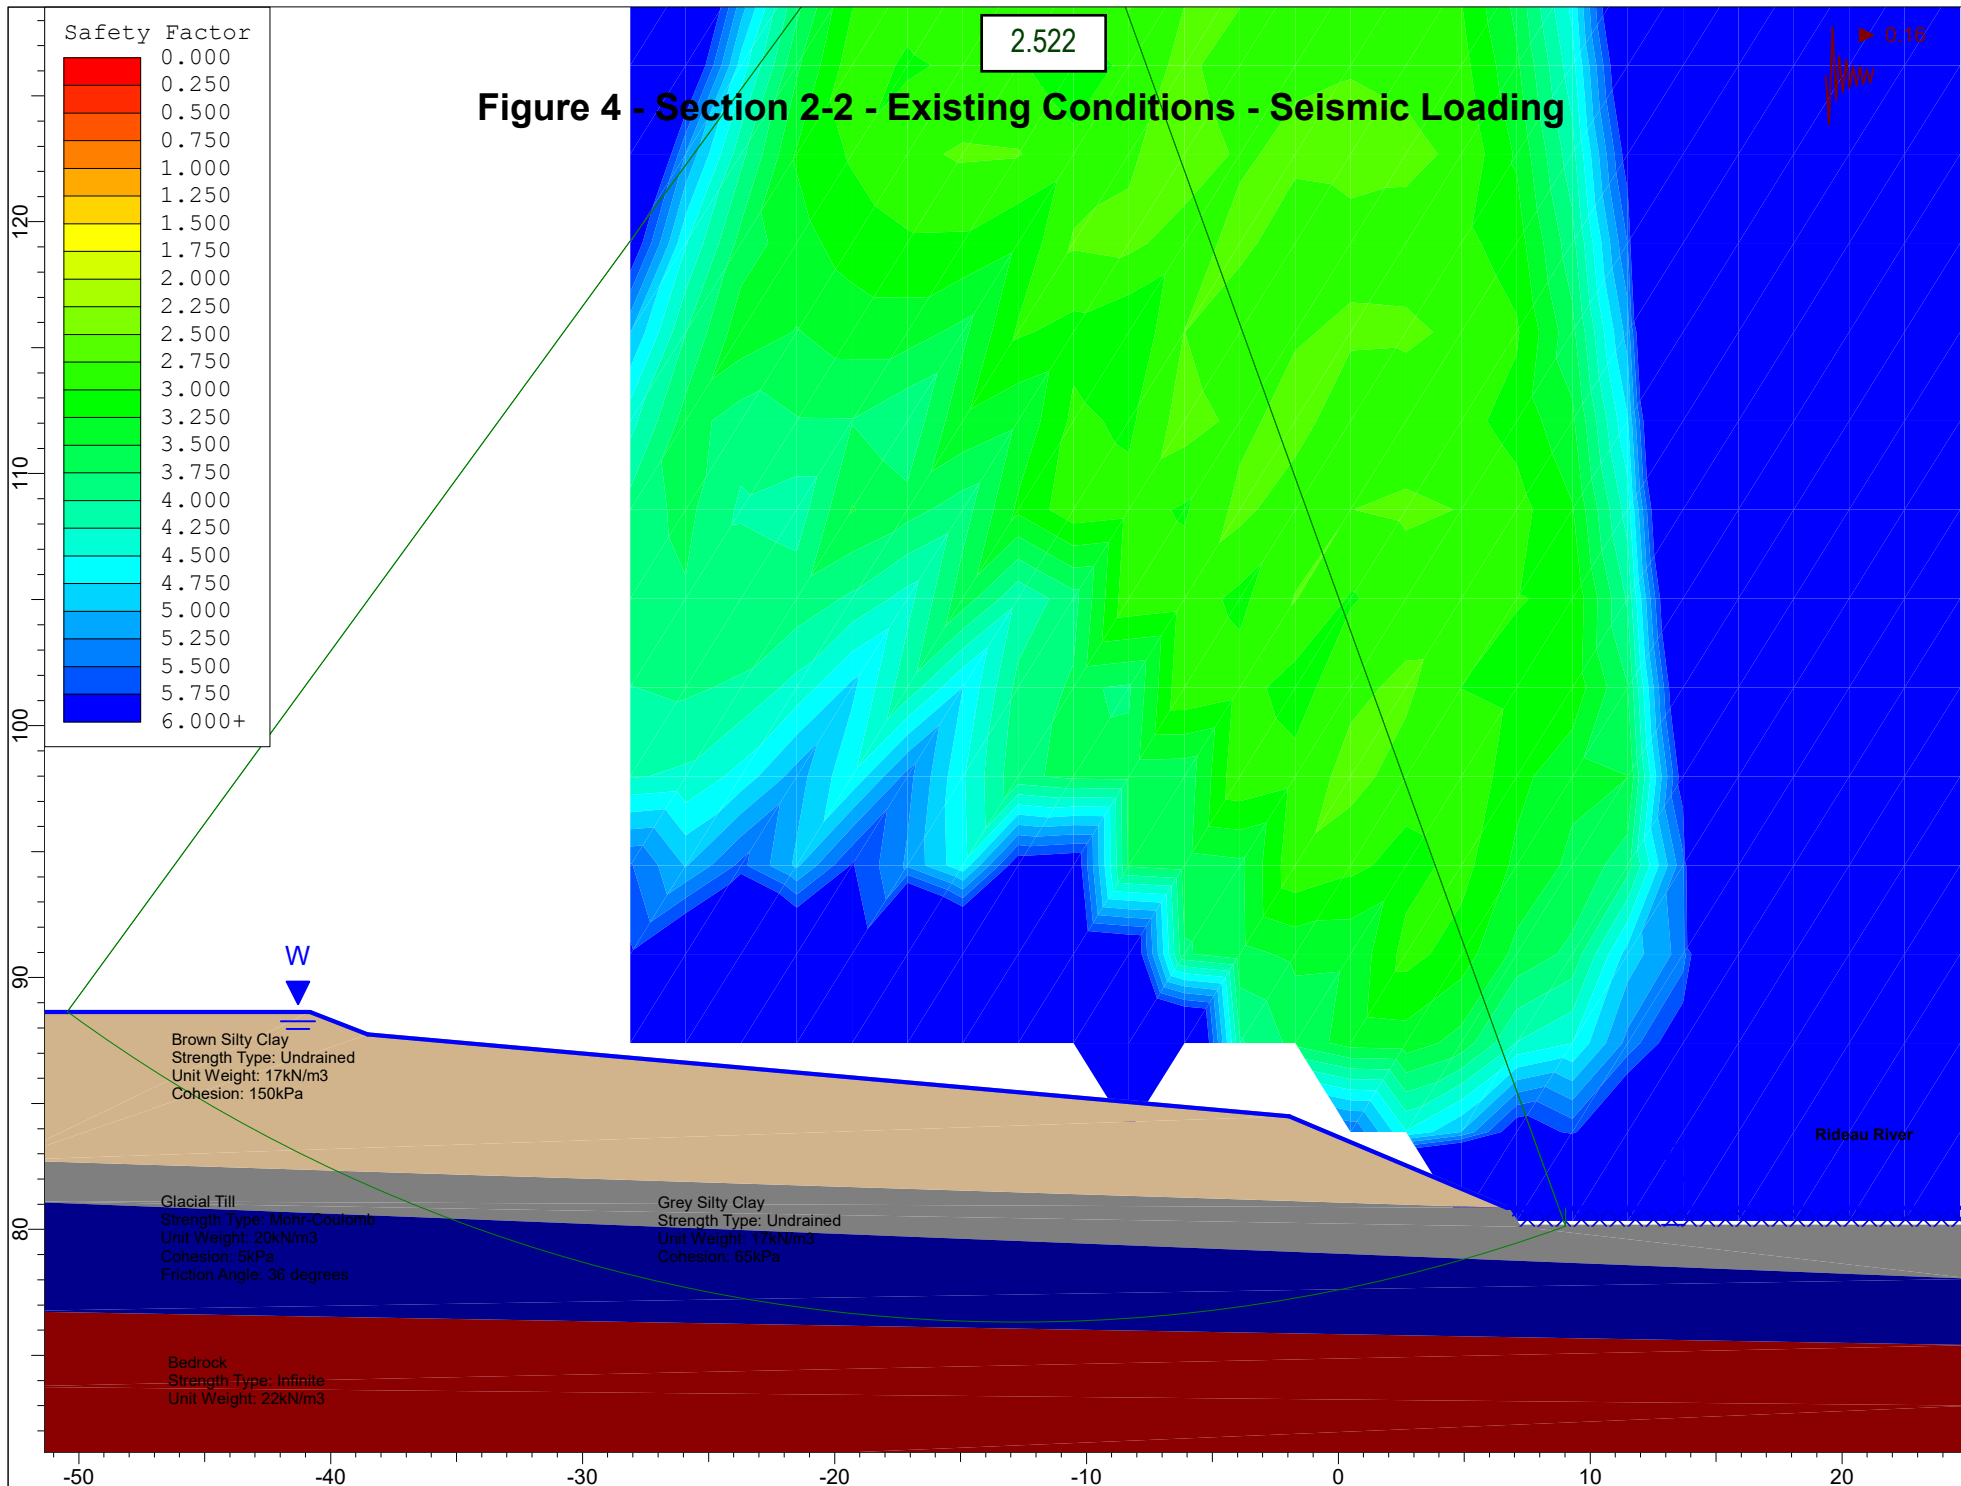
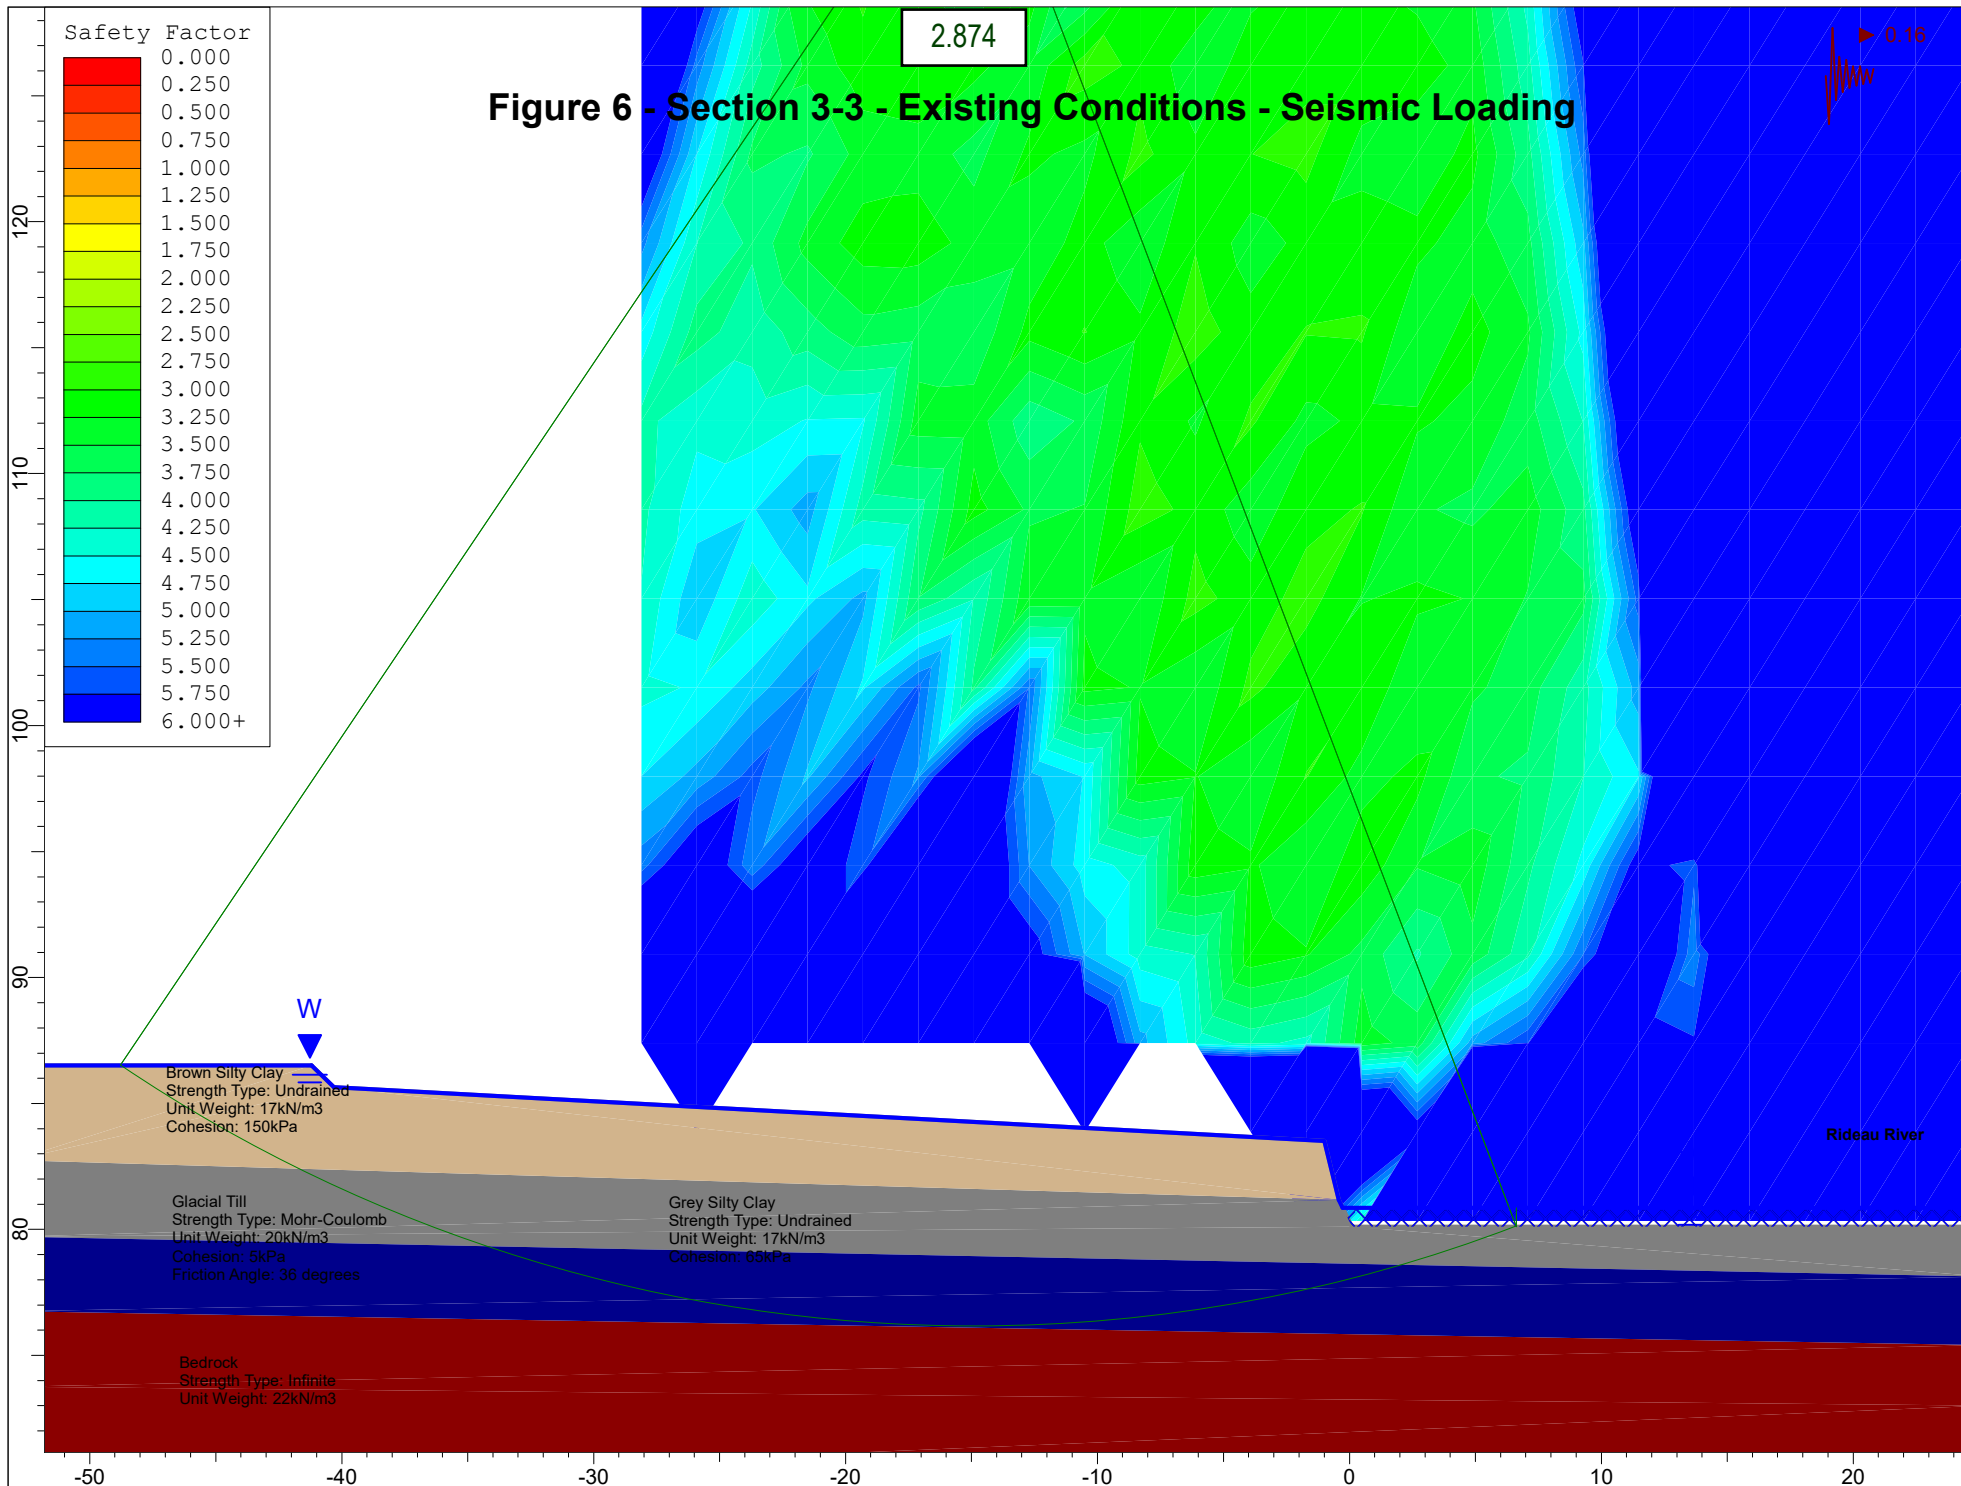
An analysis considering seismic loading and the groundwater at ground surface was also completed. A horizontal acceleration of 0.16g was considered for all slopes. A factor of safety of 1.1 is considered to be satisfactory for stability analyses including seismic loading. The results of the analyses including seismic loading are shown in Figures 2, 4, and 6. The results indicate a slope with a factor of safety greater than 1.1 at all sections. However, it should be noted that the stable slope setback associated with our static loading analysis governs the required stable slope setback required for static conditions.

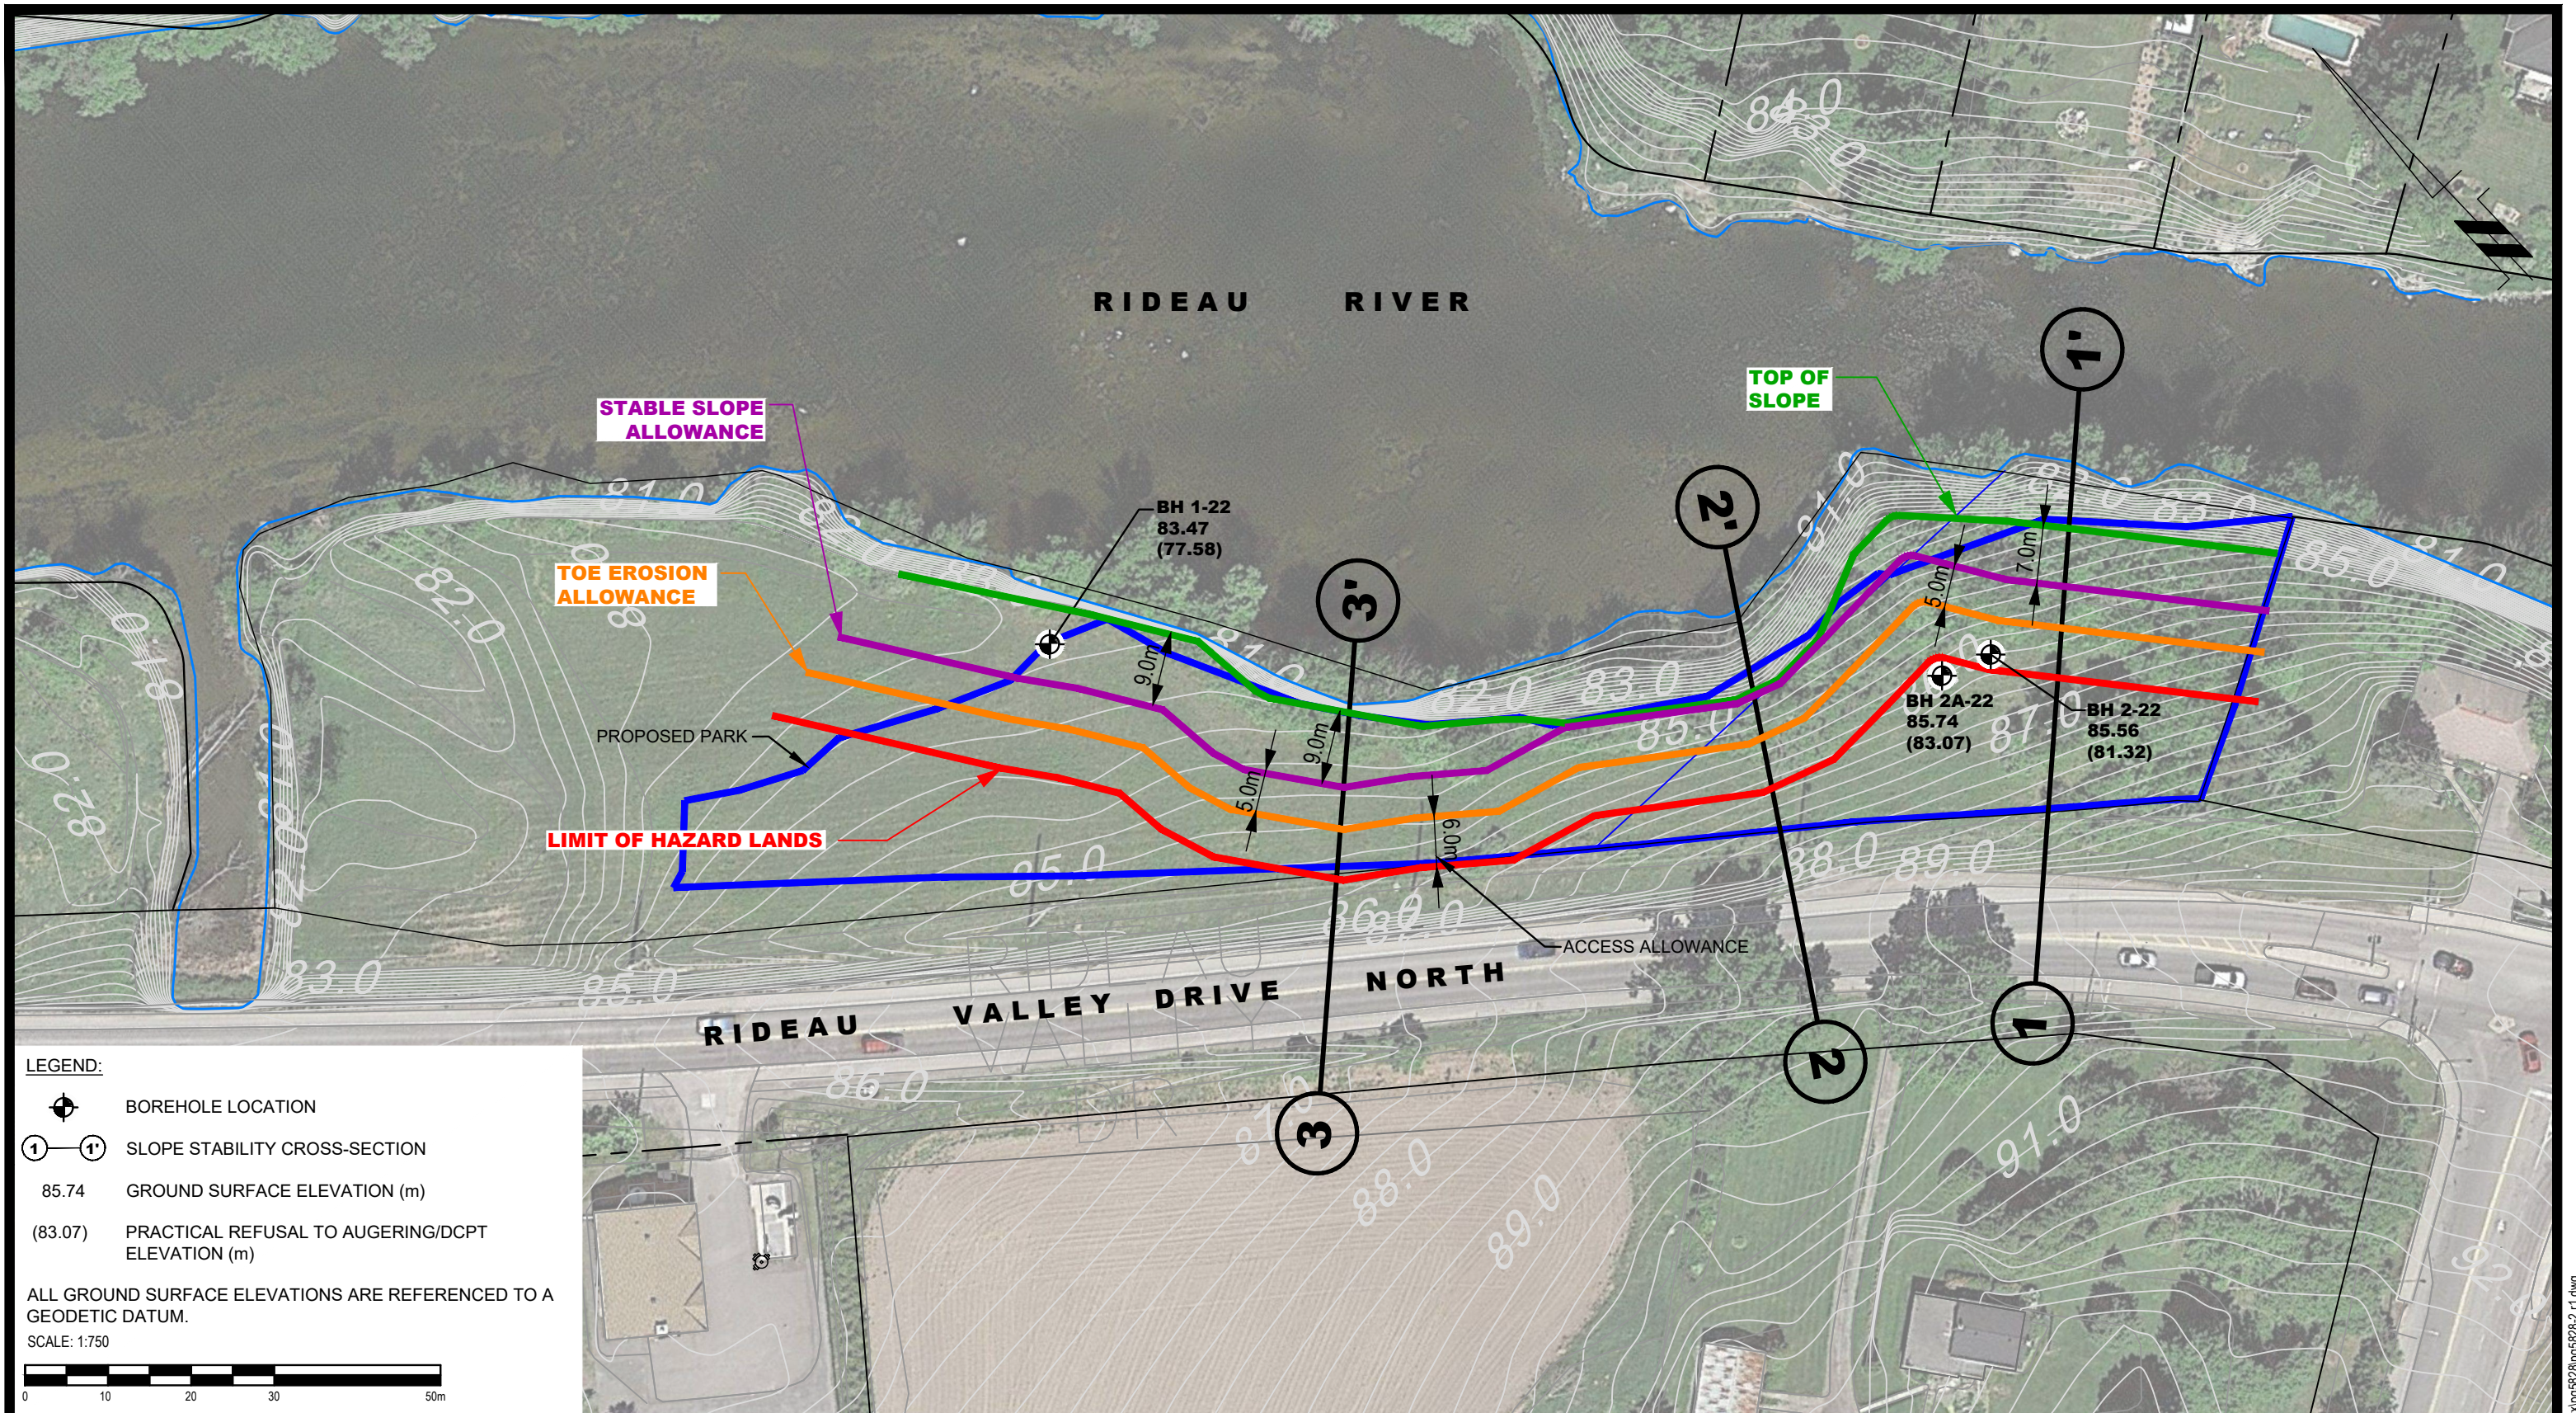
Title: **LIMIT OF HAZARD LANDS PLAN**

Based on the soil profiles encountered at the borehole locations and the soil encountered throughout the river, a stiff grey silty clay is anticipated to be subject to erosion activity by the river flow. Based on the encountered soils and the observed active erosion, a toe erosion allowance of 5 m should be applied for the subject slope. Furthermore, a minimum 6 m access allowance should be considered.

Based on the above, a setback taken from the top of the current slope has been provided as based on the above-noted observations and analysis. Reference should be made to Drawing PG5828-2 – Limit of Hazard Lands Plan for the proposed River Park at the subject site.
