Phase I Environmental Site Assessment

1600 Stagecoach Road Ottawa, Ontario

Prepared for Ark Engineering

Report: PE5918-1 November 28, 2022

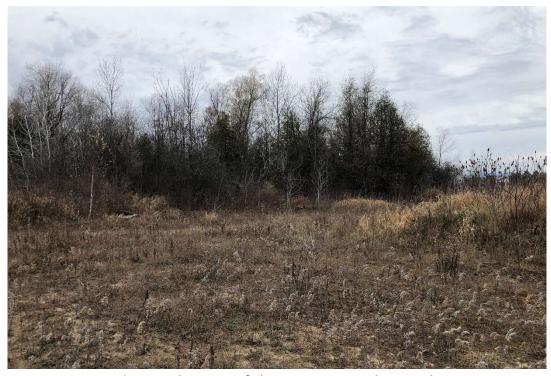
Photograph 1: View of Phase I Property Looking North

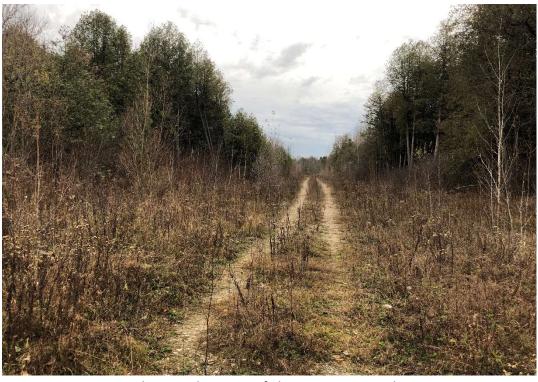
Photograph 2: View of Phase I Property Looking West
