TREE CONSERVATION REPORT
1770 Heatherington Road

June 13, 2024

Prepared for:
City of Ottawa

Stantec Consulting Ltd.
1331 Clyde Avenue
Ottawa ON K2C 3G4
Project No. 160401942

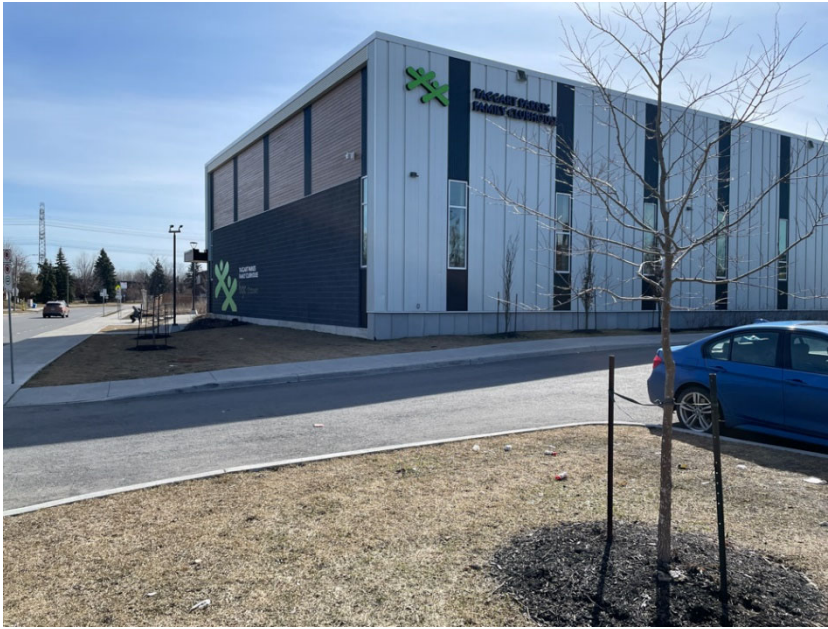
Photograph 1: Recently planted trees around the Taggart Parkes Family Clubhouse, all under 10cm DBH.

Based on current plans, it is anticipated that all trees inventoried on the subject site will require removal to facilitate development works. Trees recently planted around Taggart Parkes Family Clubhouse should be retained and protected.

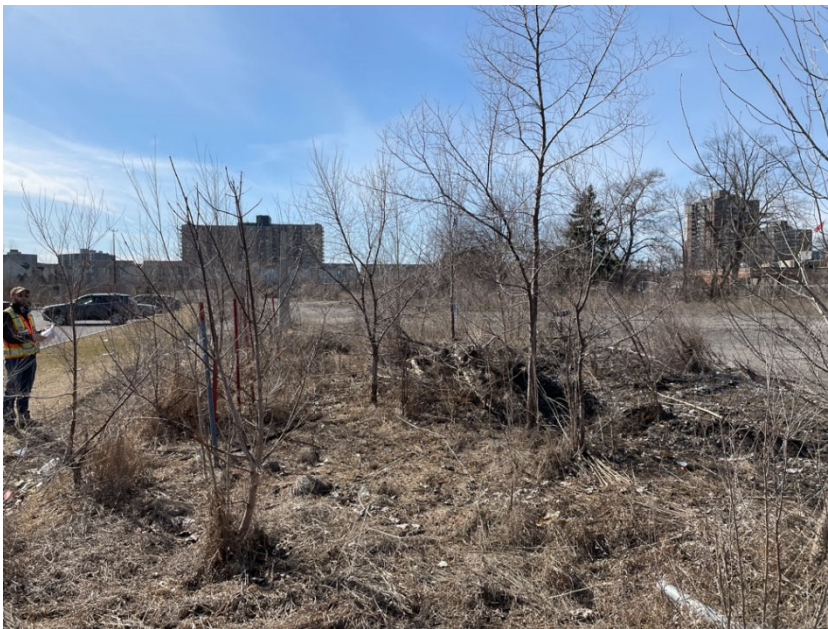
Photograph 2: Area with naturalized saplings and dense understory.

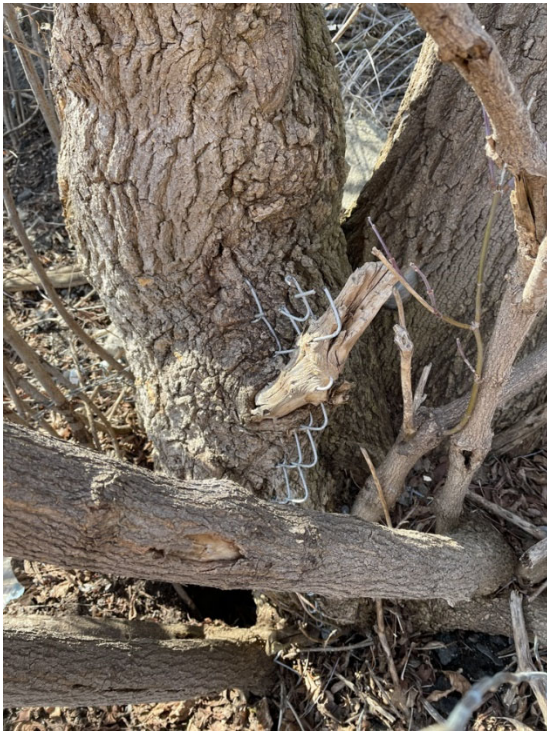
The condition or health of trees within the subject site was found to be mostly fair. Trees were assessed for trunk integrity (TI), canopy structure (CS) and canopy vigour (CV)*. Tree assessed as fair or poor typically included some of the following defects: weak unions, co-dominant branches, mechanical trunk damage.

Photograph 3: Example of several trees with mechanical trunk damage.

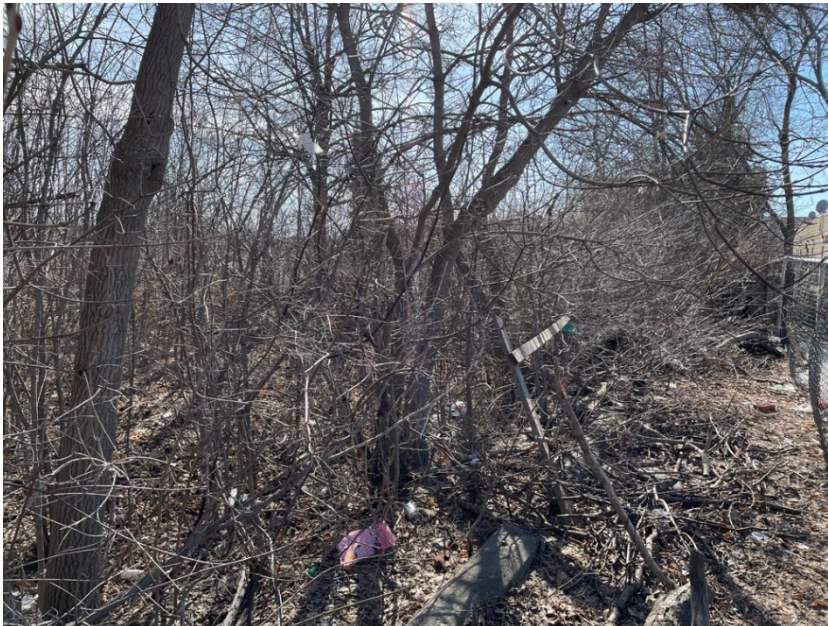
Photograph 4: Dense understory along the north property line.

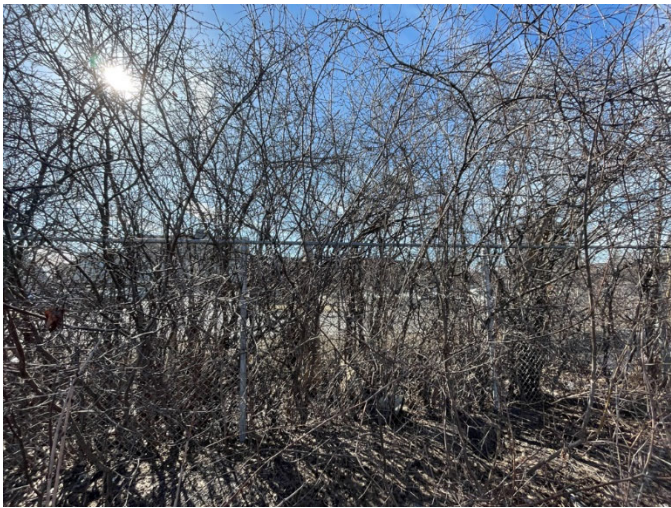
The west perimeter of the site has dense understory vegetation established between two fence lines. The space between the fences is low and wet with areas of standing water. Several dead and dying trees (assumed Emerald Ash Borer damage) are located between these fences.

Photograph 5: Dense understory between the two fences along the west property line.

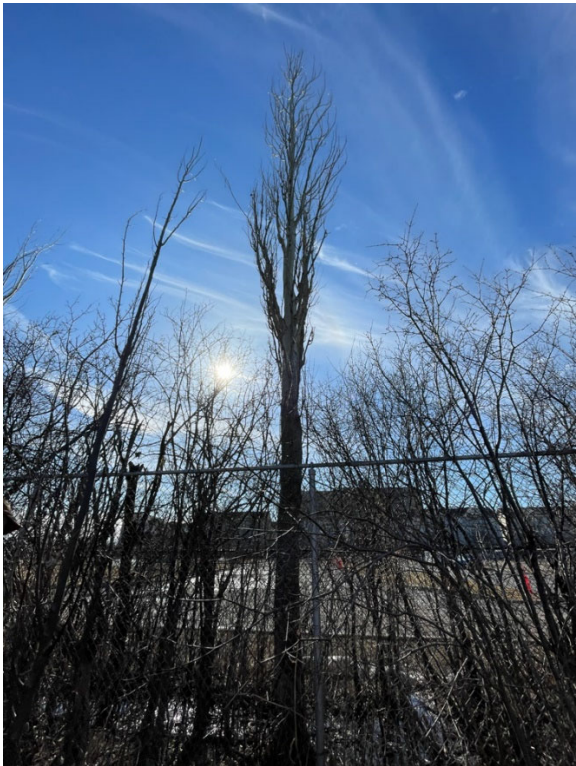
Photograph 6: Several dead trees on the property are recommended to be removed.

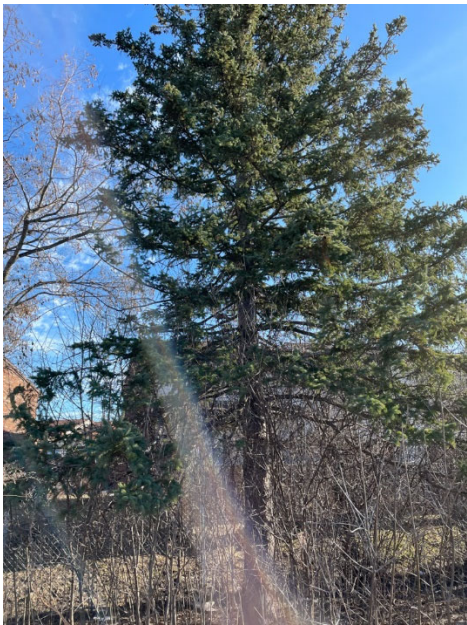
Photograph 7: One of two conifers found on subject site.

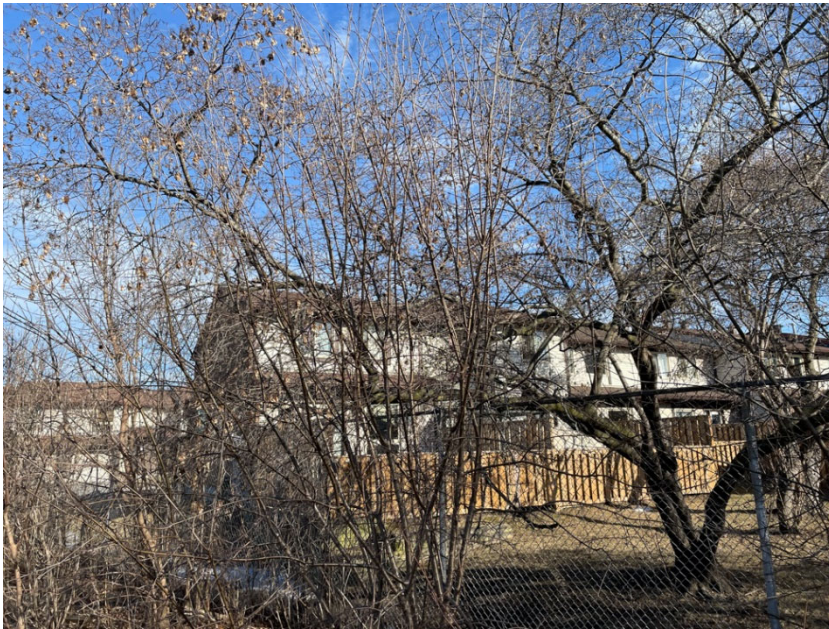
Photograph 8: An adjacent property tree with a wide canopy with some branches that enters into subject site.

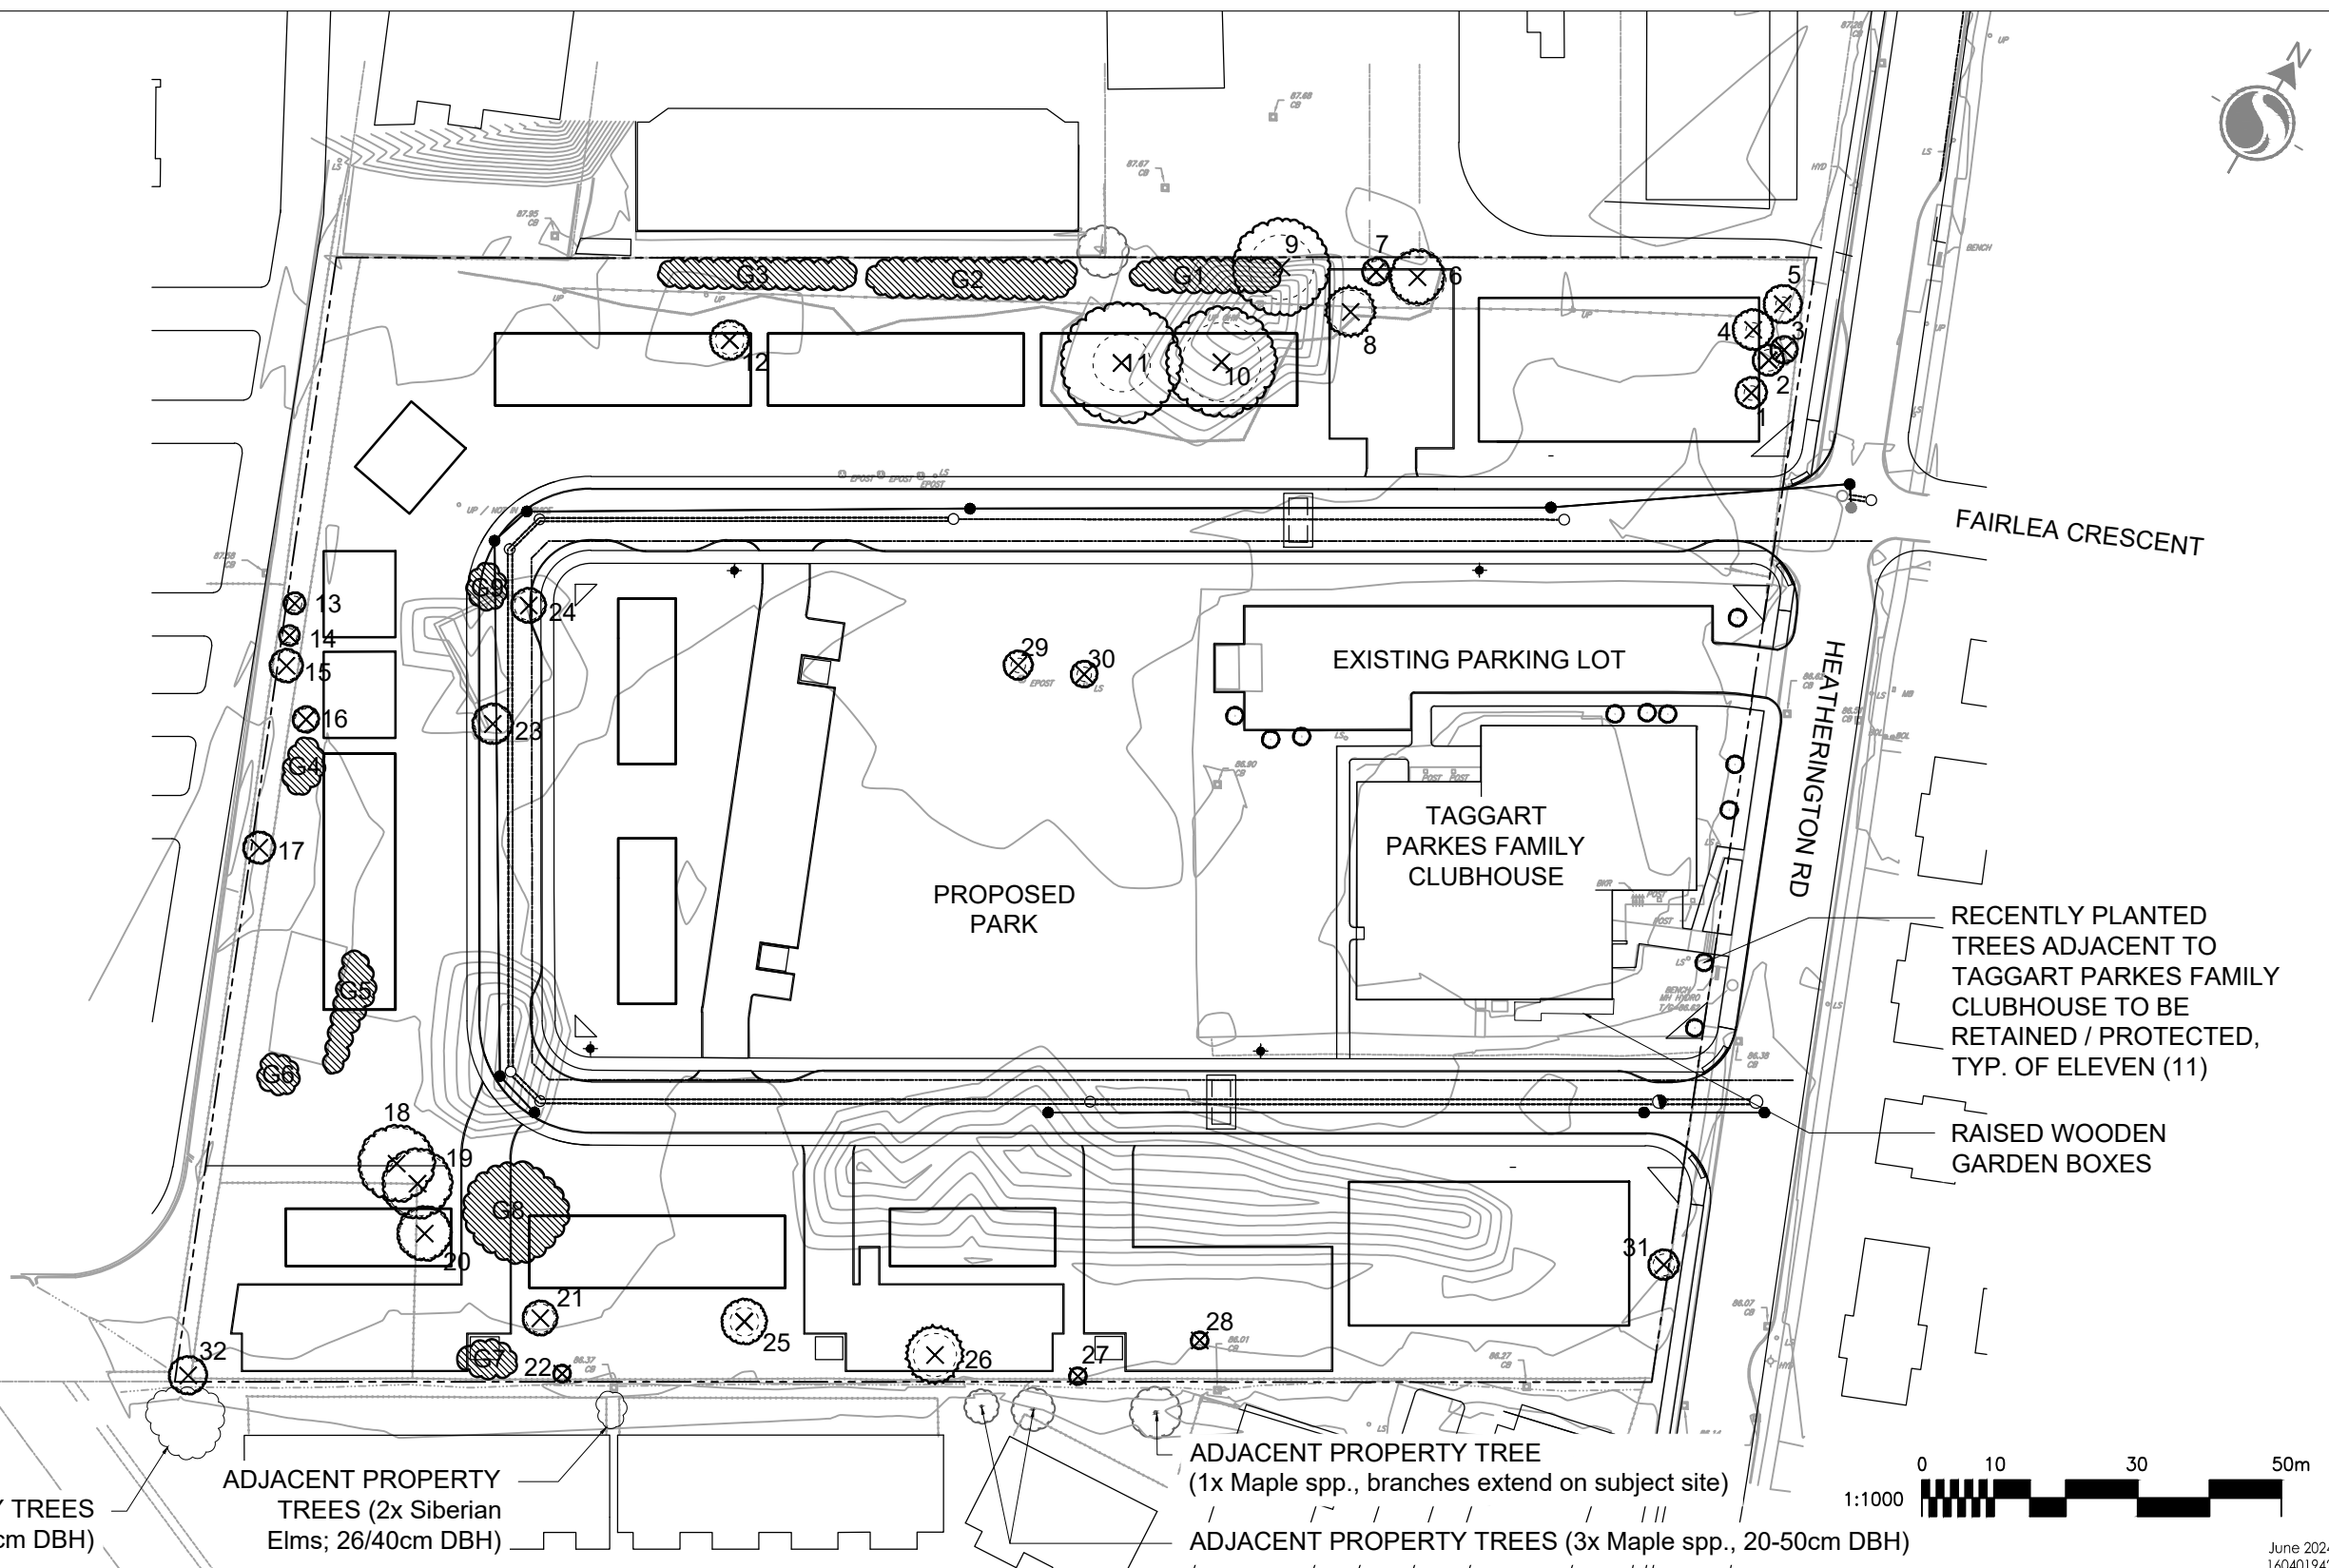
ADJACENT PROPERTY TREES
 (3x Norway Spruce; 35-40cm DBH)

ADJACENT PROPERTY
 TREES (2x Siberian
 Elms; 26/40cm DBH)

ADJACENT PROPERTY TREE
 (1x Maple spp., branches extend on subject site)

ADJACENT PROPERTY TREES (3x Maple spp., 20-50cm DBH)

RECENTLY PLANTED
 TREES ADJACENT TO
 TAGGART PARKES FAMILY
 CLUBHOUSE TO BE
 RETAINED / PROTECTED,
 TYP. OF ELEVEN (11)
