2510 St. Laurent Blvd – Tree Conservation Report

Claridge Homes

| REPORT TITLE: | 2510 St Laurent Blvd - Tree Conservation Report |
| ARCADIS REFERENCE: | 140253 |

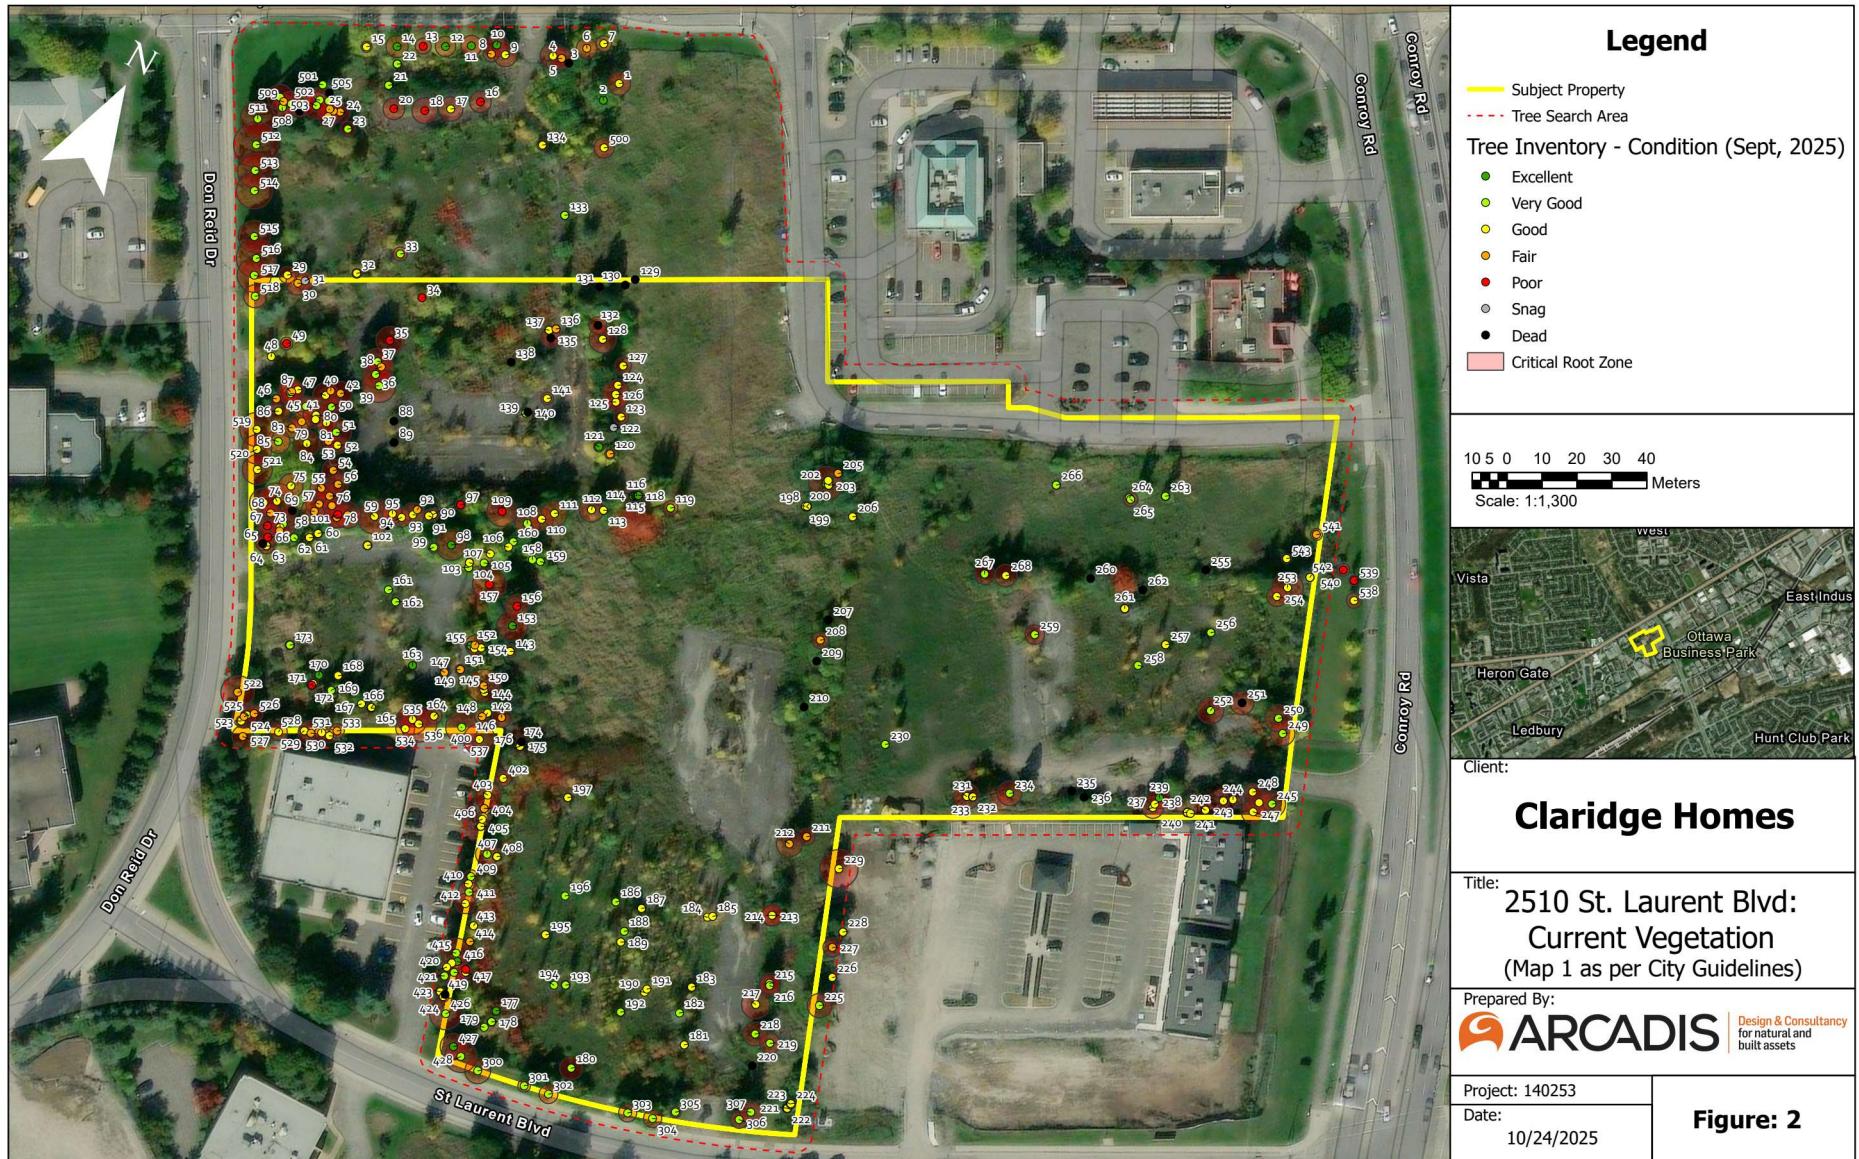
The following **Table 1** provides a summary of the tree inventory results with a full Tree Inventory and Preservation Plan included in **Appendix A**. **Figure 2** below displays the tree locations and associated health conditions.

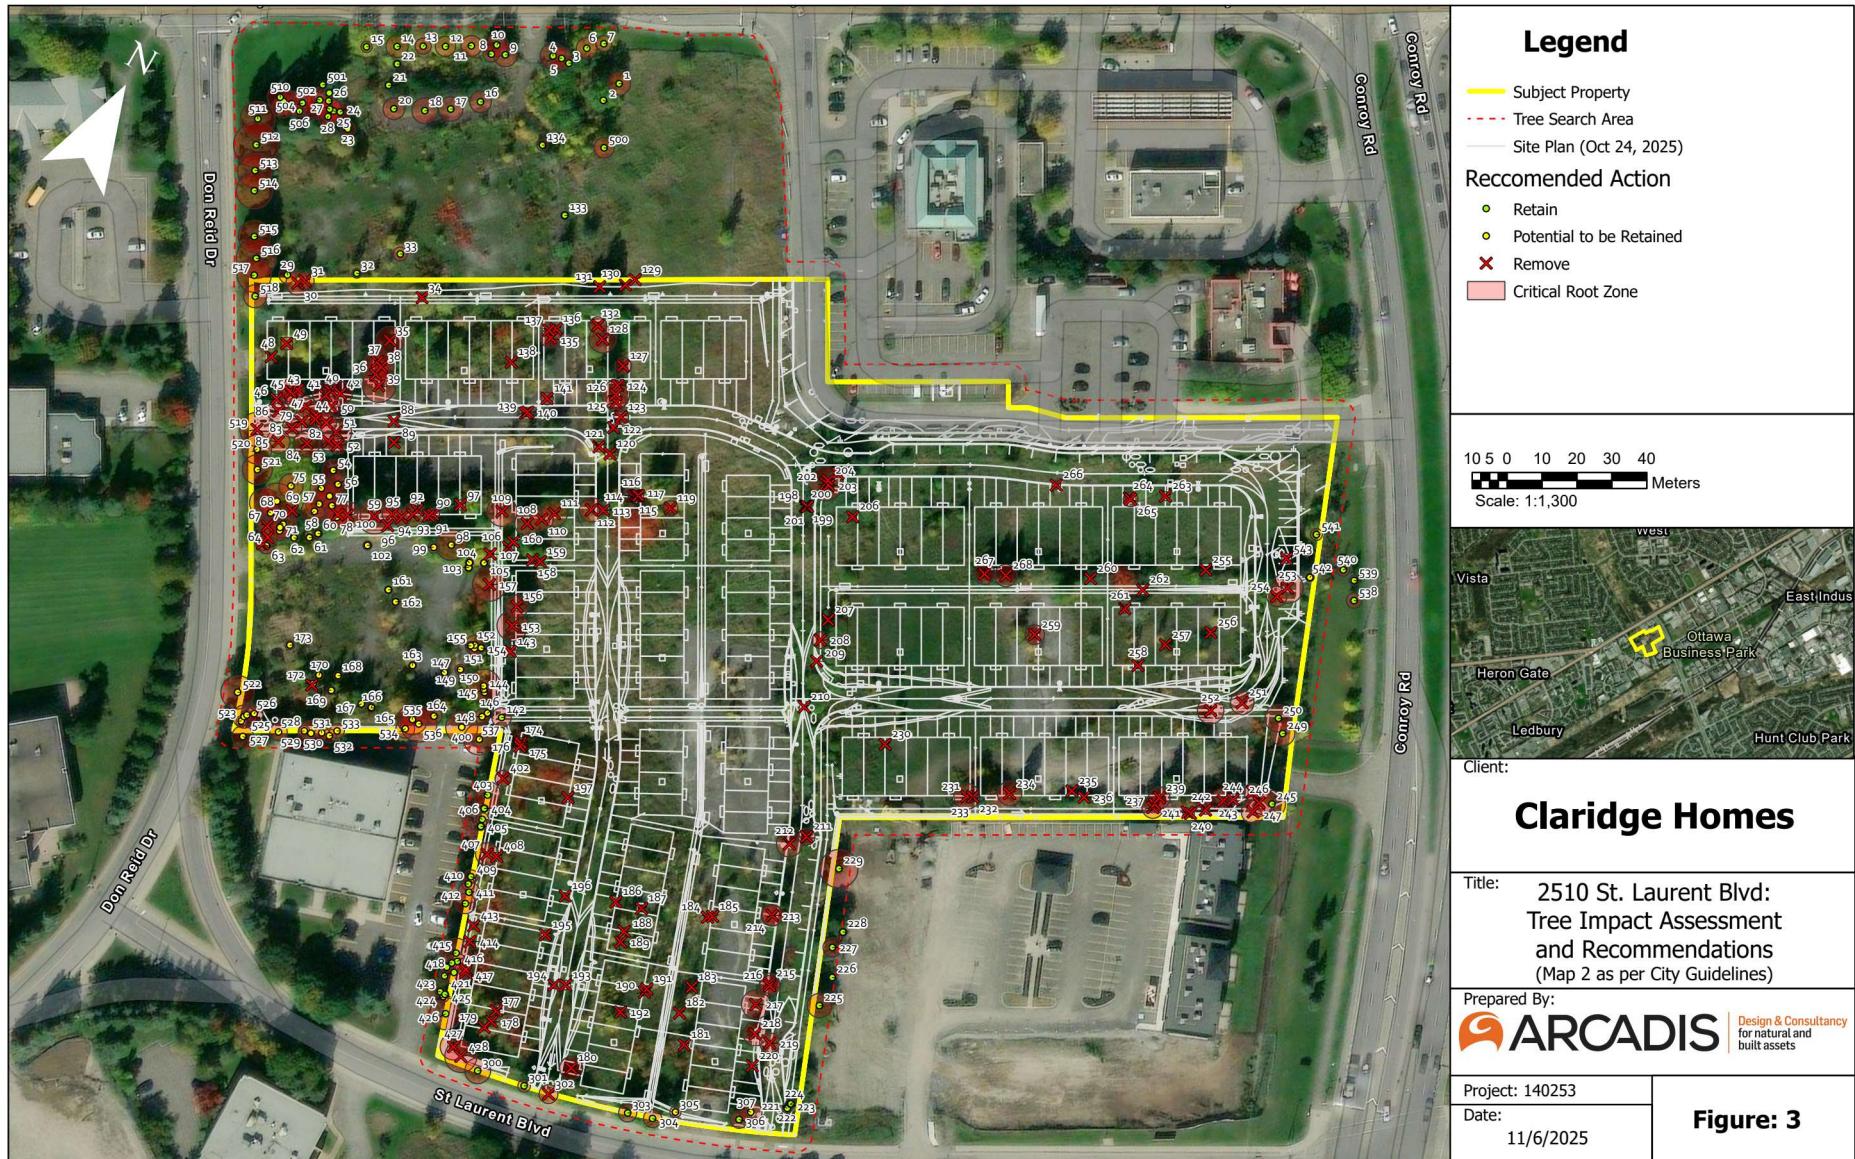
Figure 3 below displays the results of the tree inventory overlaid with the current site plan. Recommendations for removal, retention, and potential for retention are included.

The Critical Root Zone (CRZ) of **185 trees are in direct conflict with the proposed site plan and or grading limits and will require removal (Appendix A)**. Physical impacts on the CRZ by construction activities rapidly deteriorates the overall health, quality, and ecological service of the tree. Therefore, tree locations that will impact majority of the CRZ have been recommended for removal.

Trees have been considered for retention in instances where they do not conflict with the development footprint, or where there is limited anticipated impact to the CRZ of high-quality trees. Additionally, retention has been considered for trees owned by the City of Ottawa, or adjacent landowners. **A total of 91 trees has been identified as being considered for retention (Appendix A)**.

There are 71 trees within the proposed park area or along the perimeter of the Site that are slated for Potential Preservation (Appendix A). Once the Detail Design of the parkland is finalized impacts to trees in this area will be updated and included in a subsequent TCR.
