A: Pre-project conditions

B: Building Envelope condition prior to project

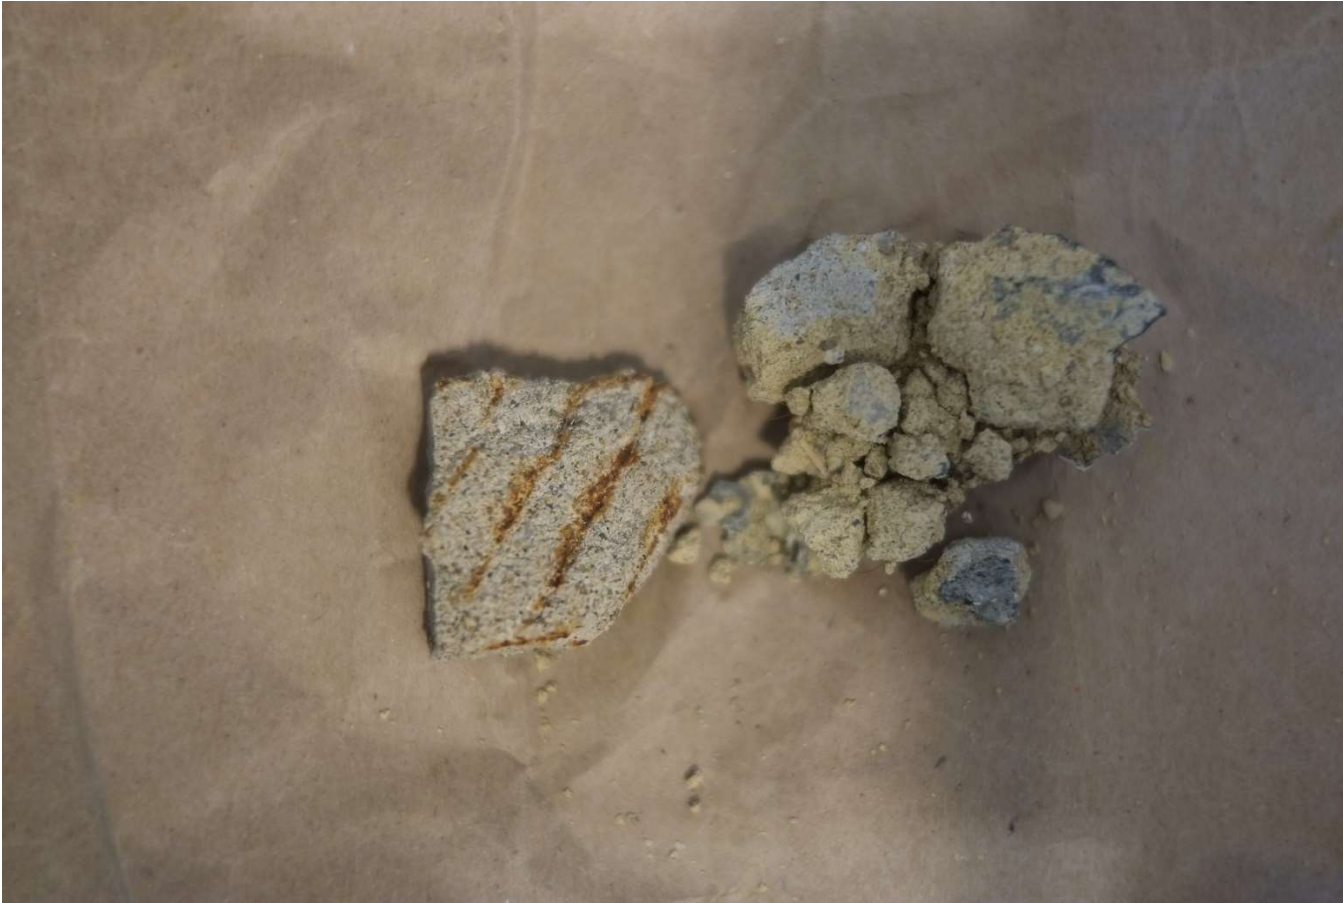
B.1 Stucco panels

Fig. 3: Stucco substrate is crumbling and separating from rusty support wire mesh. Impossible to remove stucco panels without damaging them.

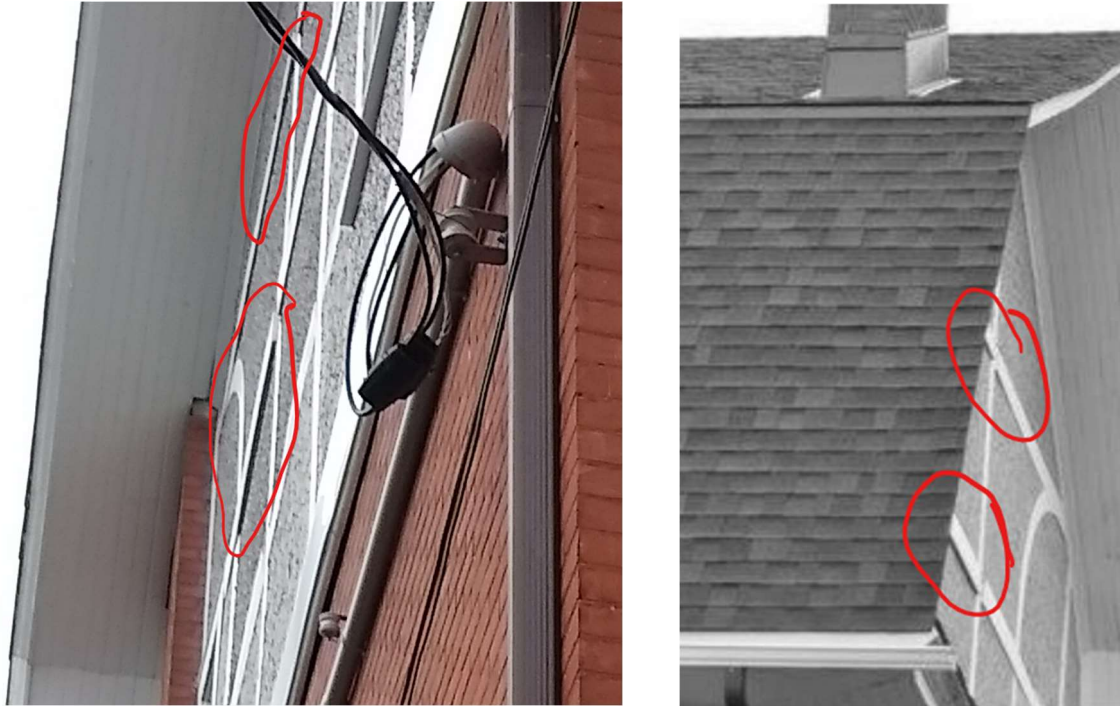
B.2 Battens

Fig. 4 and Fig. 5: Battens have started popping out form the stucco panels. An attempt was made to reset the battens in place unsuccessfully. This is a sign that the stucco panel assembly was no longer secure and safe.

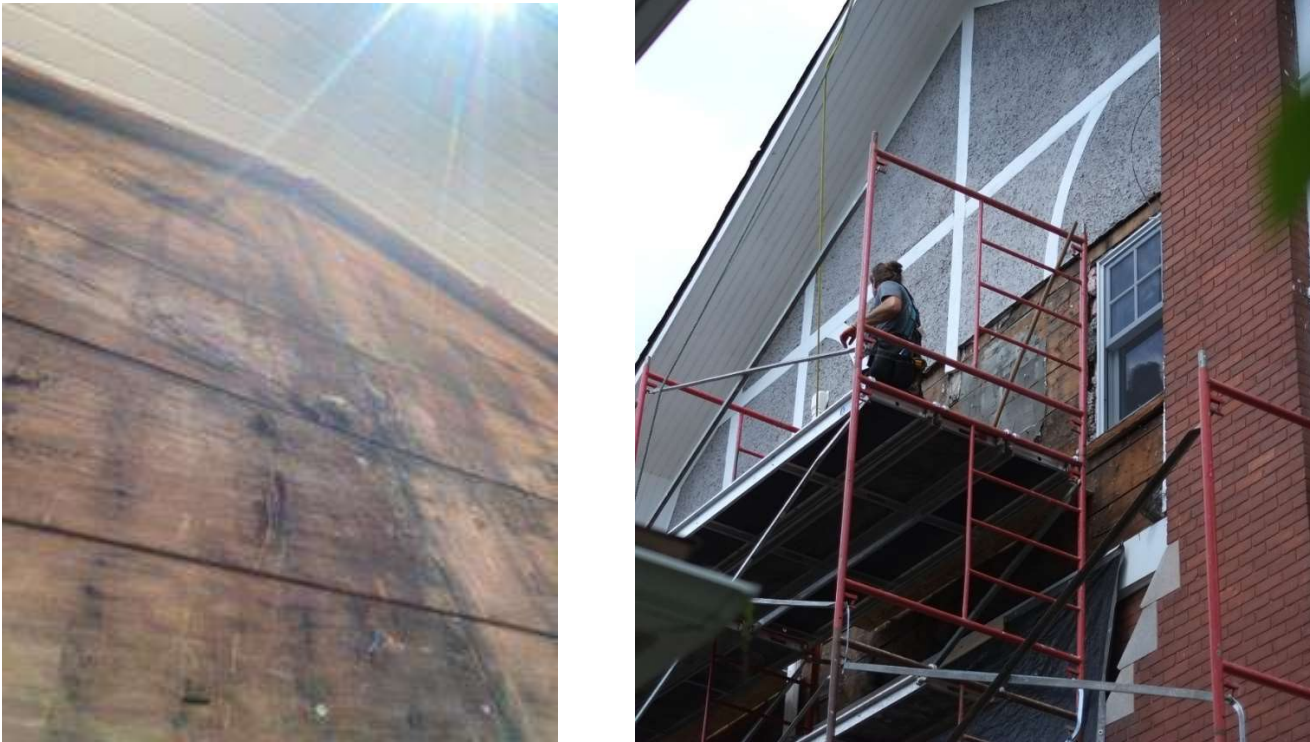
### B.3 Condition of sub-structure boards

Fig. 6 and Fig. 7: Exposed boards after stucco panels were removed

- Darkened boards indicate that stucco panels were no longer waterproof and not protective of the sub-structure of the house which will lead to accelerated deterioration of the boards.
- Many of the sub-structure boards were loose and had to be renailed – whole exterior wall assembly was no longer safe

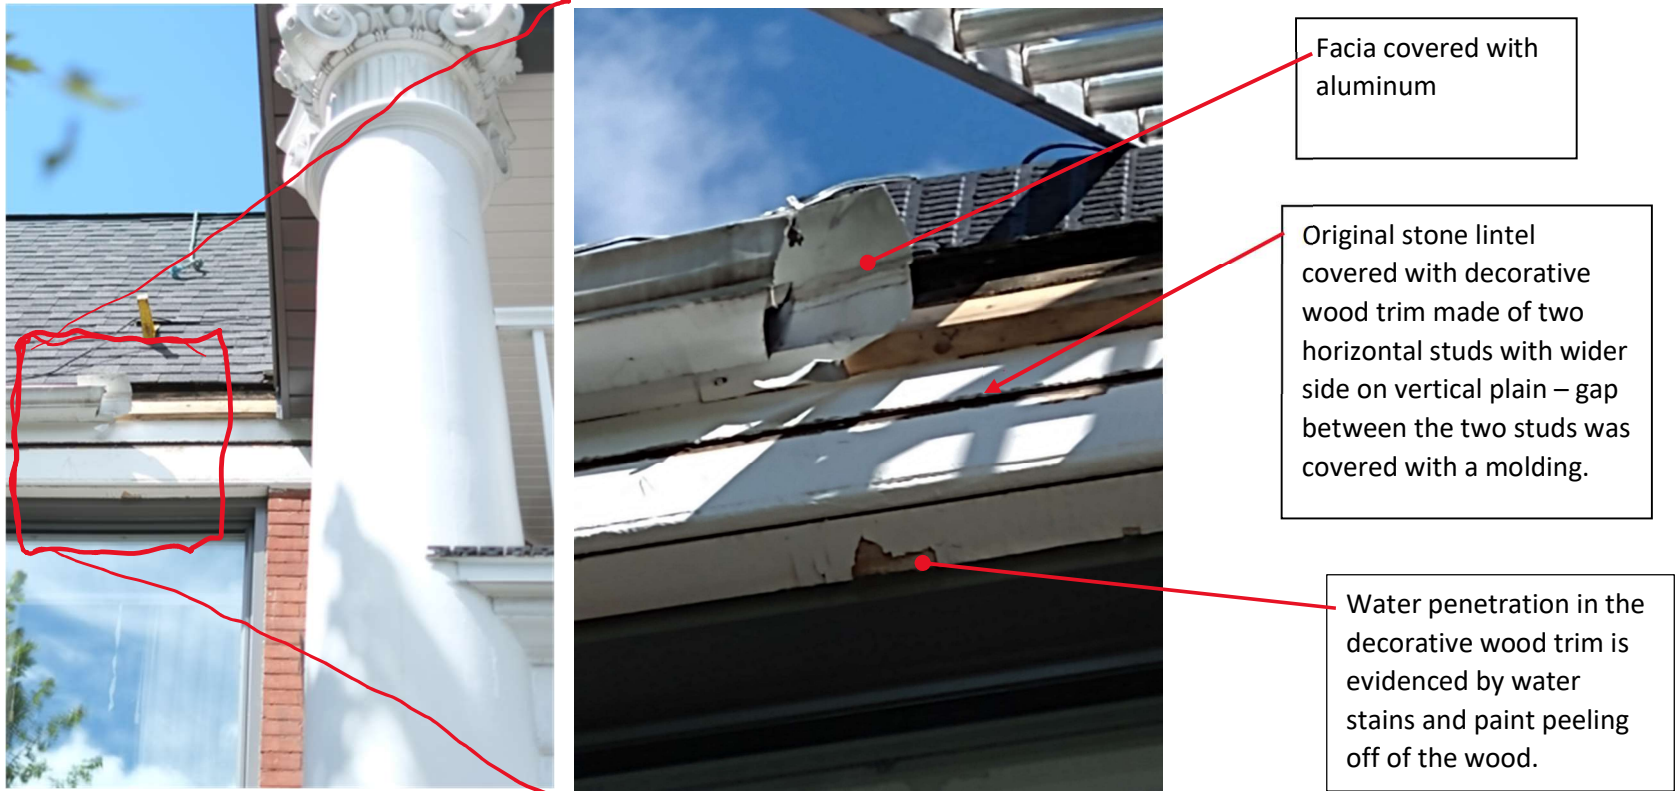
B.4 Covered window lintel and use of aluminum on facia

Fig. 8 and Fig. 9: Front of house – upper facia and decorative trim above 2<sup>nd</sup> floor windows: Photo shows that facia was covered with aluminum. Rain gutter was also installed. Water penetration is evident. Long term concern is water damaged wood will attract infestation of insects such as carpenter ants.

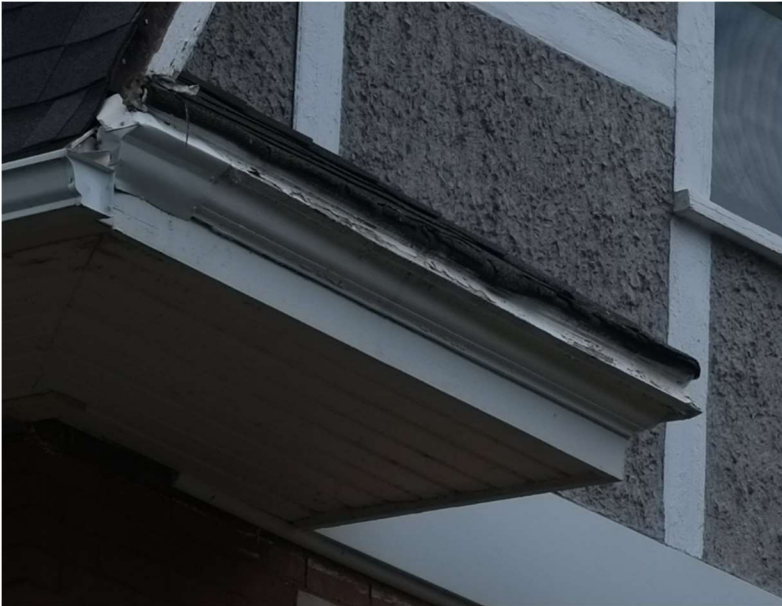
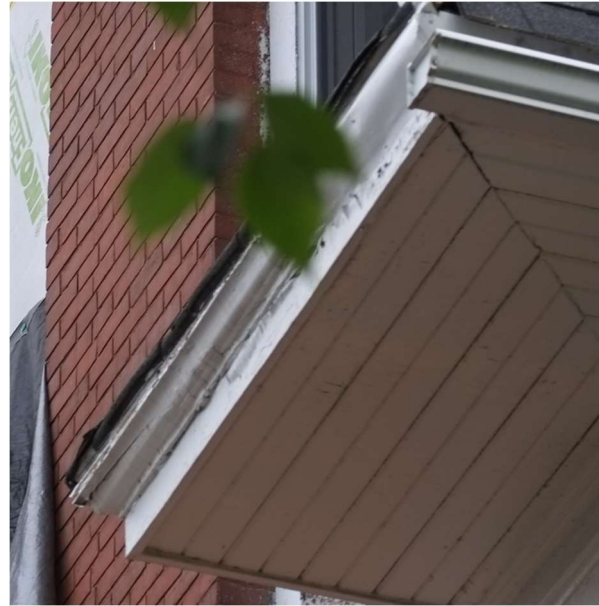
B.5 Crown Mouldings

Fig. 10 and Fig. 11: Crown mouldings have deteriorated pass point of repair. Aluminum caps on the end of the crown mouldings are visible in both photos

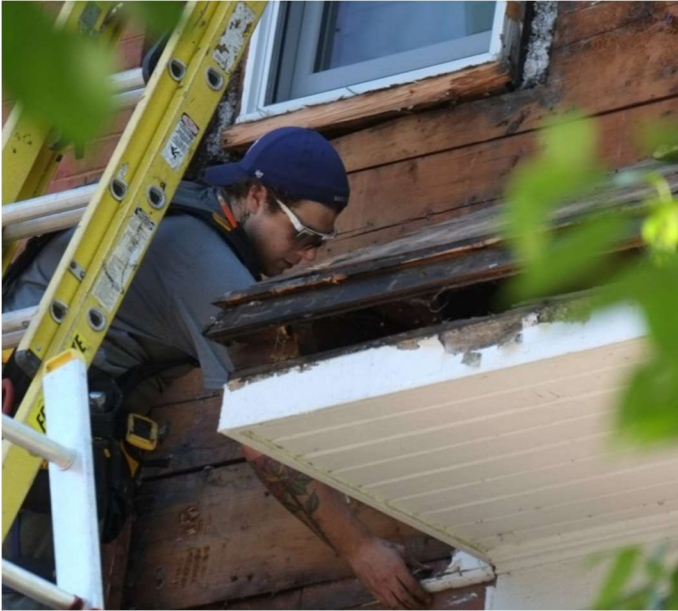
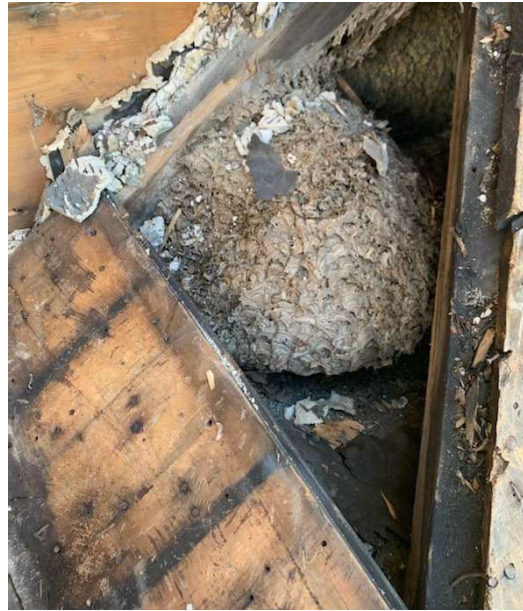
B.6 Flashing was not part of building practices back in 1920's

Fig. 12 and Fig. 13: As flashing was not used in original construction, crown mouldings and boards were subject to rot over the years leaving gaps where squirrels, birds and wasps were able to enter and nest

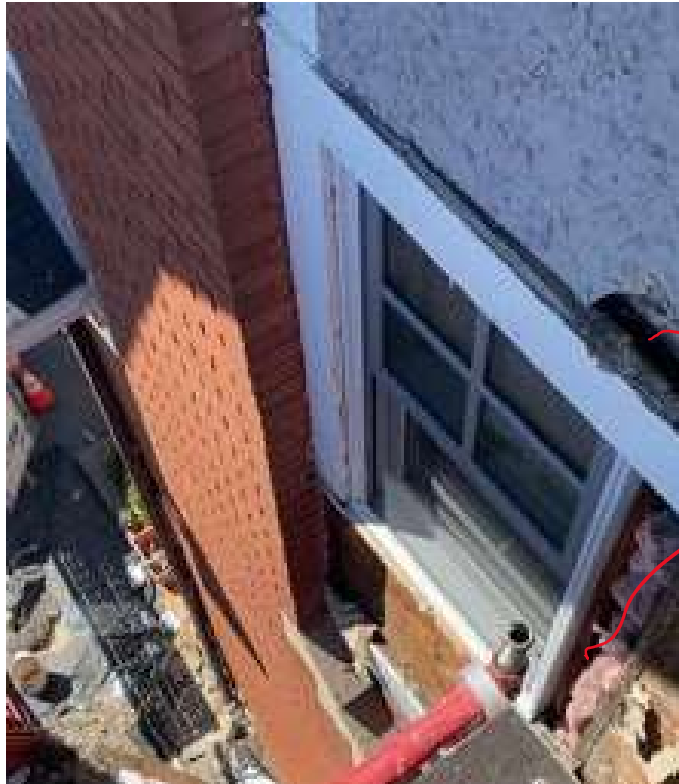
B.7 Insulation

Lack of proper insulation as well as no insulation at all in some areas around the windows of the 3<sup>rd</sup> floor

Fig. 14: Inadequate insulation at all windows

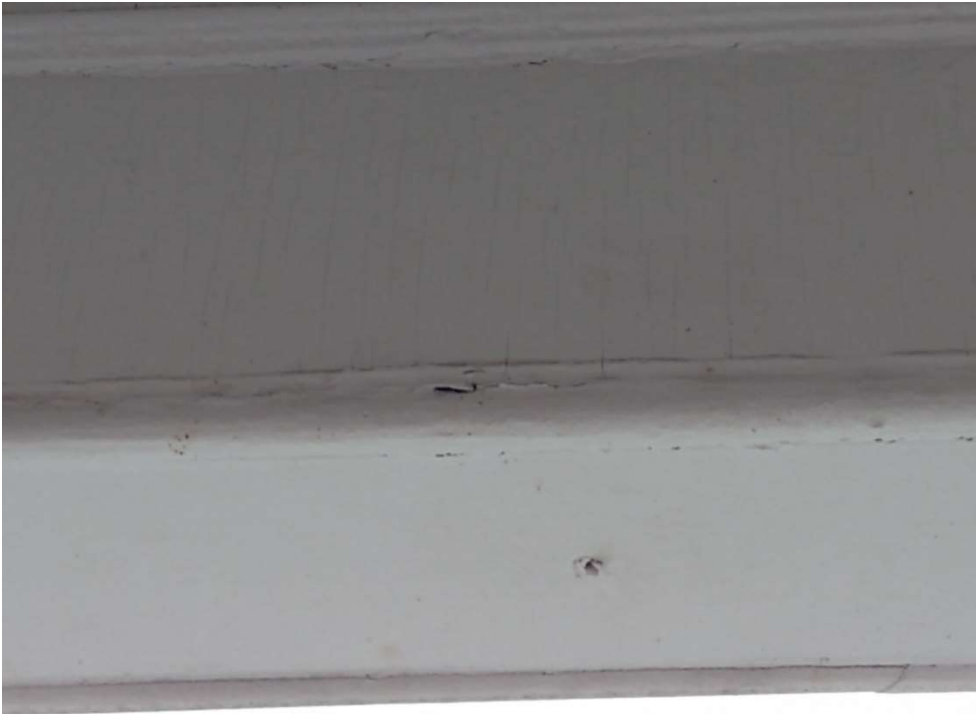
B.8 Water damage in beams below 2<sup>nd</sup> floor balcony

Fig. 15: Underside and inside vertical side of beam under 2<sup>nd</sup> floor balcony looking out away from the house. Paint and caulking are lifting in some areas due to water infiltration from above. Area has not been opened yet for inspection.

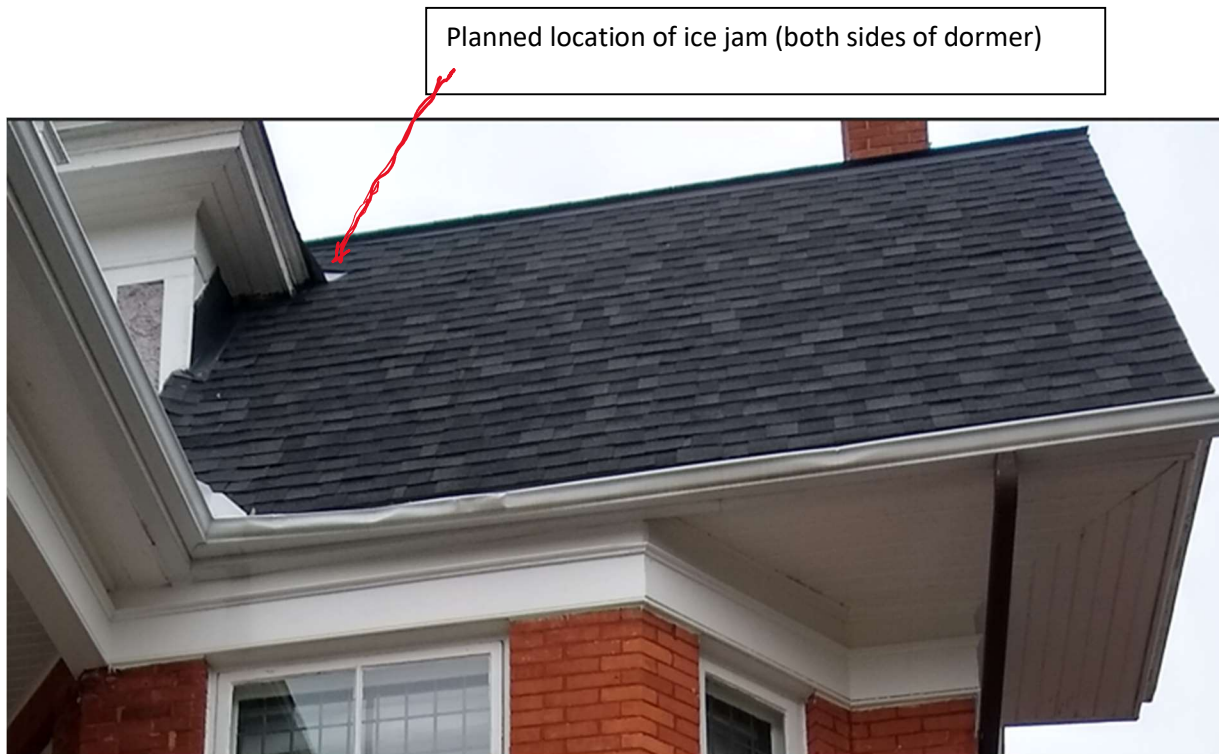
B.9 Ice damage to eavestroughs

Fig. 16: Eavestroughs damaged from ice sliding down from above

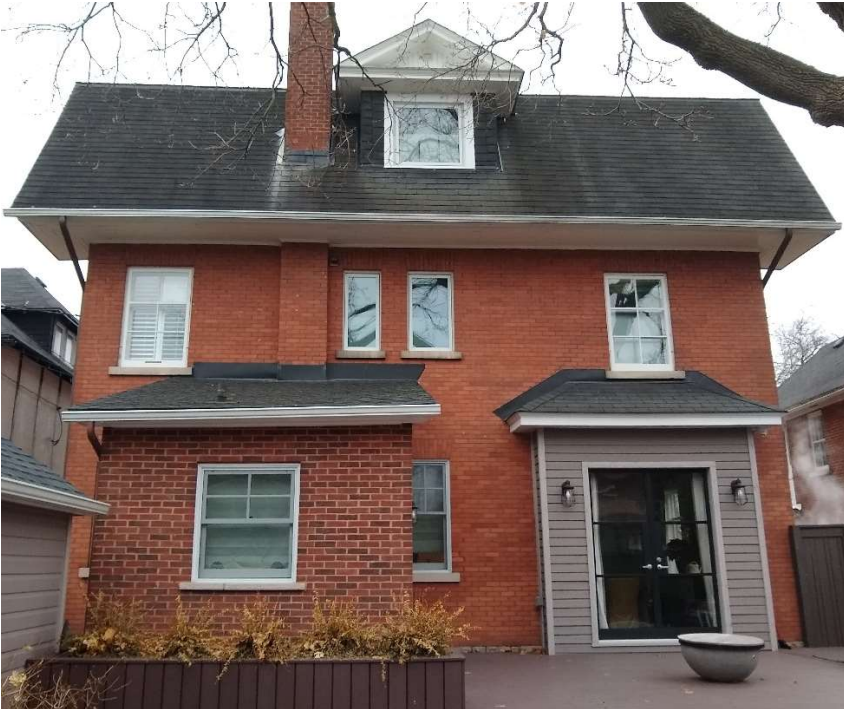
Fig. 17: Before. Asphalt shingles used on dormer

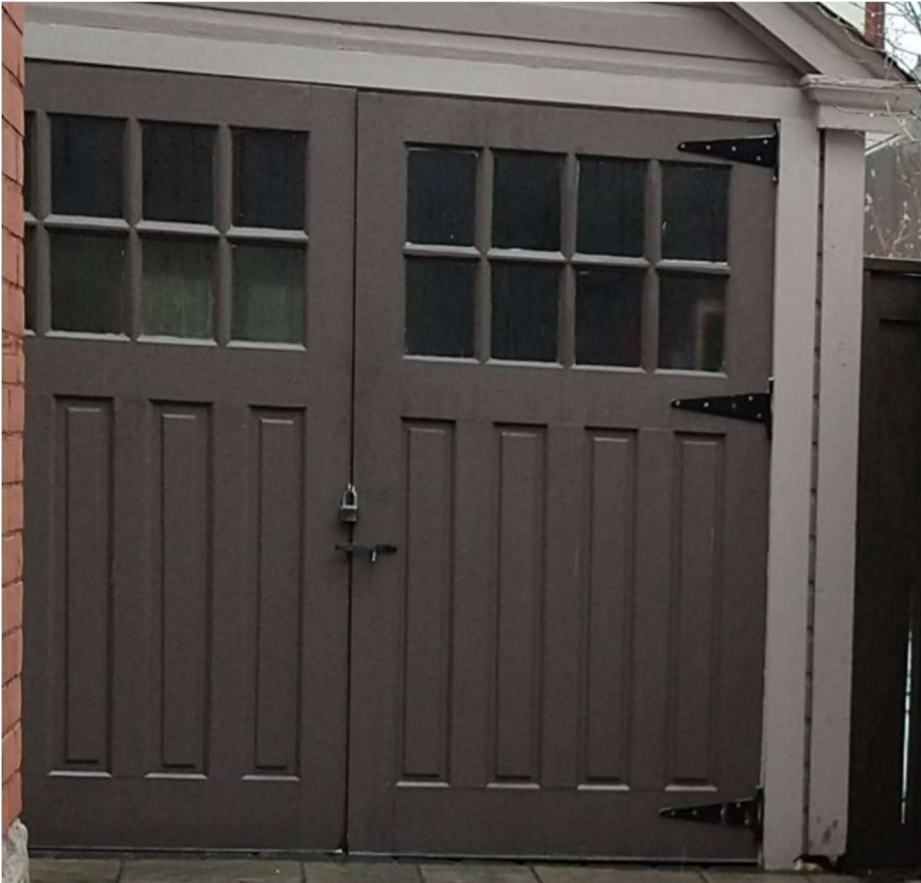
D. Garage door

Fig. 21. Garage doors were replaced by then owner in the 1990's as original doors were finished. Doors swing sideways and cannot be opened during the winter months due to frost heave of the driveway in front of the garage. Doors were cut 2 inches last year to attempt to correct issue, but another 2 inches would need to be cut from the bottom so that they could swing open properly.
