REVISED HERITAGE IMPACT ASSESSMENT & CONSERVATION PLAN FOR 211-231 BANK

Applications D02-02-22-0127 / D07-12-22-0188 and plan number 18910 $\,$

Revision 2: October 2024

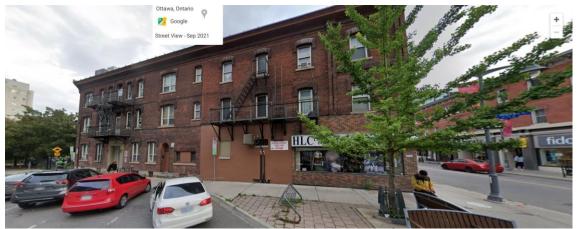
Figure 11: A view of the north elevation of 211 Bank/ 178 Nepean. The slightly different tone of brick delineates the two construction periods.

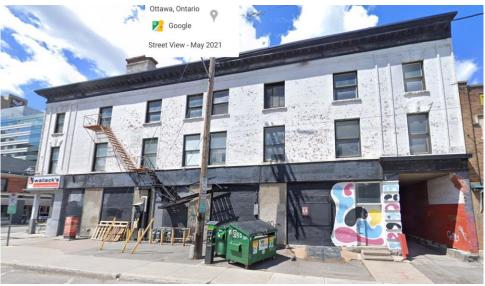
Figure 15: The south elevation of the 231 Bank Street. The ground floor windows have been removed and panels added. Source: Commonwealth.

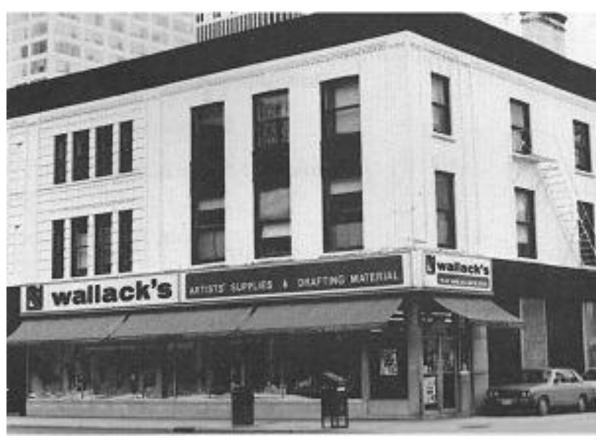
Figure 19: A view of 231 with the retail entrance shifted from its original central location to the corner and the upper façade painted white. A black band can be seen between the ground floor retail and the upper floors.

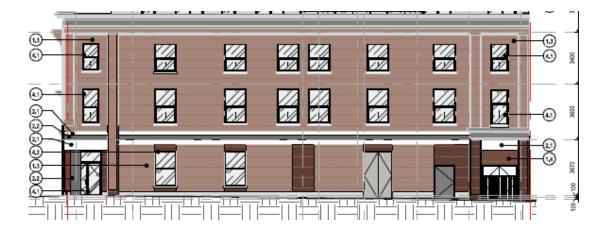
• Is the blue highlighted area on the images below a sign band? If so, consider reducing the height. The Lisgar façade has what appears to be plywood in the location. Please remove and repair any damaged brick below. Additional drawings/updates:

Response: The horizontal panel along Lisgar façade has been part of the building since it operated as a grocery store (Dominion). The plan is to carry out some removals and determine if it can be removed without extensive brick repairs. It appears to be plywood panels fastened directly onto the brick. If it can be removed and the brick repaired, that is our 1st choice. If there is too much damage, we will consider replacing the panel with a narrower horizontal fascia-board, as shown on the revised drawing.

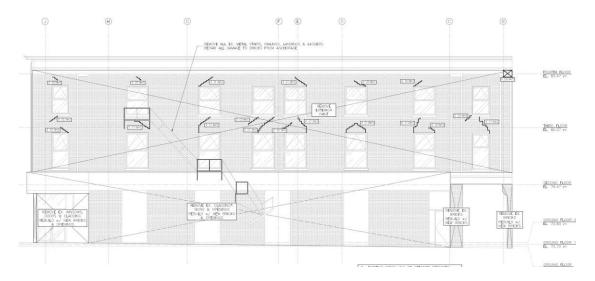
The façade of the Wallack's Building has been painted. In the detailed view, the spalling of the paint is extensive, suggesting that the removal of paint will not be too difficult.

The pilasters at either end of the facade will have to be replaced at the street level. The large black panels at grade were originally windows that have been boarded over.
