## SOMERSET HOUSE REHABILITATION

352 Somerset Street West, Ottawa, Ontario, K2P 0J9

### 2023 DESIGN INTENT REPORT

Project No. 0653  
Revision No. 00  
June 23, 2023

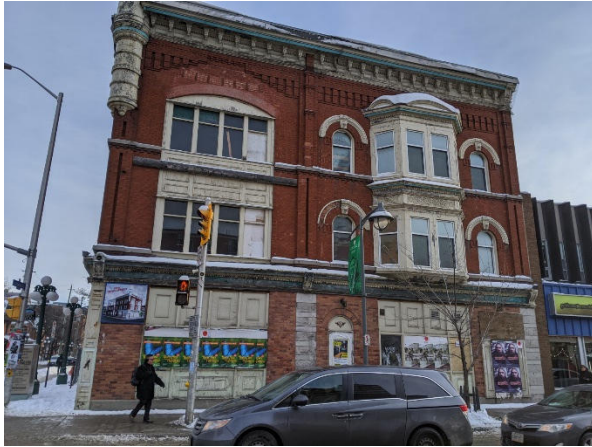
**Figure A1 – West Exterior Wall**

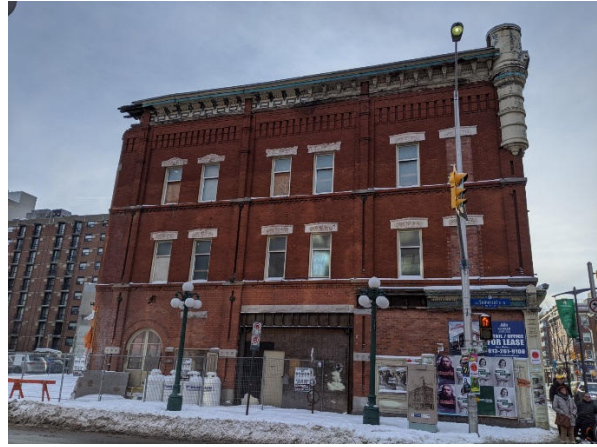
**Figure A2 – North Exterior Wall**

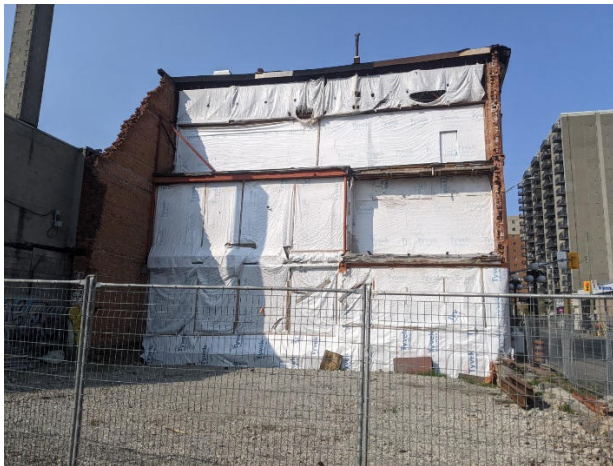
**Figure A3 – East Side of the Building**

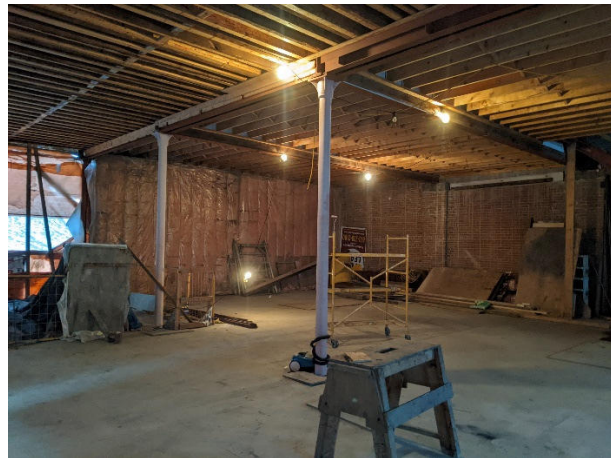
**Figure A4 – Ground Floor Facing East**

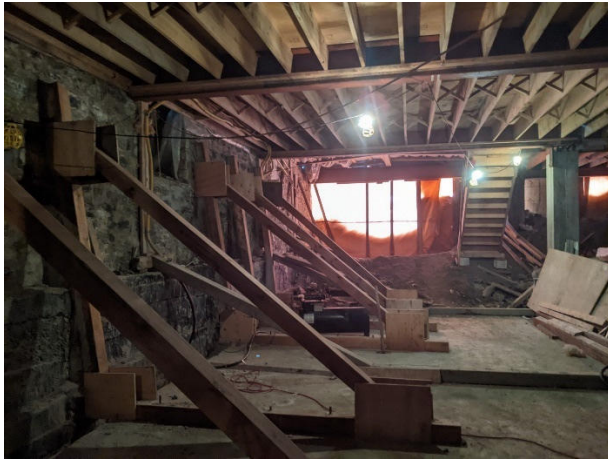
**Figure A5 – Basement North Foundation**

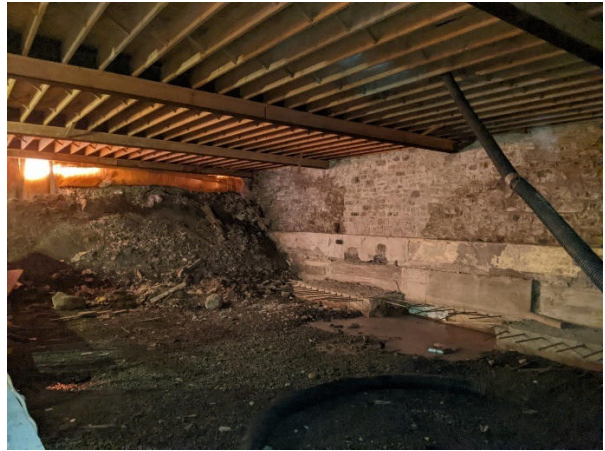
**Figure A6 – Basement South Foundation**

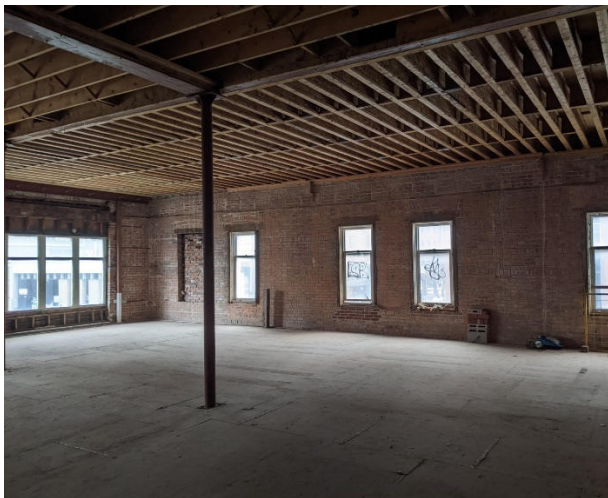
**Figure A7 – Second Floor Facing North**

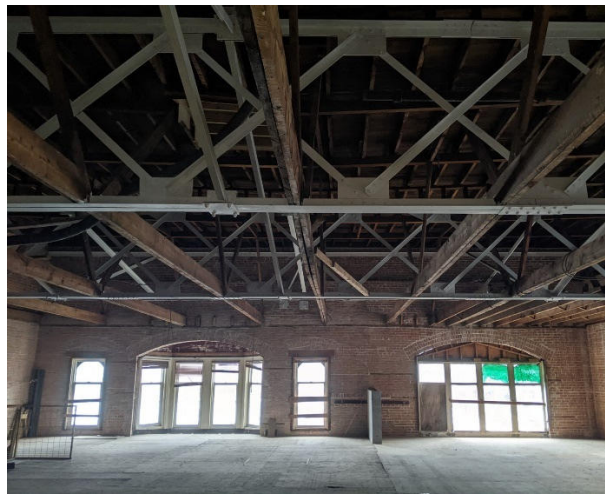
**Figure A8 – Third Floor Facing West**

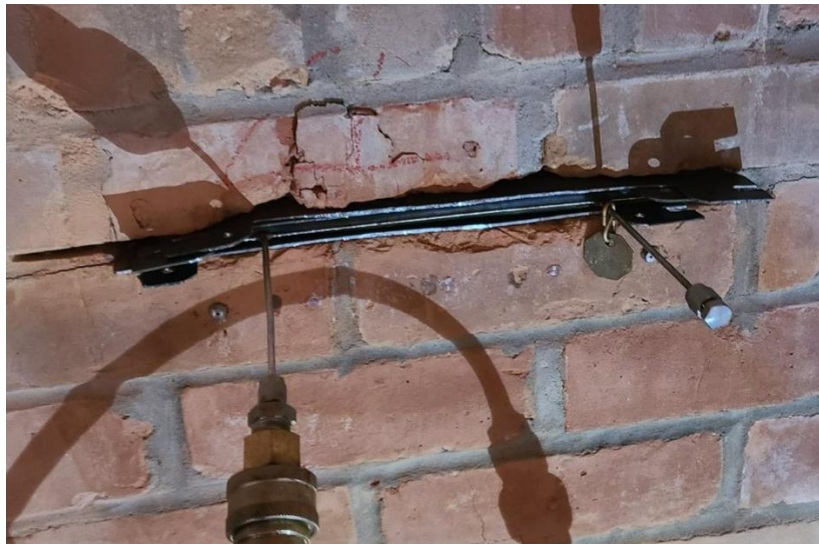
Deformations of the masonry behaved as expected for the initial loading conditions. Brick units however began falling under load at low values, early into the tests. On release of the load, most joints within the test area cracked.

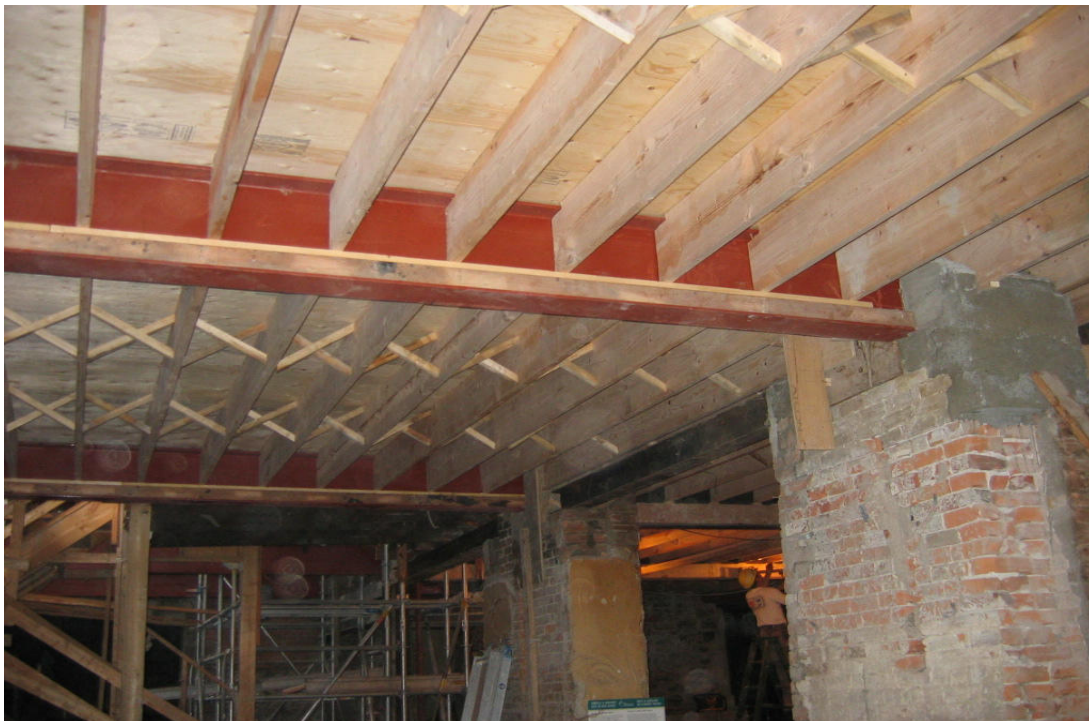
**Figure 7: Previously Existing Condition Outlining Brick Piers in Basement**
