SOMERSET HOUSE  
HERITAGE IMPACT ASSESSMENT  
352 SOMERSET STREET WEST, OTTAWA

COMMONWEALTH HISTORIC RESOURCE MANAGEMENT  
Version 4. JULY 2023

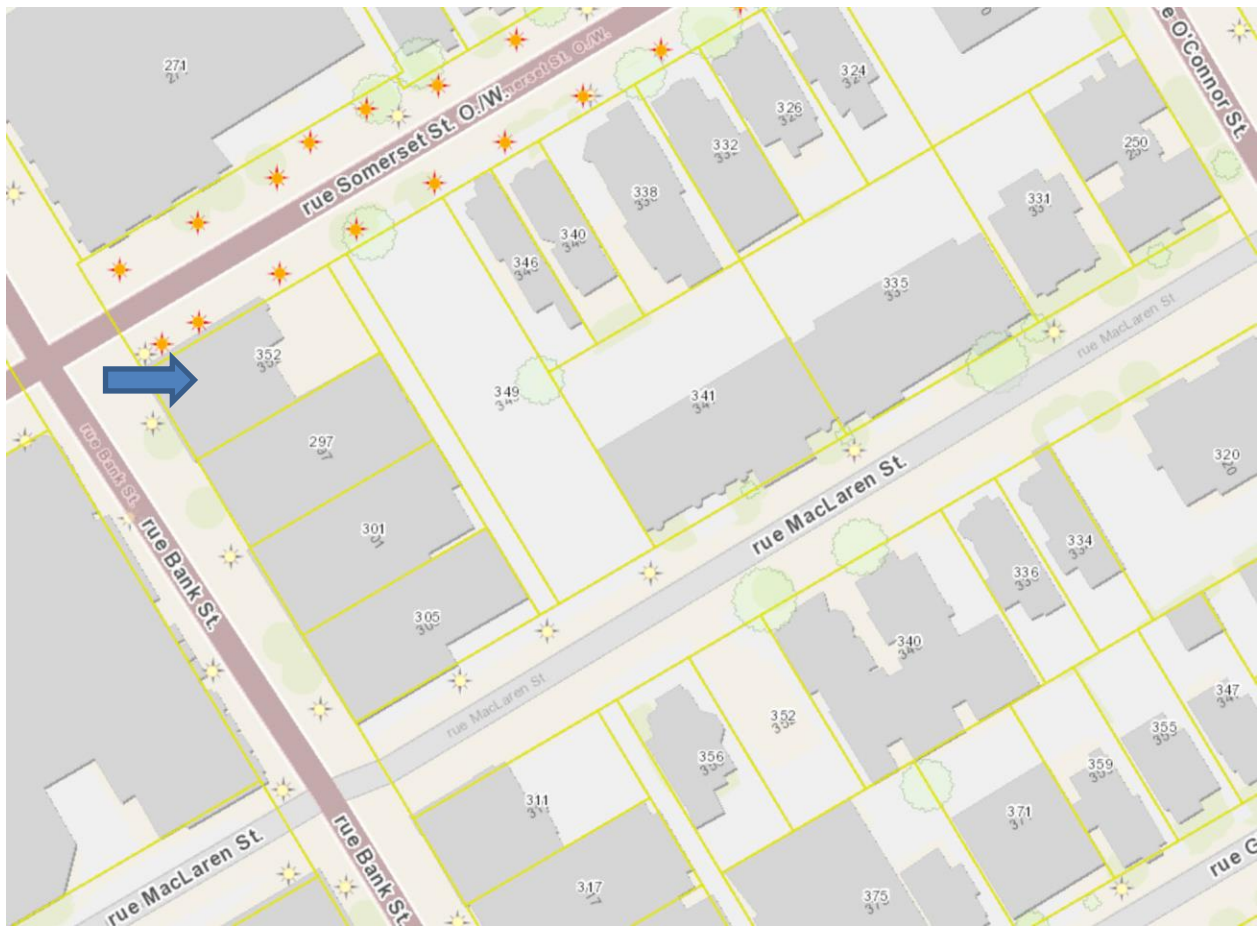
Figure 1: Block plan illustrating the built context surrounding the development site (Arrowed). Source: Geottawa

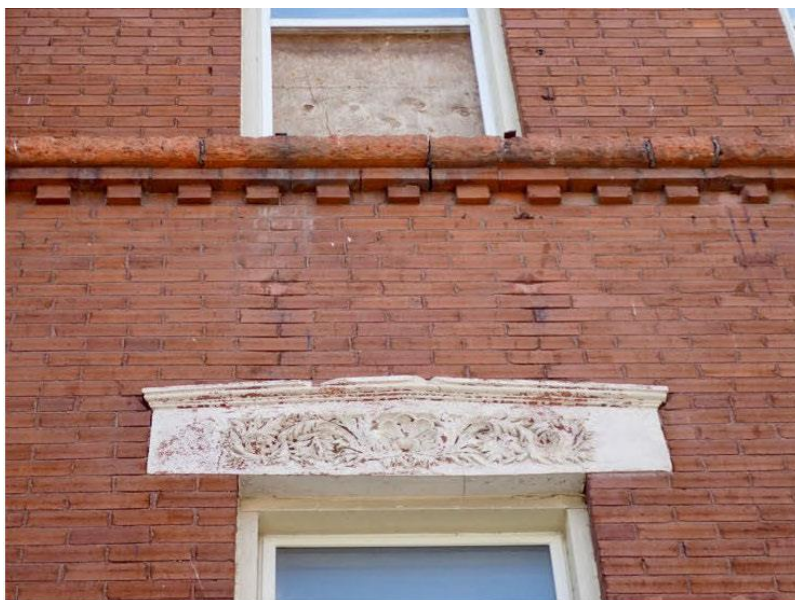
Figure 10: Detail view of the second-floor sill course on the Somerset Street elevation. Note the rusticated terracotta sill (belt) course above the brick dentil band and the painted terracotta window lintels. Source: Heritage Ottawa / Archives Ottawa.

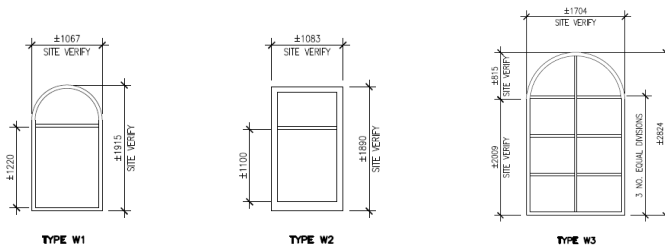
#### 4.8.2 Large Bay Windows on the Bank St. Façade.

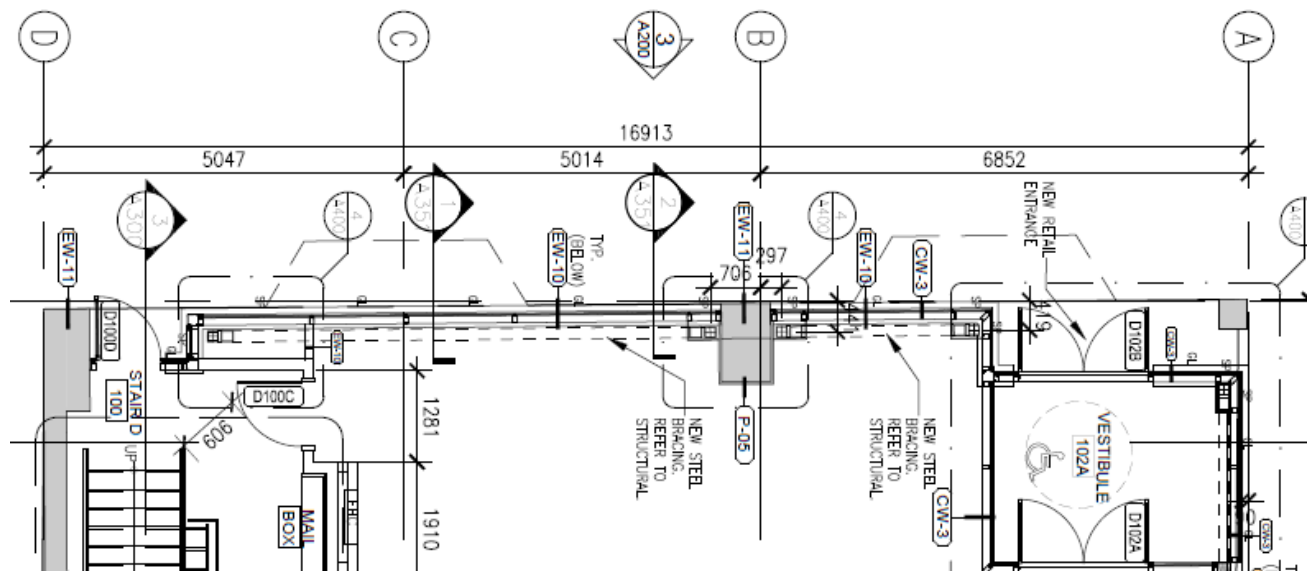
PLAN OF BANK STREET STOREFRONT

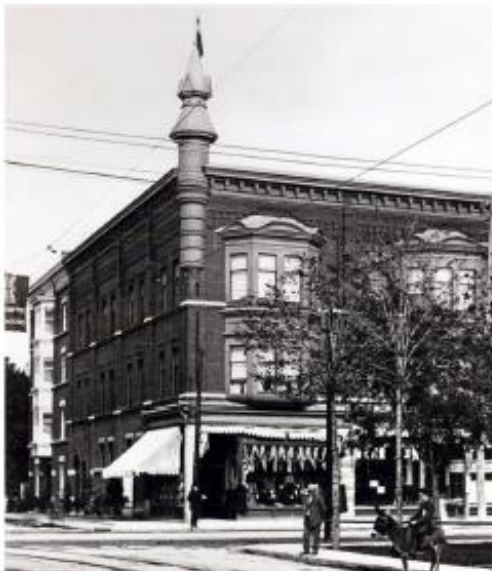
Figure 1: Department Store

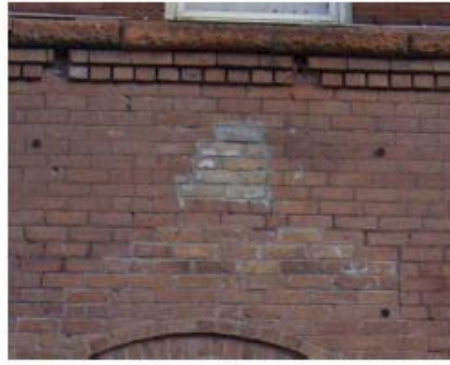
Figure 7: Incompatible previous repair above north façade door and deteriorated brick corbelling above.

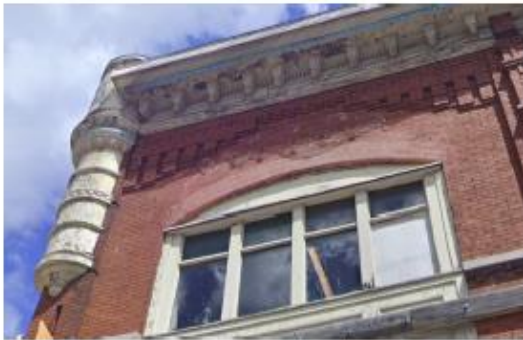
Figure 14: Deteriorated brick above previous location of bay windows on the west façade.

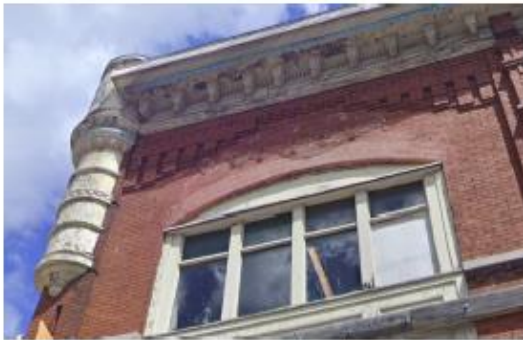
Figure 11: Brick erosion on the west façade.

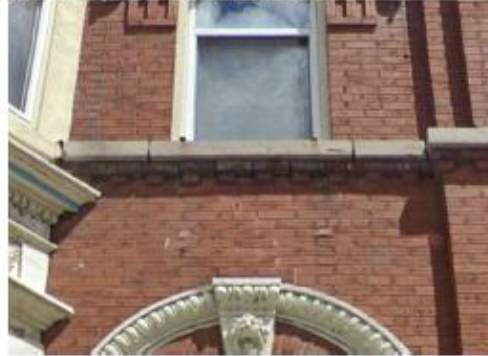
Figure 13: Open skyward facing joints on the stone stringcourse with stained and eroded brick dentils below.

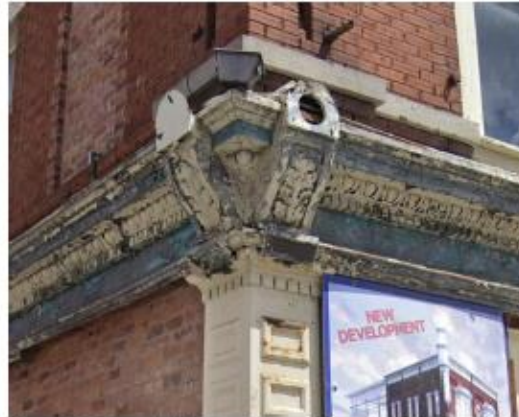
Figure 16: General deteriorated condition of first floor cornice.

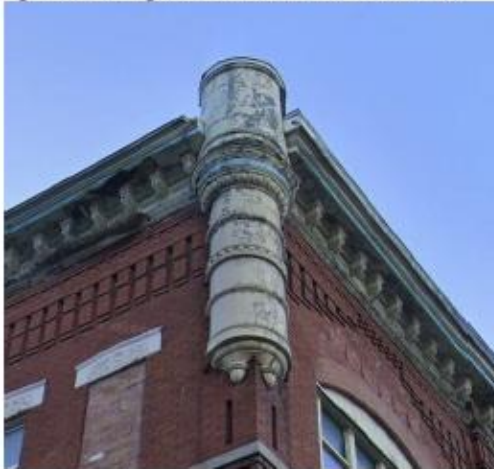
Figure 17: Peeling paint, open soffit, and general deteriorated condition of corner turret.

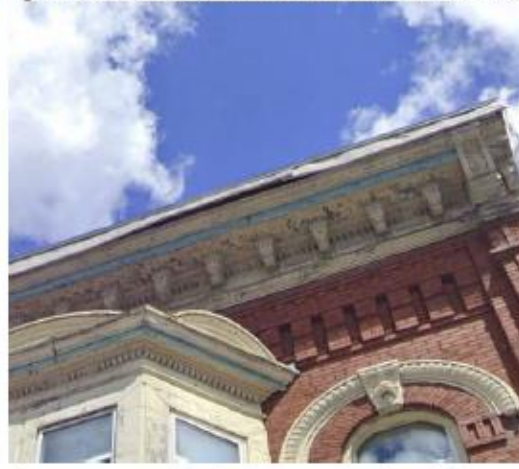
Figure 18: Separated fascia, deteriorated cornice and frieze.

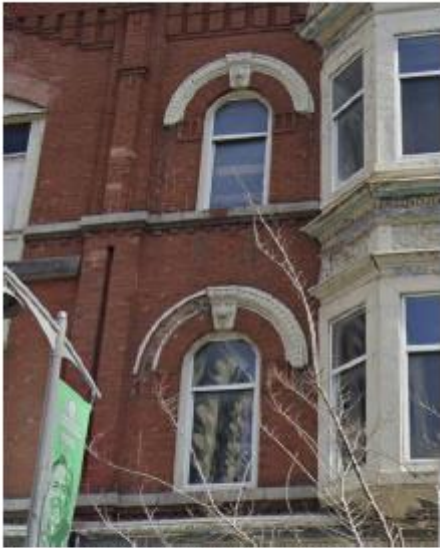
Figure 20: Missing arched metal lintel on west façade.

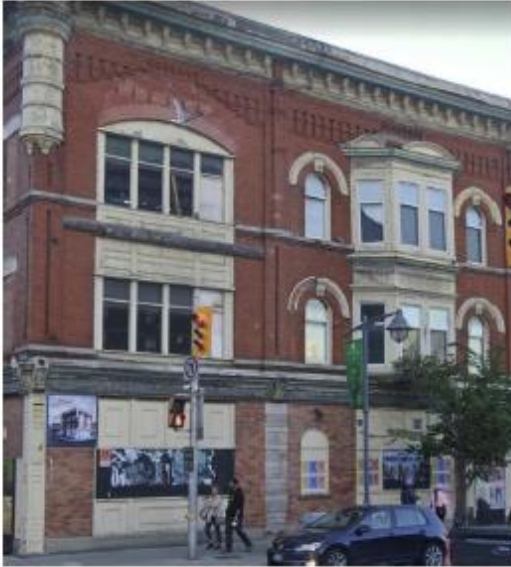
Figure 21: Openings on the west façade.

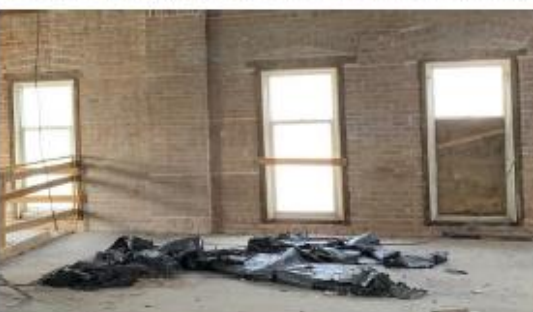
Figure 34: Interior of third floor windows on the north façade.

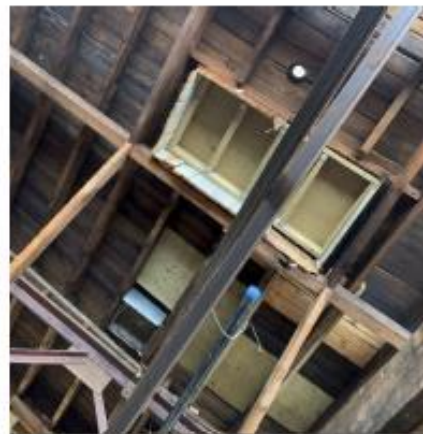
Figure 36: Roof drains

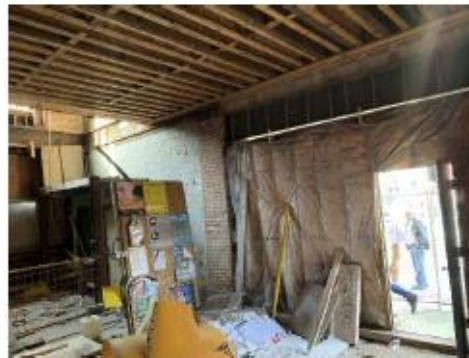
Figure 38: Openings on the ground level.

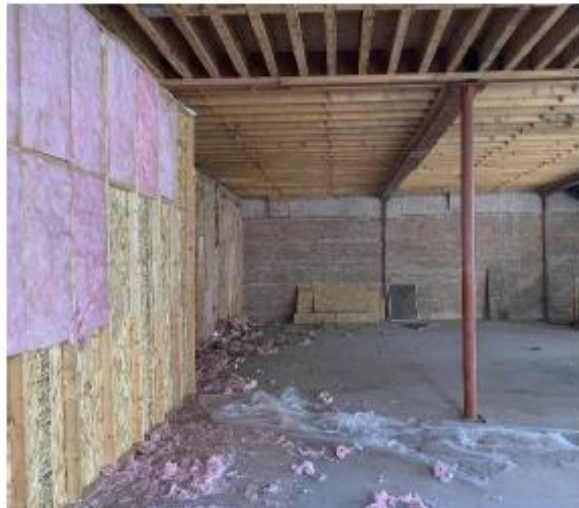
Figure 44: Interior condition of second floor walls.

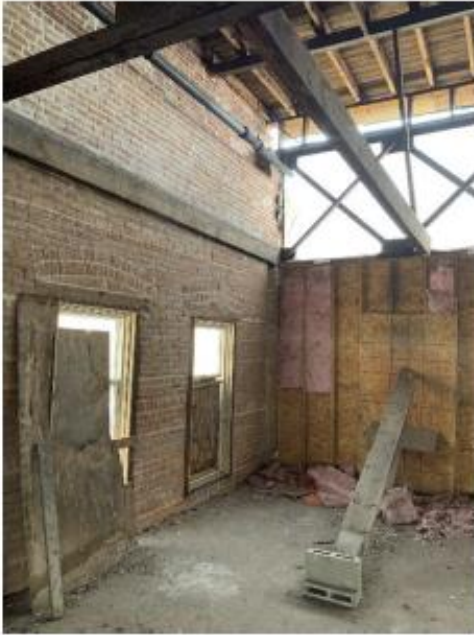
Figure 45: east wall supports on the third floor.

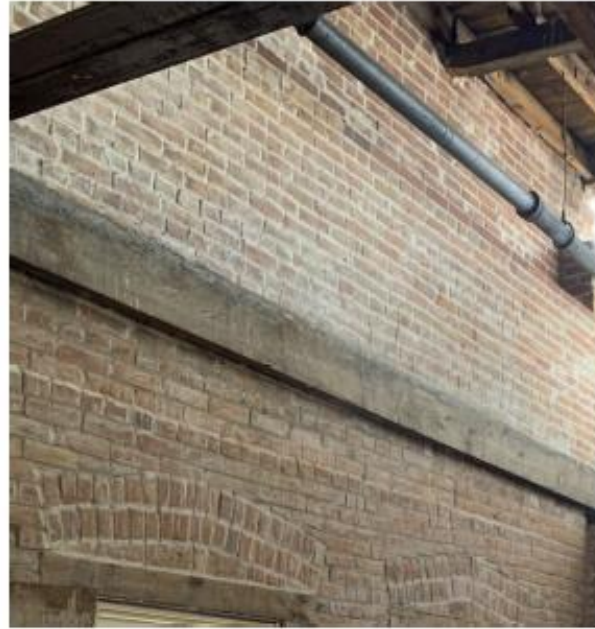
Figure 46: Deteriorated brick on interior of third floor with debonded wythes, frost damage, and surface damage.

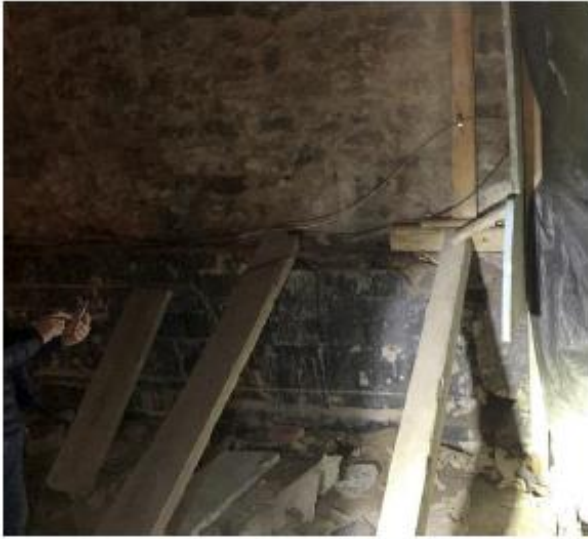
Figure 49: Deteriorated condition of the north foundation wall.

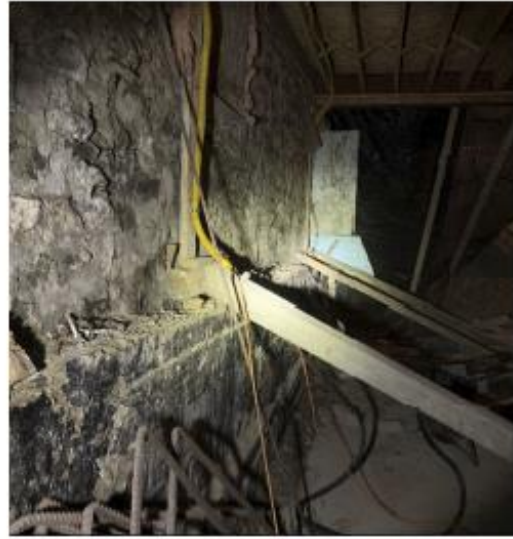
Figure 50: Cracks in the concrete foundation wall.

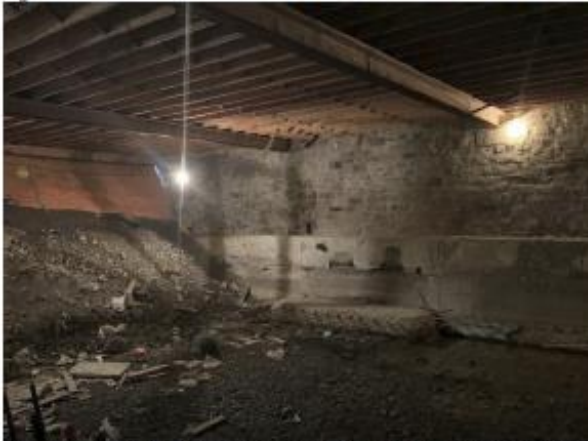
Figure 51: Backfilling at the previous east wall and voids in the south foundation wall.

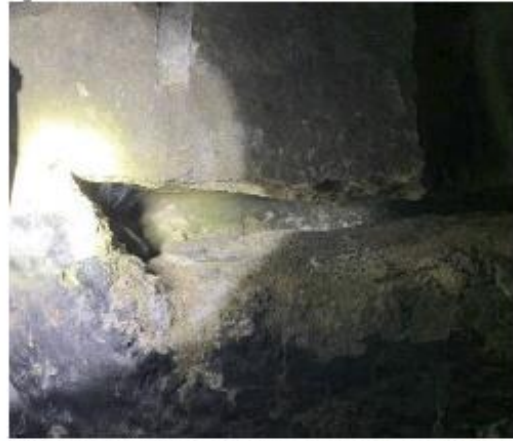
Figure 52: Deteriorated condition of mortar and voids in the stone foundation.

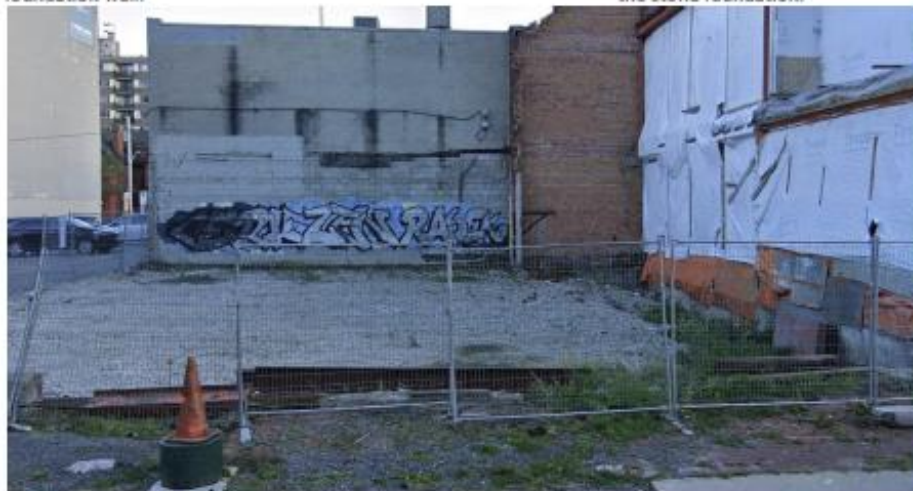
Figure 53: Backfilled location of previous addition, sloping towards the remainder of Somerset House.
