October 11, 2022

**Re: 359 Kent Street Façade Conservation
Structural Engineering Feasibility Review**

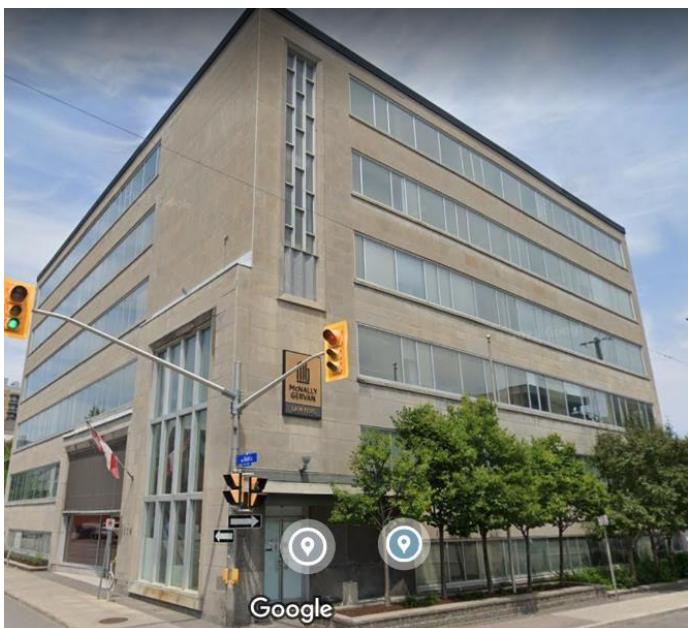
Figure 1. South and West Facades of the Legion House (2022).

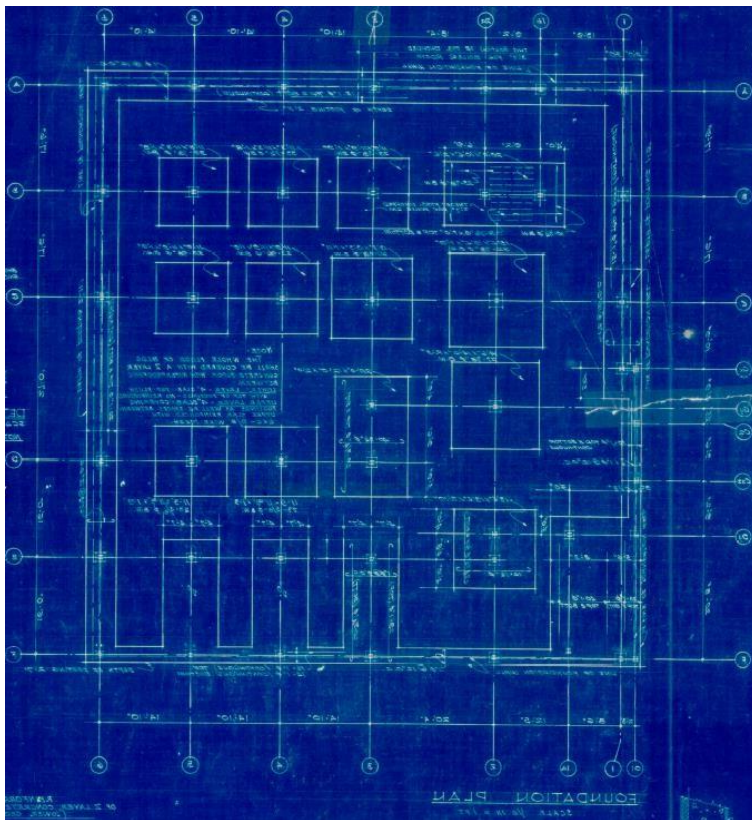
The structure is supported on relatively large, spread footings. The underside of the footings is below frost level, constructed approximately 5 feet below exterior grade. A 4” thick concrete slab on grade is located immediately above the spread footings and is approximately 3 feet below grade. There is no dedicated lateral load resisting system but resistance to earthquake loading is aided by the infill masonry walls.

Drawings for the three-storey vertical addition, constructed some 3 years after the original, were not available. We carried out a load review for a typical column footing and found that it is likely that the original footings were sized for the vertical addition and that SLS pressures are in the order of 2000 psf. There is no geotechnical report available but required soil pressures seems to be modest and reasonable.

Figure 2. The Legion House Foundation Plan (1955).

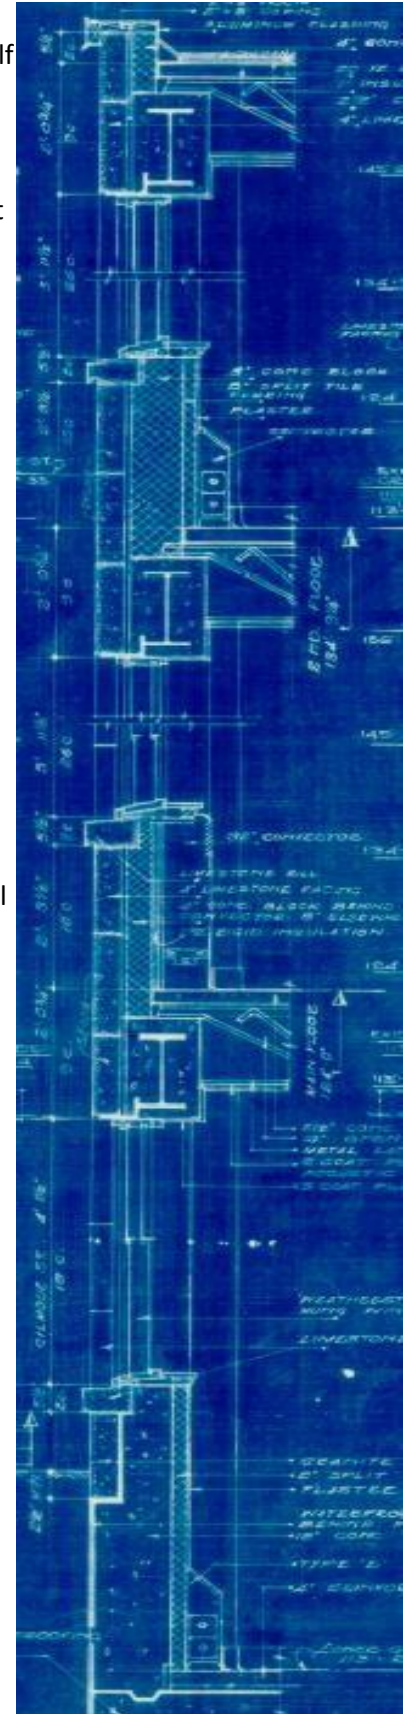
Figure 3. Wall Section

As shown, at right, in Figure 3, the 4" limestone veneer is supported by steel shelf angles at the suspended floor levels and on the concrete foundation wall, at the base. A concrete block wall is identified as the back-up to the stone veneer and would be relied upon to provide the lateral support to the limestone veneer. There is no indication of insulation or a significant air space, which are important features of cavity wall design.

The concrete masonry wall is only 4" thick at the ventilators but 8" thick, otherwise. The veneer and back-up walls are not bonded to act as one. The ties connecting the stone veneer to the concrete block back-up and the shelf angles are likely to be corroded after 66 years of service life. The condition of these important elements would need to be verified. There is no insulation in the wall and energy efficiency of the perimeter wall system would be very poor.

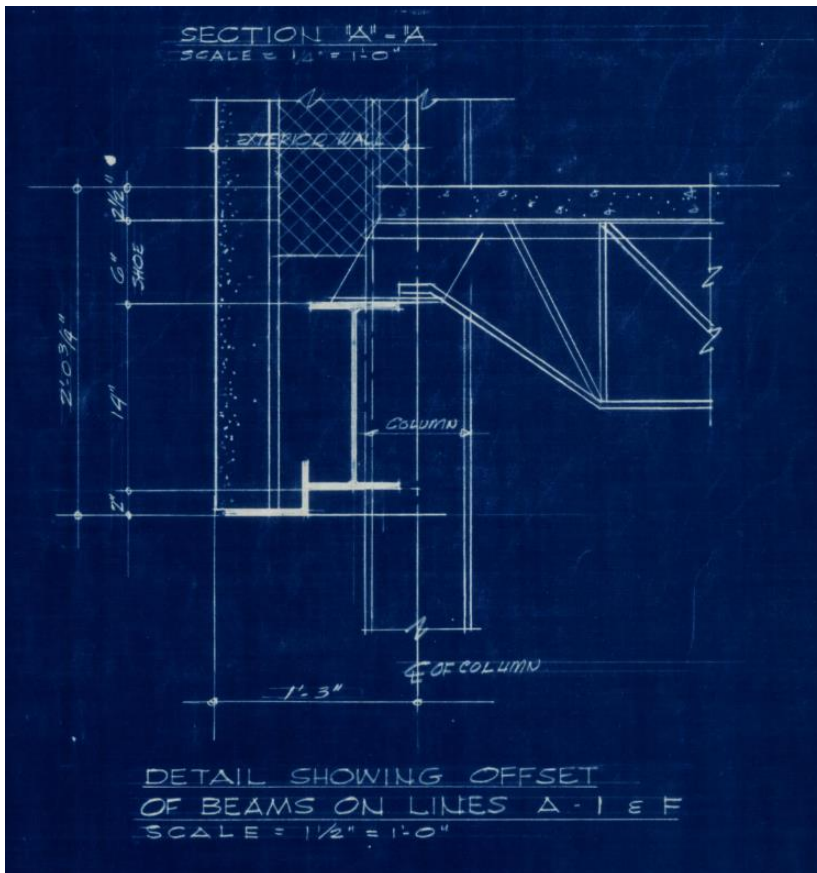
The existing floor joists bear on an offset beam on the gridlines considered for retention. The joist shoe is connected to an offset beam and the beam is cast in concrete for fire proofing purposes. The veneer and back-up masonry block wall bear on this concrete-encased at each floor and induce torsion on the beam (see Figure 4 for the typical detail). The joists brace the beam and provide resistance to the torsion created by the eccentric masonry loads. Removal of the interior joists will require compensating construction to deal with the eccentric loads and this complicates in situ retention of the facade.

Figure 4. Typical Off-Set Beam Detail at GL 1 and F.

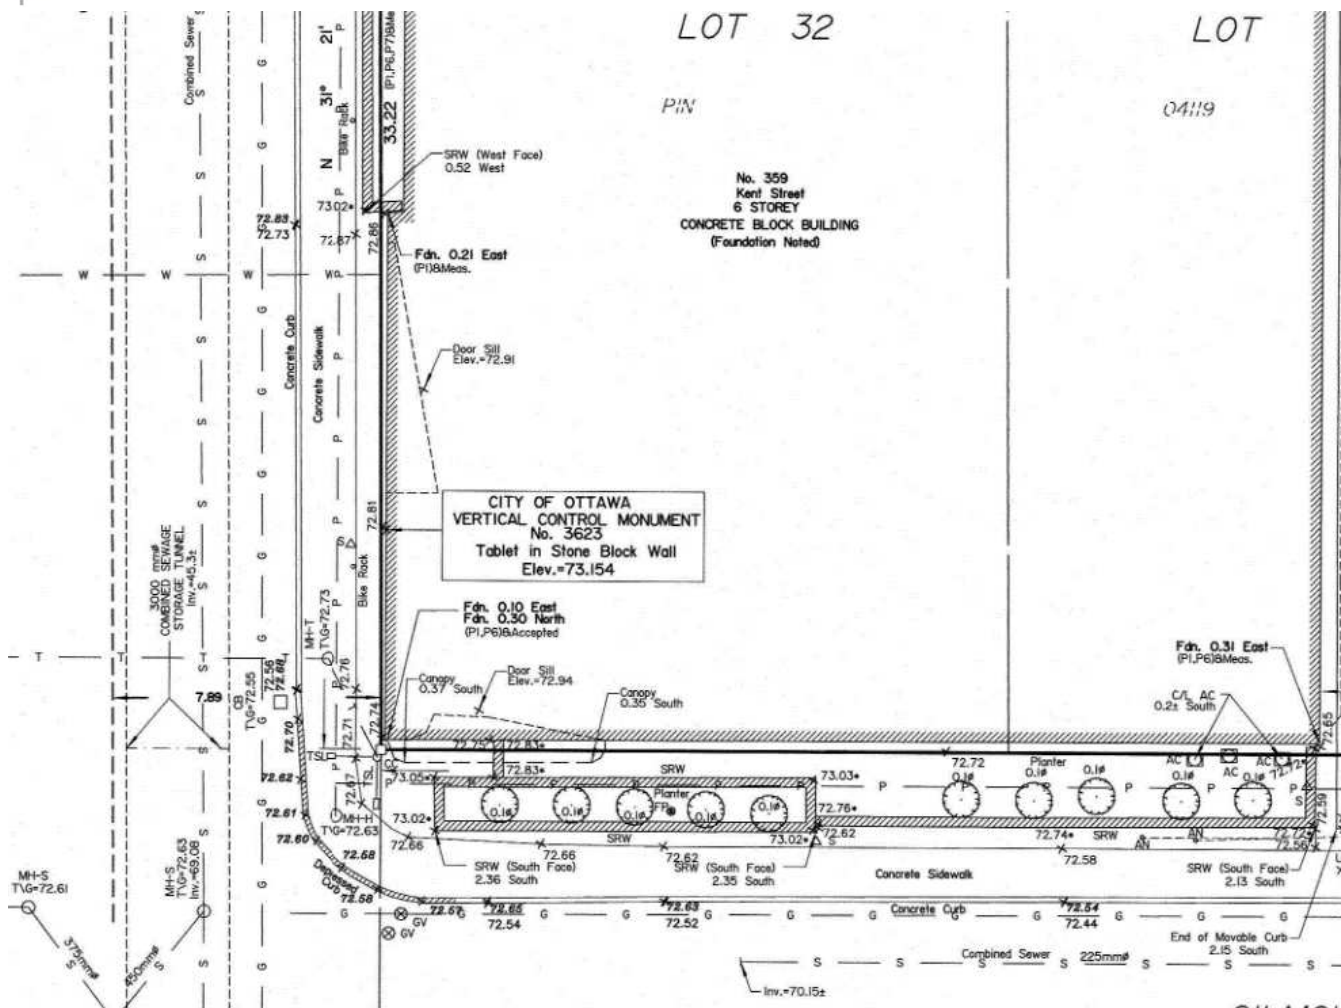
We understand that there is significant infrastructure within the footprint of the bracing system which would greatly complicate piling and lengthy sidewalk and lane closures could be expected. We leave it to the Civil Engineers to further evaluate the interference with respect to the underground services.

Figure 5. Survey of 359 Kent Showing Underground Services (2021).
