Planning, Infrastructure and Economic Development Dept.
City of Ottawa
110 Laurier Ave.
Ottawa, ON

March 4, 2021
Revised: August 13, 2021
Project No. 21113

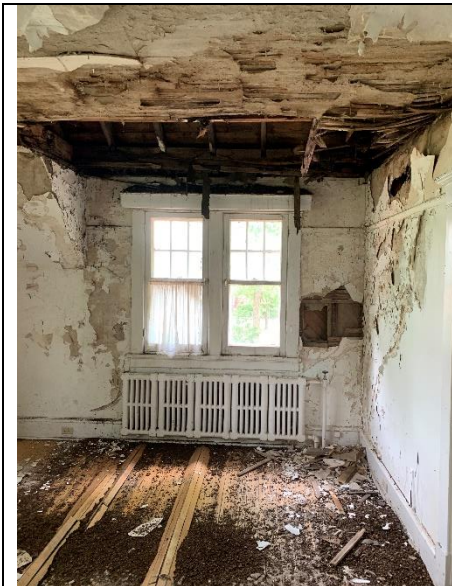
Photo 1: South second story wall overview, damages noted to floor, wall and ceiling finishes surrounding the area of significant water damage [JCAL 2021]

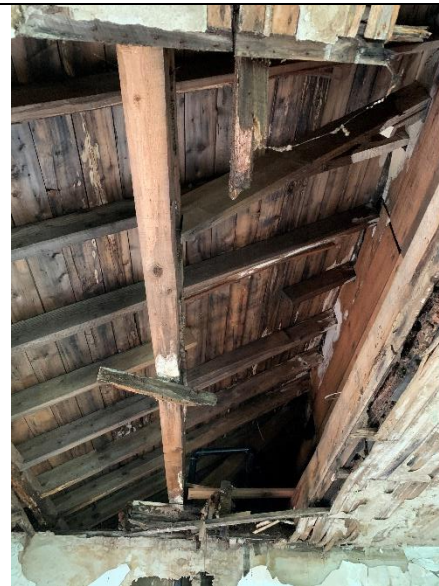
Photo 2: View into ceiling damage shown in photo 1- roof rafters decaying [JCAL 2021]

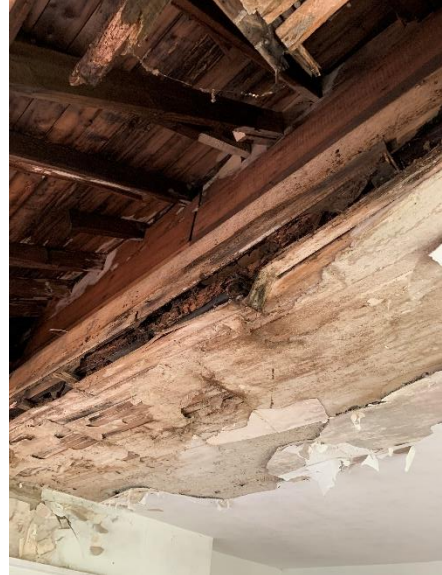
Photo 3: Closer view of damage and decay to edge of third floor framing [JCAL 2021]

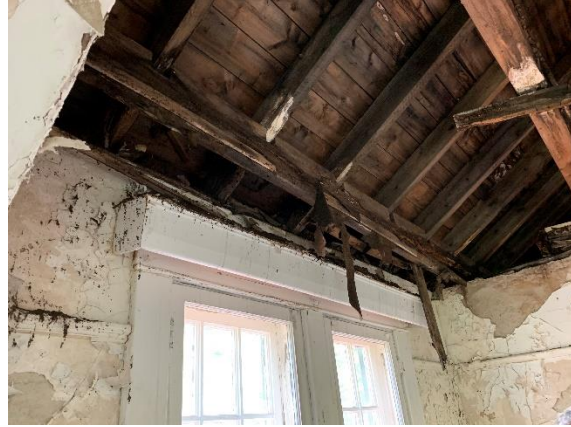
Photo 4: Closer view of damage and decay to top of exterior wall [JCAL 2021]

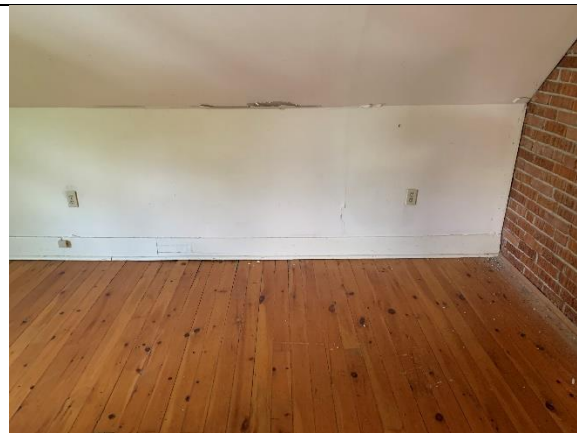
Photo 5: Third story SE corner water damage to finishes [JCAL 2021]

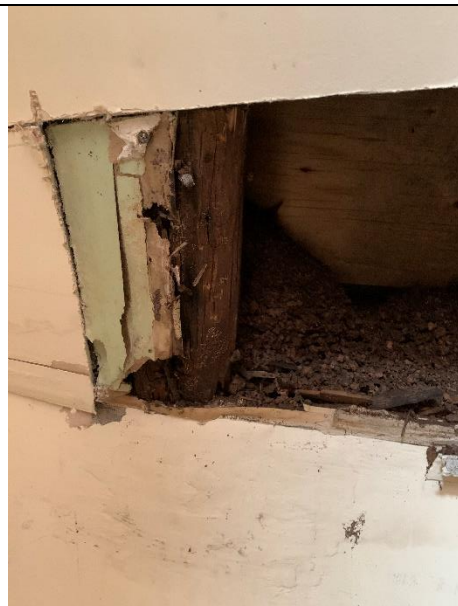
Photo 6: Third story north sloped roof; damage noted within roof and on roof joists [JCAL 2021]
