SCOPED HERITAGE IMPACT ASSESSMENT

1 MAPLE LANE & 1112 LISGAR ROAD

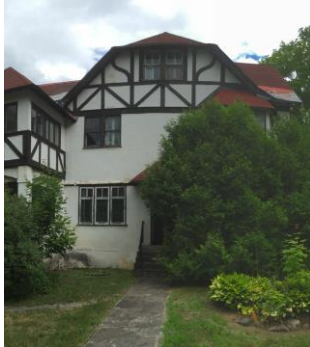
Views of the existing and proposed house illustrating the preserved Lisgar and Maple Lane entrance walk.

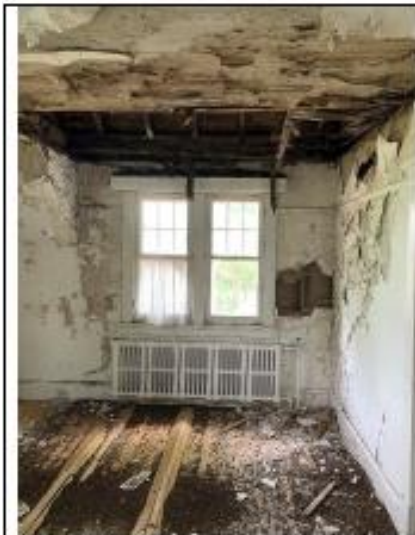
Photo 1: South second story wall overview, damages noted to floor, wall and ceiling finishes surrounding the area of significant water damage [JCAL 2021]

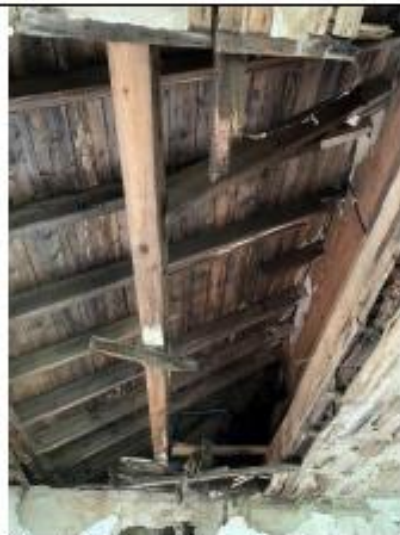
Photo 2: View into ceiling damage shown in photo 1- roof rafters decaying [JCAL 2021]

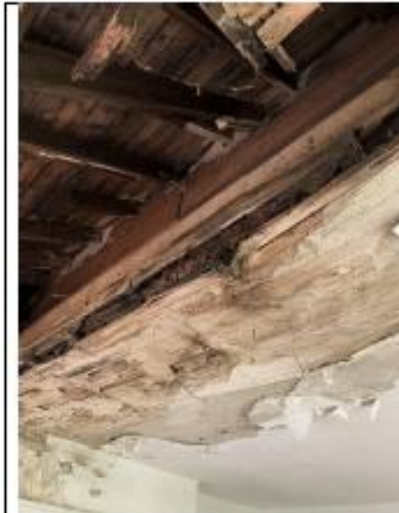
Photo 3: Closer view of damage and decay to edge of third floor framing [JCAL 2021]

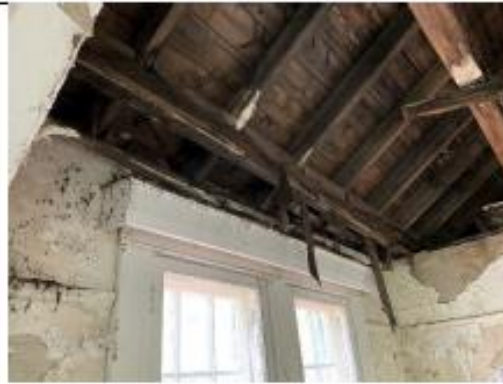
Photo 4: Closer view of damage and decay to top of exterior wall [JCAL 2021]

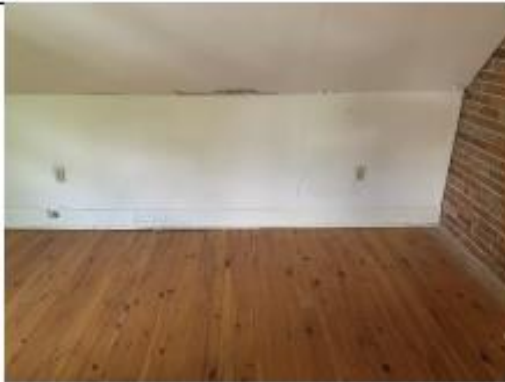
Photo 5: Third story SE corner water damage to finishes [JCAL 2021]

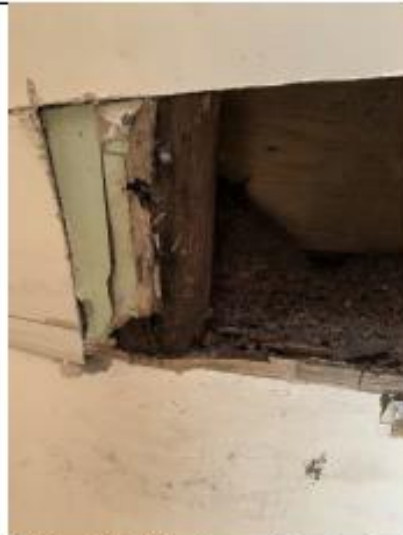
Photo 6: Third story north sloped roof; damage noted within roof and on roof joists [JCAL 2021]

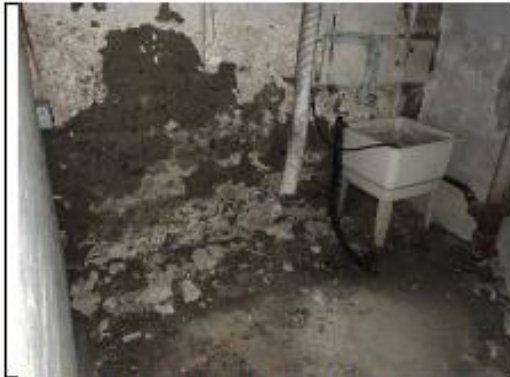
Photo 7: Concrete foundation damage and salt deposits [JCAL 2021]

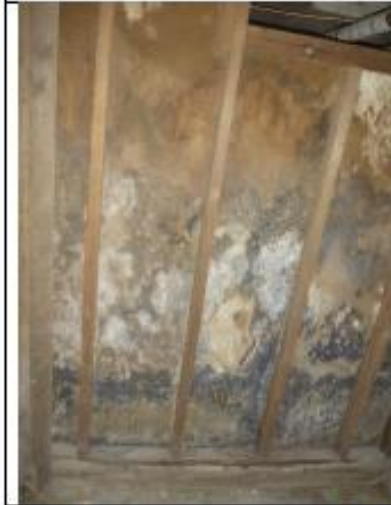
Photo 9: Interior basement wall typical condition with extensive mold. [JCAL 2021]

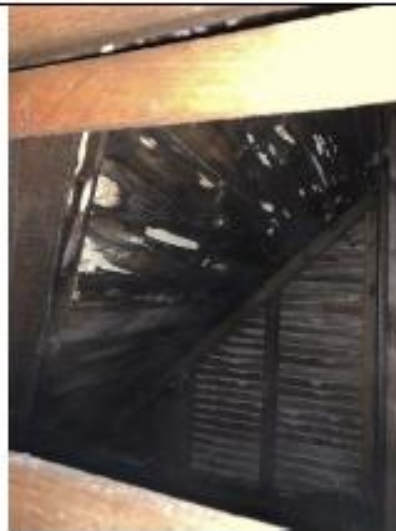
Photo 12: Roof water damage and mold within valley [JCAL 2021]

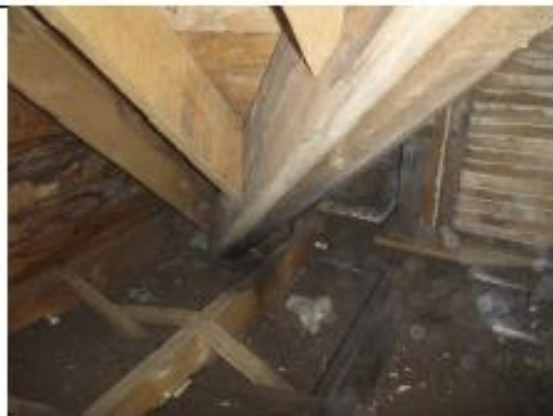
Photo 13: Water damage at base of valley [JCAL 2021]

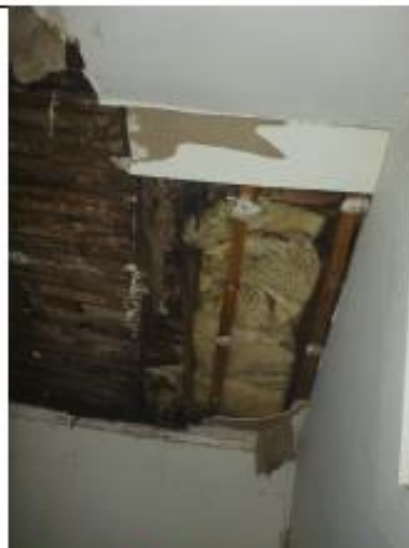
Photo 14: West room closet water damage and mold [JCAL 2021]

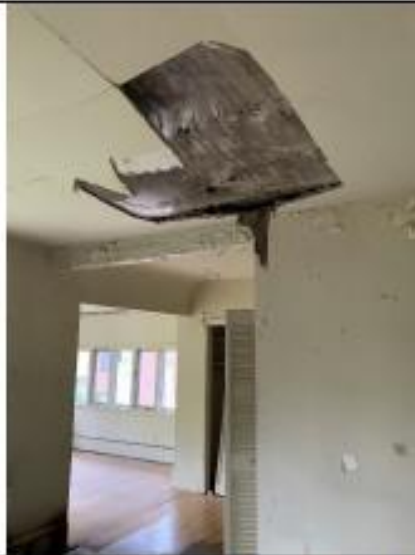
Photo 16: Second floor damage to ceiling finishes [JCAL 2021]

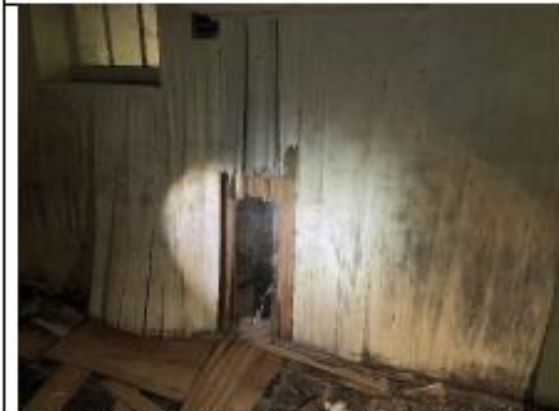
Photo 21: Typical extent of mold throughout basement [JCAL 2021]

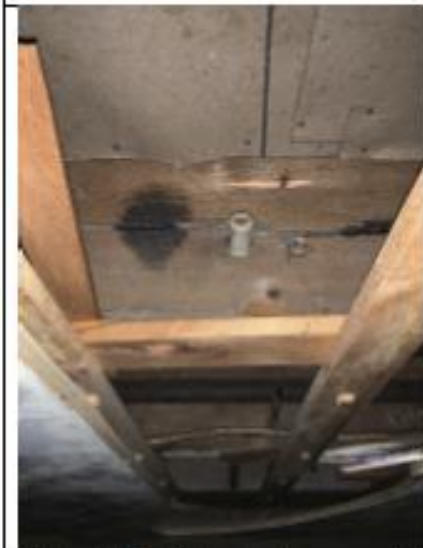
Photo 23: Mold noted on ground floor structure [JCAL 2021]
