Project No. 2020-134

November 17, 2020

**Re: 1 Maple Lane and 1112 Lisgar Road – Ottawa, ON
Field Inspection Report**

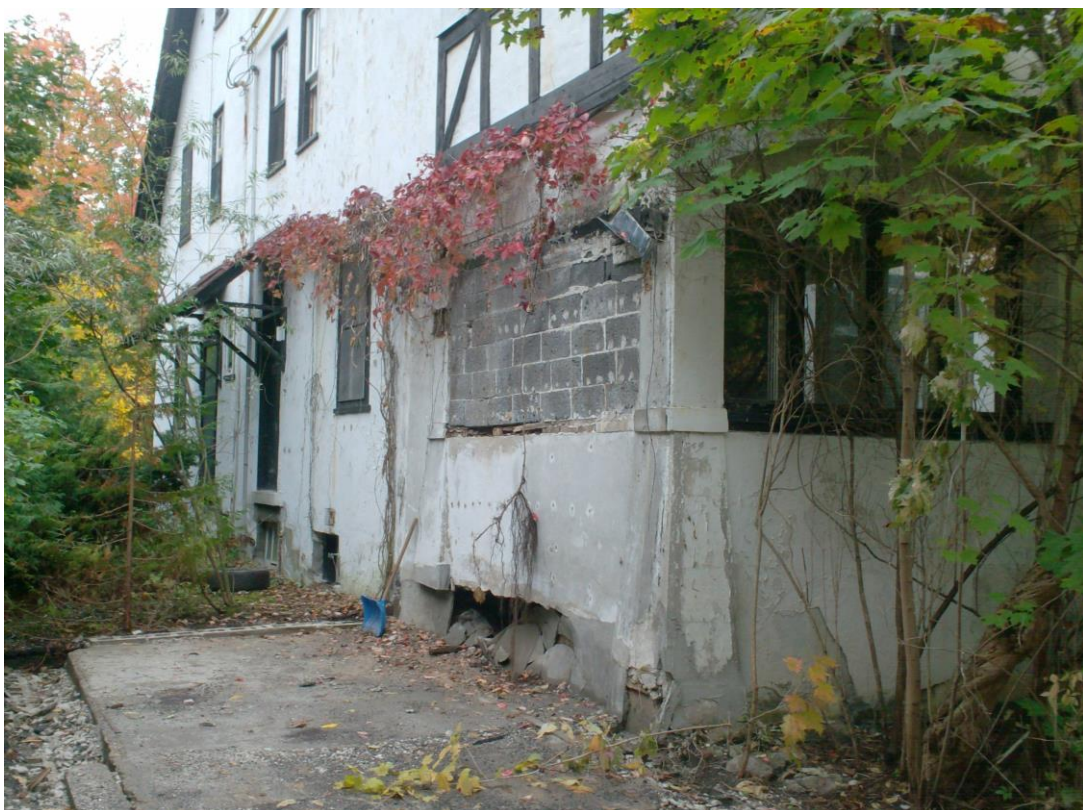
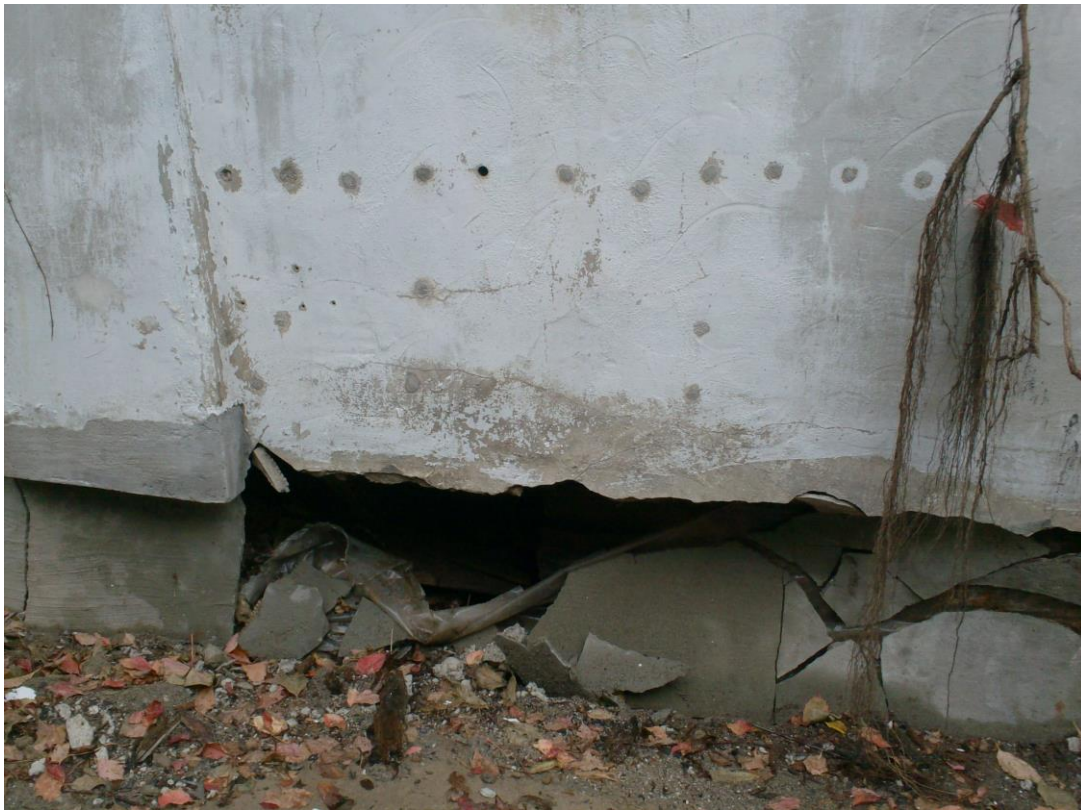
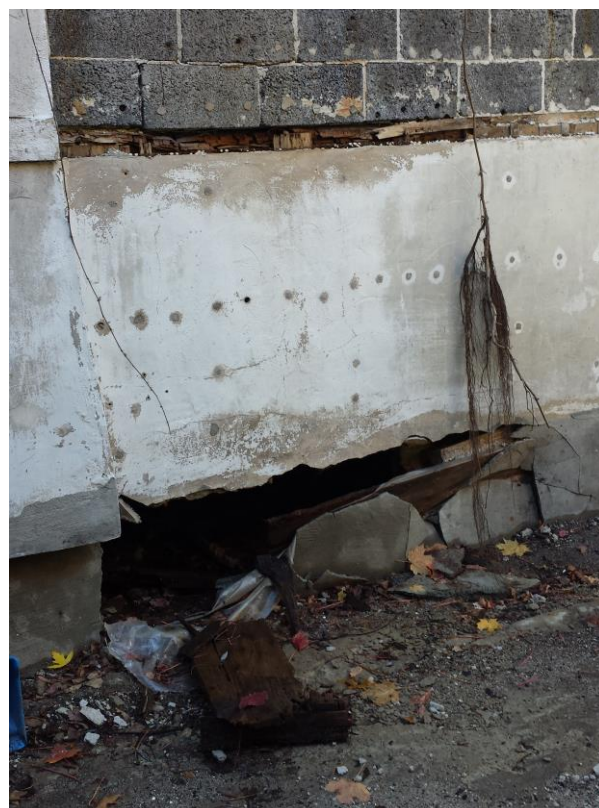
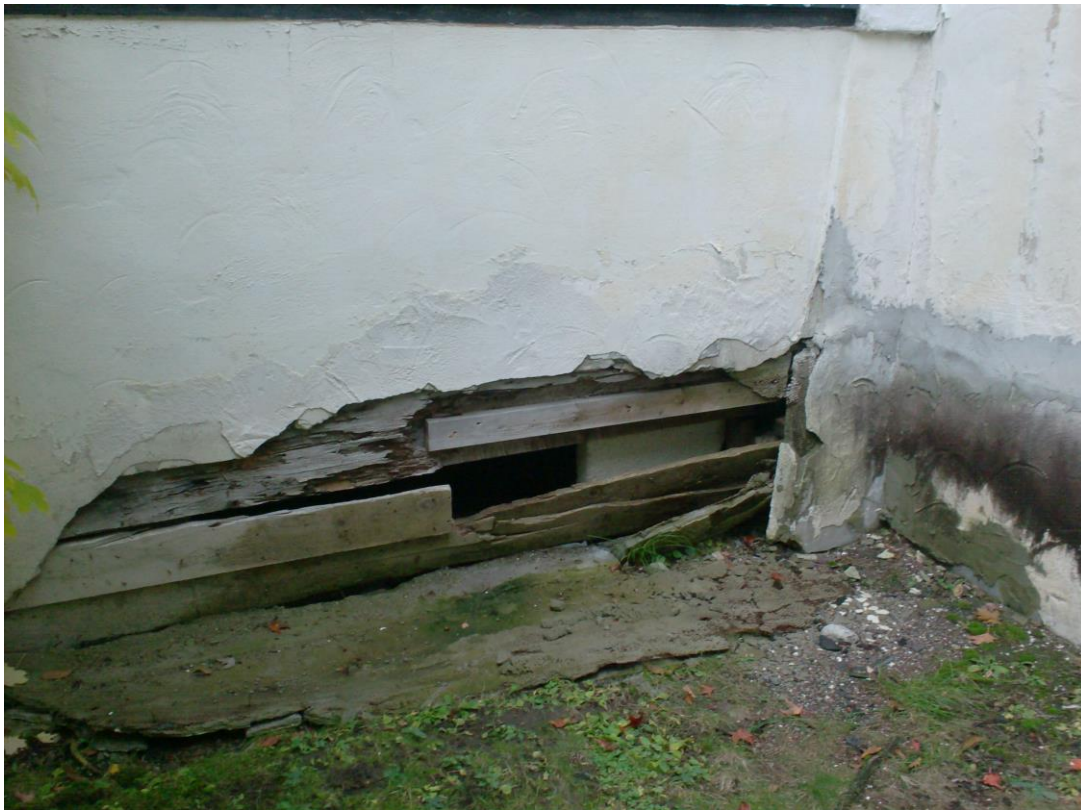
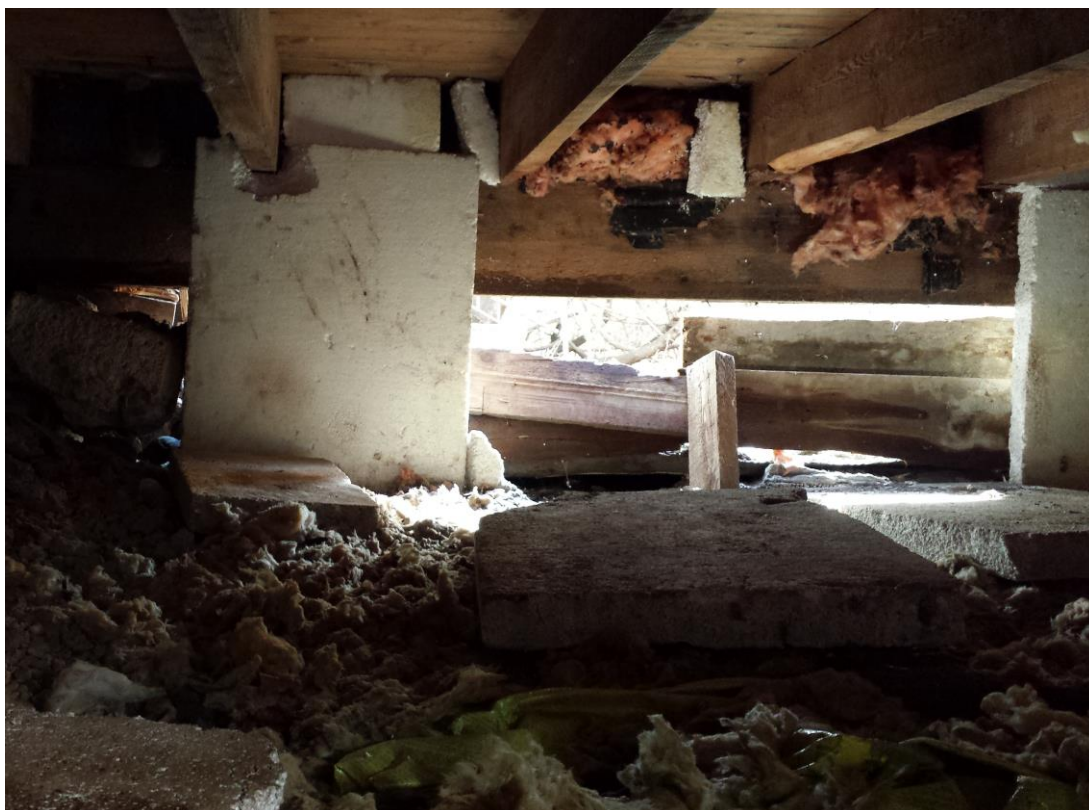
The façade of the building is deteriorating in many areas. The foundation walls collapsed in some places creating holes in exterior walls (photos 2-6). Roof shingles are in a poor condition. (photo 7). We were not able to check the wood framing but the home owner informed us that he replaced some shingles 3 years ago, and wood was found very rotten. We could see outside exposed members, and they are rotten confirming the owner information.

Partial demolition and repairs/renovations are not feasible, there are no salvageable elements remain due to mould accumulation. We recommend full demolition of the existing building. All demolished items must be removed from the site and disposed accordingly. Special care should be taken by the contractor to ensure all works are performed safely within the property lines to not affect adjacent properties.

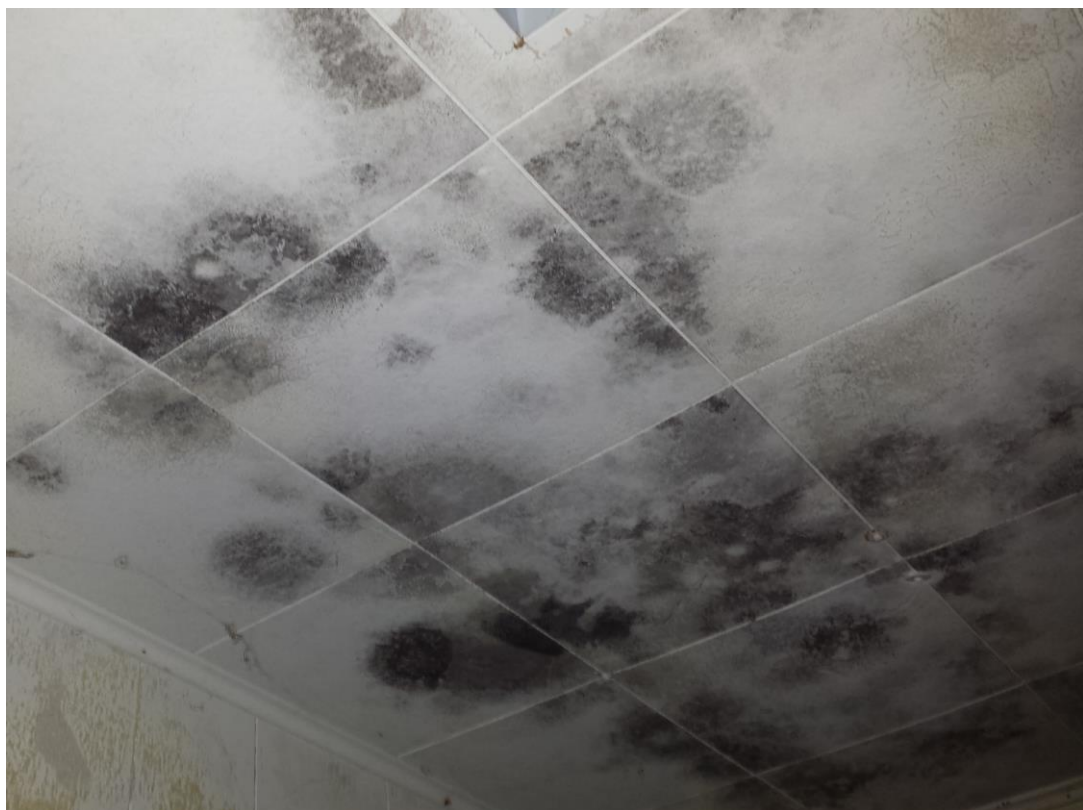
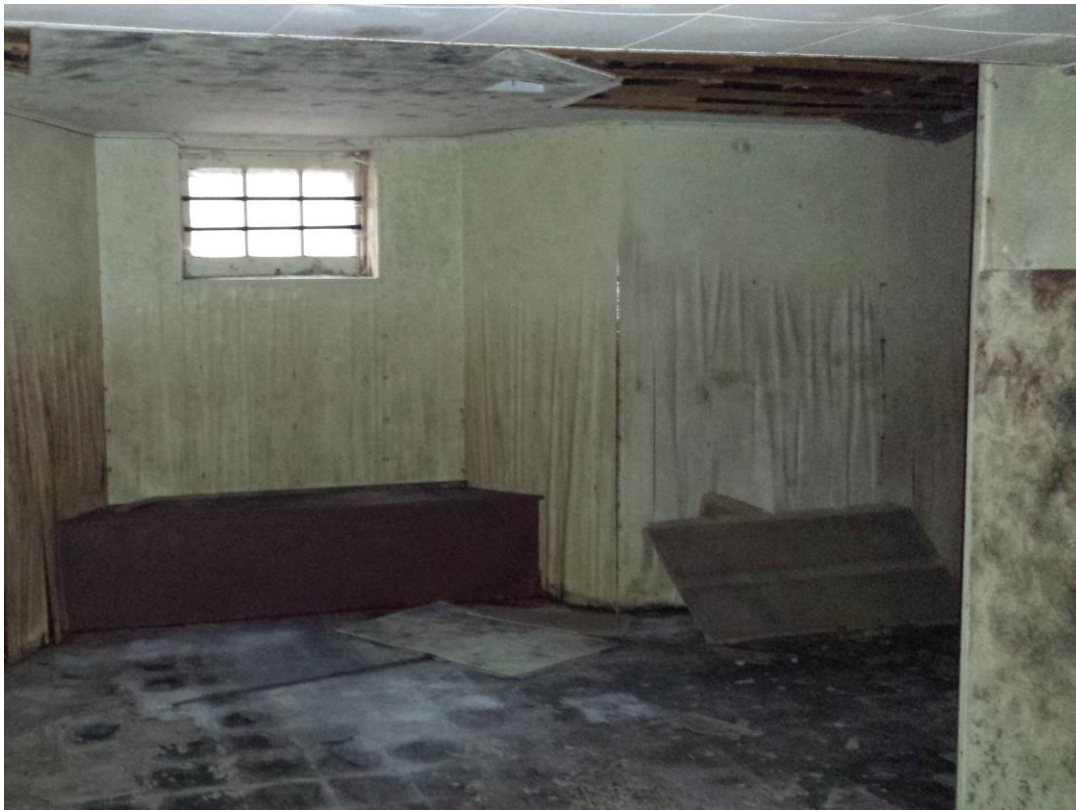
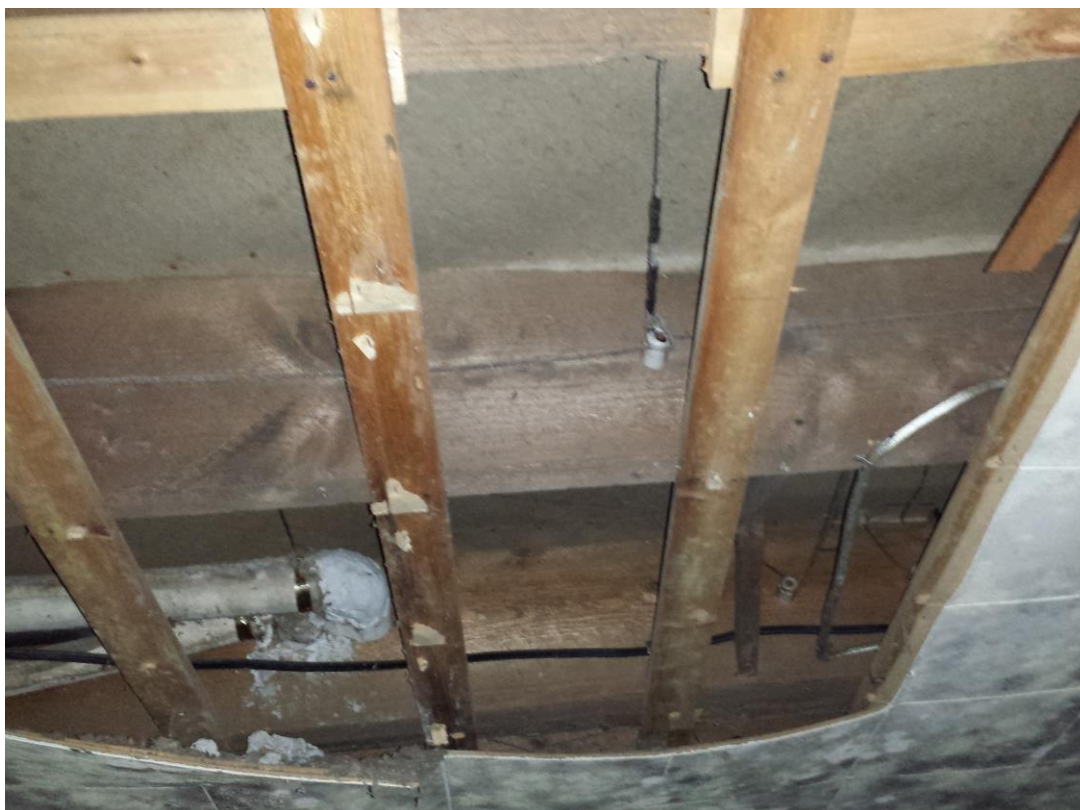
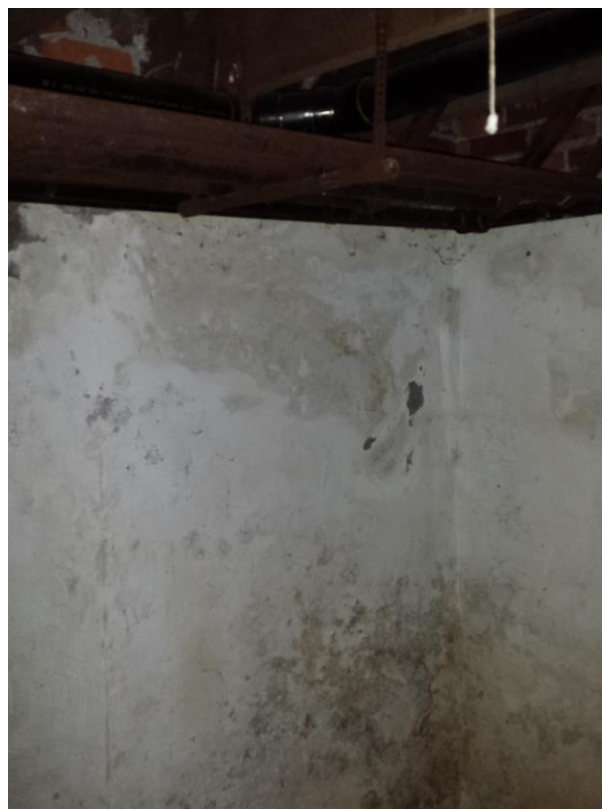
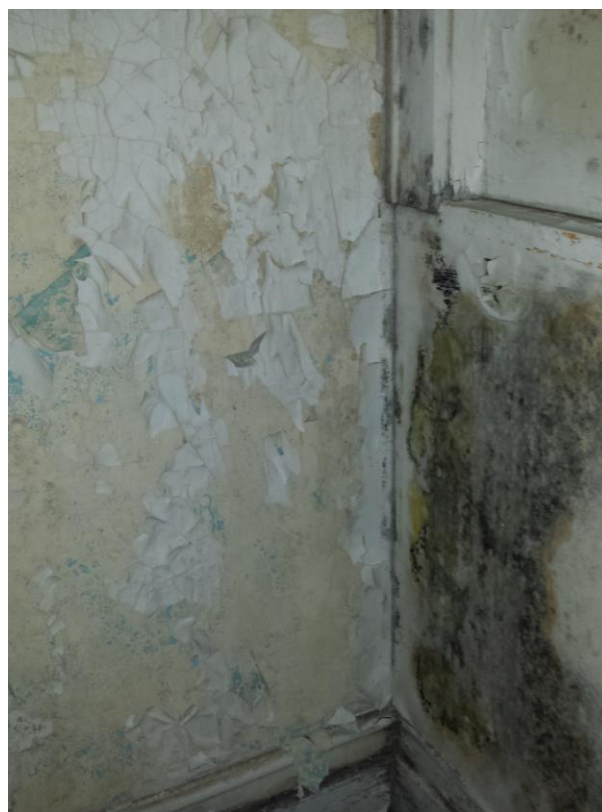
Ground floor and the second floor of both units are in poor condition. There is extensive mould and rot throughout the building (photos 8 - 12). Due to moisture and the freeze-thaw cycle there is continuing damage to all timber structural elements at all different levels (photos 13-16). The ceiling collapsed in numerous spots revealing worn and moulded insulation (photos 17 - 20).

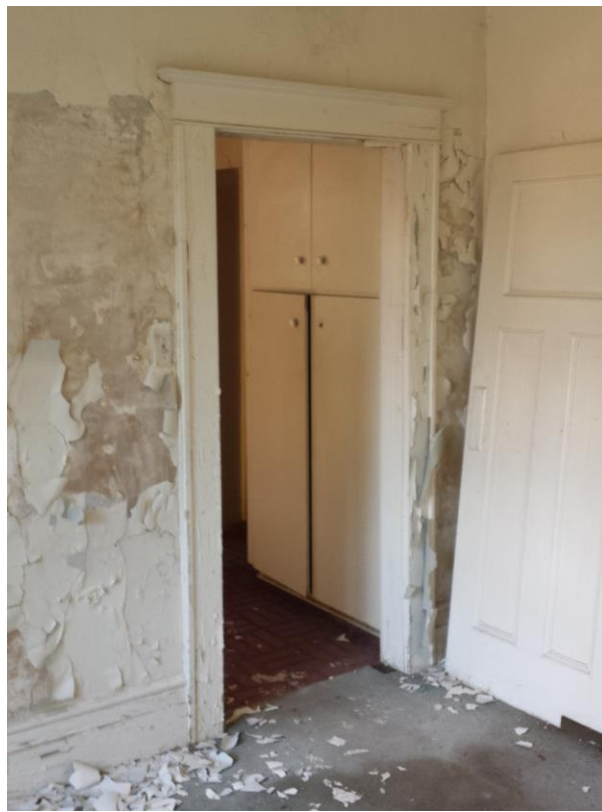
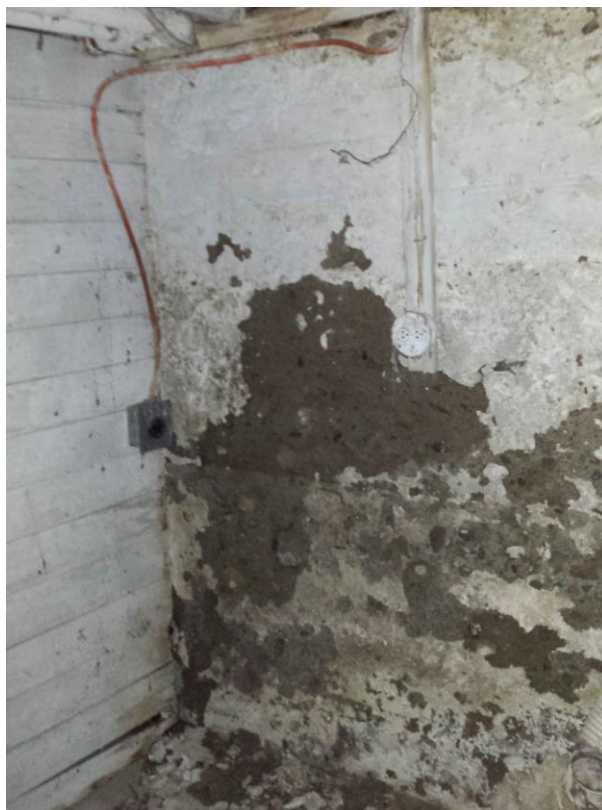
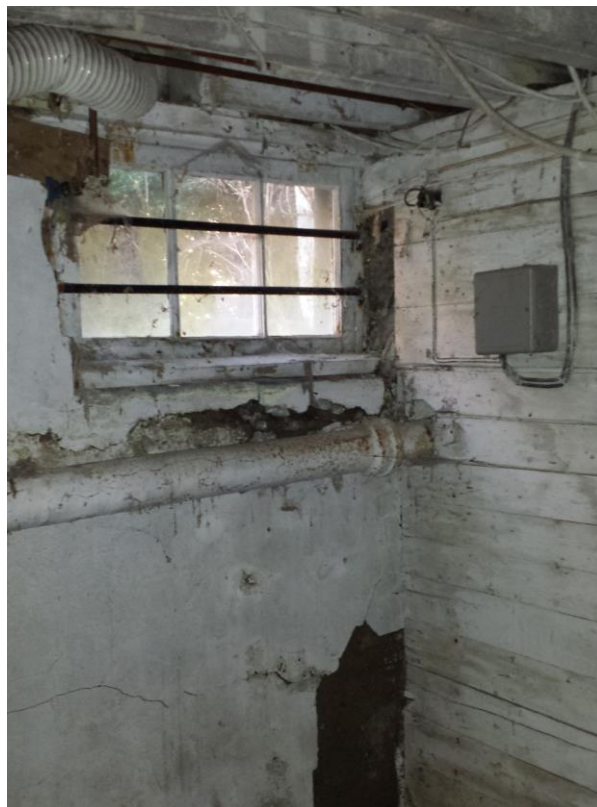
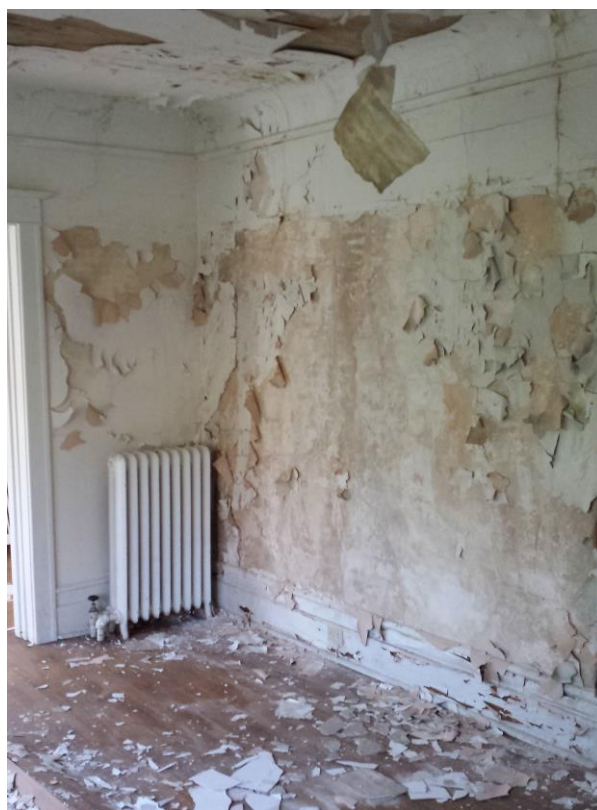
Water presence and long-term excessive moisture accelerate deterioration of all the structural members. Lack of heating in the winter season causes frost penetration in the foundations and all other components weakening the building structure.

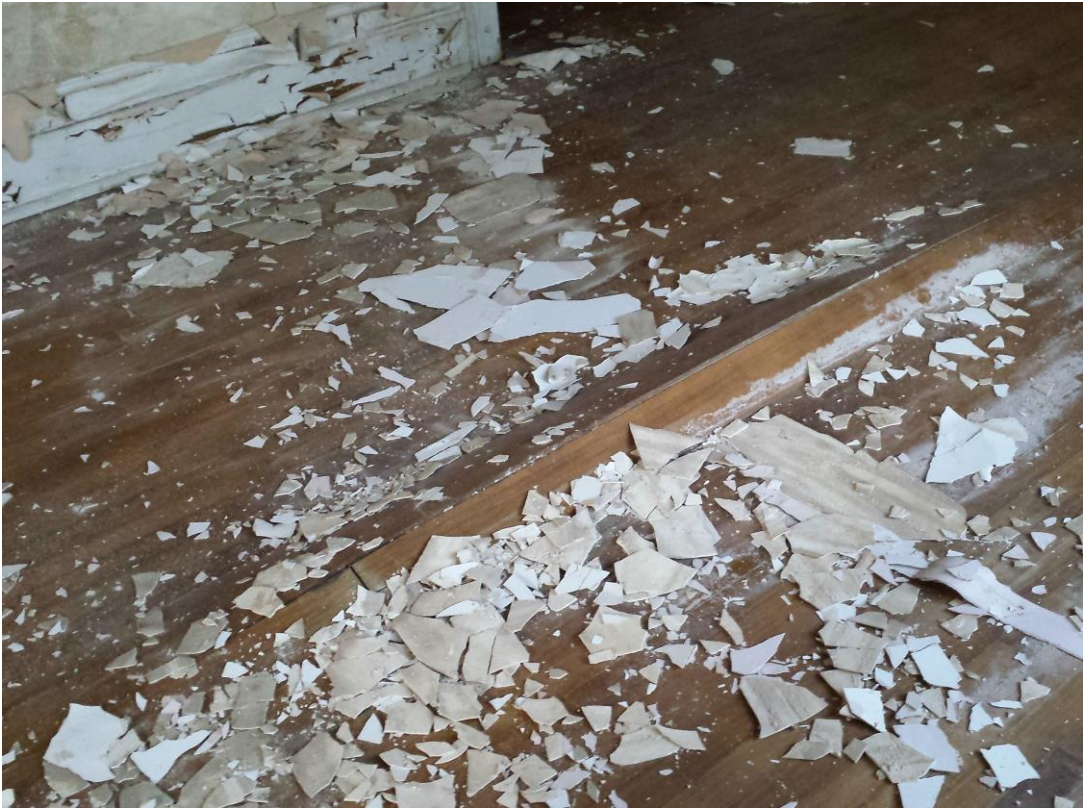
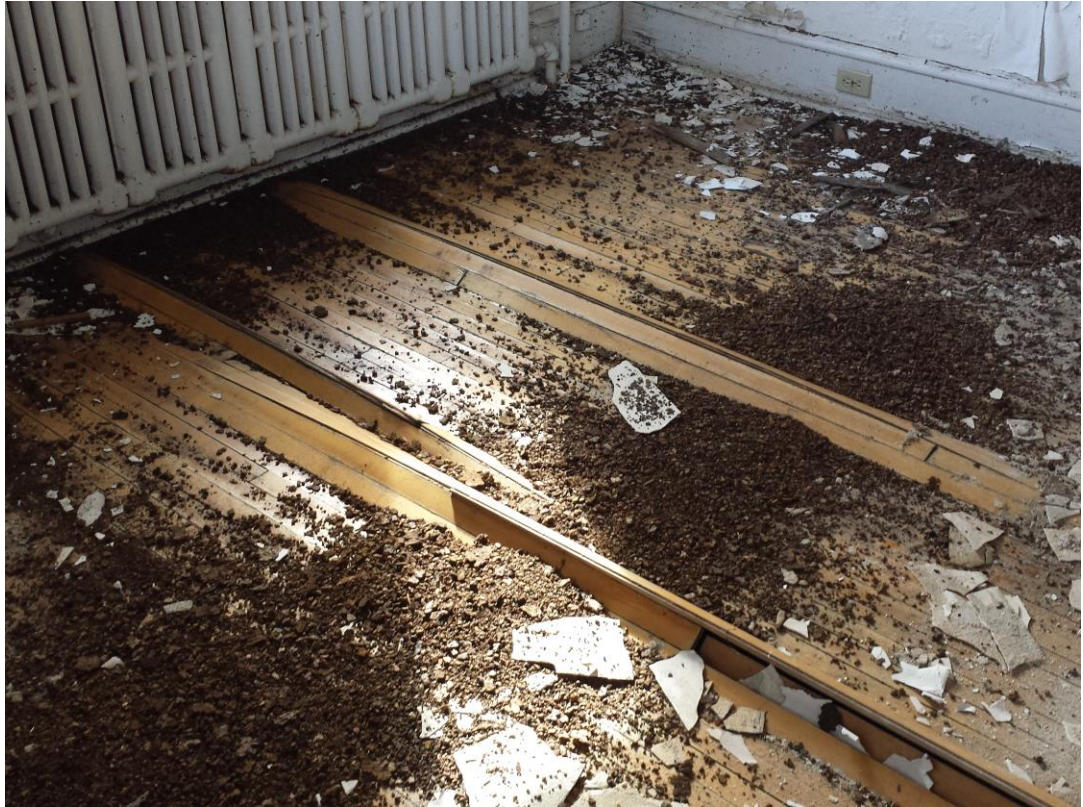
Because of lack of heat and consequently changing temperatures and humidity the wood floor started to bulge in many spots (photos 21, 22). In many areas there are significant deteriorations of structural members due to mould and temperature changes (photos 23 - 27).
