CAPACITY ENGINEERING LTD.

Condition Assessment

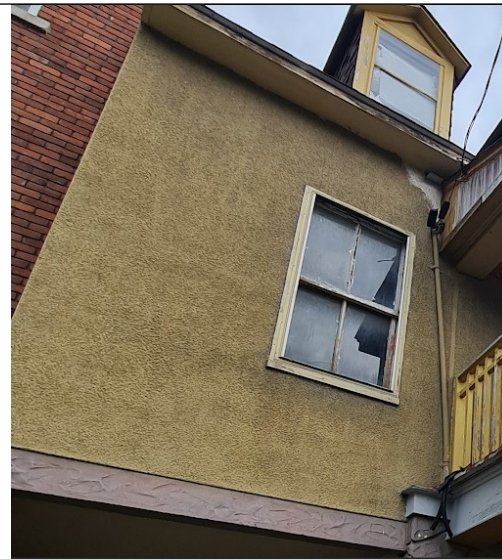
Photo 2: Front Stucco weathering & staining.

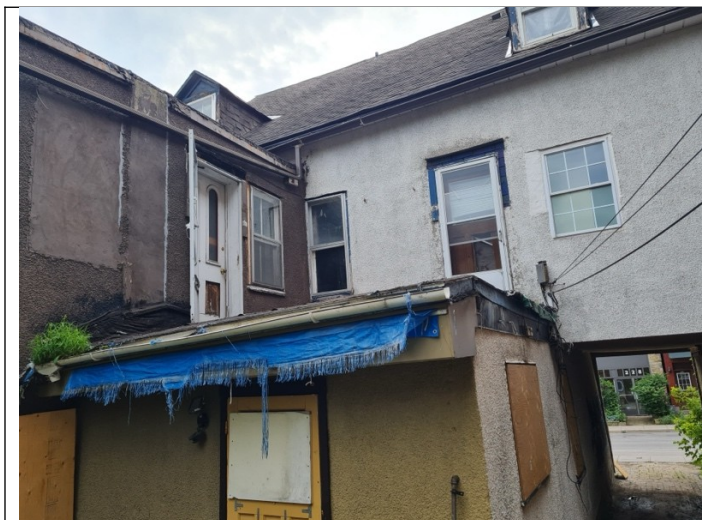
Photo 3: Rear view of home, one-storey addition, and stucco deterioration.

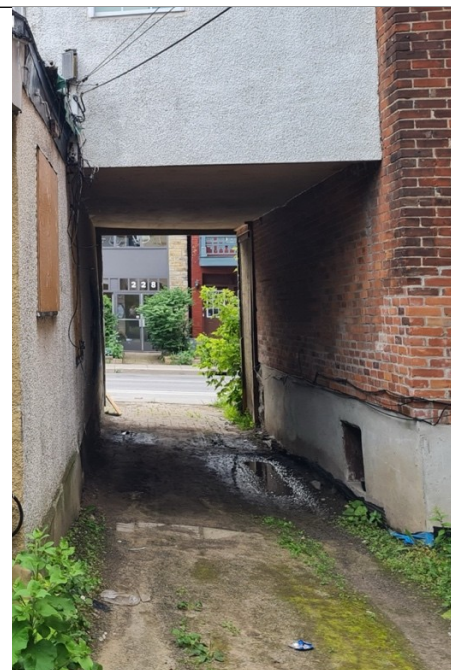
Photo 4: Laneway covering is slanted.

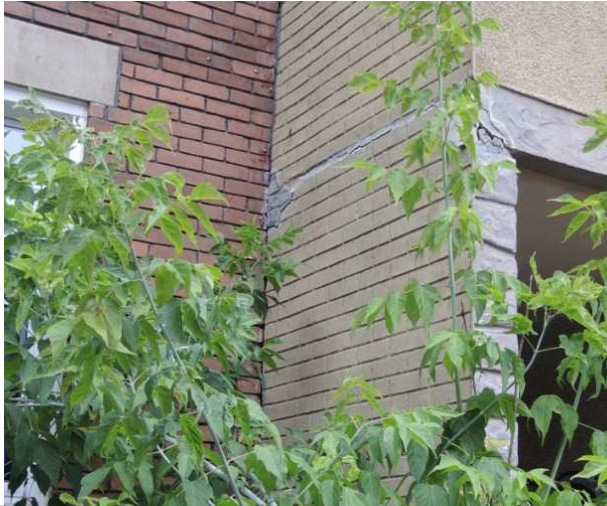
Photo 5: Horizontal cracking can be observed across the mortar in addition to cracking across the face of the bricks attached to the adjacent property. Cracking can also be observed at the corner above the laneway.

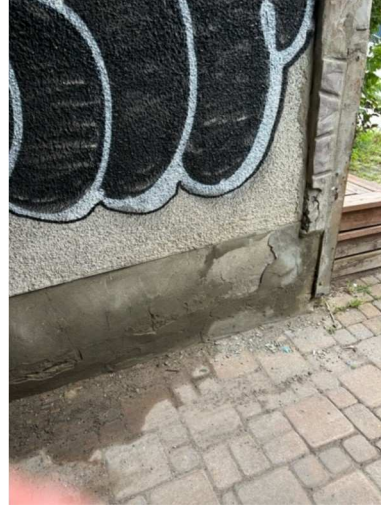
Photo 6: Cracking in back of veneer.

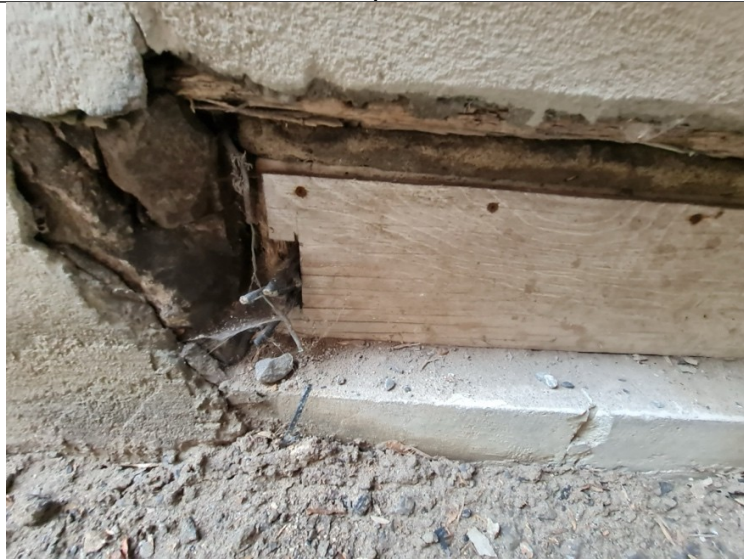
Photo 7: Foundation wall deterioration.

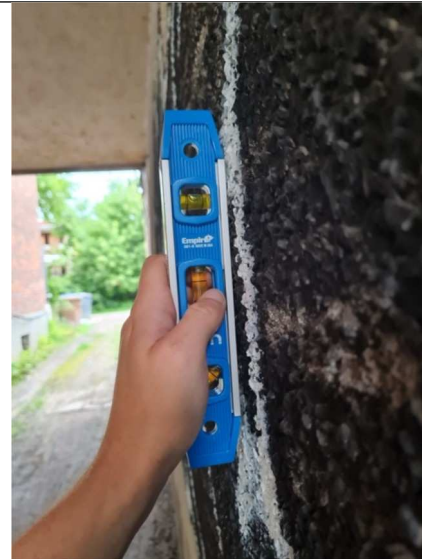
Photo 8: Laneway wall plumbness.

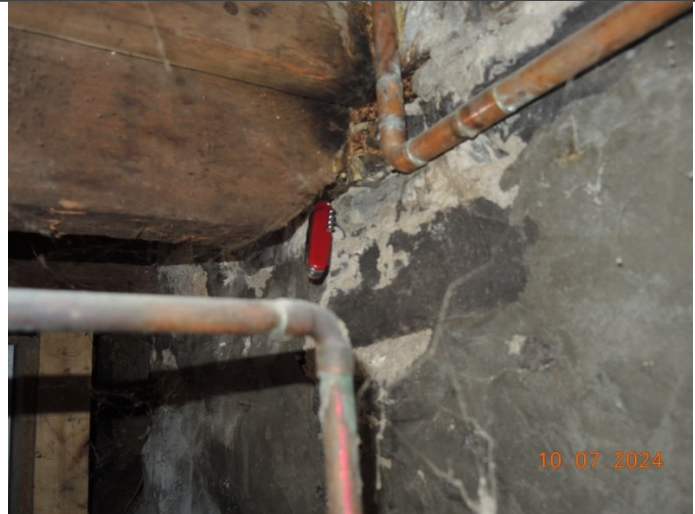
Photo 11: Joists going directly into moist foundation wall, decay observed.

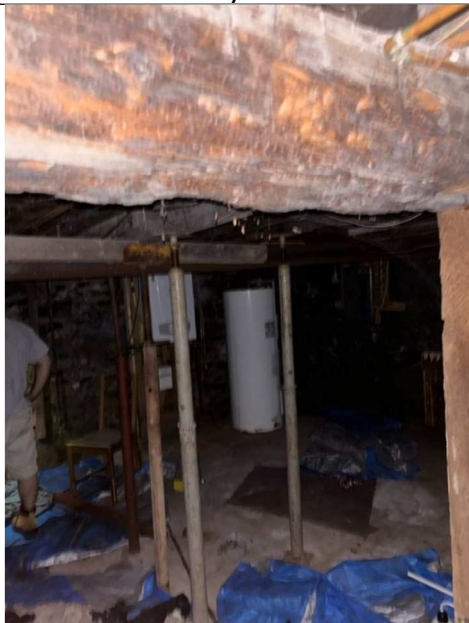
Photo 12: Temporary jackposts installed to support sagging floors.

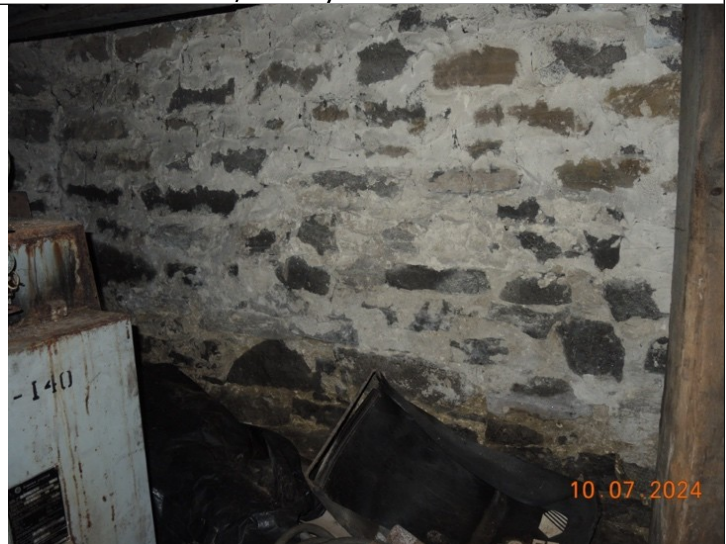
Photo 13: Previous attempted mortar repointing & repair.

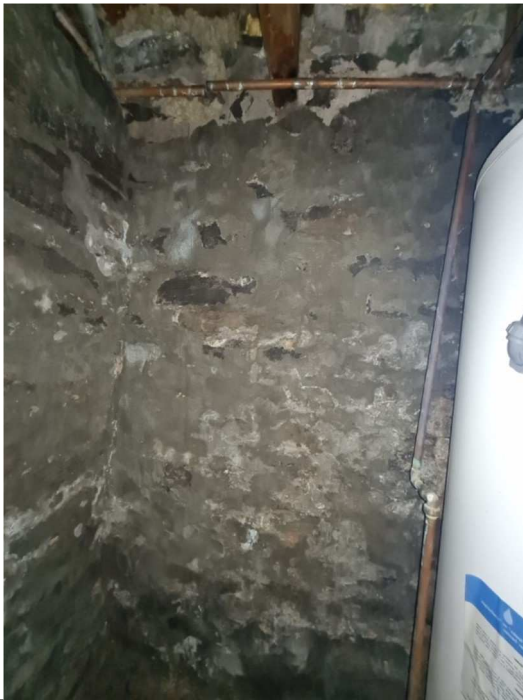
Photo 14: Previous Portland cement-based mortar application to interior surface.

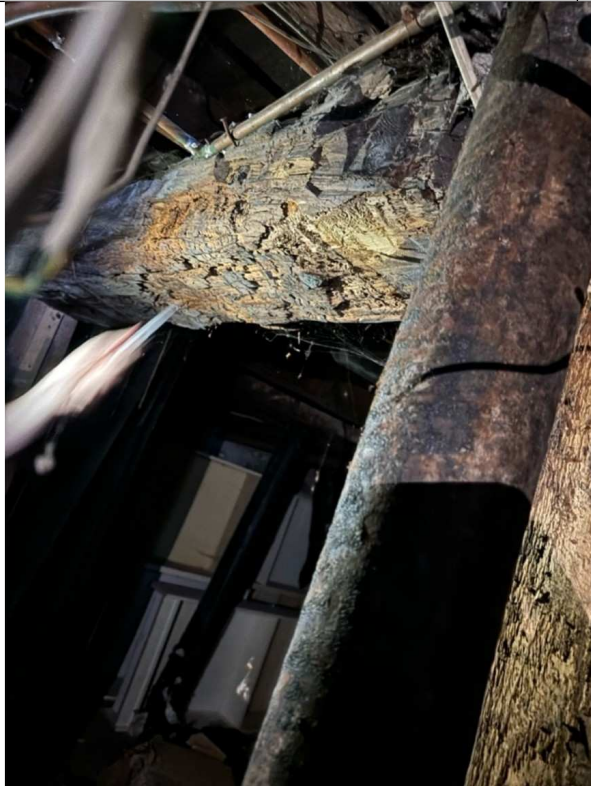
Photo 16: Severe deterioration of beam due to rot.

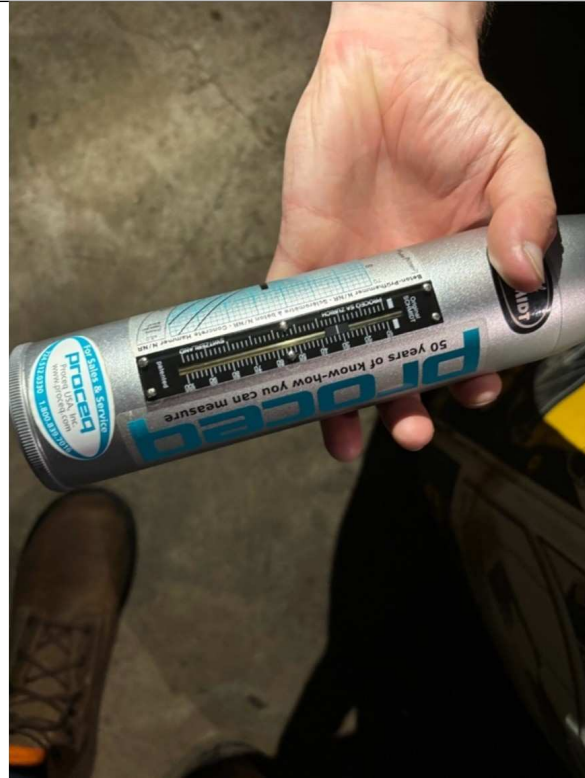
Photo 17: Schmidt hammer test result for foundation wall.

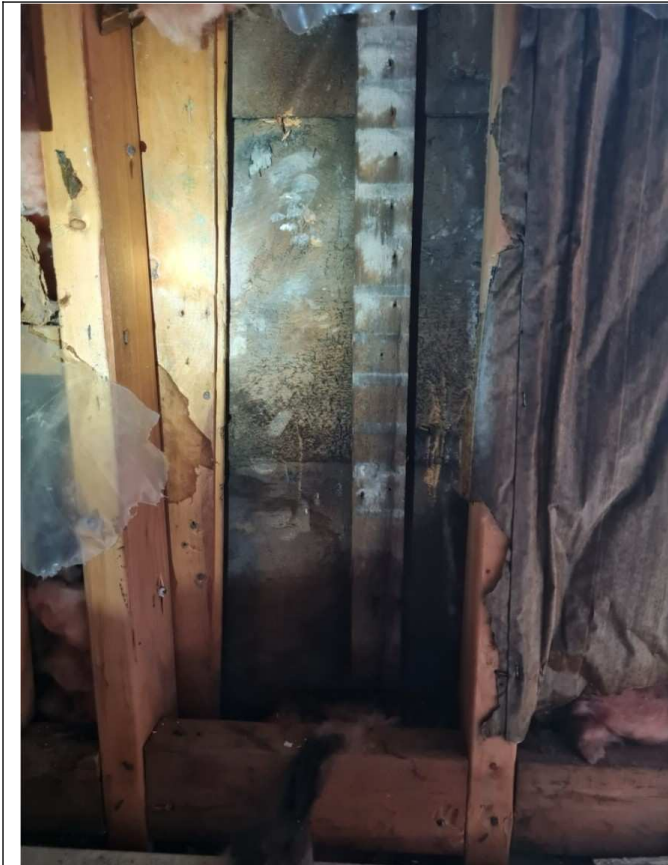
Photo 18: Exposed exterior wall showing signs of water damage on first floor at the front (South) wall of the building.

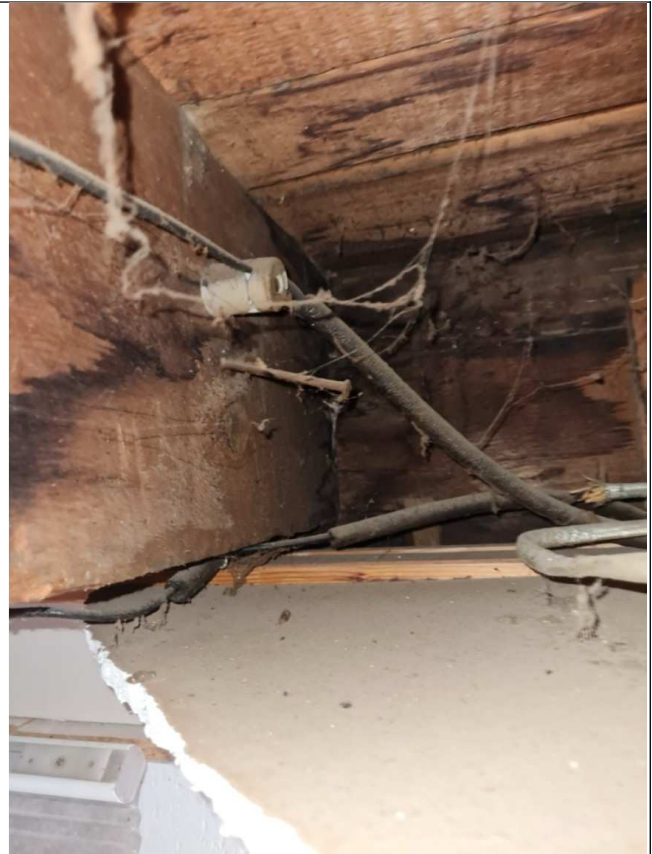
Photo 19: Dark stained joists and rim board in the second floor plenum at the front (South) wall of the building.

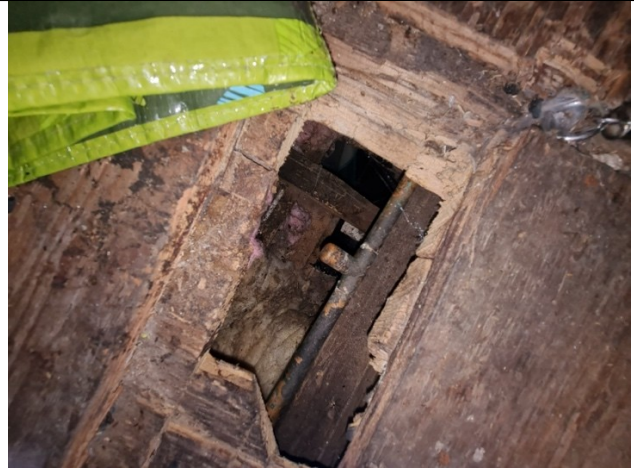
Photo 21: Hole in floor displaying signs of rot.

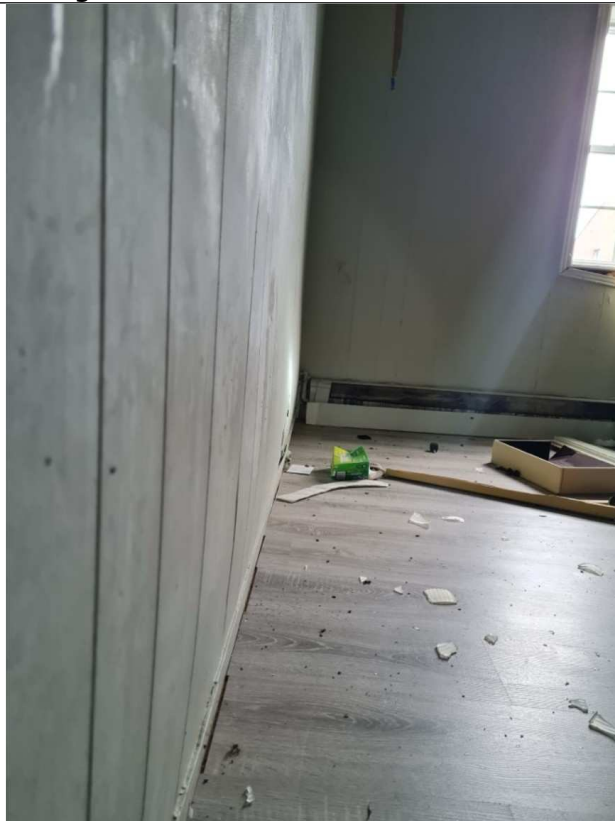
Photo 22: Interior wall bulge and sloped floor above laneway below.

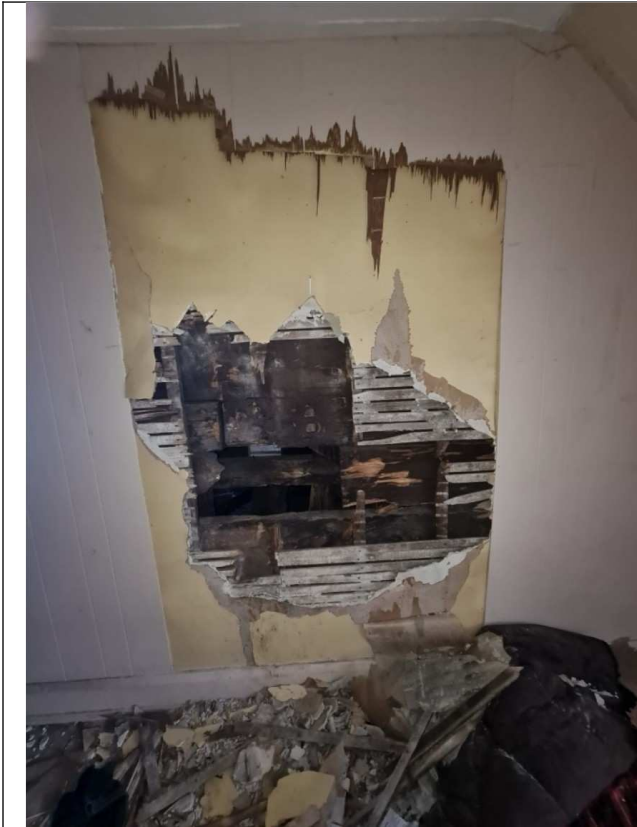
Photo 24: Hole in wall connecting to adjacent attic in 231/233 St-Patrick. Decay noted in plank-on-edge structure.

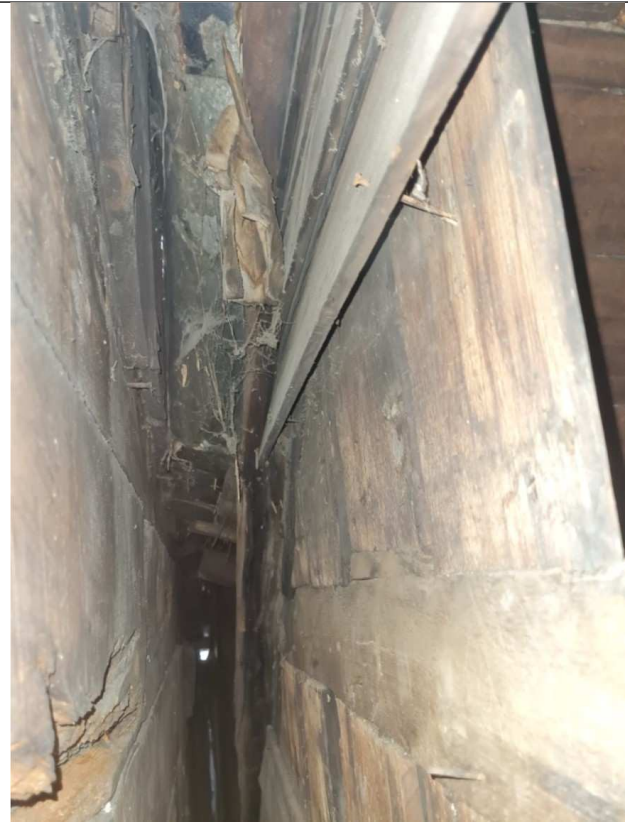
Photo 25: Inside of wall showing signs of decay along both structures. Daylight observed on all sides.

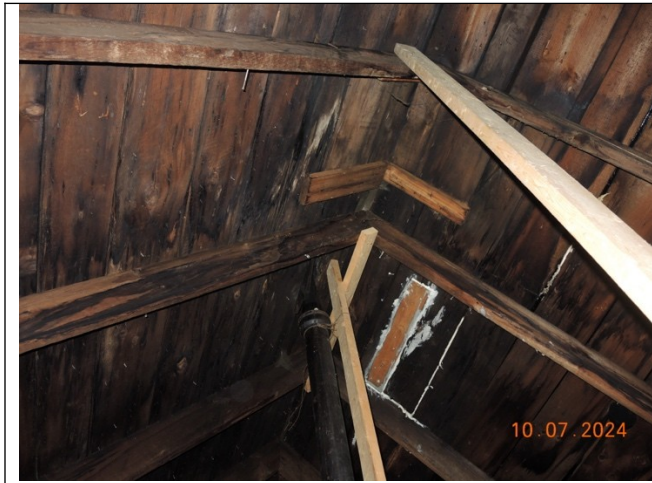
Photo 26: Dark staining in roof by plumbing stack. Prior local repair noted.

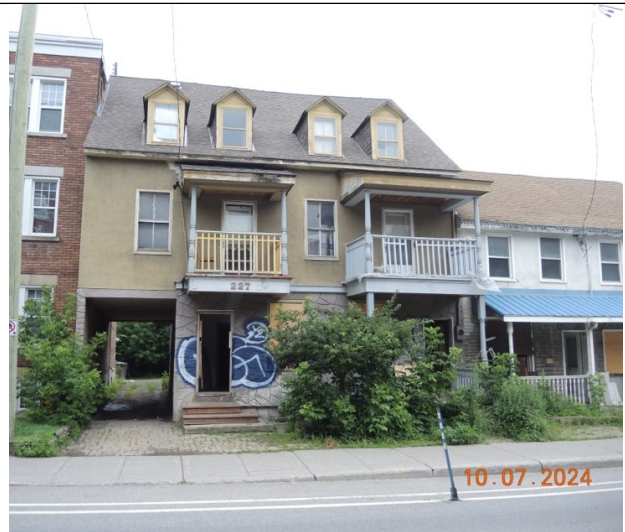
Photo 27: Roof line shows signs of sagging near the middle of the roof.

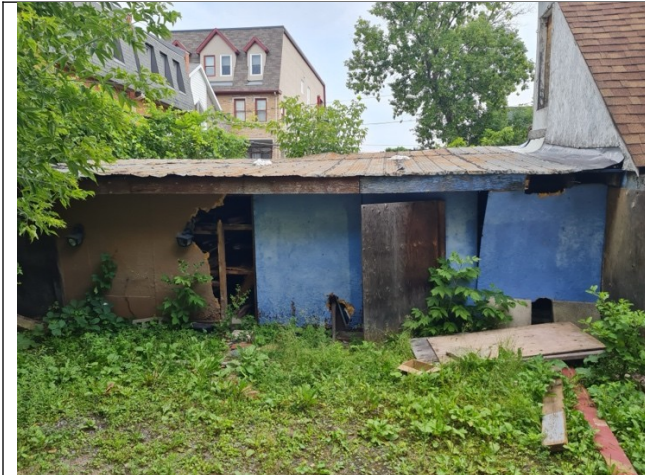
Photo 30: Certain pieces of wooden wall are broken/missing. Shed is leaning, roof slope is curved.

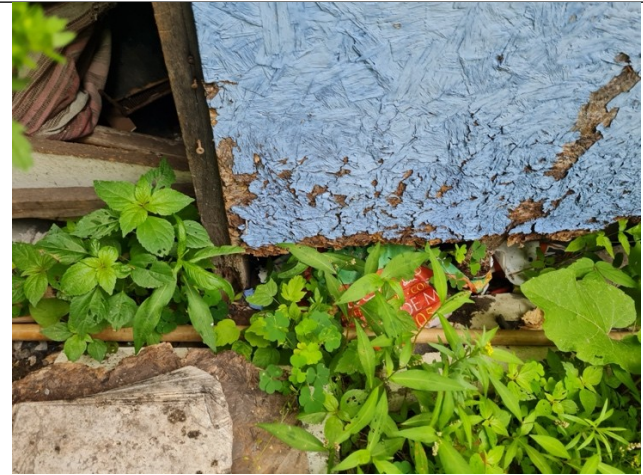
Photo 31: Shed lacks a foundation, bearing on water damaged areas. The paint is peeling, indicative of weathering of the wood.

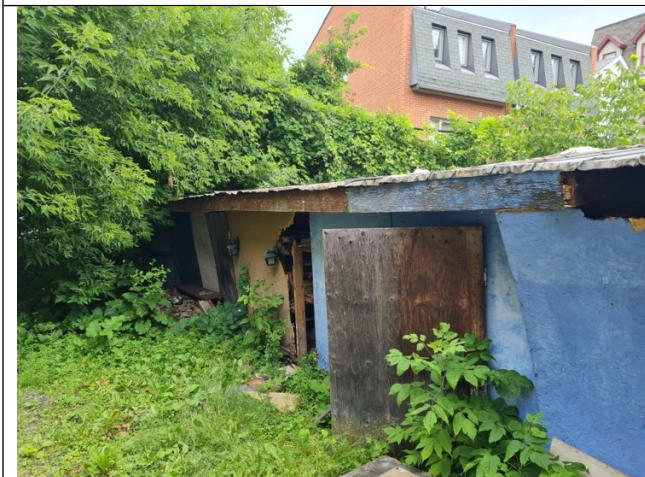
Photo 32: Shed is visibly settling and leaning.

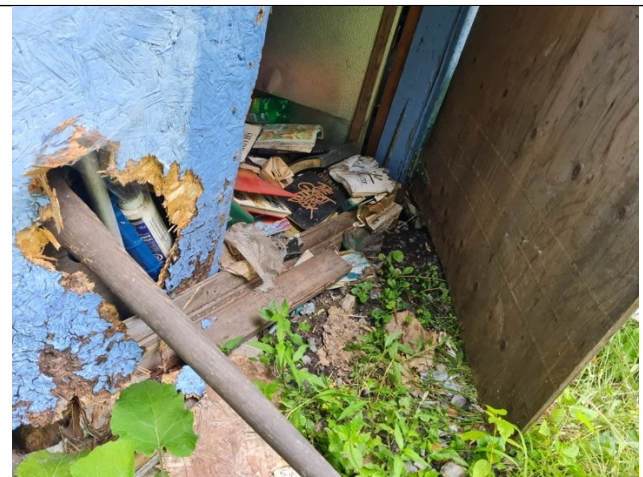
Photo 33: Visible damage to exterior walls of the shed.

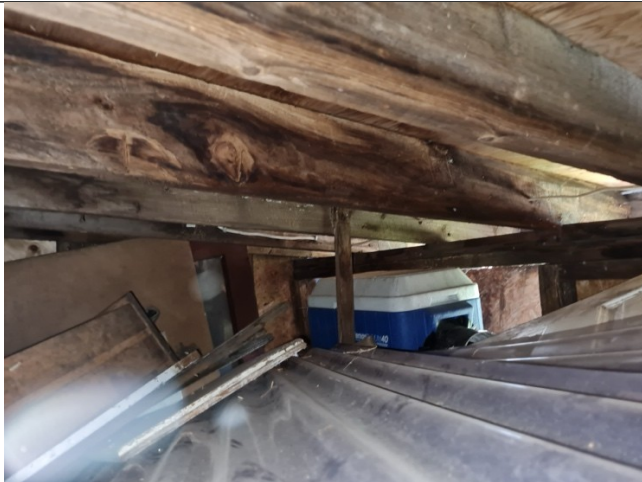
Photo 34: Dark wet staining on roof joists, indicative of rot.

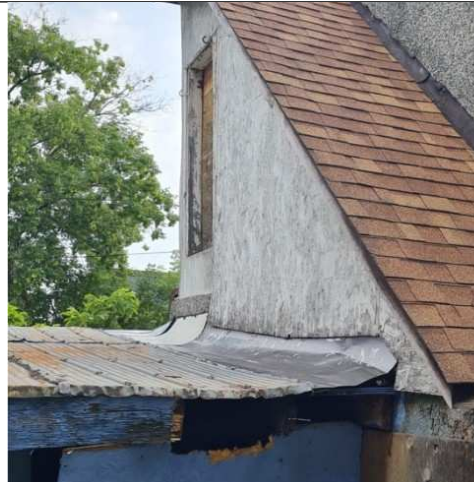
Photo 35: Corrosion of roof sheathing.

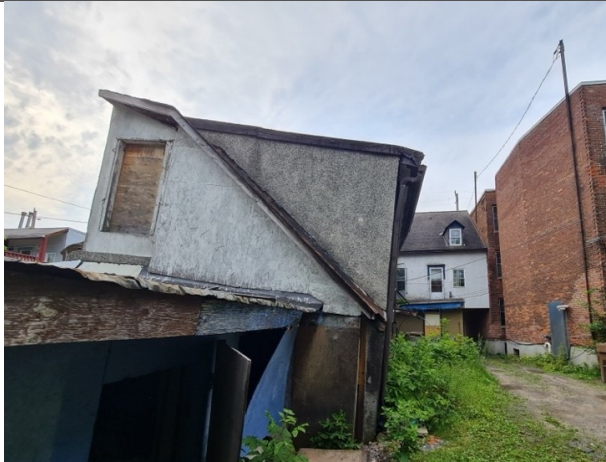
Photo 36: Addition wall leaning dramatically. Unstable structure in state of active collapse.

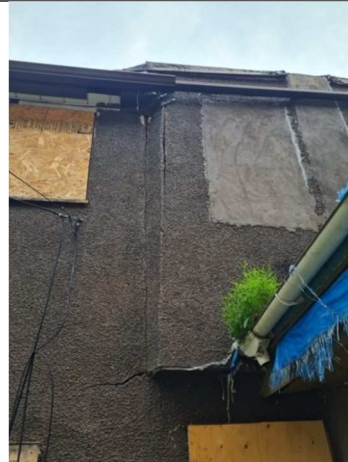
Photo 37: Stucco cracking and shifting visible on addition.

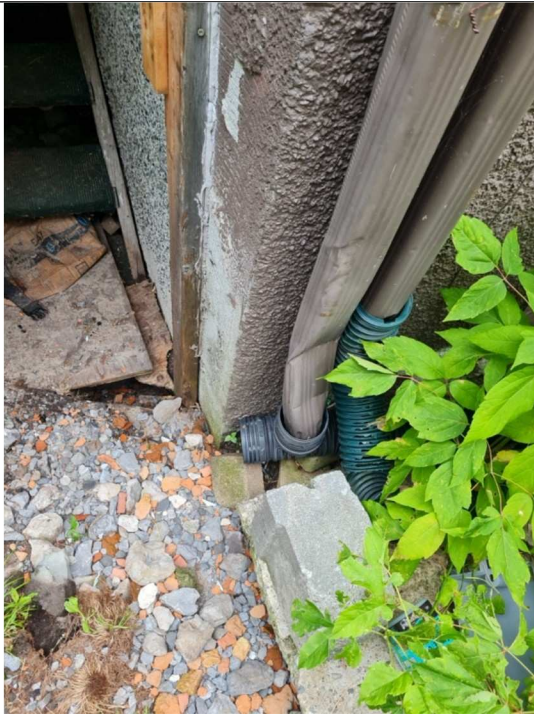
Photo 38: Downspouts coming down in localised area, washing away soil beside/beneath foundation wall.

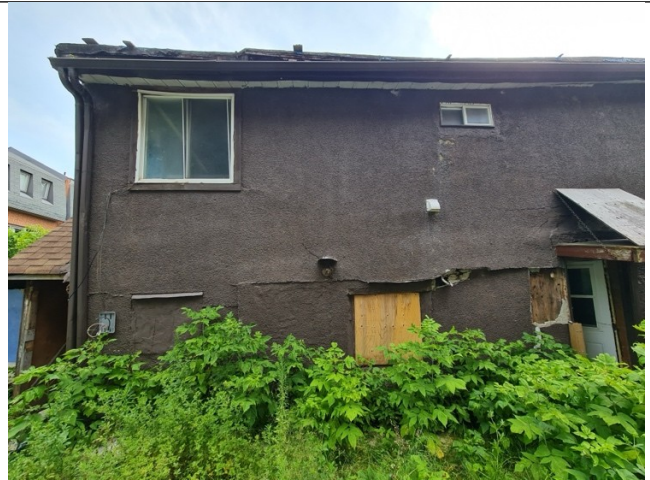
Photo 39: Stucco is buckling out and cracked.

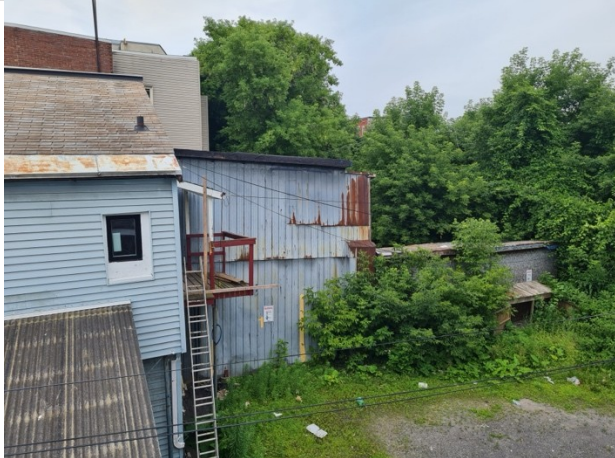
Photo 40: The addition has visibly settled relative to the adjacent building(s) as can be seen from 235/237 St. Patrick Street.

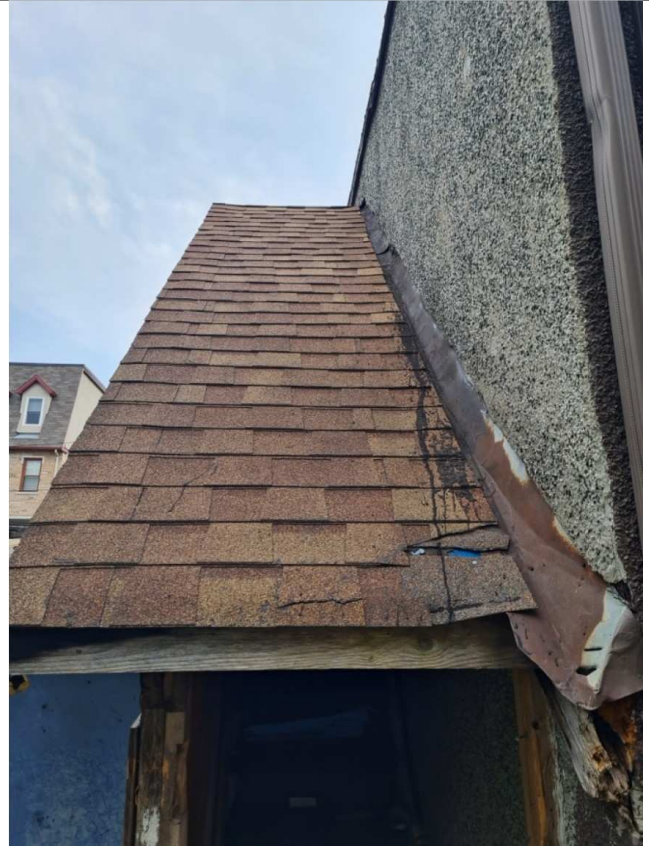
Photo 43: Poor flashing detail, corroding
away.

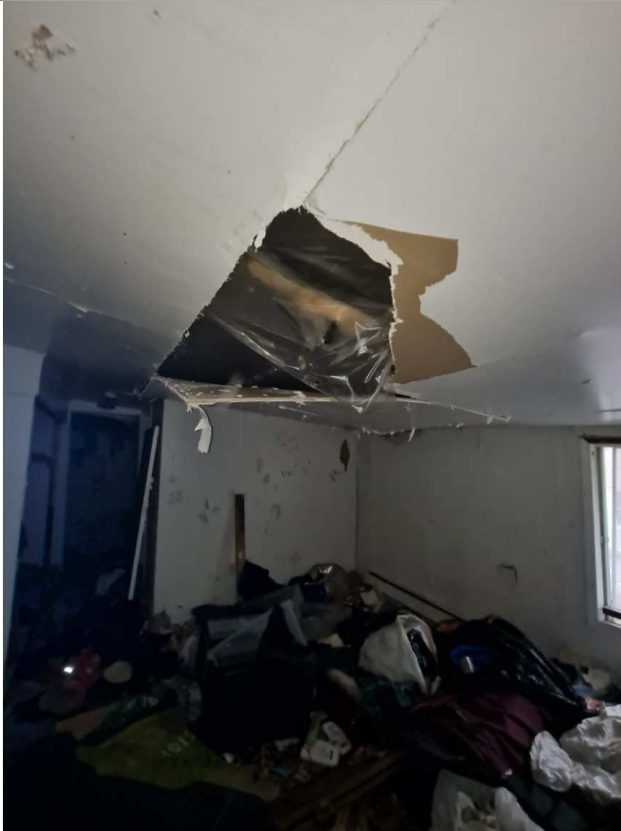
Photo 44: Ceiling is damaged and appears to be sagging.

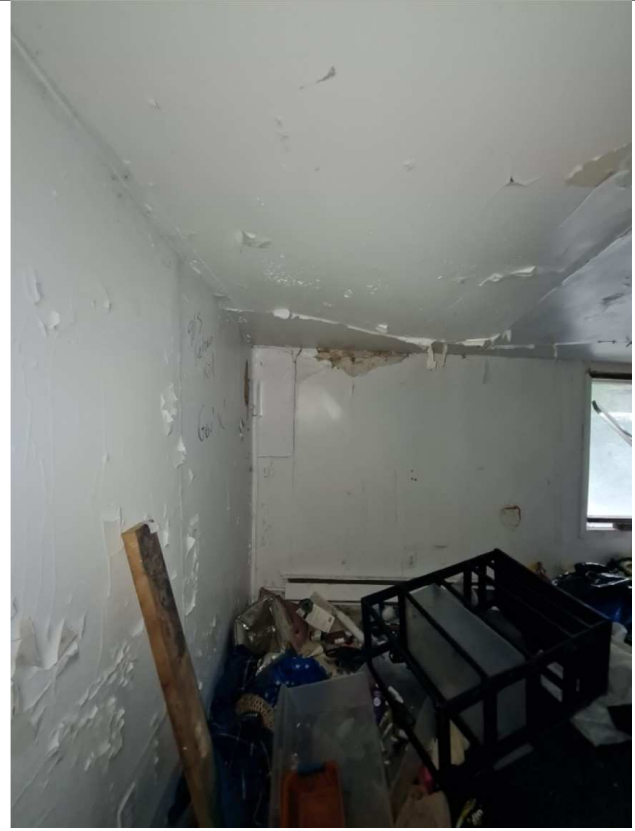
Photo 45: Ceiling appears to be sagging and interior walls are damaged.

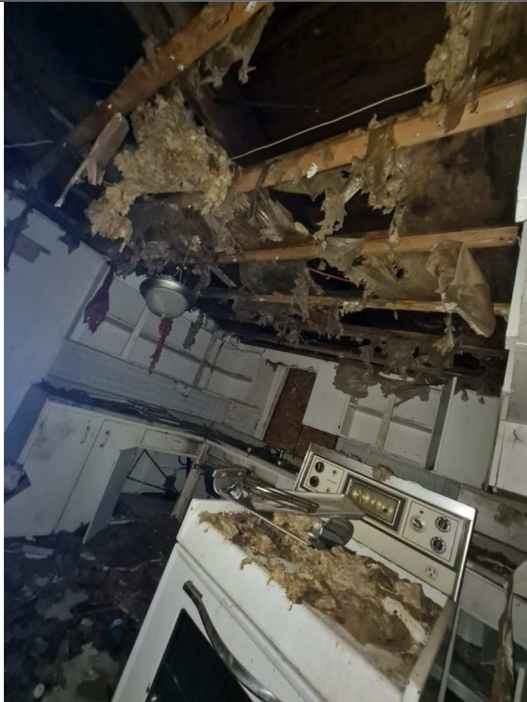
Photo 46: Ceiling and insulation have been

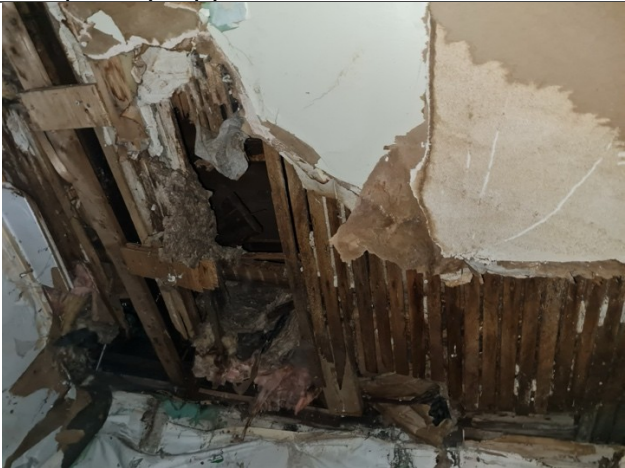
Photo 48: Water damage to exposed wood.	This square is intentionally left blank.
