CAPACITY ENGINEERING LTD.

# Condition Assessment

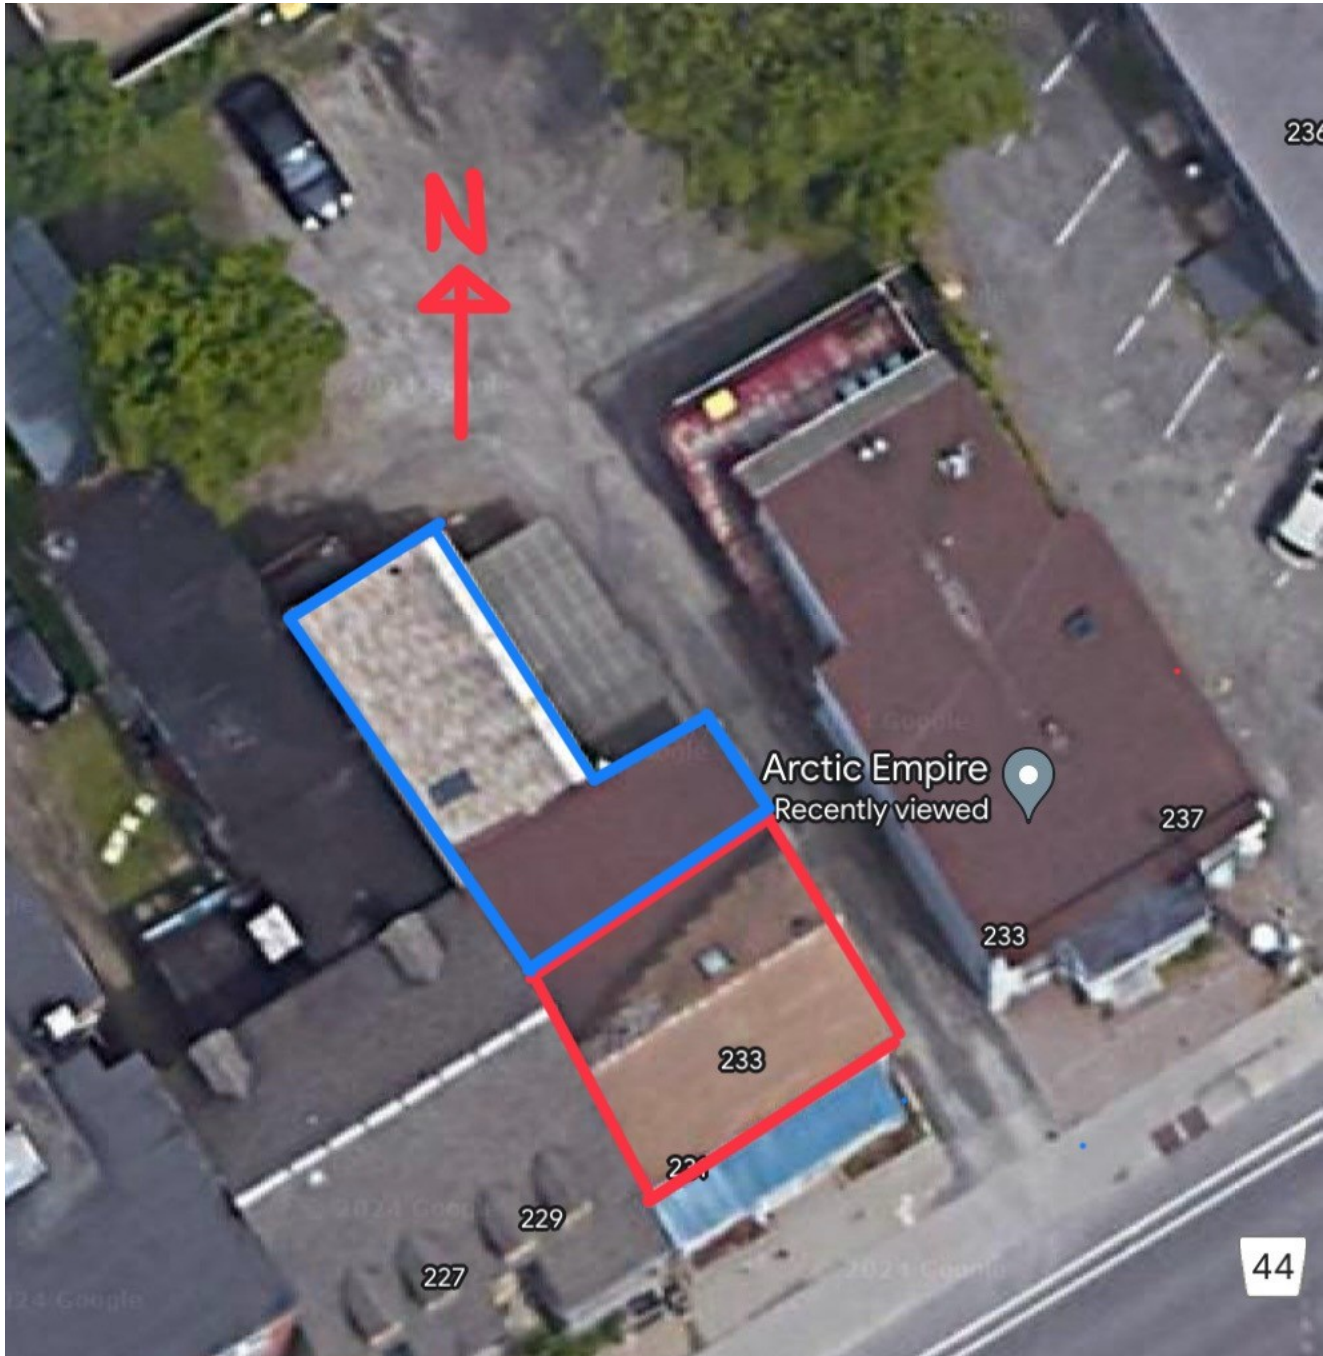
In the figure above, the original structure of 231/233 St-Patrick St can be seen outlined in red above, the blue outline denotes the addition.

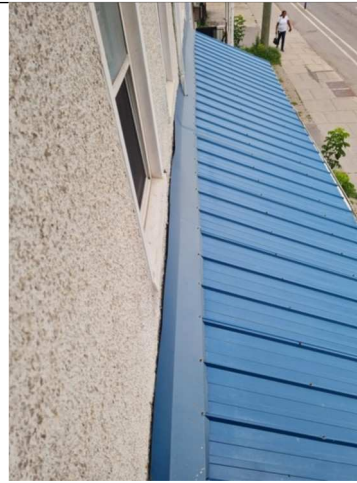
Photo 2: Flashing is not tied into stucco cladding and stucco is cracked along the interface.

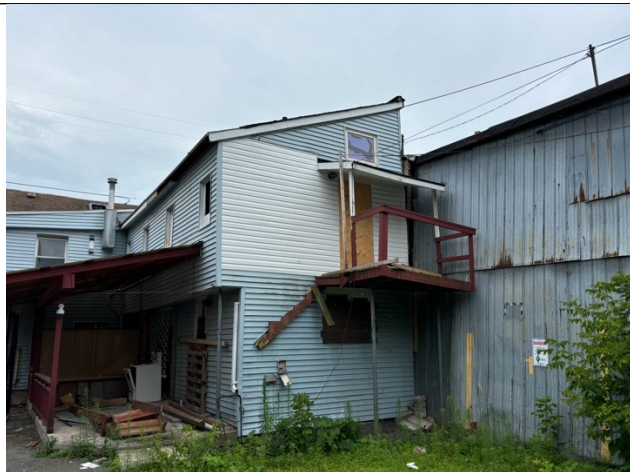
Photo 3: Elevated rear deck is leaning and is only supported by two jackposts.

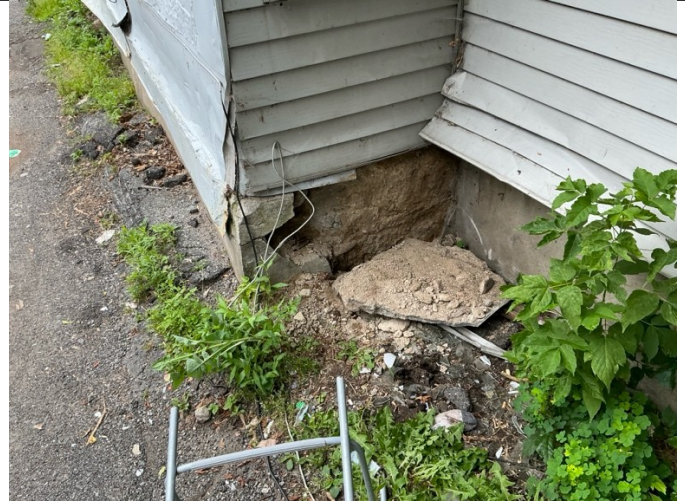
Photo 5: Exterior concrete spalling of foundation wall exposed above grade.

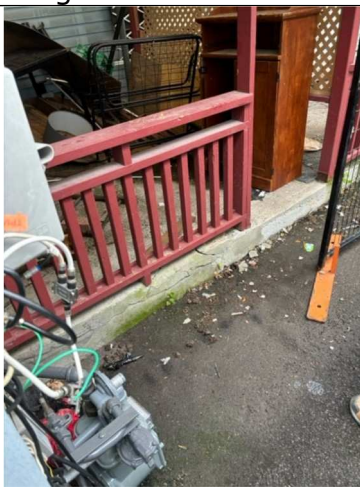
Photo 6: Cracking of the rear porch slab.

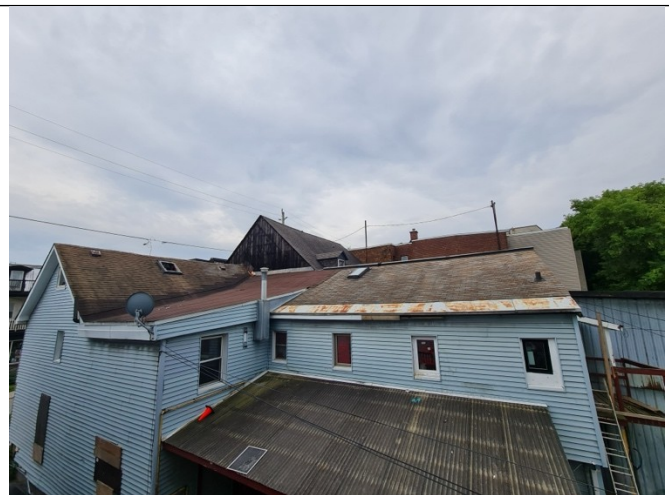
Photo 7: 231/233 St. Patrick St roof condition.

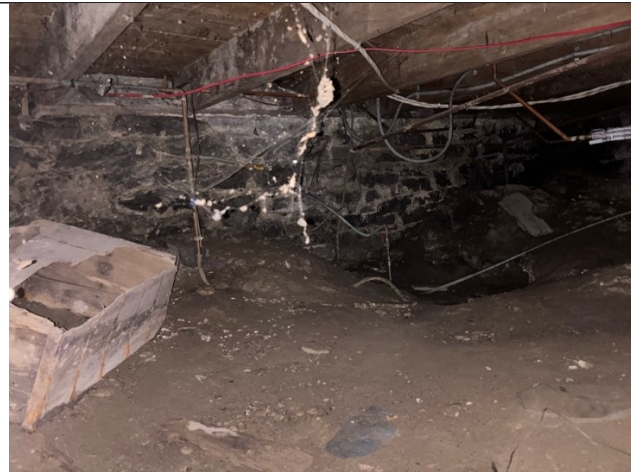
Photo 8: Water staining on joists and wet foundation wall.

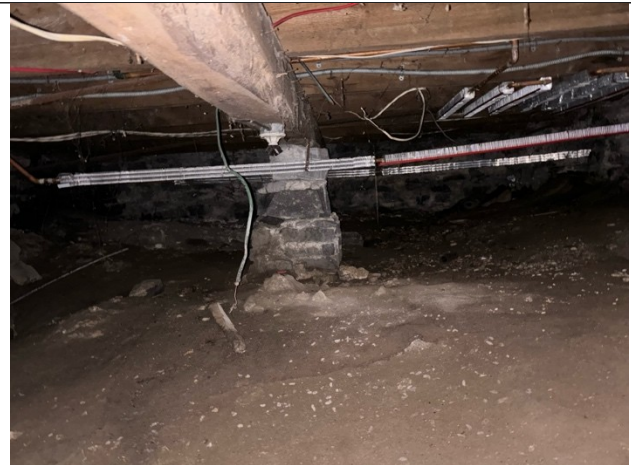
Photo 9: Deterioration of masonry pier.

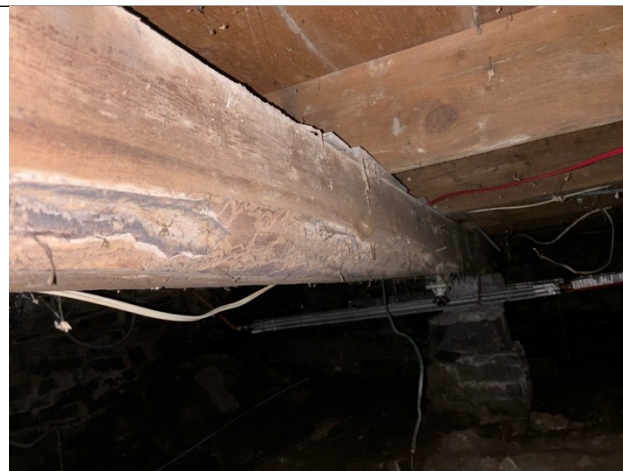
Photo 10: Decay on underside of main spine beam.

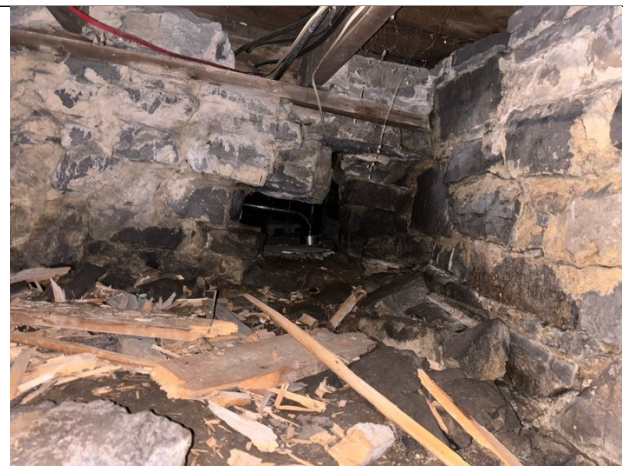
Photo 11: Opening at the corner of the foundation wall.

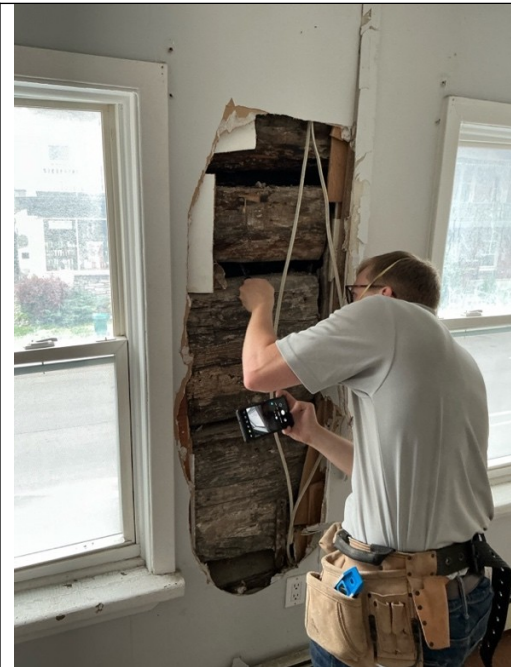
Photo 12: Rot in exterior South wall on second storey.

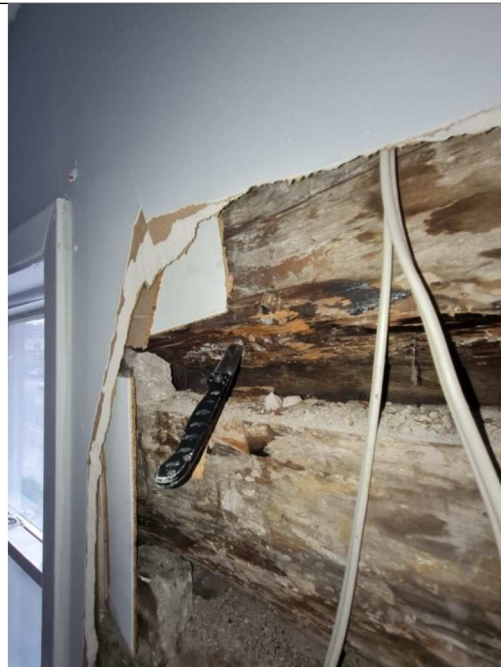
Photo 13: Field knife probe easily entered deep into exterior wall elements.

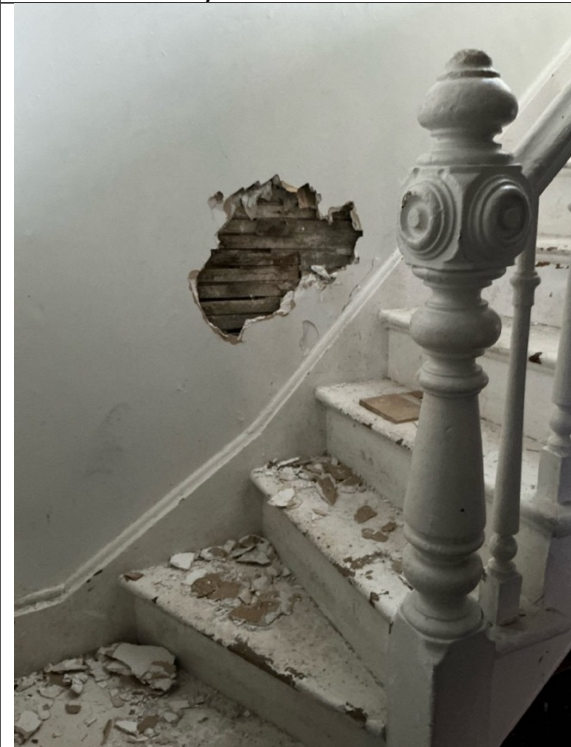
Photo 14: Exposed Lath showing signs of moisture damage.

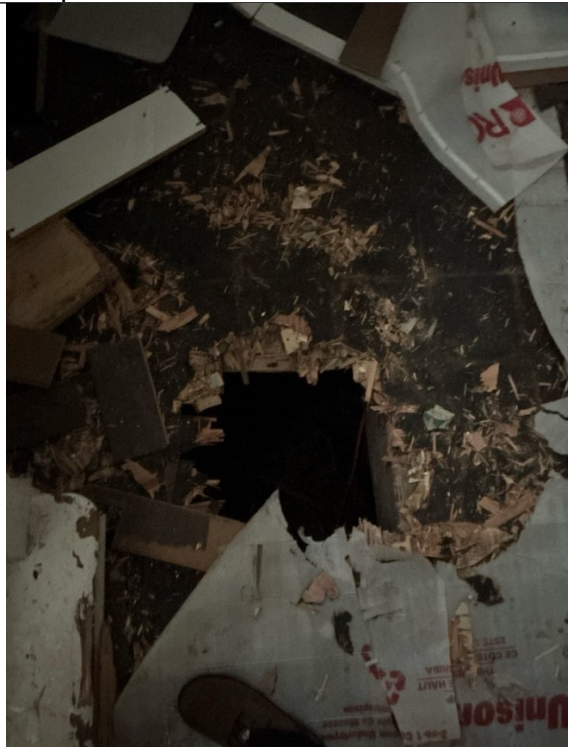
Photo 15: Hole in floor down to crawlspace. Rot is present.

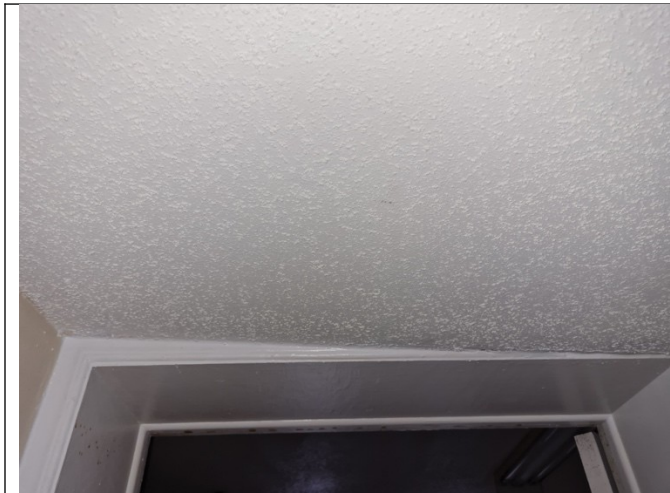
Photo 16: Slanted Ceiling.

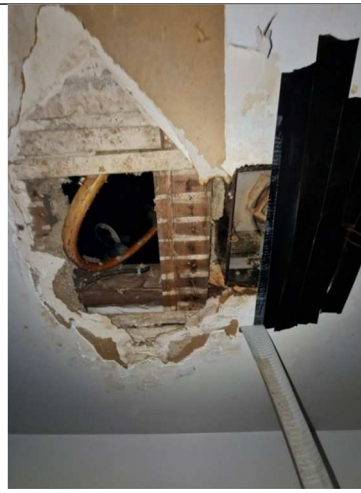
Photo 17: Hole in ceiling. Showing signs of water damage.

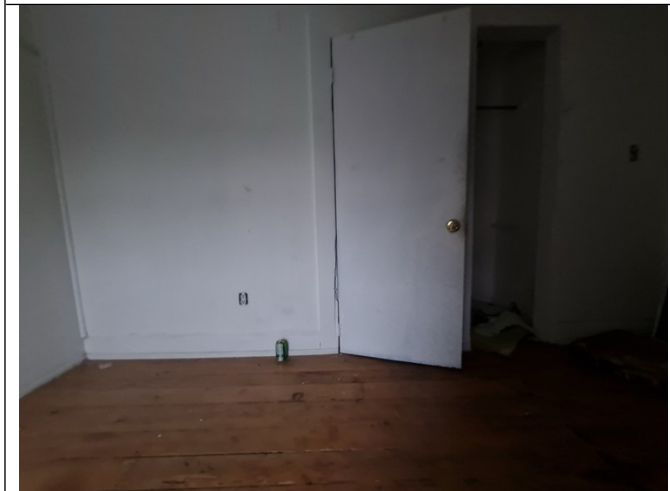
Photo 18: Slanted Floor.

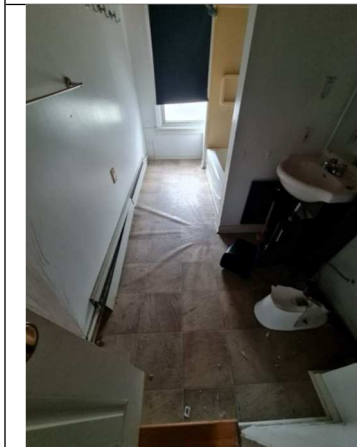
Photo 20: Flood caused water damage to floors, likely underlying damage.

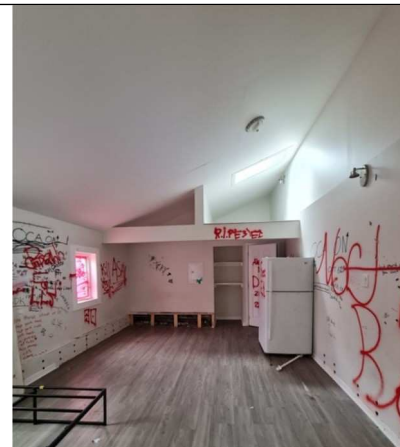
Photo 21: Small bulge in drywall.

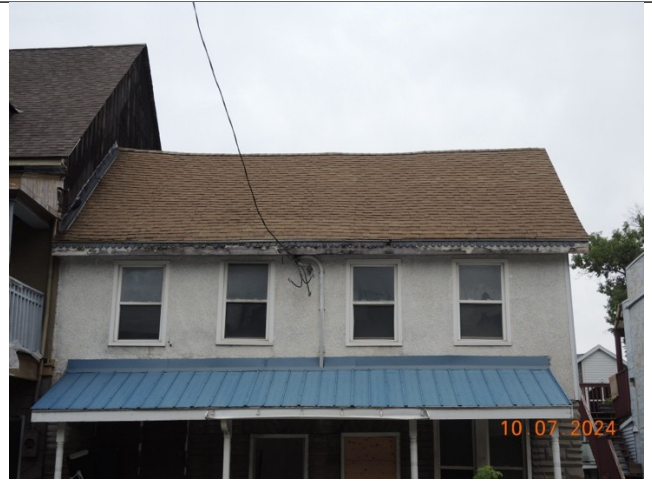
Photo 23: The roof line has a general West-East slope with localized sagging in certain areas.

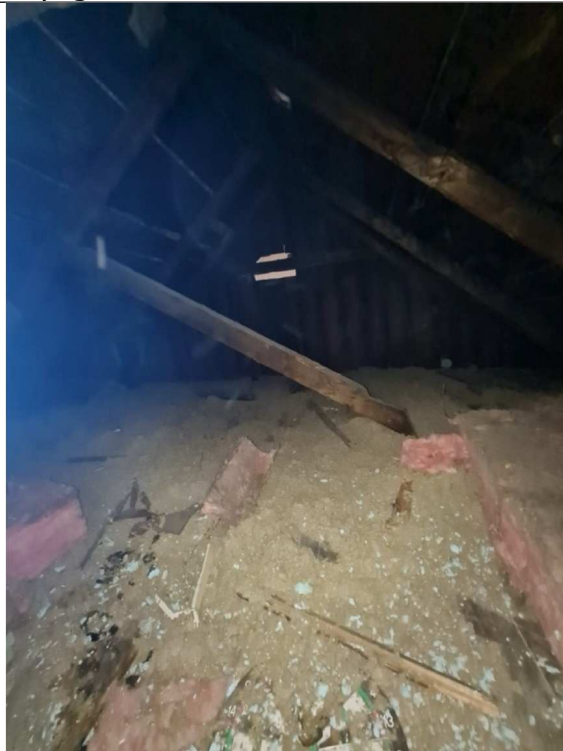
Photo 24: Rafter-tie is disconnected from rafter. End where previously connected has dark staining.

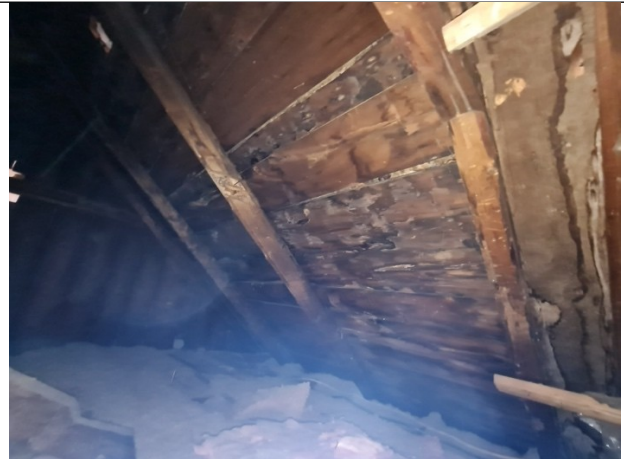
Photo 25: Staining of roof rafters and plank decking. Contemporary roof sheathing has been installed on top.

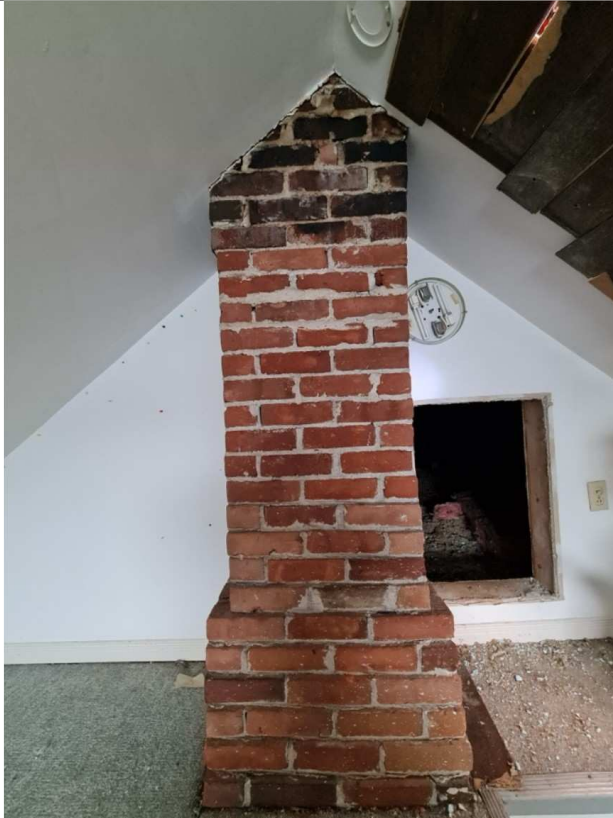
Photo 26: Chimney, with upper portion showing decay and moisture damage.
