CAPACITY ENGINEERING LTD.

# Condition Assessment

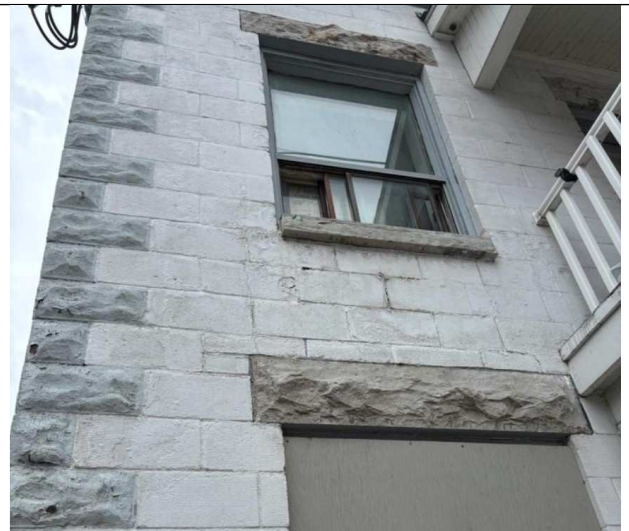
Photo 2: Weathering, vertical cracking and step cracking in cladding.

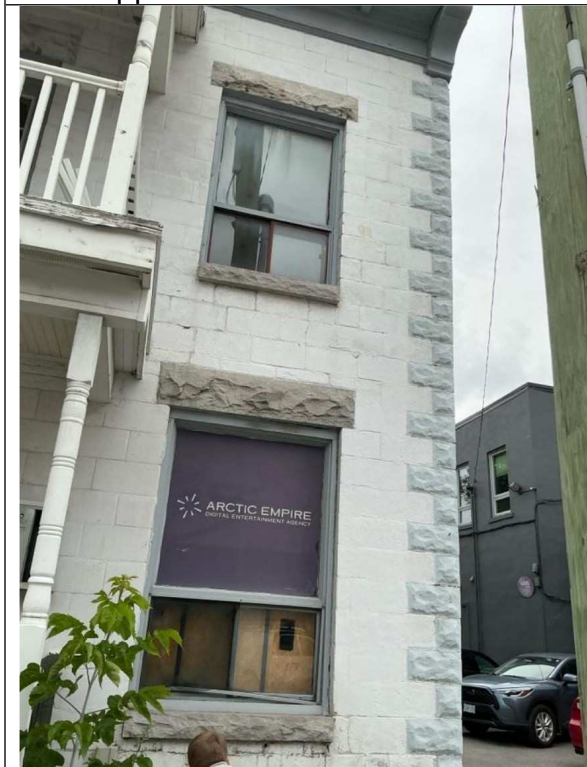
Photo 3: Weathering, vertical cracking and step cracking in faux-stone concrete veneer.

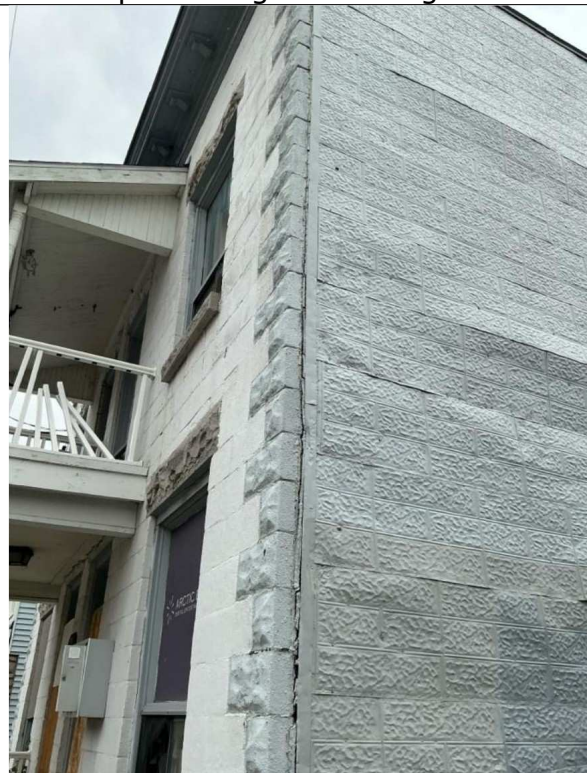
Photo 4: Nail applied tin panelling over timber wall (right) and Faux-stone concrete veneer detaching from underlying structure at South-East corner.

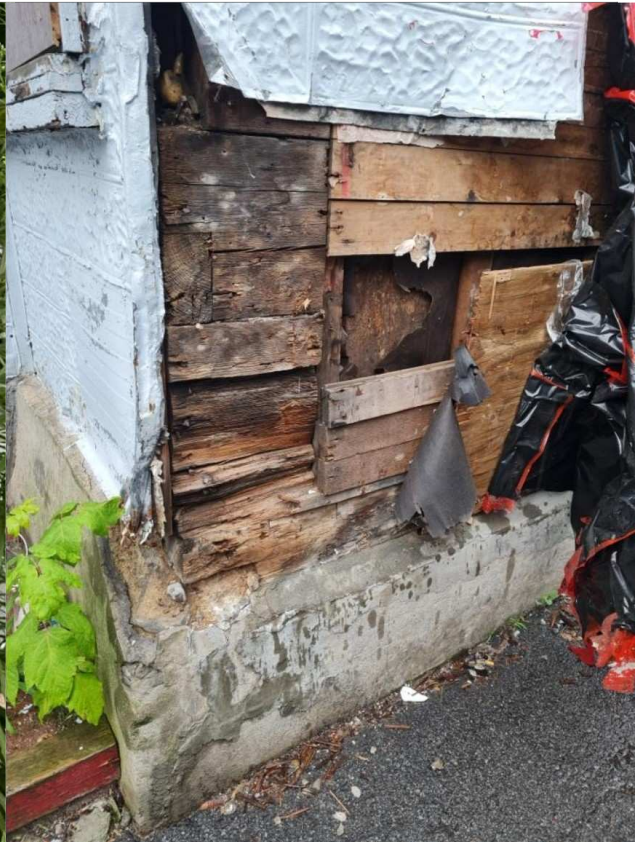
Photo 6: Previously replaced exterior wall section with decay and foundation wall deterioration.

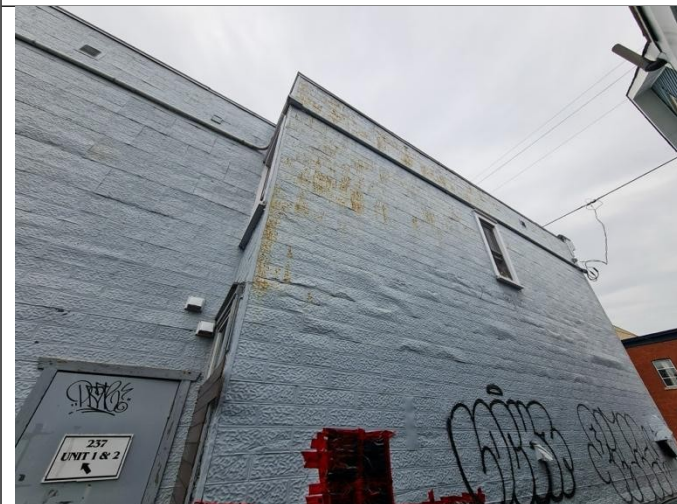
Photo 7: Bulging and peeling of existing cladding on West wall.

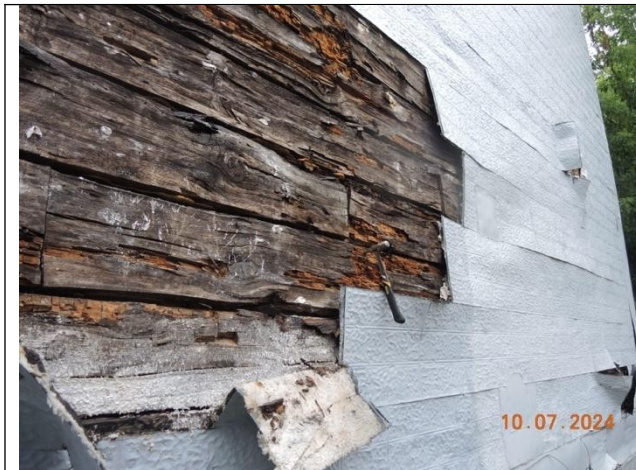
Photo 9: Advanced decay in exterior walls at opening in the cladding on East wall.

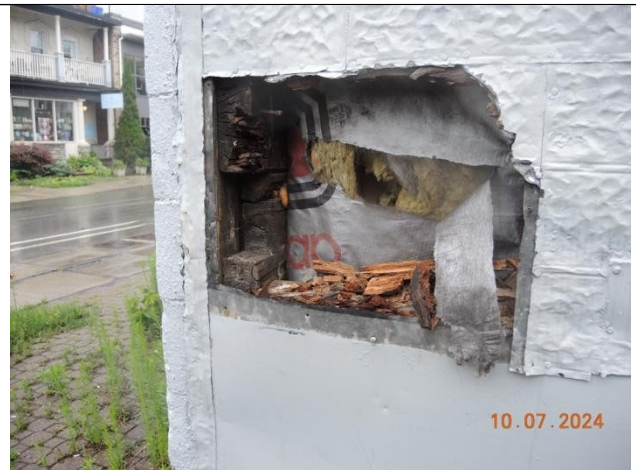
Photo 10: Advanced decay in exterior walls at opening in the cladding on East wall.

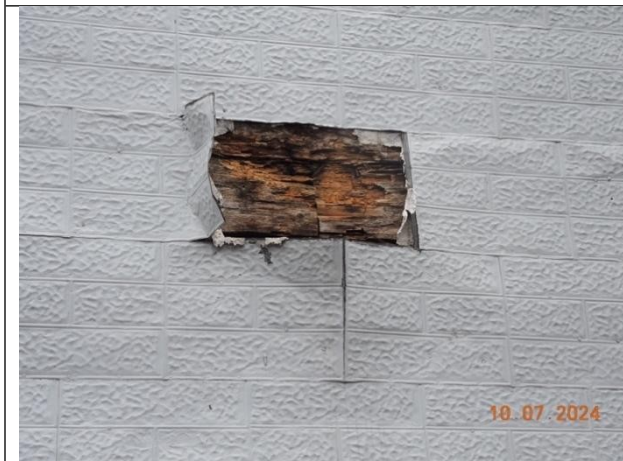
Photo 11: Advanced decay in exterior walls at opening in the cladding on East wall.

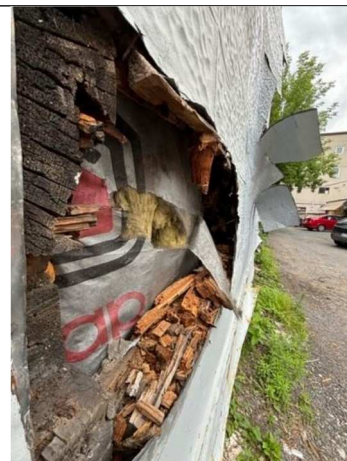
Photo 12: Remains of deteriorated wall are visible piling up at the base of opening in the East wall at the Southern edge.

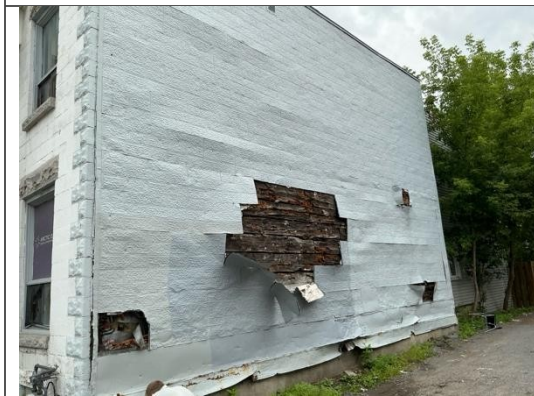
Photo 13: View of East wall.

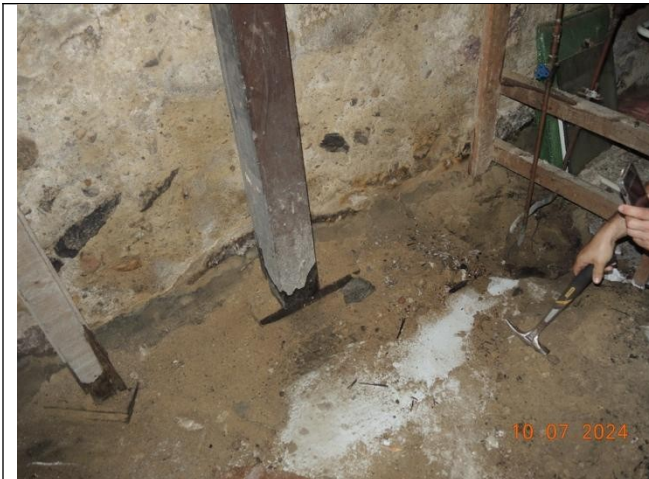
Photo 15: Sand build-up at base of wall due to deterioration.

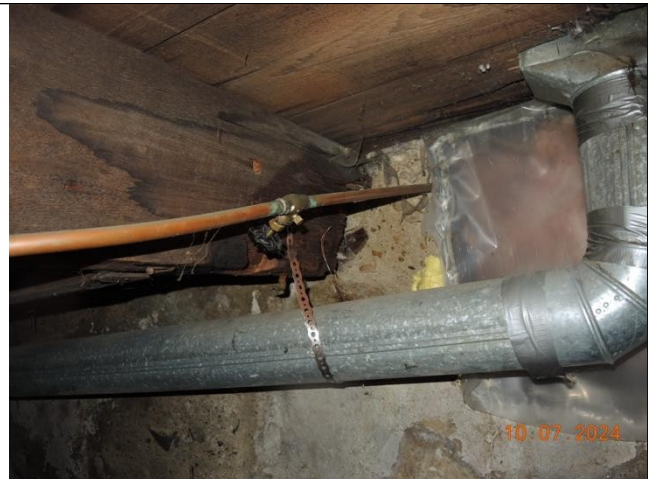
Photo 16: End of beam deteriorated due to rot. Beam has lost all connection to foundation wall.

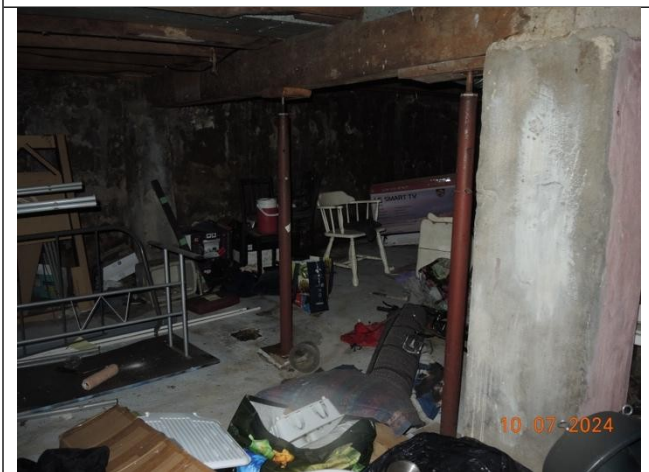
Photo 17: Jackposts and steel beam installed to support sagging floors.

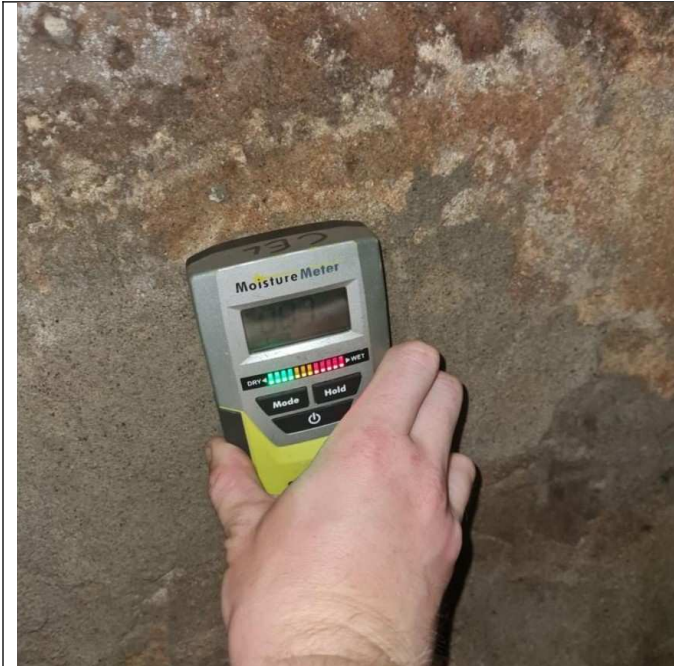
Photo 19: High moisture content near base of foundation wall (87%)

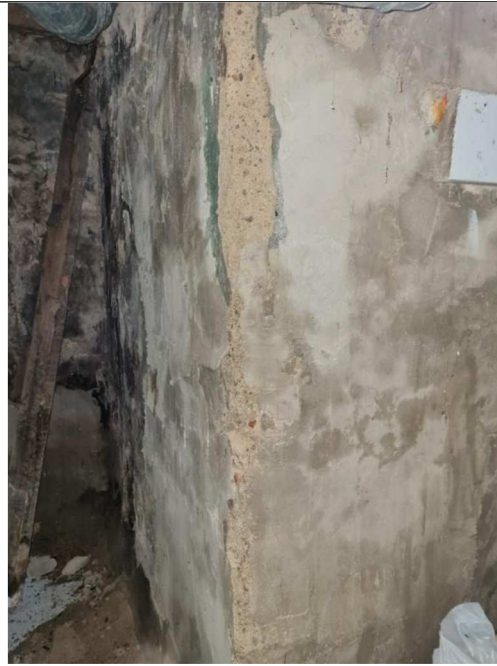
Photo 20: Deterioration of foundation wall.

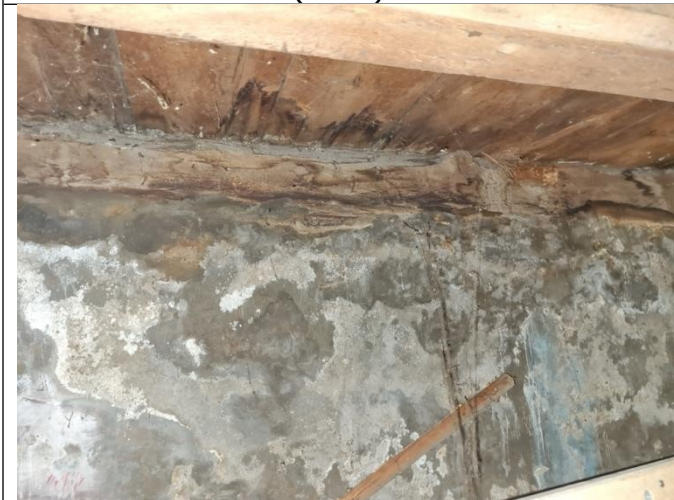
Photo 21: Decayed and stained wood structure on top of foundation wall.

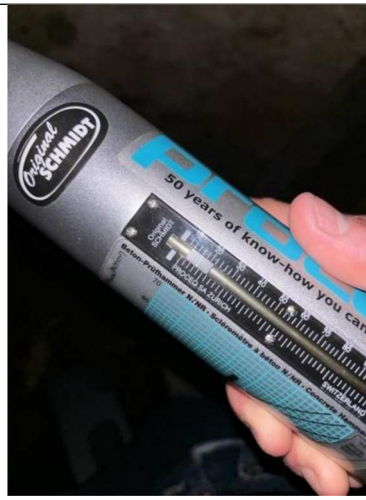
Photo 22: Photo of a Schmidt hammer test of foundation wall compressive strength.

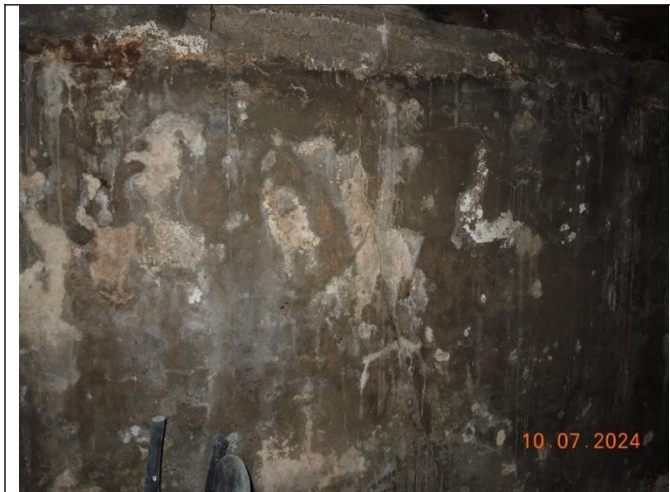
Photo 23: Crack and discolouration in foundation wall.

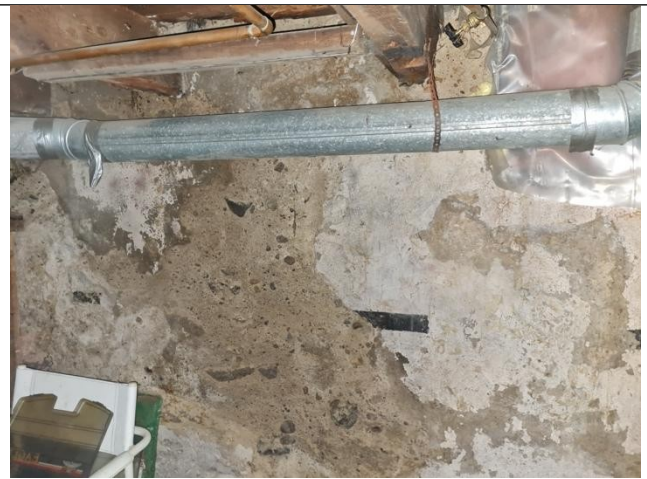
Photo 24: Severe scaling of the wall.

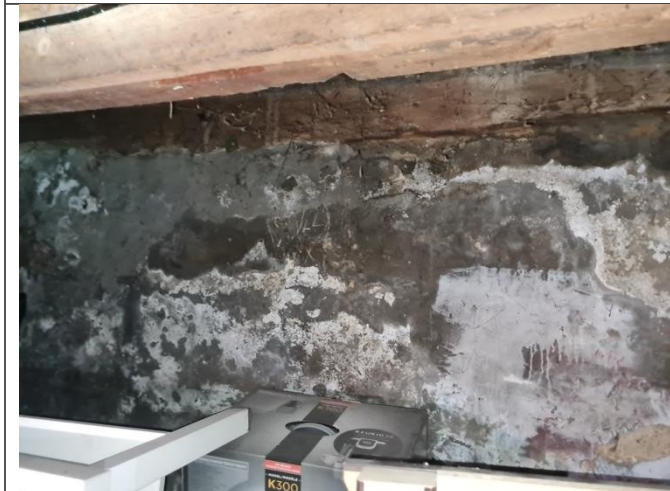
Photo 25: Efflorescence, discolouration & staining on the wall. Possible sulphate attack.

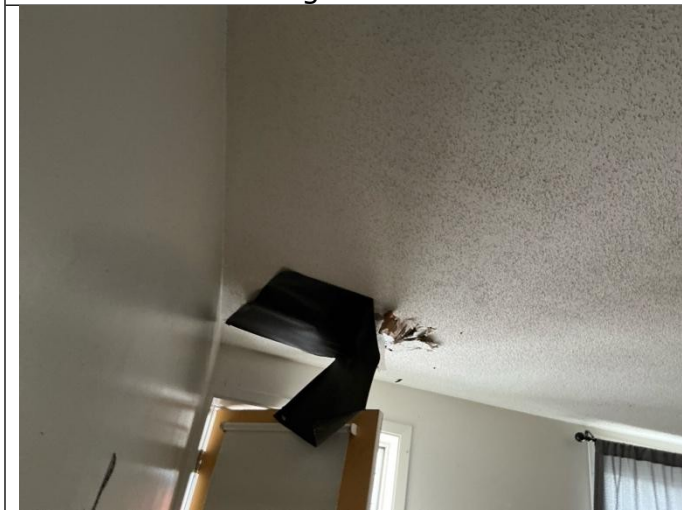
Photo 28: Ceiling damage.

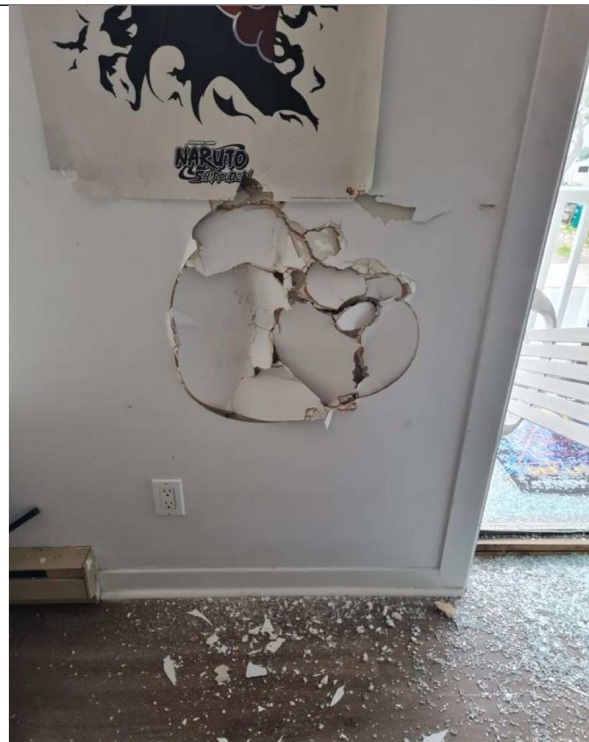
Photo 29: Drywall damage.
