**AZURE URBAN DEVELOPMENTS INC.**

## **254 ARGYLE AVENUE**

### **Church Relocation Scenarios Analysis**

**Project Number: 2023-049-2**

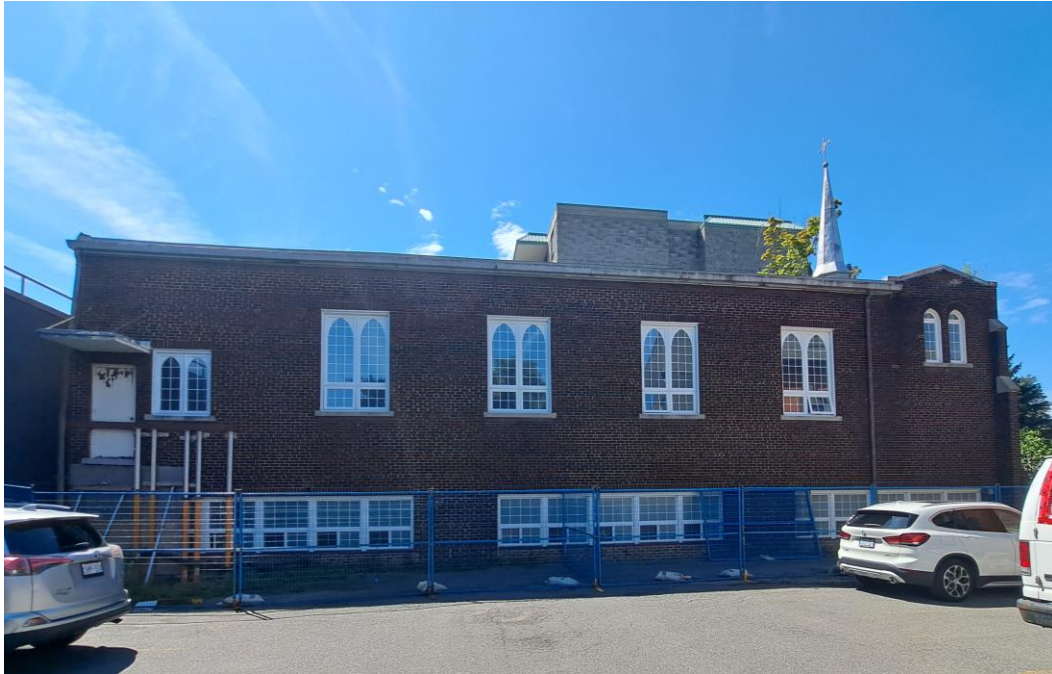
**Figure 3: Left Side Wall (East Facade)**

It was observed that the exterior left wall is suffering from significant damage throughout. The following list displays the numerous deficiencies noticed on this wall during our visit on site:

- There are wide step cracks in the brick cladding at the top corners of the two large basement windows and several wide cracks at the southeast corner and a damaged area is covered with plywood in the southeast corner. This could indicate subsidence or movement to the wall, as well as a serious structural issue to the building.

- There is a substantial settlement in the south-east corner, which is the closest area to the excavation works performed at 203 Catherine Street back in 2015. The total movement at the southeast corner was 72mm when observed by Keller Engineering on February 24, 2017.

- Vertical supports are provided as temporary measures to prevent the whole south-east corner separating from left and back walls (see Figure 3 & 4).
- Some windows have broken glass in the basement level which is additional evidence of the movement of the wall.

- There are several cracks ranging from 3mm to 5mm especially around the windows and at the southeast corner. The main reason for such cracks is the settlement of the building.

- The wall is leaning outwardly by 1cm for every meter.

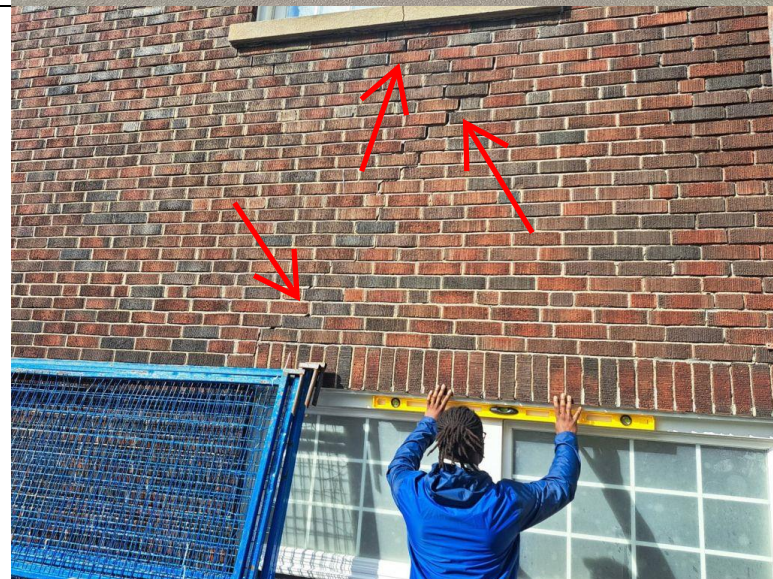
Photo 5  
Stepped wide cracks noted along the South wall

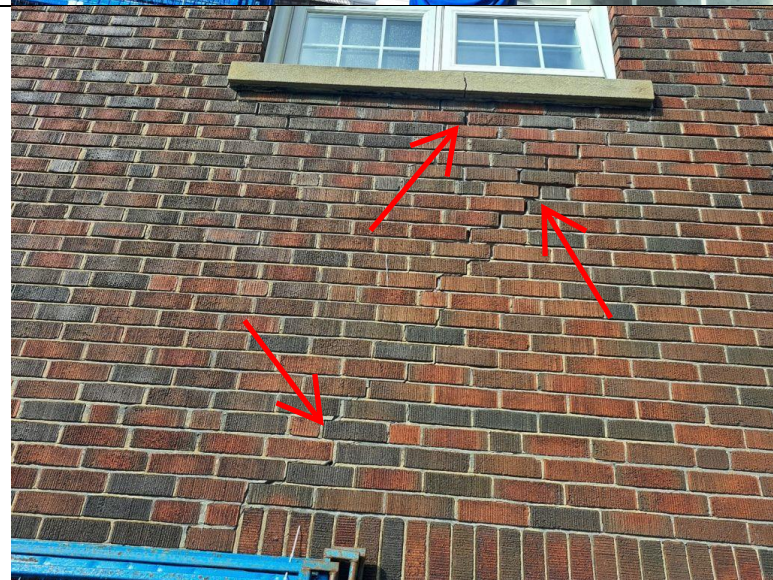
Photo 6  
Stepped wide cracks noted along the South wall

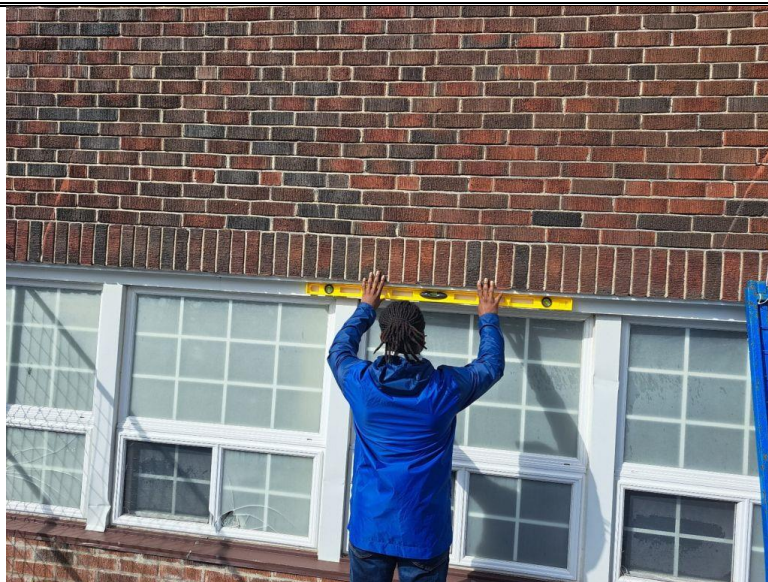
Photo 7

The building is tilted and there is noticeable settlement at the Southeast corner

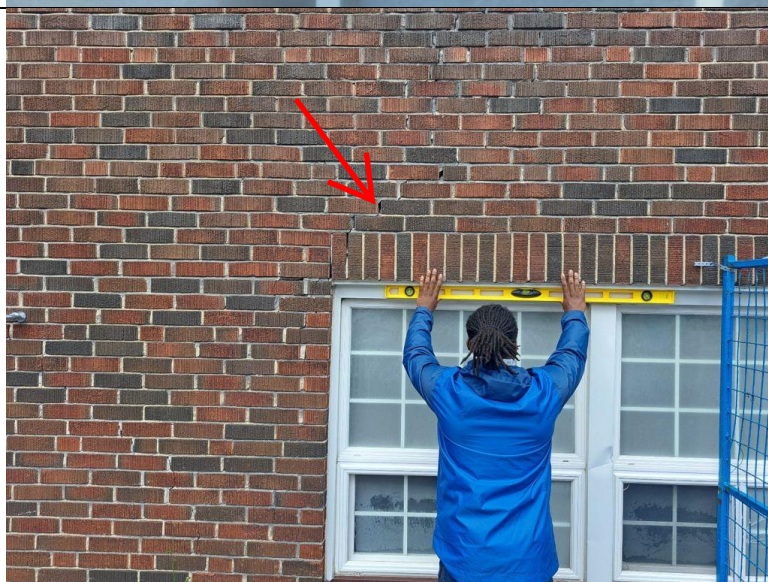
Photo 9

Stepped wide cracks noted along the South wall

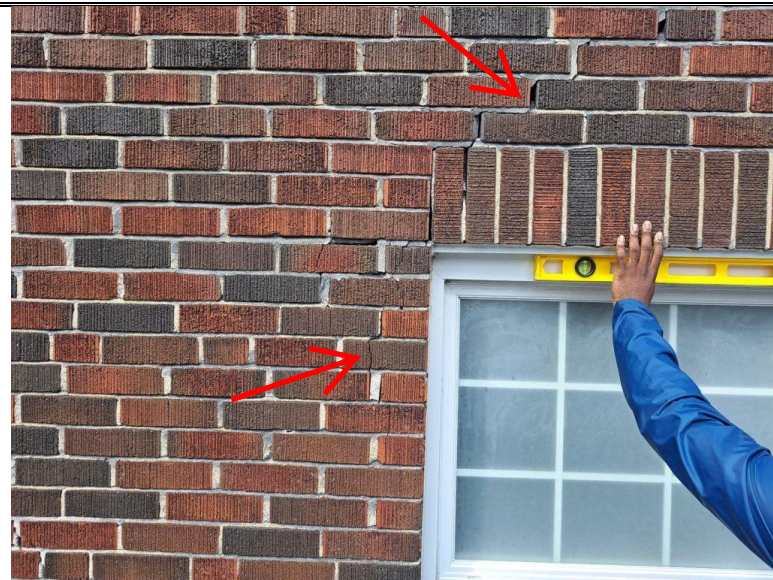
Photo 10  
Stepped wide cracks noted along the South wall

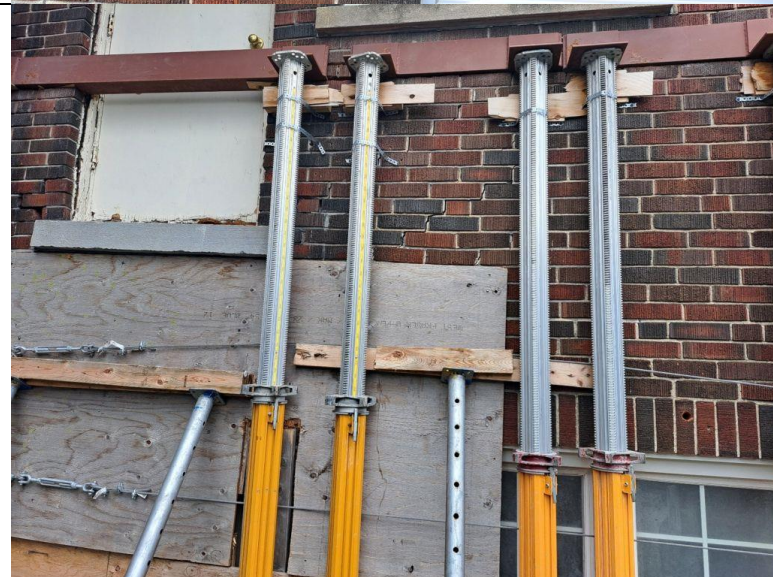
Photo 11  
The southeast corner is secured by fastening plywood to the brick and three cables

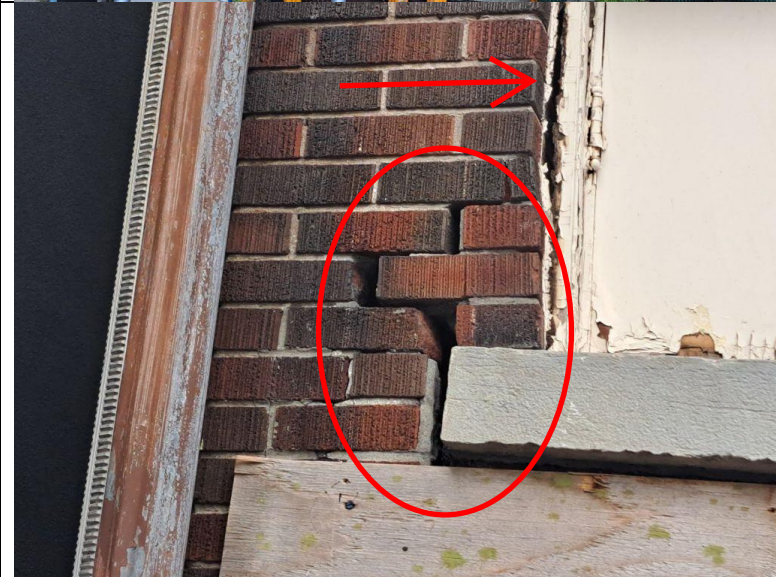
Photo 14

Huge cracks noticed at the Southeast corner

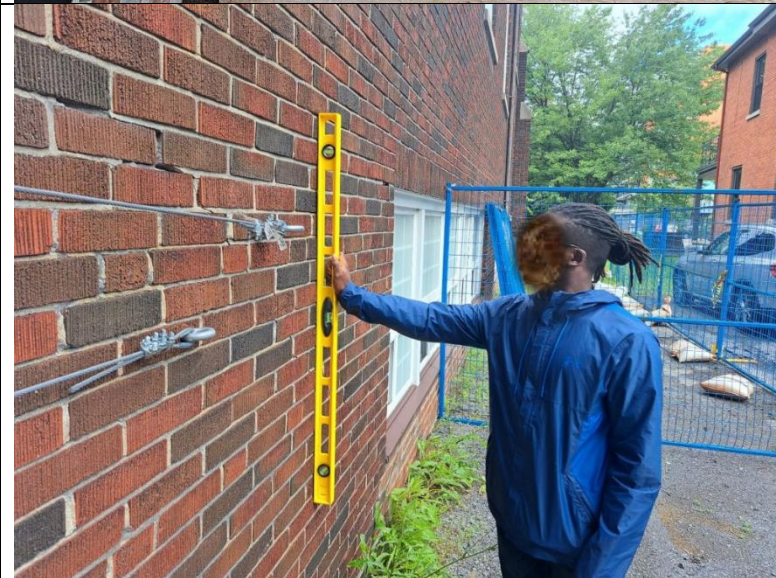
Photo 15

The South wall is leaning to the outside by 1cm for every meter

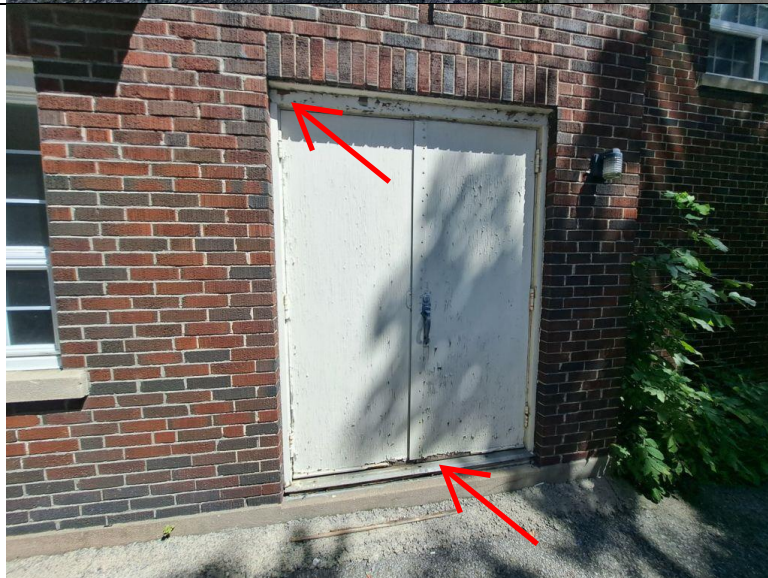
Photo 18  
The side door is in a poor condition

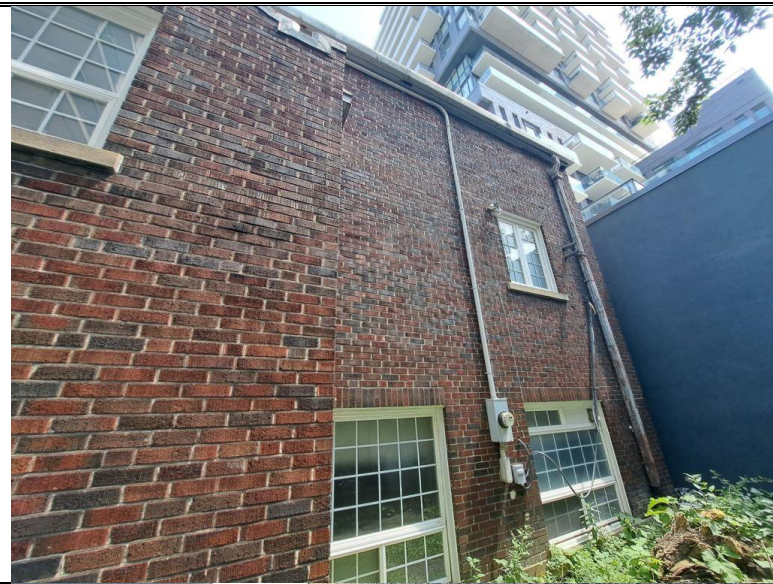
Photo 19

Hair cracks are noted at the top corners of the side door and two windows to the East

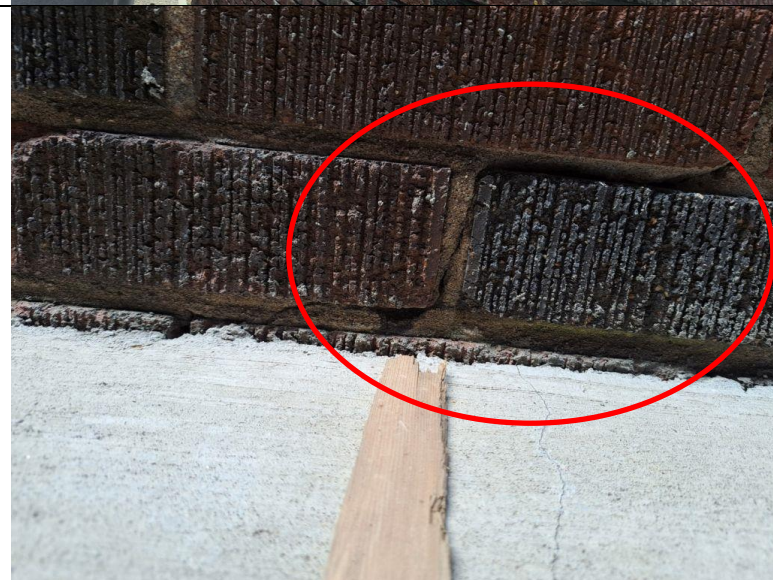
Photo 21

One step crack in the middle of the East wall

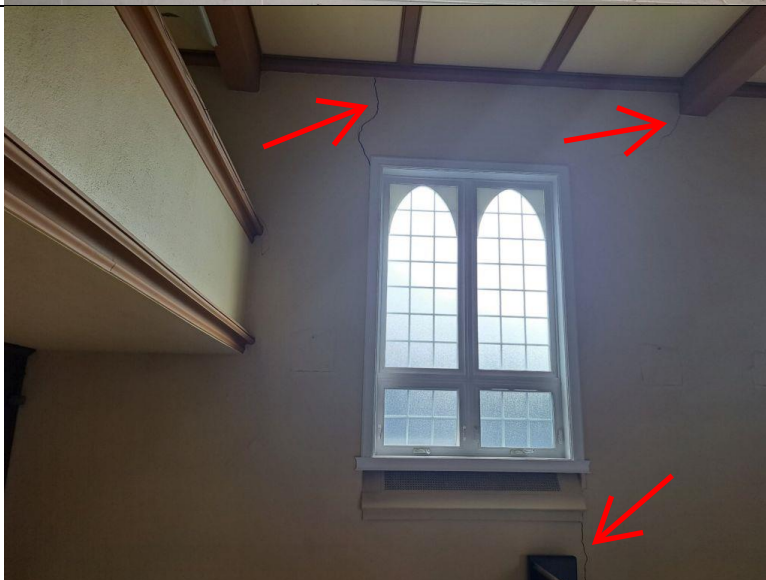
Photo 24  
Cracks are noted along the left side (South) wall

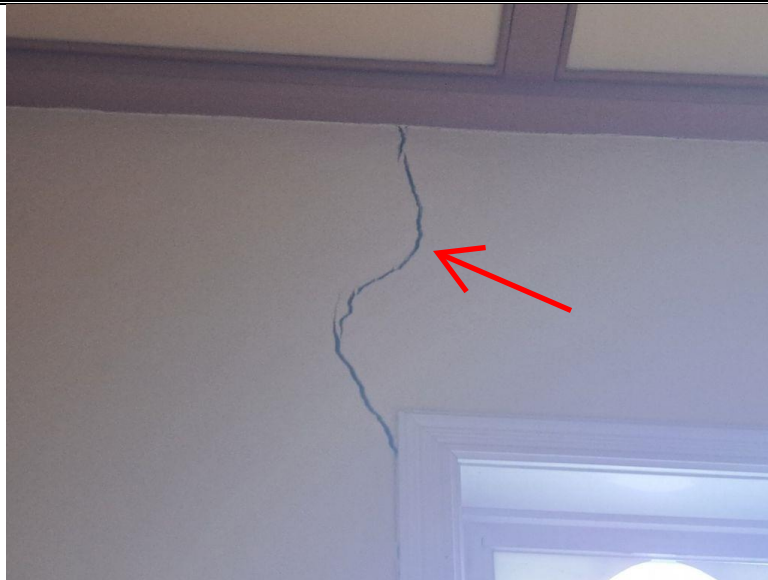
Photo 25  
Cracks are noted along the left side (South) wall

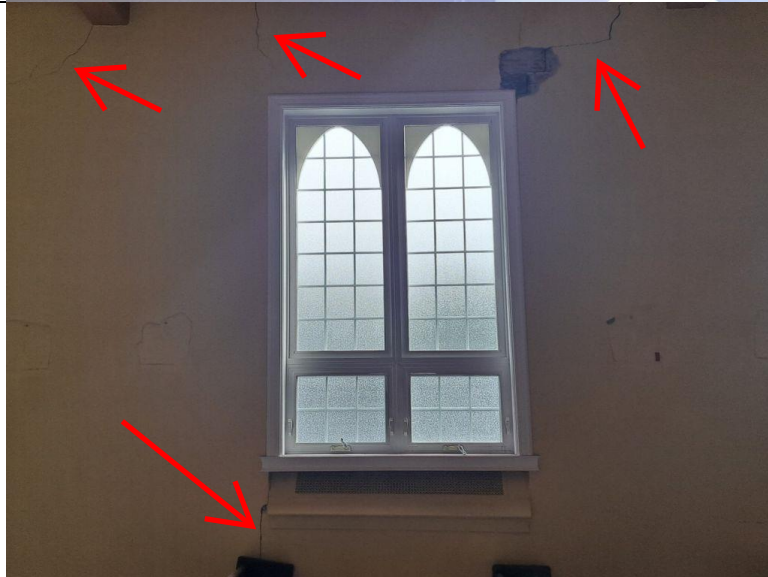
Photo 26  
Cracks are noted along the left side (South) wall

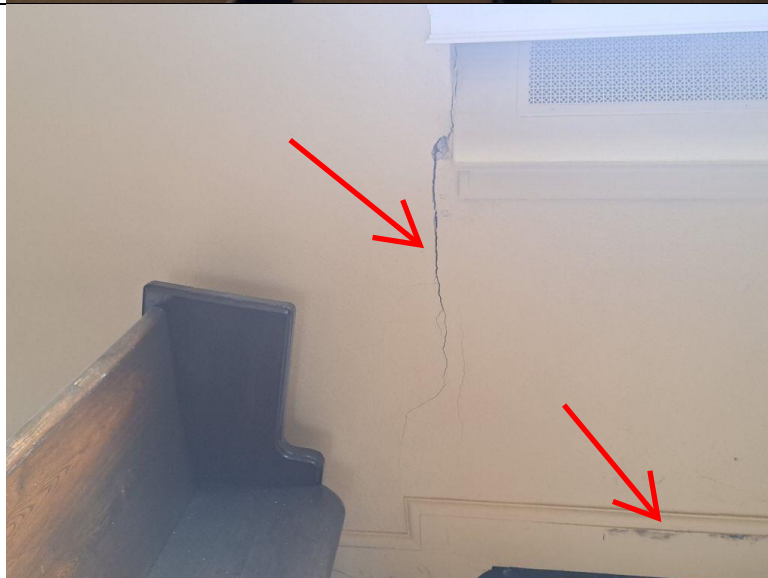
Photo 27  
Cracks are noted along the left side (South) wall

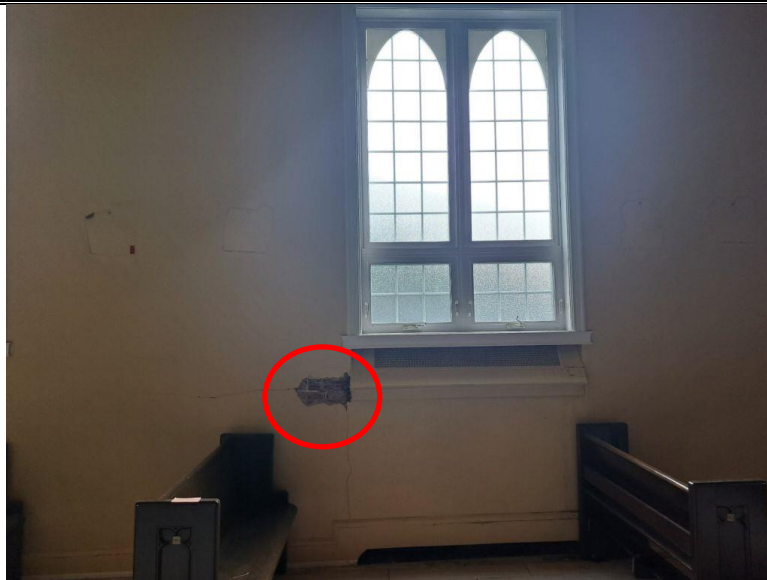
Photo 28  
Cracks are noted along the left side (South) wall

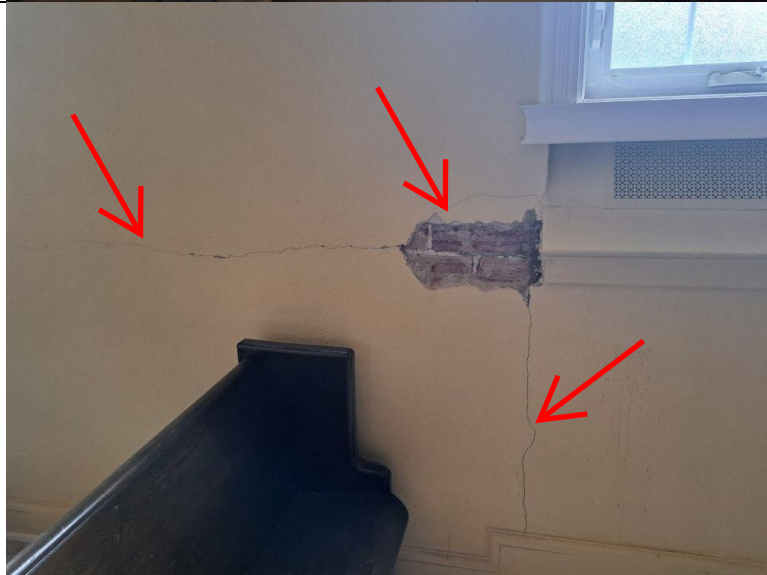
Photo 29  
Cracks are noted along the left side (South) wall

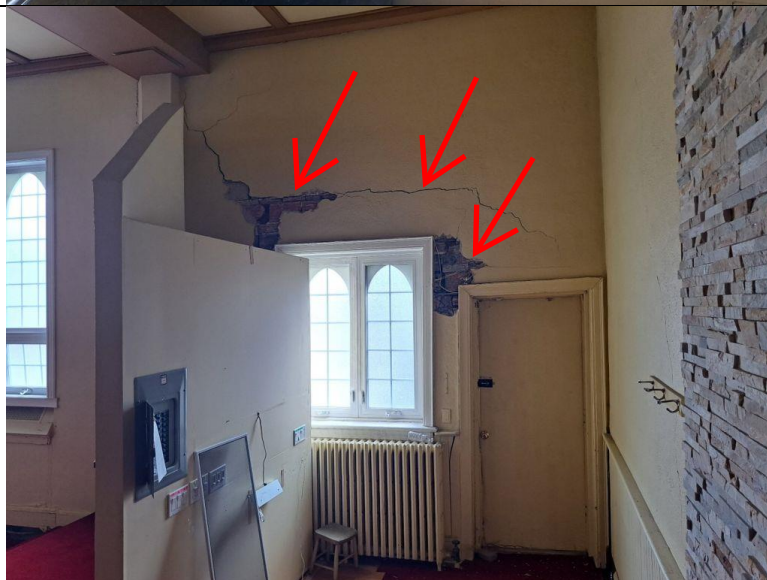
Photo 30  
Cracks are noted along the left side (South) wall

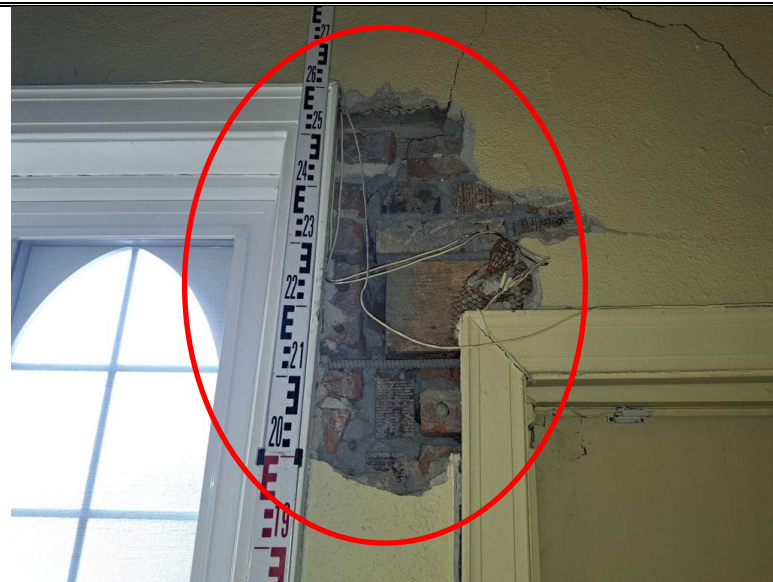
Photo 31

Plaster has spalled exposing the terracotta hollow core blocks and the wood lintel

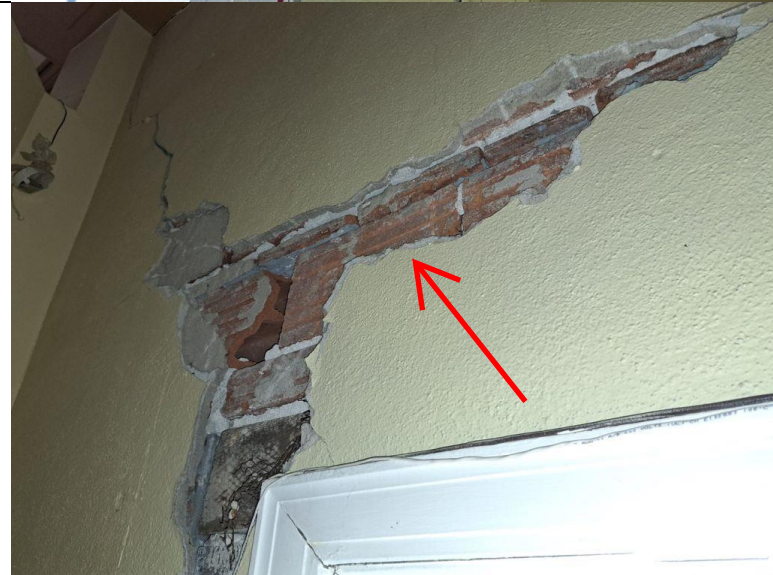
Photo 32

Plaster has spalled exposing the terracotta hollow core blocks and the wood lintel

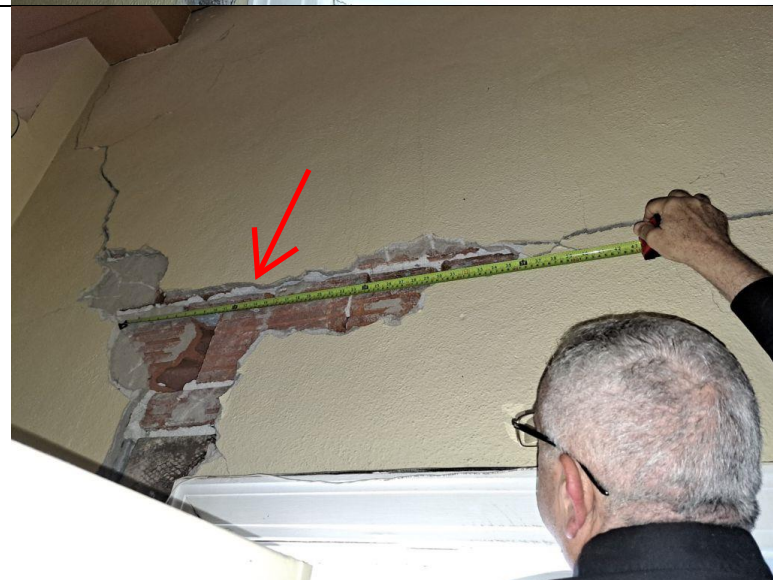
Photo 33

Plaster has spalled exposing the terracotta hollow core blocks and the wood lintel

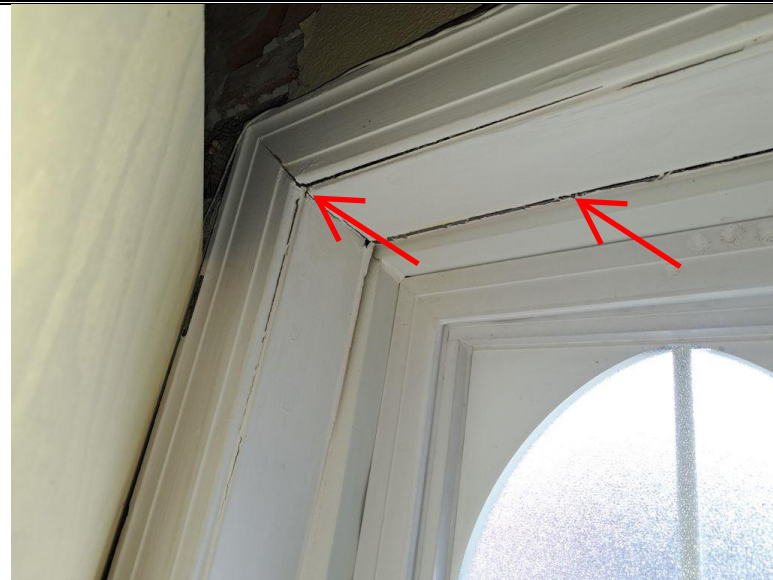
Photo 34  
Sever damage and cracks to the fire exit door  
at the Southeast corner

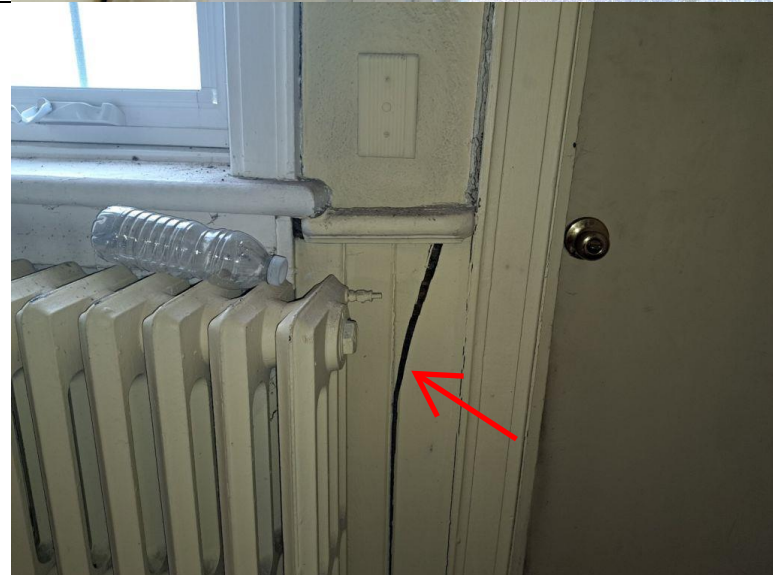
Photo 35  
Sever damage and cracks to the fire exit door  
at the Southeast corner

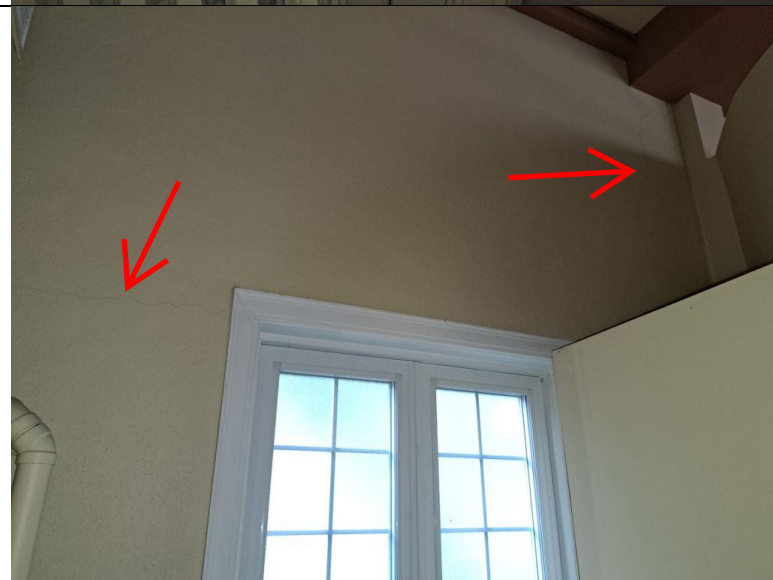
Photo 36  
Several hair cracks at the top and the bottom  
of the windows and door lintel, and painted  
plaster with average quality

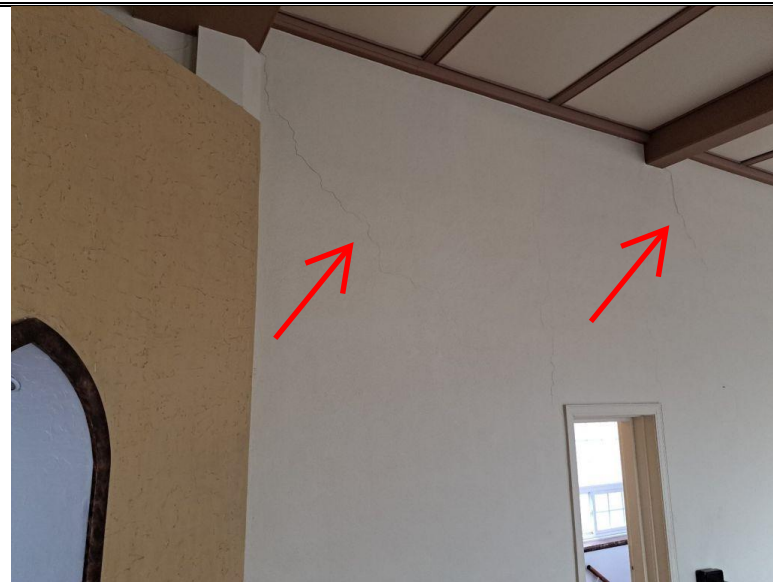
Photo 37

Several hair cracks at the top and the bottom of the windows and door lintel, and painted plaster with average quality

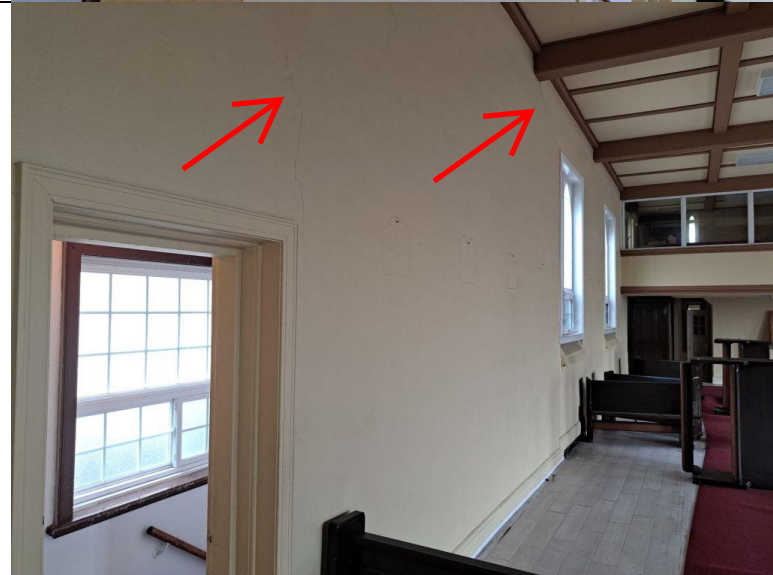
Photo 38

Several hair cracks at the top and the bottom of the windows and door lintel, and painted plaster with average quality

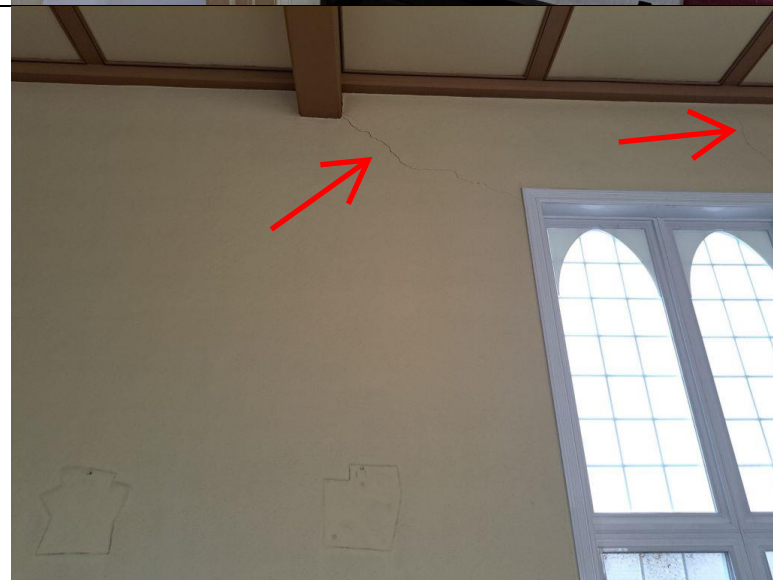
Photo 39

Several hair cracks at the top and the bottom of the windows and door lintel, and painted plaster with average quality

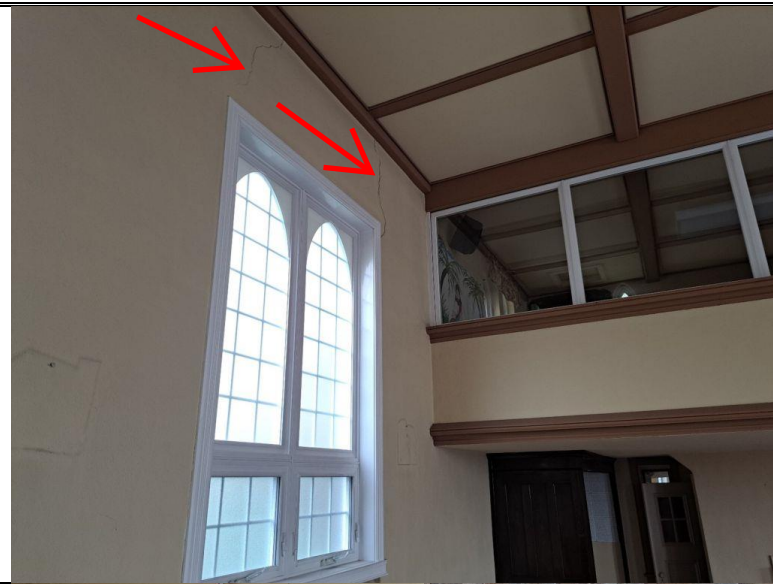
Photo 40

Several hair cracks at the top and the bottom of the windows and door lintel, and painted plaster with average quality

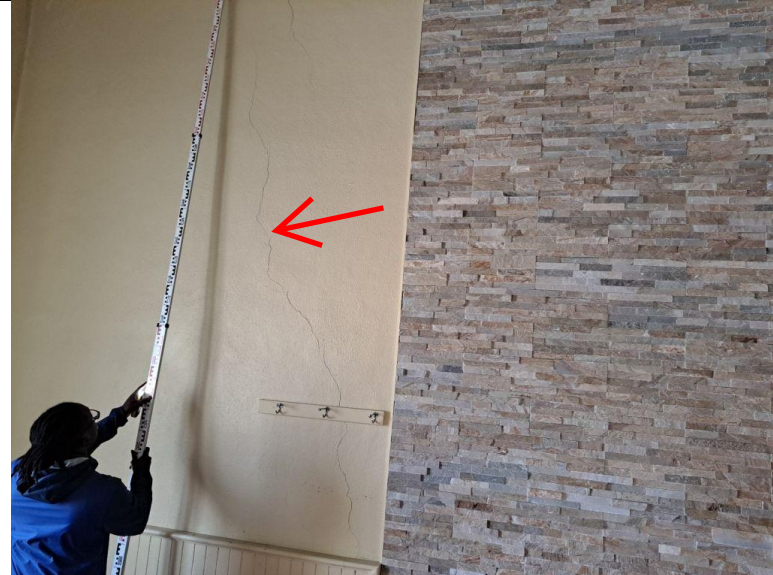
Photo 41

A vertical crack of 1mm width is noted from the top to the bottom of the rear wall (East side)

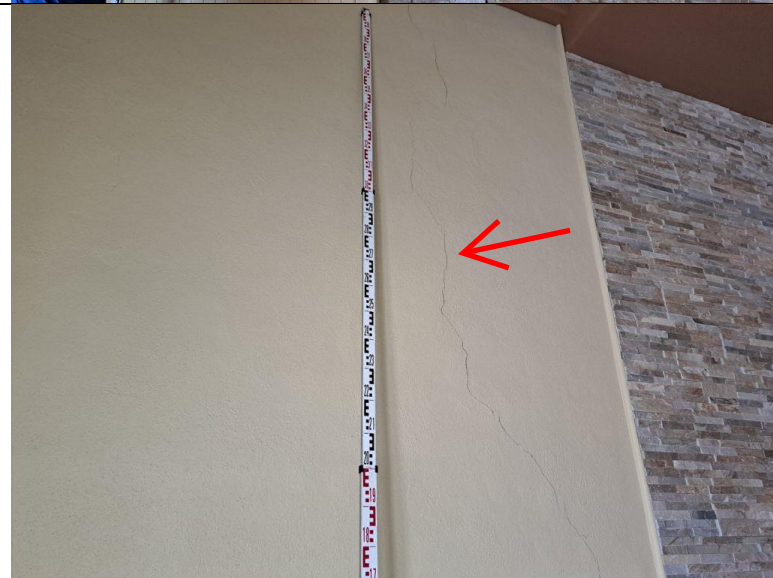
Photo 42

A vertical crack of 1mm width is noted from the top to the bottom of the rear wall (East side)

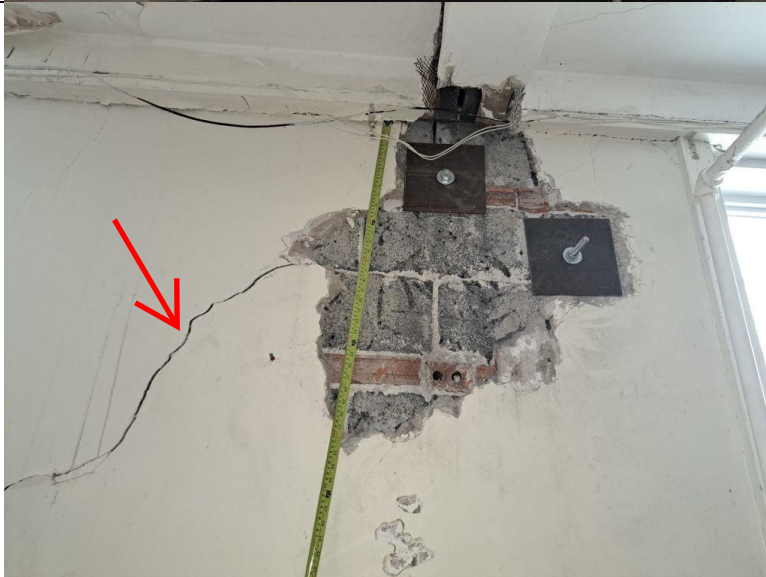
Photo 50  
Diagonal cracks of 4mm width

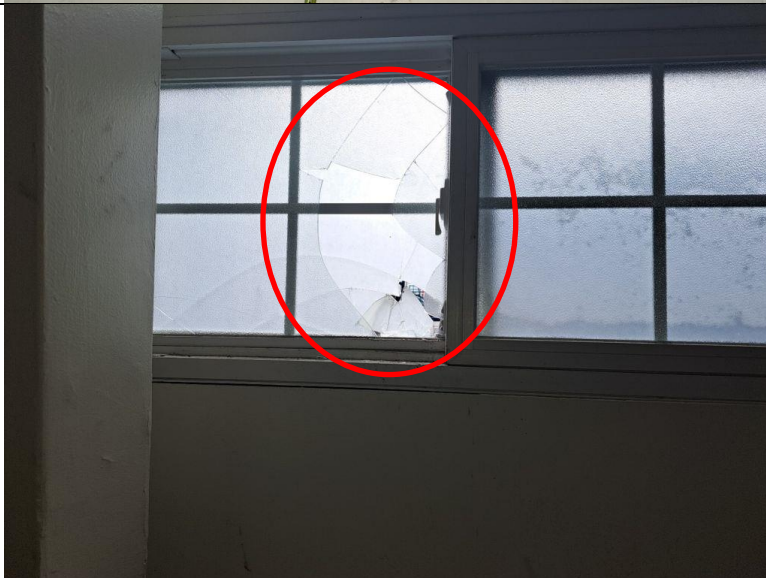
Photo 51  
Windows with broken glass

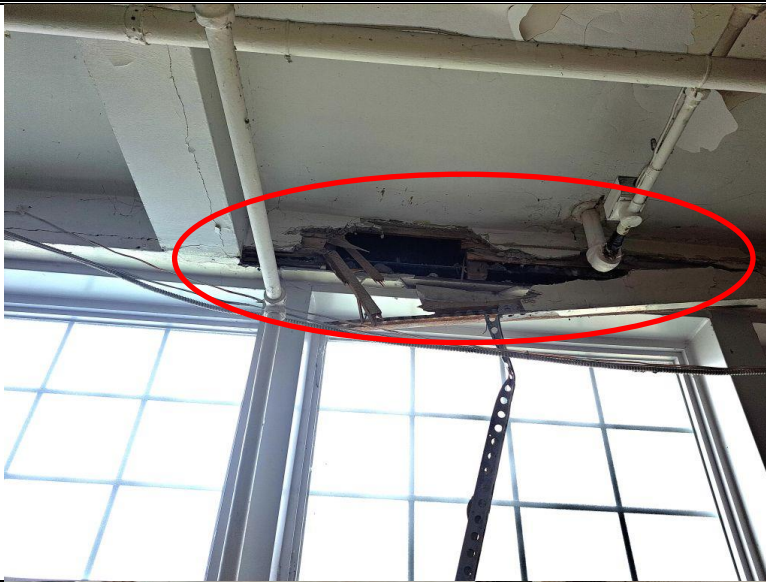
Photo 52  
Sever damages at the Southeast corner

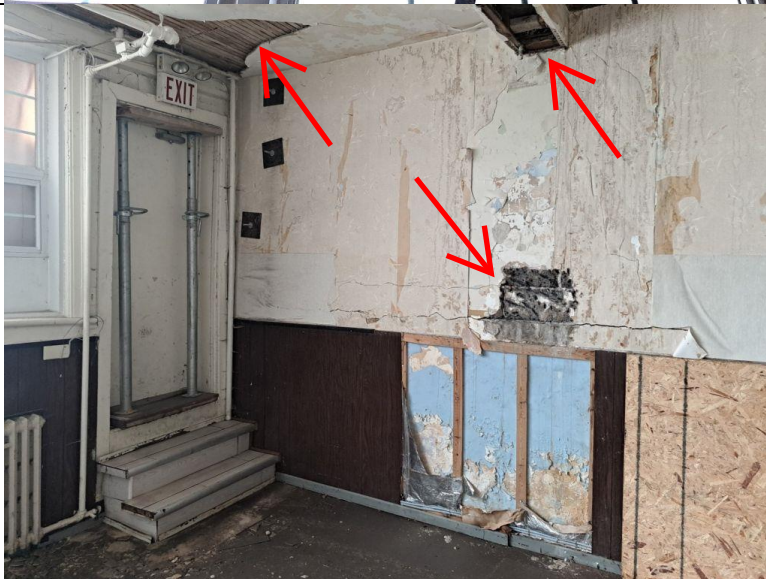
Photo 53  
Sever damages at the Southeast corner

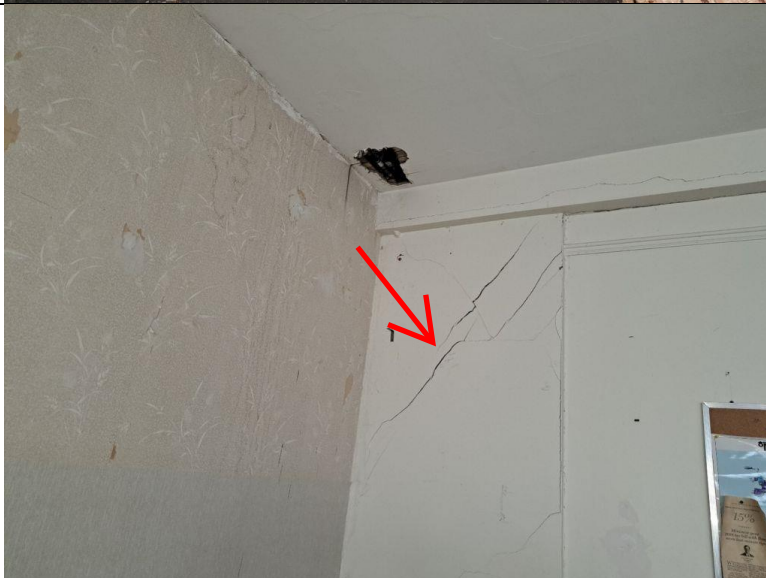
Photo 54  
Diagonal cracks of the right (North side) wall

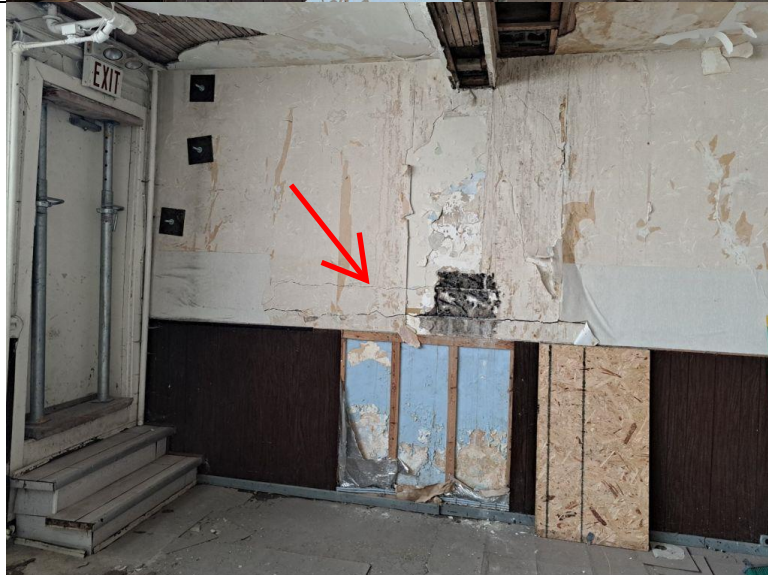
Photo 56  
Horizontal crack of at least 5mm width at the  
rear side wall (East side) at the basement level

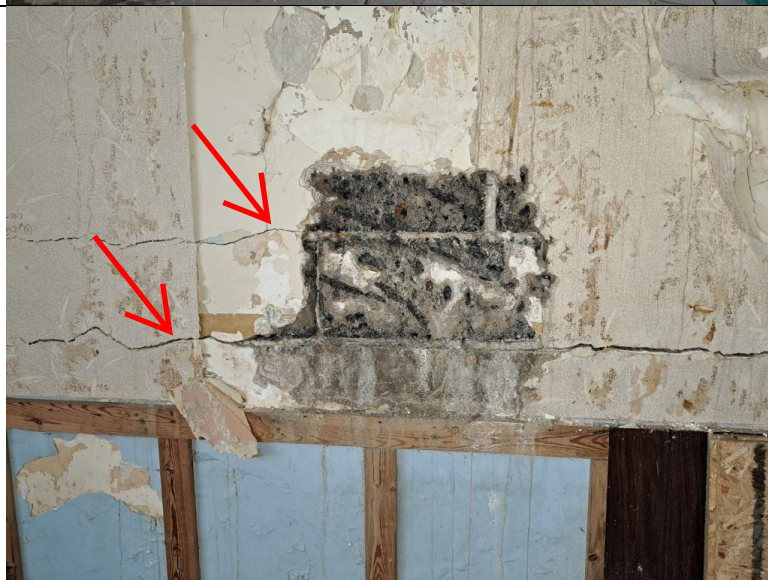
Photo 57  
Horizontal crack of at least 5mm width at the  
rear side wall (East side) at the basement level

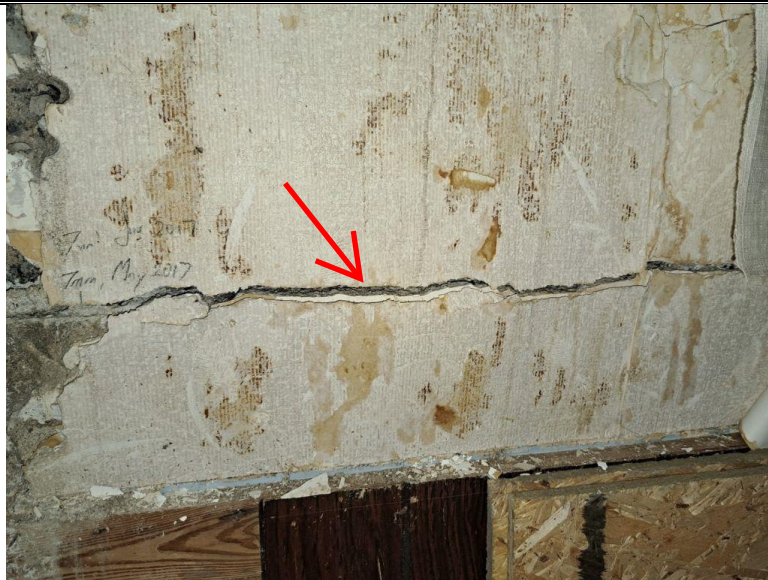
Photo 58  
Horizontal crack of at least 5mm width at the rear side wall (East side) at the basement level

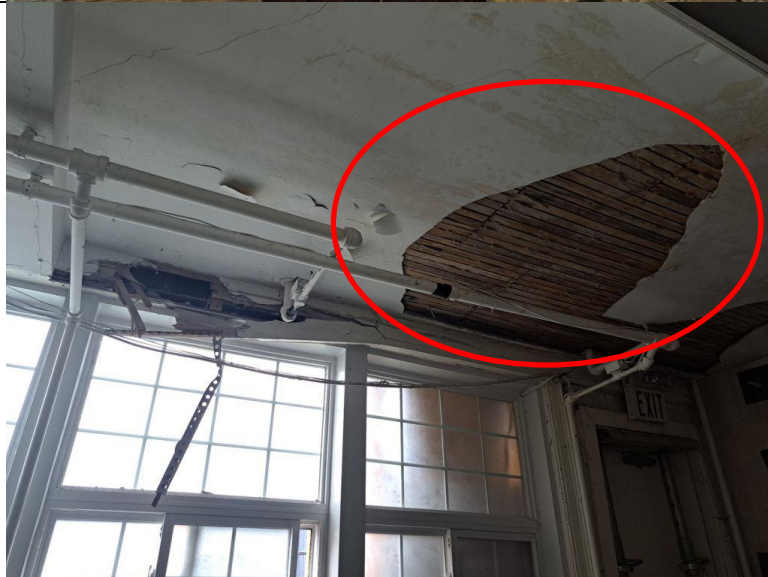
Photo 59  
Exposed ceiling due to plaster that fell down, and damaged wood frame by water, wood has started to rot

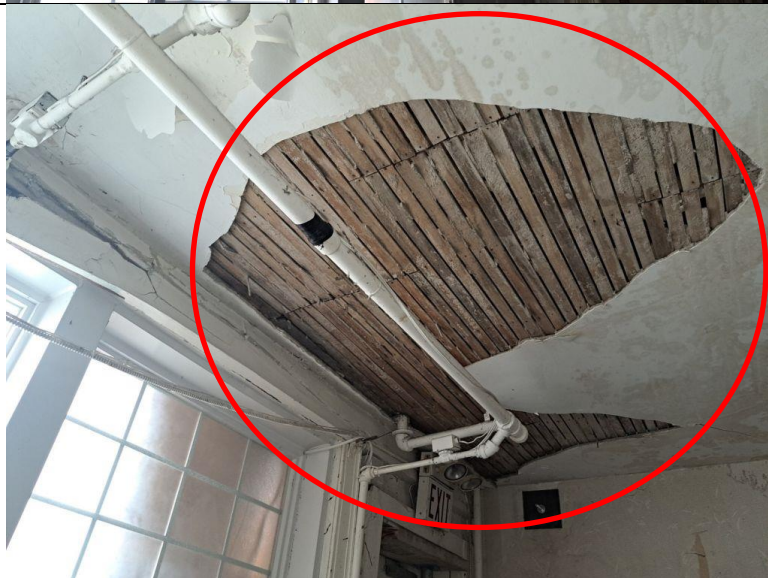
Photo 60  
Exposed ceiling due to Gyproc that fell down, and damaged wood frame by water, wood has started to rot

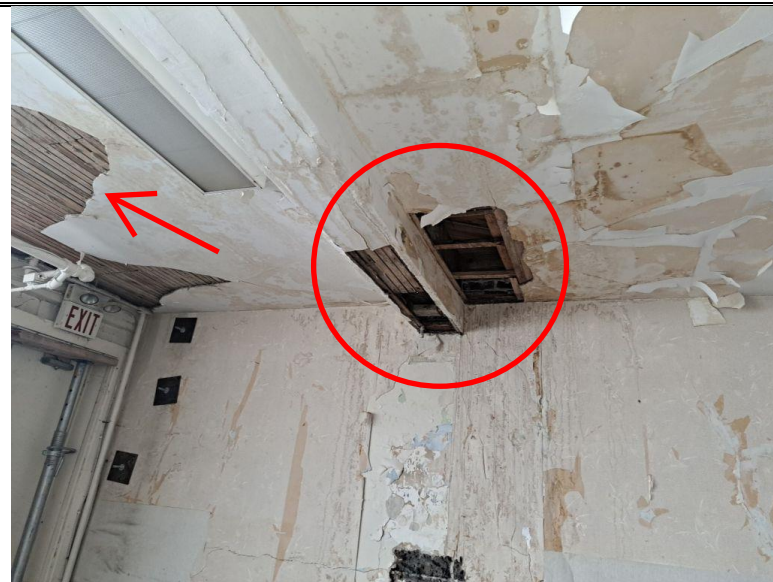
Photo 61

Exposed ceiling due to plaster that fell, and damaged wood frame by water, wood has started to rot

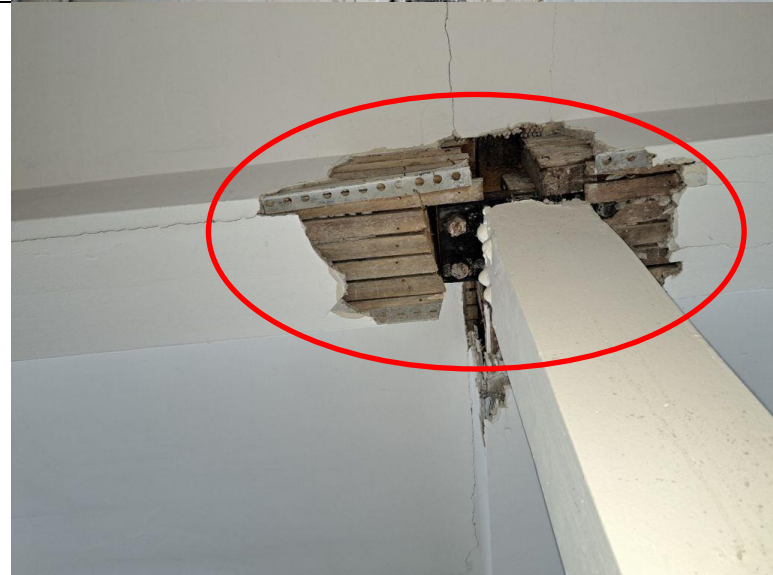
Photo 62

Exposed ceiling due to plaster that fell down, and damaged wood frame by water, wood has started to rot

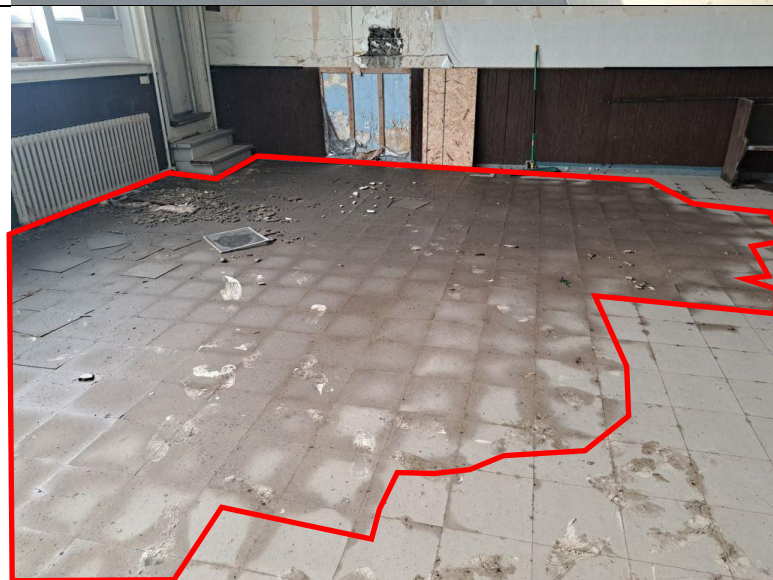
Photo 63

Wet floor due to water leakage

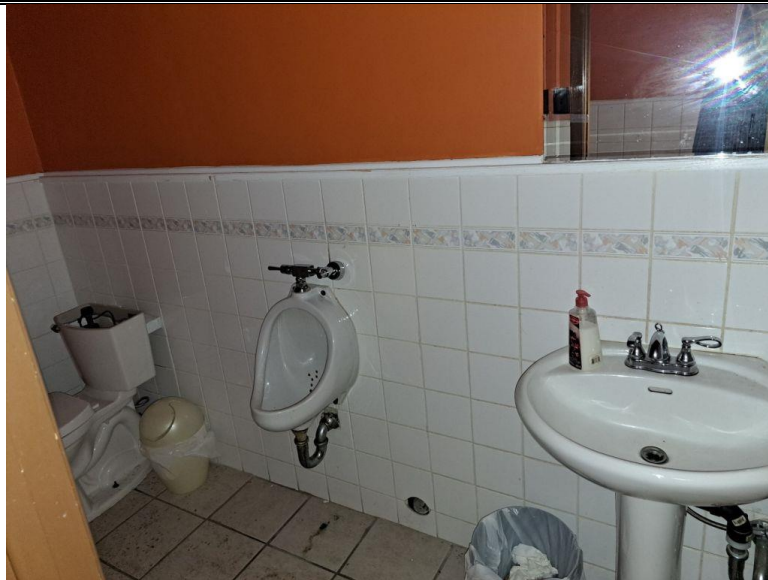
Photo 64  
Room view of the washroom, water was disconnected at the time of inspection, and the washroom was dirty and not maintained

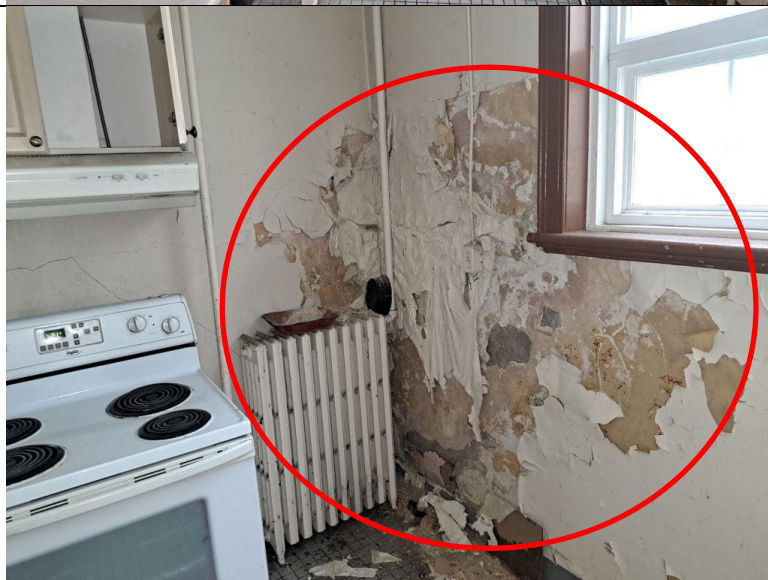
Photo 66  
Moisture intrusion, paint peeling off, and water leakage on the floor

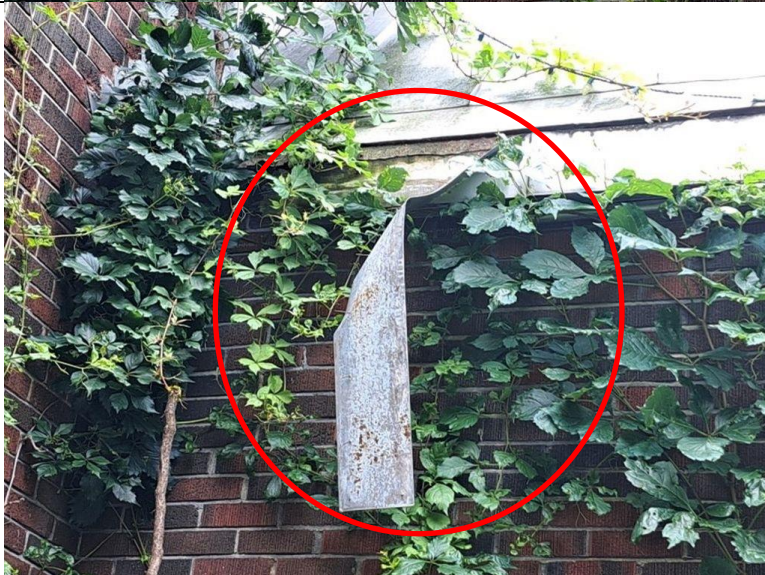
Photo 68  
Flashing damage is noted

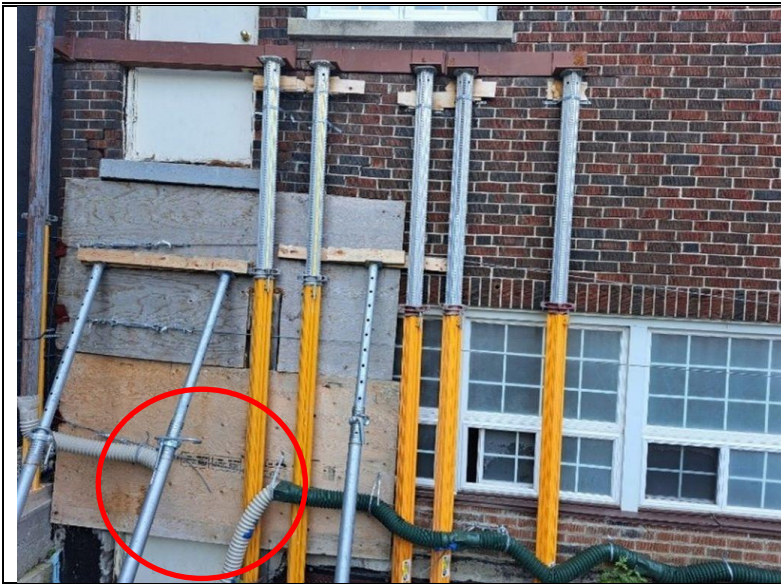
Photo 70

- Downspouts empty too close to the building, concentrating water against the foundation, a very likely source of basement water entry.
- The staircase to the doorway on the main floor was removed.

All down spouts are discharging the rainwater adjacent to building, which leads to moisture penetration to the basement and settlement of the foundation
