**Re: 79 Guigues Avenue, Ottawa
Structural Review Fire and Water Damage
Our Reference Number: 24-8613**

As requested, Cleland Jardine was on site on Sept 4th, 2024 to review the damage done at 79 Guigues Avenue, Ottawa. .

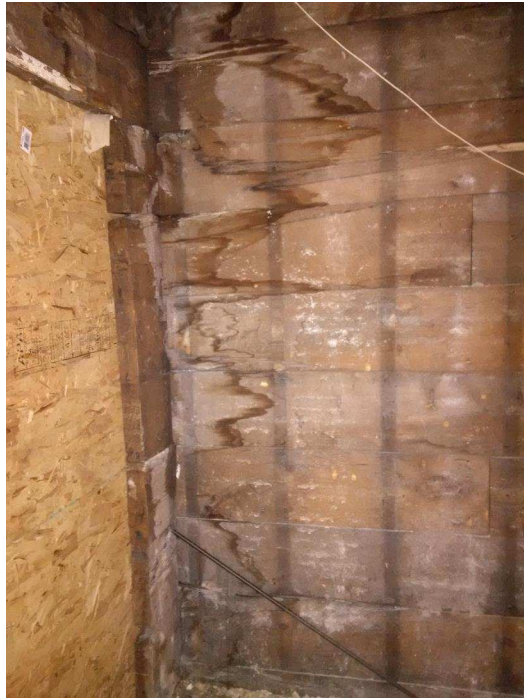
- The plank wall framing has sustained continuous moisture penetration at numerous locations over the decades. Particularly at openings in the building and East Elevation of the building (See Photos One and Seven). This has led to the deterioration of the wood in planks in several locations.
- The wood framing of the roof is in poor condition. There had been water infiltration of numerous years. See attached pick of opening that has rotted thru the roof (See Photo Two). This has occurred at multiple locations. The existing roof planking is in a state of rot needs to be completely replaced over the entire roof area. The roof rafters and joist so signs of dry and wet rot. However, due to the condition of the poor condition of the roof we were opinion that trying to access this area was not safe.

Photo One – Moisture Penetration

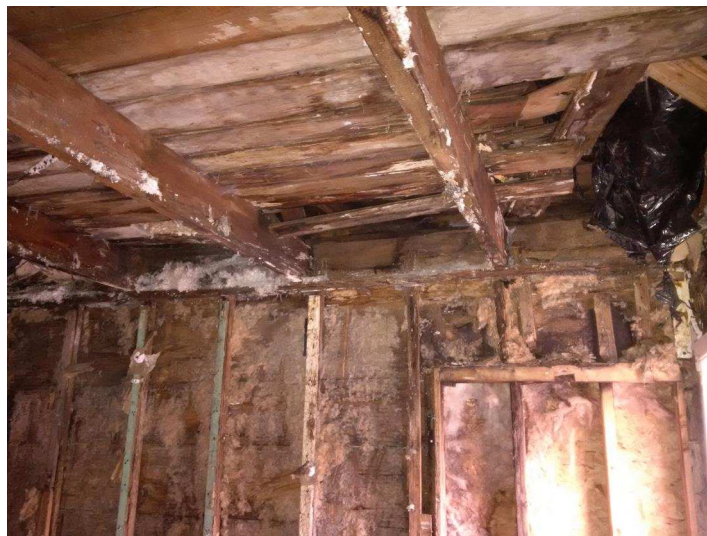
Photo Two – Water Damaged Roof Framing and Rot

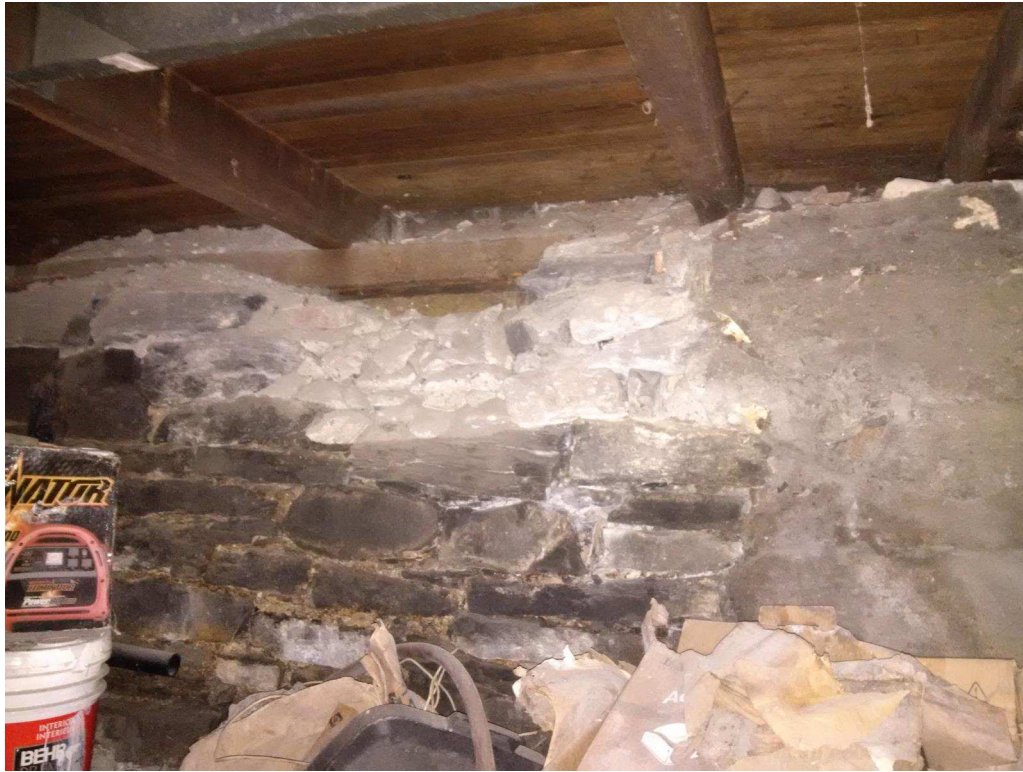
Photo Three – Dry Rot on Wood Framing

- Areas of dry rot are present in the basement, primarily where the floor joists are embedded in the rubble stone walls (See Photo Three). Which is common with this era of construction.

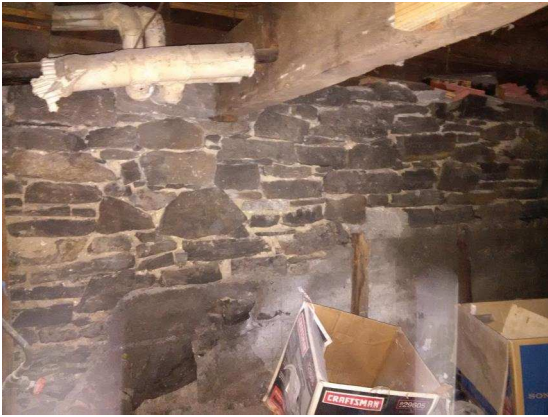
- The foundation walls are constructed of rubble stone and are in poor condition. The mortar joints are very soft, to non-existent in many locations with signs of obvious water infiltration. The areas where the mortar was still present could easily be scraped away with a screwdriver to the full depth of the screw driver (See Photos Four and Five).

Photo Four – Rubble Stone Wall

2. The foundation deterioration has progressed to a point that complete removal and reconstruction is required of the rubble stone foundation wall. A house of this nature would require it be lifted into the air in order to replace the foundations in order to get access to the East wall which is right on the property line. However, the current conditions would likely result in the building collapsing if a lift was attempted.

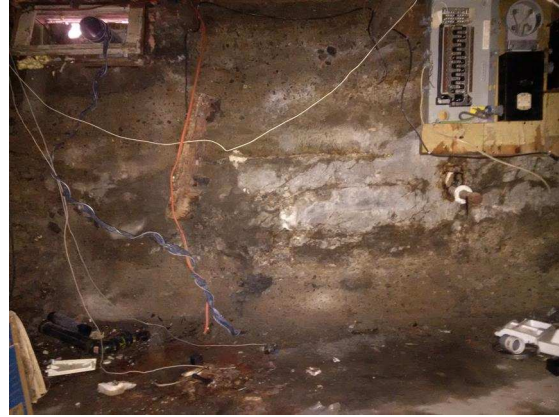
- There are locations of apparent “underpinning/remediation” with concrete. These repairs were poorly executed and are not providing the necessary support that they were originally intended too. When hammer sounded these mass pours are hollow, indicated that they are relatively thin and not bonded to the stone. For all intense purposes they are strictly non-structural and veneer in nature (See Photo Five).

Photo Five – Underpinning/Remediation

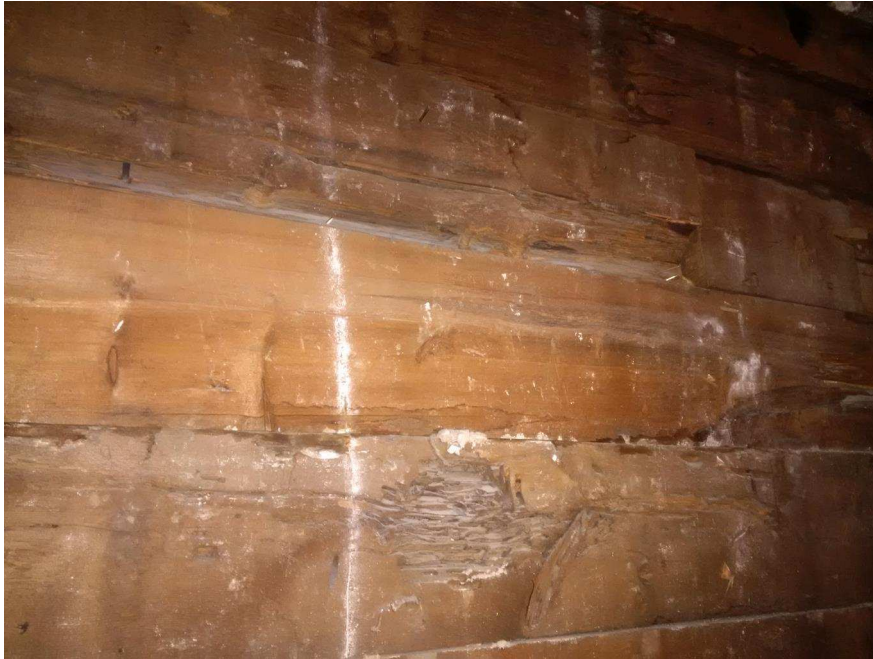
- The plank log walls have had significant carpenter ant damage over the years. Several boards have been structurally compromised. Replacing these boards is extremely difficult due to their stacking nature (See Photo Six).

- The front of the building has been structurally modified over the years with larger windows and openings which has structurally compromised the integrity of the plank framing system to support gravity and lateral forces. Most of the walls are no longer plumb and are in the early stages of buckling out (See Photo Six).

Photo Six – Carpenter Ant Damage

3. Deterioration of the log walls from dry rot, wet rot, and carpenter ants, are to such an extent that to try and repair/replace with involve the complete removal and reinstatement of complete walls, which is realistically not possible in our opinion.

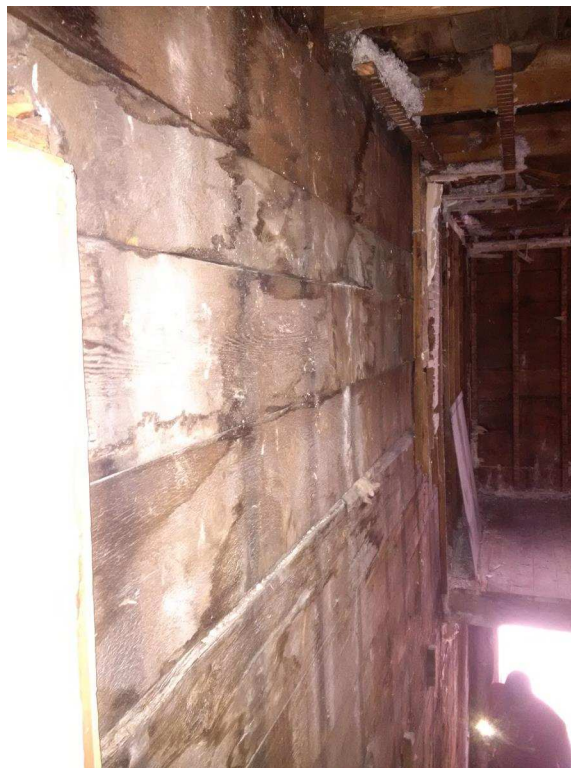
Photo Seven – Out of Plumb Wall/Water Infiltration

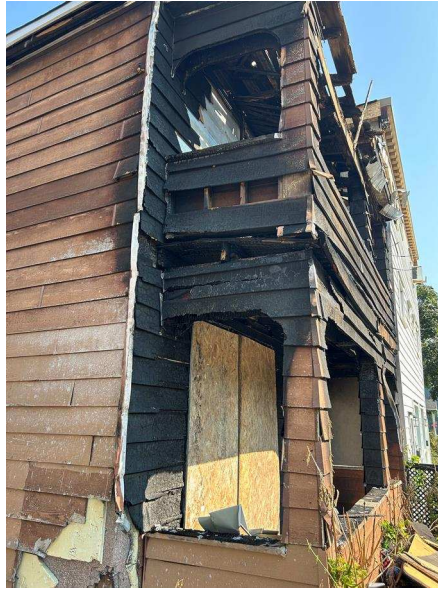
- The Front Balcony was severely damaged as a result of fire, to the point that it is no longer safe and must be demolished. Beams, columns, joists, and rafters have been damaged beyond repair at the roof and balcony level.(See photo Eight)

Photo Eight Fire Damage

4. The building has suffered another fire, it is our recommendation that the building be demolished, as it has suffered catastrophic fire and smoke damage that is unrepairable.

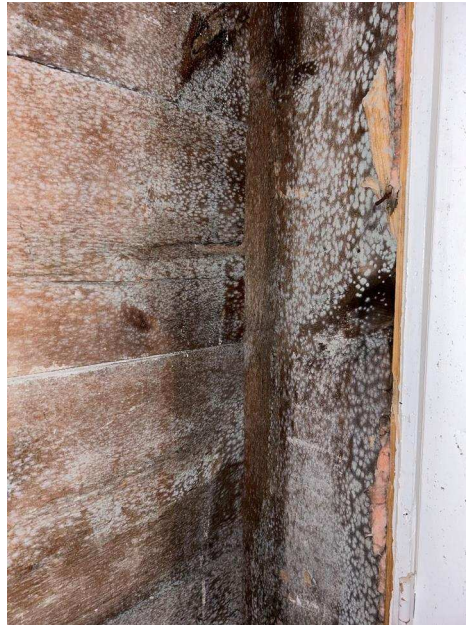
- Extensive mold damage on the inside of the building as a result of firefighting operations soaking the structure to ensure the fire was extinguished. There is most-likely mold on the exterior face of the plank structure trapped behind the multiple layers of exterior finish. (See Photo Nine)

Photo Nine Mold

5. There is now extensive mold inside the wood building as result of the fire fighting operations. This clean up would require the removal of all exterior finishes to ensure a proper remediation of the building. The removal of the exterior finishes would further compromise the structure and cause it to become unstable and collapse.
