PROJECT  
1445 & 1451 WELLINGTON  
& ROCKHURST PARKETTE  
OTTAWA, ON

DRAWING  
TREE CONSERVATION REPORT

SCALE: 1:200	DRAWING NO.
DRAWN: LM	<b>ARB1</b>
CHECKED: LM	
DATE: 2013-06-03	REVISION NO.

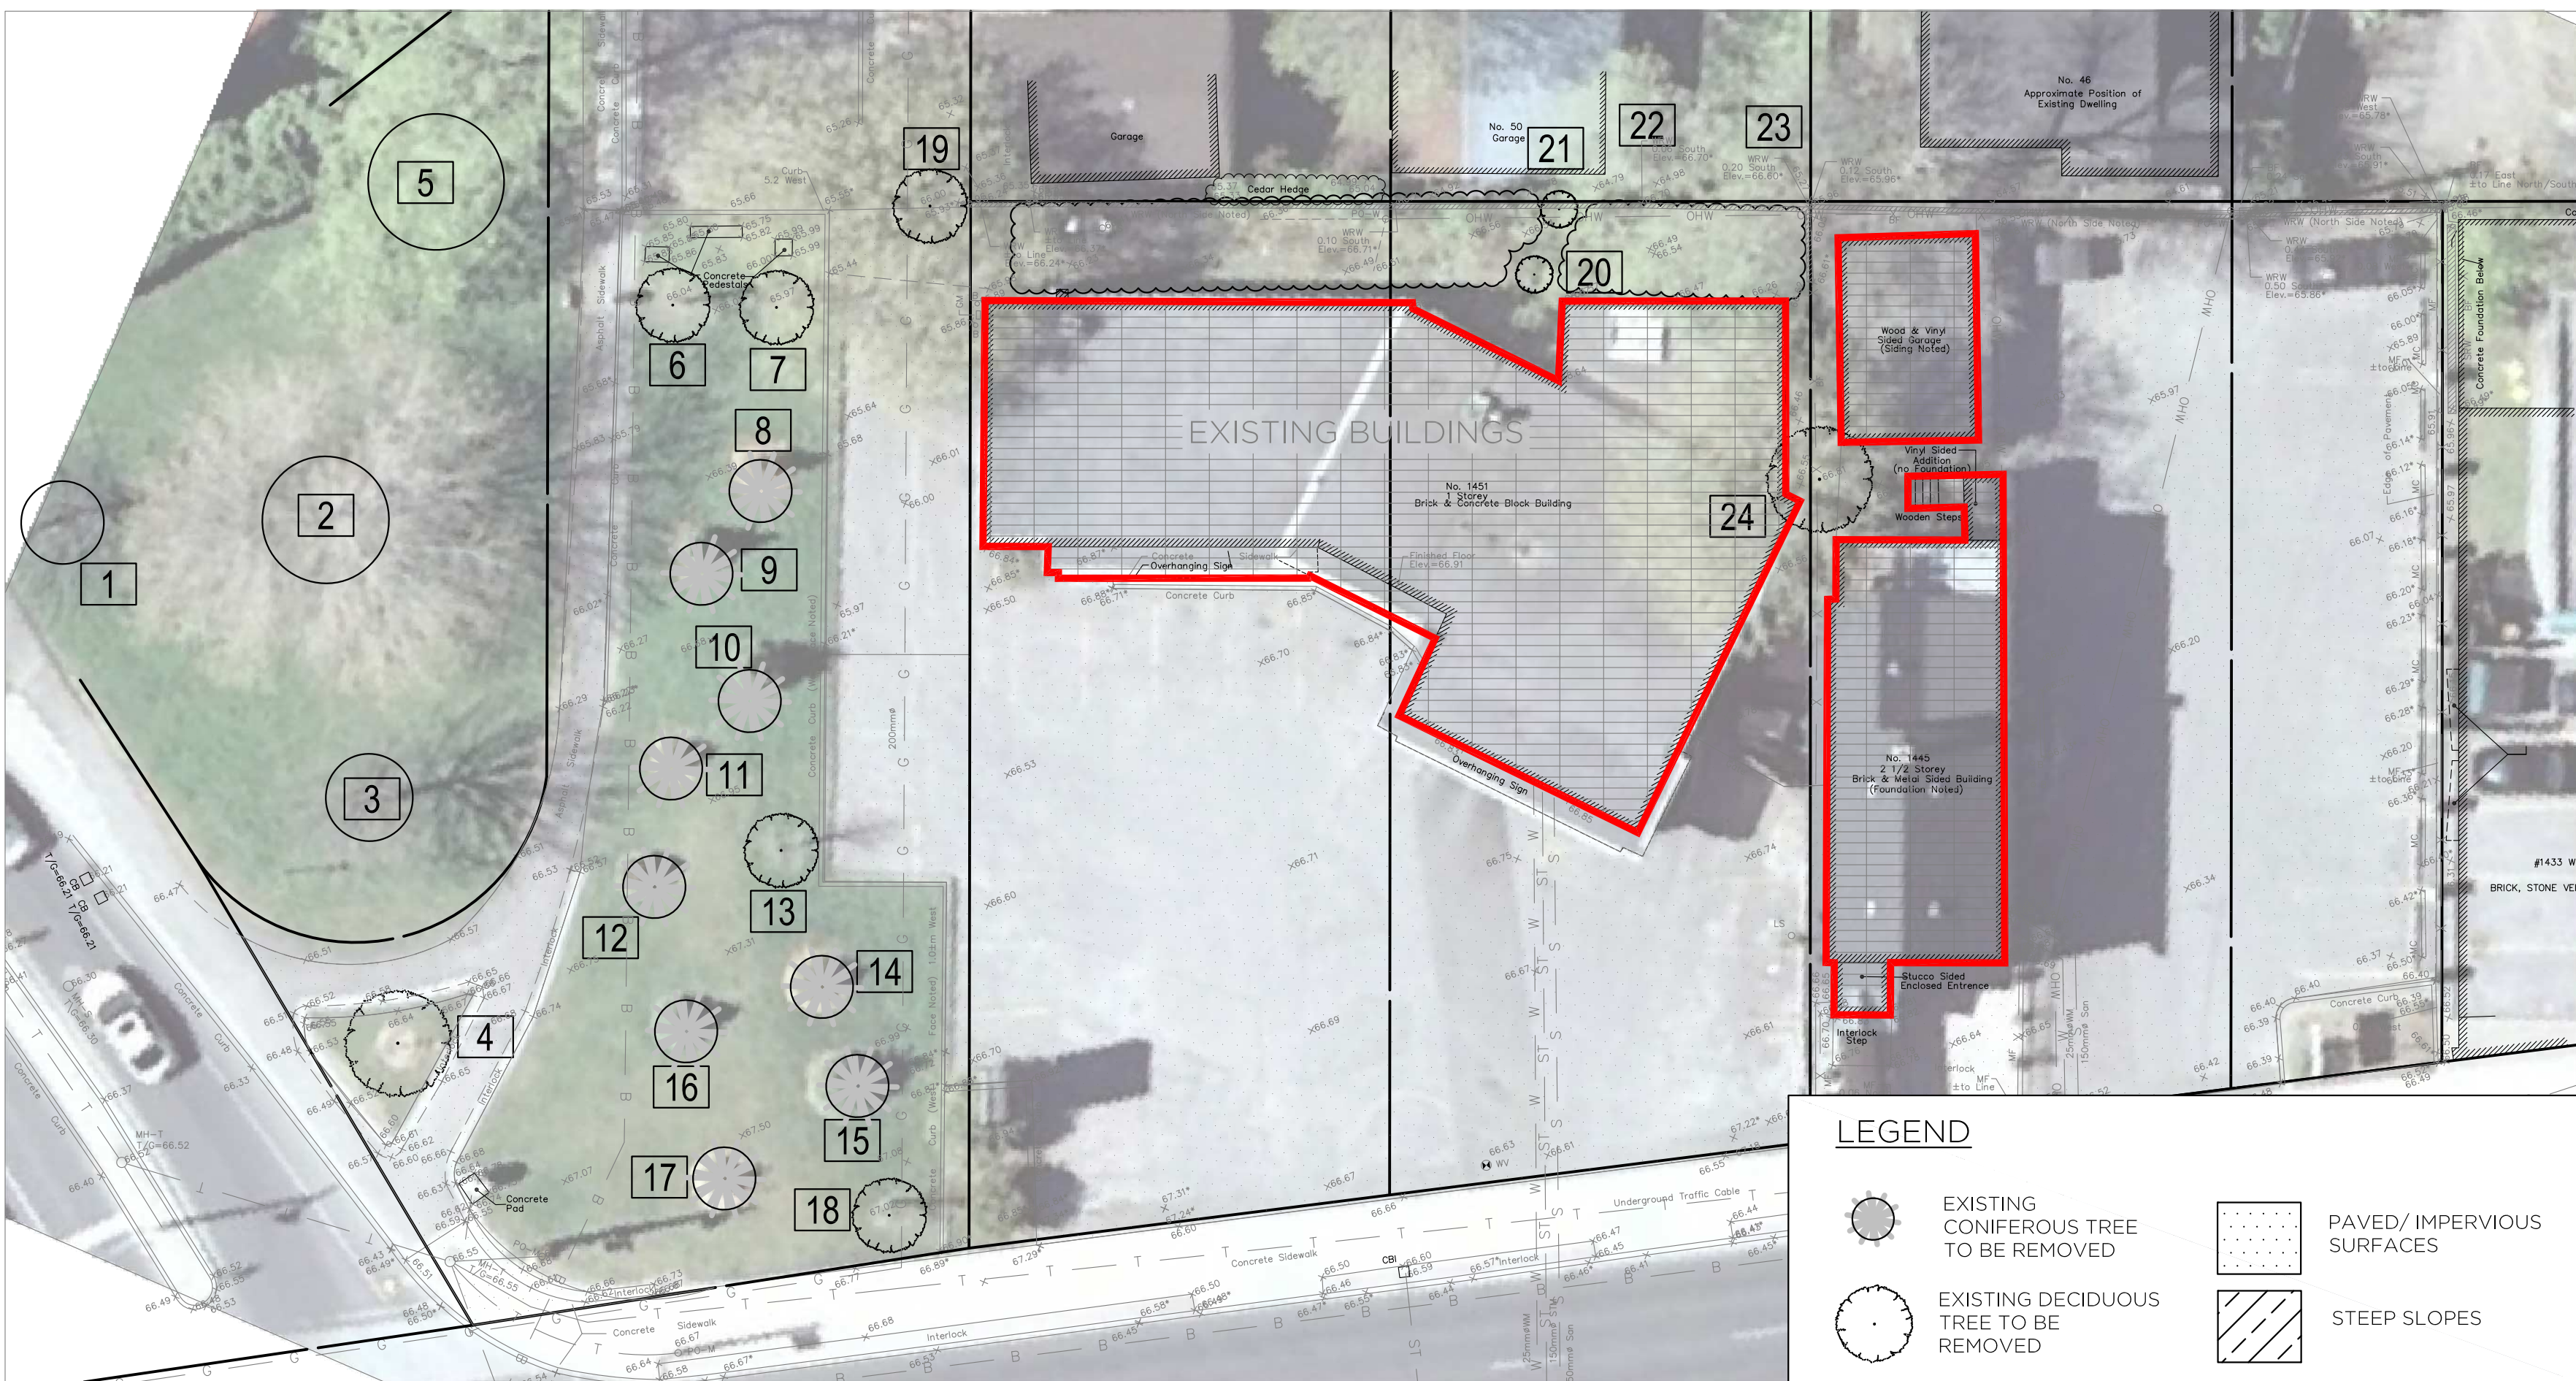
MAP 1

TREE #	BOTANICAL NAME	COMMON NAME	CALIPER	CONDITION	AGE*	HIGH QUALITY TREE	RARE TREE	TO BE PRESERVED	COMMENTS
1	Fraxinus americana	White Ash	36.0	GOOD	50	NO	NO	YES	The tree is in good condition, with no signs of EAB infestation (possibly inoculated). There is a minor wound at the base, well-healed and the presence of some insects (ants).
2	Acer saccharinum	Silver Maple	68.2	MODERATE ***	70	NO	NO	YES	The tree is leaning and poses a potential hazard. Branching begins approximately 1.5m above the root flare, and there is a split with some signs of decay at the union of one very large branch. The tree is otherwise healthy and well-formed.
3	Fraxinus americana	White Ash	32.1	GOOD	50	NO	NO	YES	The tree is healthy with no signs of EAB infestation (possibly inoculated).
4	Ulmus americana	American Elm	21.4	GOOD	25	NO	NO	NO	There are a few very minor dead branches, the tree is otherwise very healthy and well-formed.

5	Salix alba	Willow sp.	Multi-stem (2) - approx. 40 & 60	MODERATE-POOR***	70	NO	NO	NO	The stems diverge from a large, malformed base, with decay, where there is evidence of other stems once present. The smaller of the two remaining stems is leaning and presents a possible hazard.
6	Ginkgo biloba	Ginkgo tree	18.4	GOOD	35	NO	NO	NO	The tree is healthy and well-formed, with some suckering at the base, which has been pruned back.
7	Ginkgo biloba	Ginkgo tree	14.1	MODERATE	35	NO	NO	NO	The canopy is very lopsided, due to the severe encroachment of a nearby Manitoba Maple. The tree was girdled at the base, though the wounds are well-healed.
8	Picea pungens	Colorado Spruce	Approx. 12	GOOD	20	NO	NO	NO	The tree is in very good health, and is very densely-branched and well-formed, with only a slight warp in the trunk.
9	Picea pungens	Colorado Spruce	Approx. 12-15	GOOD	20	NO	NO	NO	The tree is healthy and well-formed, very densely-branched.

10	Picea pungens	Colorado Spruce	15.2	GOOD	20	NO	NO	NO	The tree is in very good health, and is very densely-branched and well-formed, with only a slight warp in the trunk.
11	Picea pungens	Colorado Spruce	Approx. 10	GOOD	20	NO	NO	NO	The tree is healthy and well-formed, very densely-branched.
12	Picea omorika	Serbian Spruce	Approx. 12	GOOD	20	NO	NO	NO	The tree is healthy and well-formed, very densely-branched, with one minor dead branch.
13	Ginkgo biloba	Ginkgo Tree	16.0	MODERATE	35	NO	NO	NO	The tree is suckering, with a large split of approximately 1m, though well-healed. The tree has a minor lean.
14	Picea pungens	Colorado Spruce	Approx. 12	GOOD	20	NO	NO	NO	The tree is in very good health, and is very densely-branched and well-formed, with only a slight warp in the trunk.
15	Picea pungens var. Glauca	Blue Colorado Spruce	Approx. 12	GOOD	20	NO	NO	NO	The tree is in very good health, and is very densely-branched and well-formed, with only a slight warp in the trunk.

16	Picea pungens var. Glauca	Blue Colorado Spruce	Approx. 12	GOOD	20	NO	NO	NO	The tree is healthy and well-formed, very densely-branched.
17	Picea pungens var. Glauca	Blue Colorado Spruce	Approx. 12	GOOD	20	NO	NO	NO	The tree is healthy and well-formed, very densely-branched.
18	Ginkgo biloba	Ginkgo Tree	17.2	GOOD	35	NO	NO	NO	The tree branches at approximately 1.5m, and has a moderate lean, which it appears to have corrected. The tree is very healthy.
19	Acer negundo	Manitoba Maple	MS (6) 18.4-20.7	MODERATE-POOR	40	NO	NO	NO	The tree is characteristically poorly-formed, and there is some evidence of decay at the tree's base where the stems converge. Several of the stems, including the largest, are leaning severely, almost parallel to the ground.
20	Ulmus rubra	Slippery Elm	MS (3) 10.8-11.2	MODERATE	20	NO	NO	NO	The tree is somewhat poorly formed and misshapen due to its location. The stems are all leaning somewhat and the canopy is sparse.

21	Ulmus pumila	Siberian Elm	11.8	POOR	20	NO	NO	NO	The tree is poorly formed, and is leaning severely. The canopy is sparse.
22	Acer negundo	Manitoba Maple	approx. 20	GOOD	35	NO	NO	YES	The tree is growing on the adjacent property, at the base of the retaining wall along the north border of 1445 Wellington. The tree is in good health and is unusually well-formed for the species.
23	Acer negundo	Manitoba Maple	approx. 60	GOOD	85	NO	NO	YES	The tree is growing on the adjacent property, at the base of the retaining wall along the north border of 1445 Wellington. The tree is large and in good health and is unusually well-formed for the species.
24	Acer negundo	Manitoba Maple	Approx. 70	MODERATE	85	NO	NO	YES	The tree is growing extremely close to a wooden fence, which has been attached to the tree. The trunk and bark is warped and distorted, and the tree is leaning slightly. The tree is very large and appears healthy.

ALL OF THE EXISTING TREES WILL BE REMOVED FROM THE SITES IN QUESTION. THE POSSIBILITY OF TRANSPLANTING EXISTING TREES WAS INVESTIGATED, HOWEVER MANY OF THE CANDIDATES ARE EITHER TOO LARGE TO TRANSPLANT OR ARE TOO CLOSE TO EXISTING UNDERGROUND UTILITY LINES. FURTHER CONCERN ABOUT THE SPREAD OF CONTAMINATED SOILS THROUGH THE TRANSPORT OF THE ROOTBALLS MAKES THE RETENTION OF THE EXISTING TREES ON THIS SITE UNDESIRABLE.

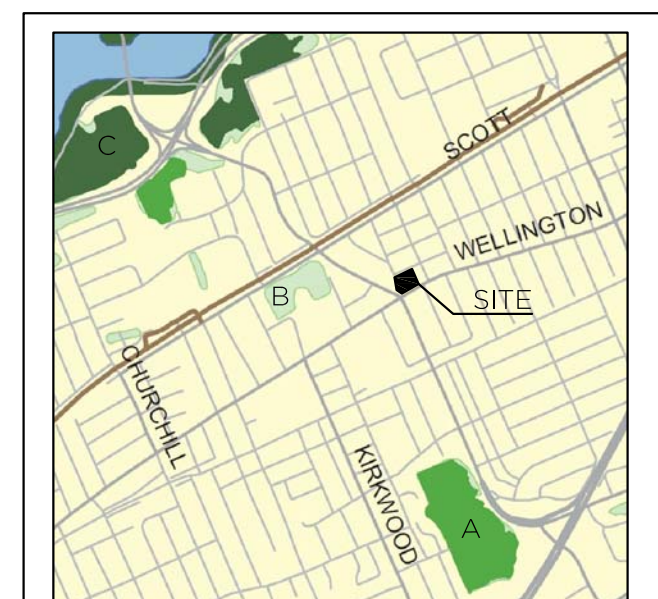
Ottawa Greenspace Master Plan, Map 1

NOTES:  
- THE SITE NOT IDENTIFIED AS SIGNIFICANT IN THE OTTAWA GREENSPACE MASTER PLAN. IT MAY HAVE SOME SLIGHT SIGNIFICANCE AS A CONNECTION POINT BETWEEN AREA 'A' AND 'C', HOWEVER AREA 'B' IS LIKELY A PREFERABLE ALTERNATIVE.
