TREE CONSERVATION REPORT

PROJECT NAME:	359 Kent Street
PROJECT NO.	21819-1
LOCATION	359 Kent Street, Ottawa ON, K2P 0R6
DATE:	August 11, 2021

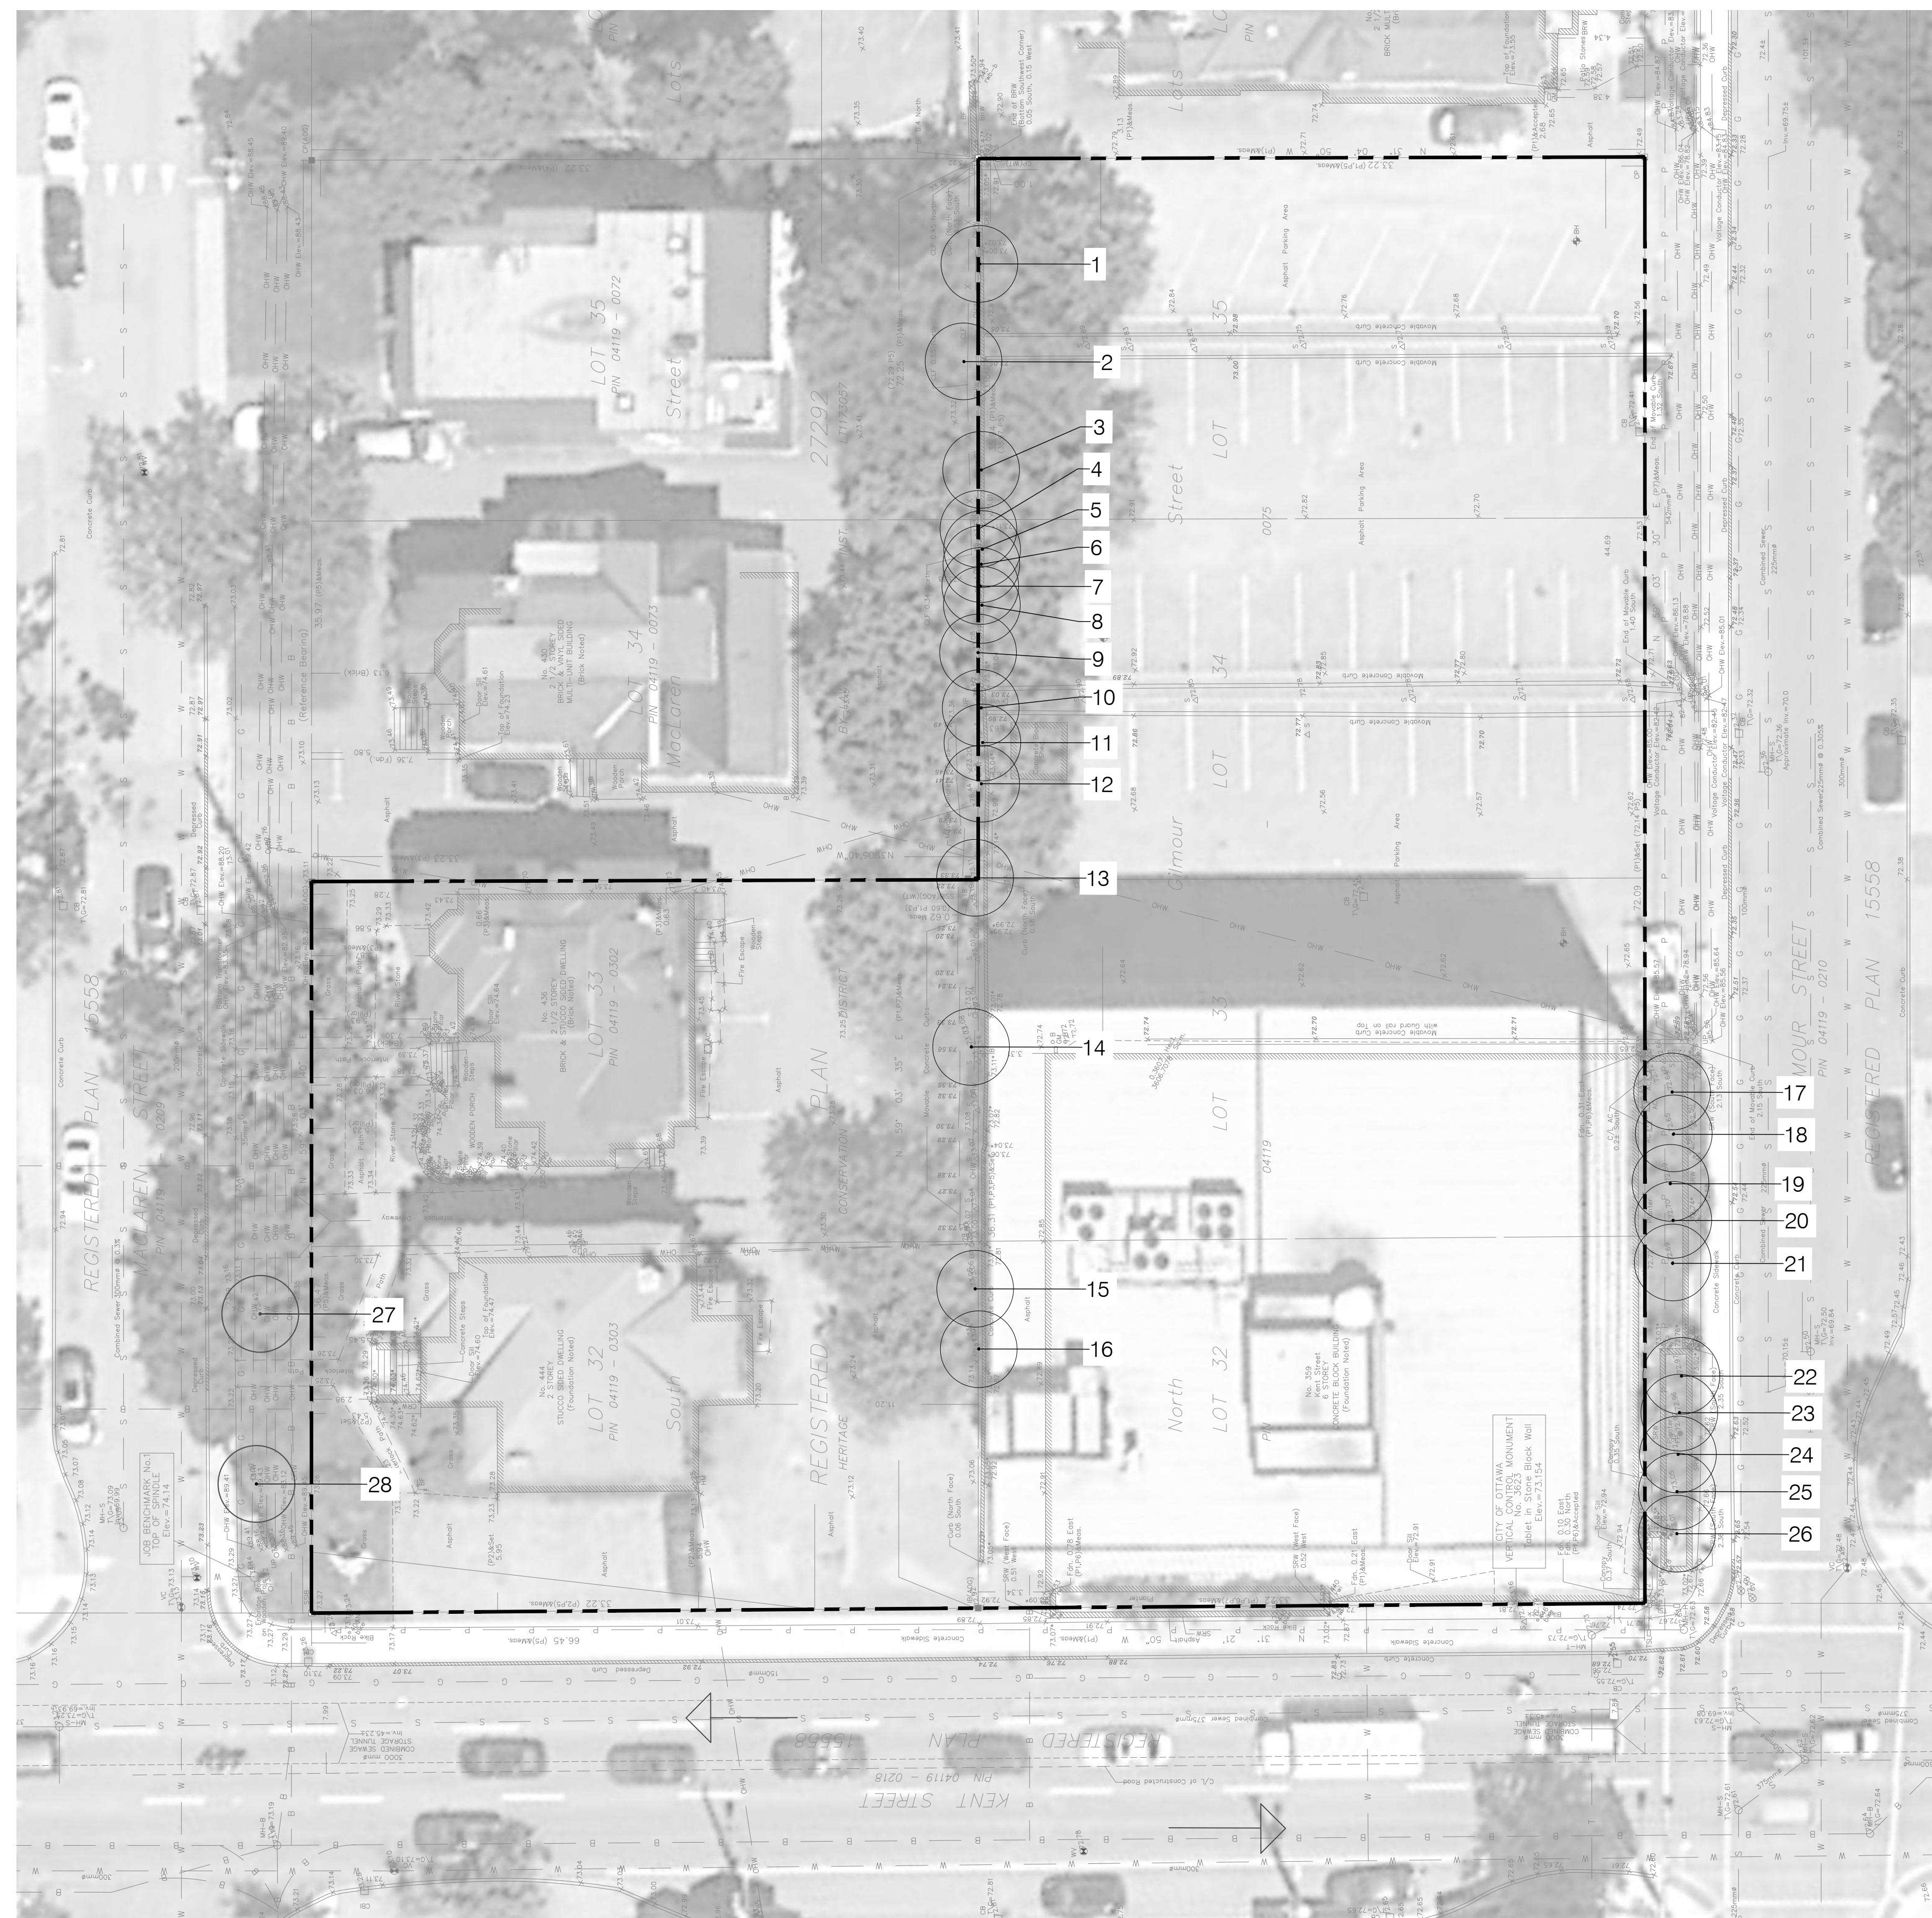
1 PRE DEVELOPMENT VEGETATION

EXISTING TREES				
NO.	SPECIES	DBH (CM)	HEALTH	COMMENTS
1	Manitoba Maple / Acer negundo	17, 35	Poor	Trunk damage, wire conflict, 2 stems joined at base
2	Silver Maple / Acer saccharinum	74	Fair	Branch dieback, on adjacent property
3	Manitoba Maple / Acer negundo	20, 24	Poor	Included fence, trunk damage, 2 stems joined at base
4	Manitoba Maple / Acer negundo	15	Poor	Included fence, trunk damage
5	Manitoba Maple / Acer negundo	19	Poor	Included fence, trunk damage
6	Manitoba Maple / Acer negundo	26	Poor	Included fence, trunk damage
7	Manitoba Maple / Acer negundo	29	Poor	Included fence, trunk damage, internal rot
8	Manitoba Maple / Acer negundo	23	Poor	Included fence, trunk damage
9	Manitoba Maple / Acer negundo	17, 17, 20	Poor	Included fence, trunk damage, 3 stems joined at base
10	Manitoba Maple / Acer negundo	25, 28	Poor	Included fence, trunk damage, 2 stems joined at base
11	Manitoba Maple / Acer negundo	17	Poor	Included fence, trunk damage

12	Manitoba Maple / Acer negundo	28	Poor	Included fence, trunk damage
13	Manitoba Maple / Acer negundo	25, 30	Poor	Included fence, trunk damage, 2 stems joined at 1m
14	Manitoba Maple / Acer negundo	41, 58	Poor	Included fence, trunk damage, 2 stems joined at base, fungal fruiting bodies
15	Manitoba Maple / Acer negundo	19, 27	Fair	2 stems joined at base
16	Manitoba Maple / Acer negundo	31, 39	Poor	2 stems joined at base, longitudinal cracking
17	Crabapple / Malus sp.	10	Good	City Tree
18	Crabapple / Malus sp.	14	Good	City Tree
19	Crabapple / Malus sp.	10	Good	City Tree
20	Crabapple / Malus sp.	14	Good	City Tree
21	Crabapple / Malus sp.	14	Good	City Tree
22	Tree Lilac / Syringa reticulata	10	Good	City Tree
23	Tree Lilac / Syringa reticulata	10	Good	City Tree
24	Tree Lilac / Syringa reticulata	14	Good	City Tree
25	Tree Lilac / Syringa reticulata	10	Good	City Tree
26	Tree Lilac / Syringa reticulata	10	Good	City Tree

27	Norway Maple / Acer platanoides	38	Good	City Tree
28	Crabapple / Malus sp.	5	Good	City Tree

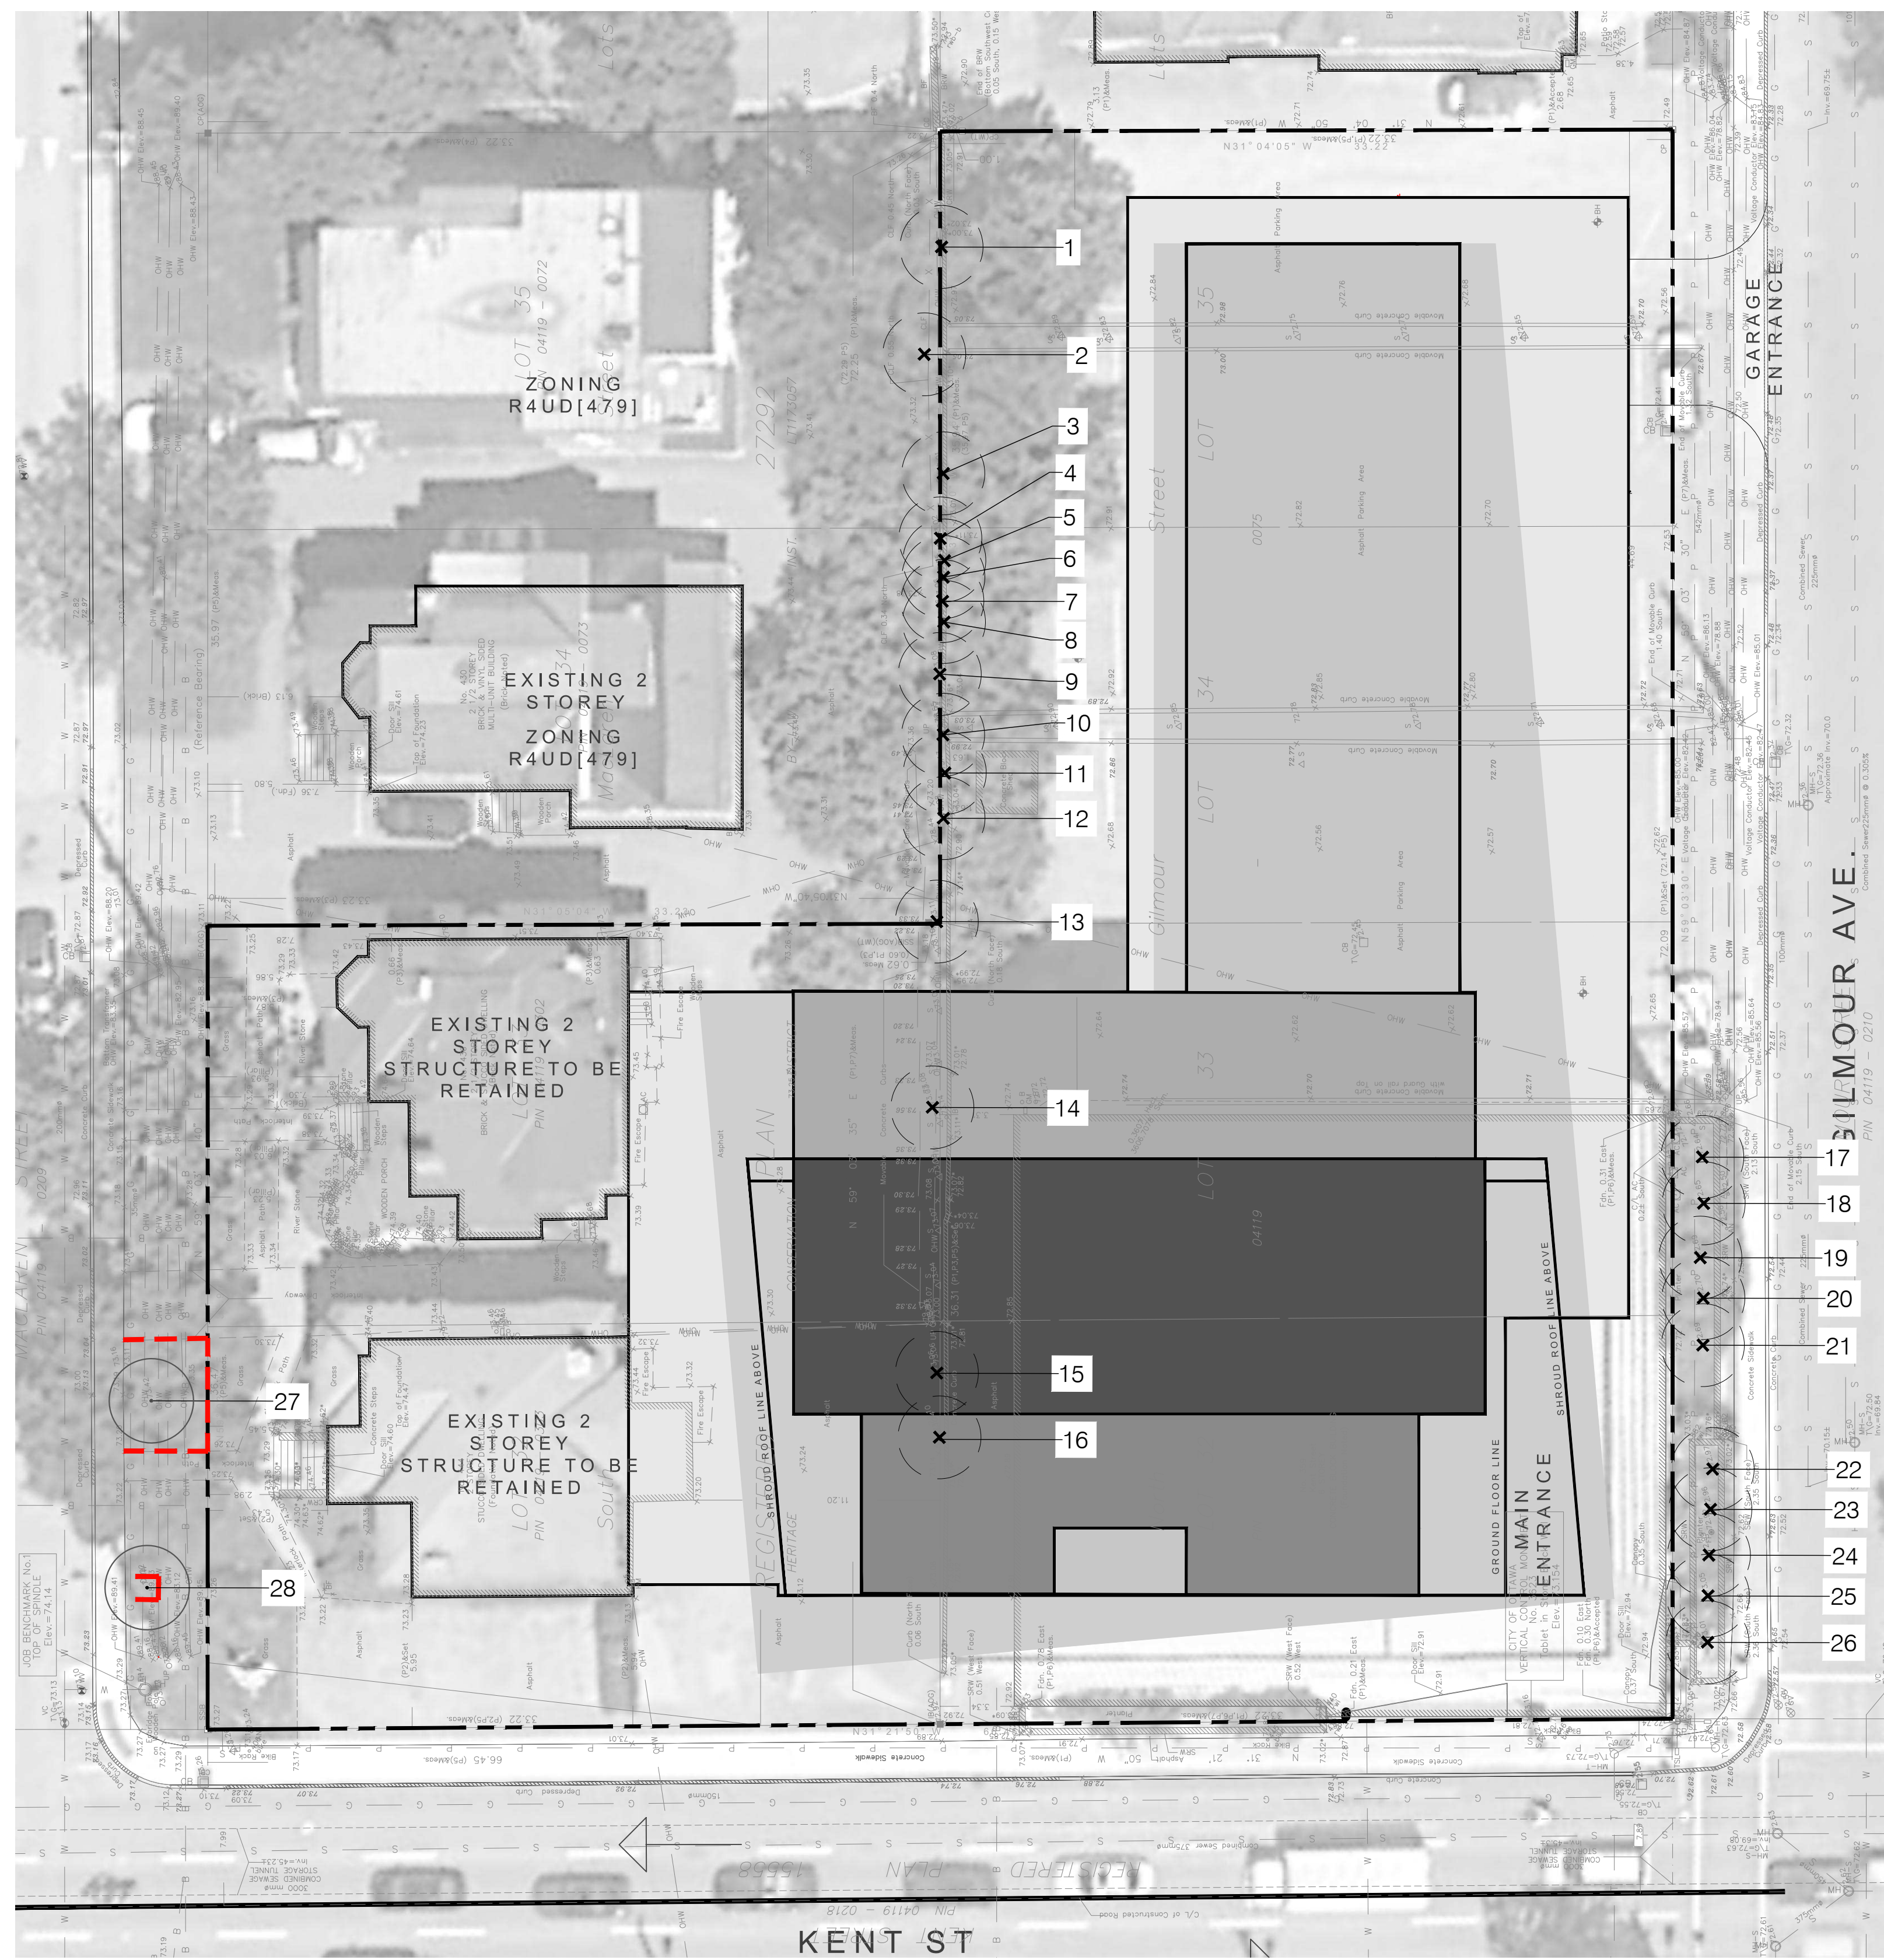
1 POST DEVELOPMENT VEGETATION

EXISTING TREES TO BE RETAINED				
NO.	SPECIES	DBH (CM)	HEALTH	COMMENTS
27	Norway Maple / Acer platanoides	38	Good	City Tree
28	Crabapple / Malus sp.	5	Good	City Tree

EXISTING TREES TO BE REMOVED				
NO.	SPECIES	DBH (CM)	HEALTH	COMMENTS
1	Manitoba Maple / Acer negundo	17, 35	Poor	Trunk damage, wire conflict, 2 stems joined at base
2	Silver Maple / Acer saccharinum	74	Fair	Branch dieback
3	Manitoba Maple / Acer negundo	20, 24	Poor	Included fence, trunk damage, 2 stems joined at base
4	Manitoba Maple / Acer negundo	15	Poor	Included fence, trunk damage
5	Manitoba Maple	19	Poor	Included fence, trunk damage
6	Manitoba Maple / Acer negundo	26	Poor	Included fence, trunk damage
7	Manitoba Maple / Acer negundo	29	Poor	Included fence, trunk damage, internal rot
8	Manitoba Maple / Acer negundo	23	Poor	Included fence, trunk damage
9	Manitoba Maple / Acer negundo	17, 17, 20	Poor	Included fence, trunk damage, 3 stems joined at base
10	Manitoba Maple / Acer negundo	25, 28	Poor	Included fence, trunk damage, 2 stems joined at base
11	Manitoba Maple / Acer negundo	17	Poor	Included fence, trunk damage

12	Manitoba Maple / Acer negundo	28	Poor	Included fence, trunk damage
13	Manitoba Maple / Acer negundo	25, 30	Poor	Included fence, trunk damage, 2 stems joined at 1m
14	Manitoba Maple / Acer negundo	41, 58	Poor	Included fence, trunk damage, 2 stems joined at base, fungal fruiting bodies
15	Manitoba Maple / Acer negundo	19, 27	Fair	2 stems joined at base
16	Manitoba Maple / Acer negundo	31, 39	Poor	2 stems joined at base, longitudinal cracking
17	Crabapple / Malus sp.	10	Good	City Tree
18	Crabapple / Malus sp.	14	Good	City Tree
19	Crabapple / Malus sp.	10	Good	City Tree
20	Crabapple / Malus sp.	14	Good	City Tree
21	Crabapple / Malus sp.	14	Good	City Tree
22	Tree Lilac / Syringa reticulata	10	Good	City Tree
23	Tree Lilac / Syringa reticulata	10	Good	City Tree
24	Tree Lilac / Syringa reticulata	14	Good	City Tree
25	Tree Lilac / Syringa reticulata	10	Good	City Tree
26	Tree Lilac / Syringa reticulata	10	Good	City Tree

- THE FOLLOWING PROTECTION MEASURES MUST BE IMPLEMENTED FOR RETAINED TREES, BOTH WITHIN THE WORK AREA AND ON ADJACENT PARCELS.
- UNDER THE GUIDANCE OF AN ARBORIST, ERECT A MODULAR FENCE AT THE CRITICAL ROOT ZONE (CRZ) OF TREES WHERE THE CRZ IS ESTABLISHED AS BEING 10 CENTIMETERS FROM THE TRUNK FOR EVERY CENTIMETER OF TRUNK DIAMETER AT BREAST HEIGHT.

- TREE PROTECTION SHALL BE ERECTED TO PROVIDE A CONTINUOUS BARRICADE BETWEEN DESIGNATED TREES AND THE WORK AREA PRIOR TO CONSTRUCTION.
 - TUNNEL OR BORE WHEN DIGGING WITHIN THE CRZ OF A TREE.
