## TREE CONSERVATION REPORT

| PROJECT NAME: | 359 Kent Street |
| PROJECT NO. | 21819-1 |
| DATE: | August 11, 2021 |

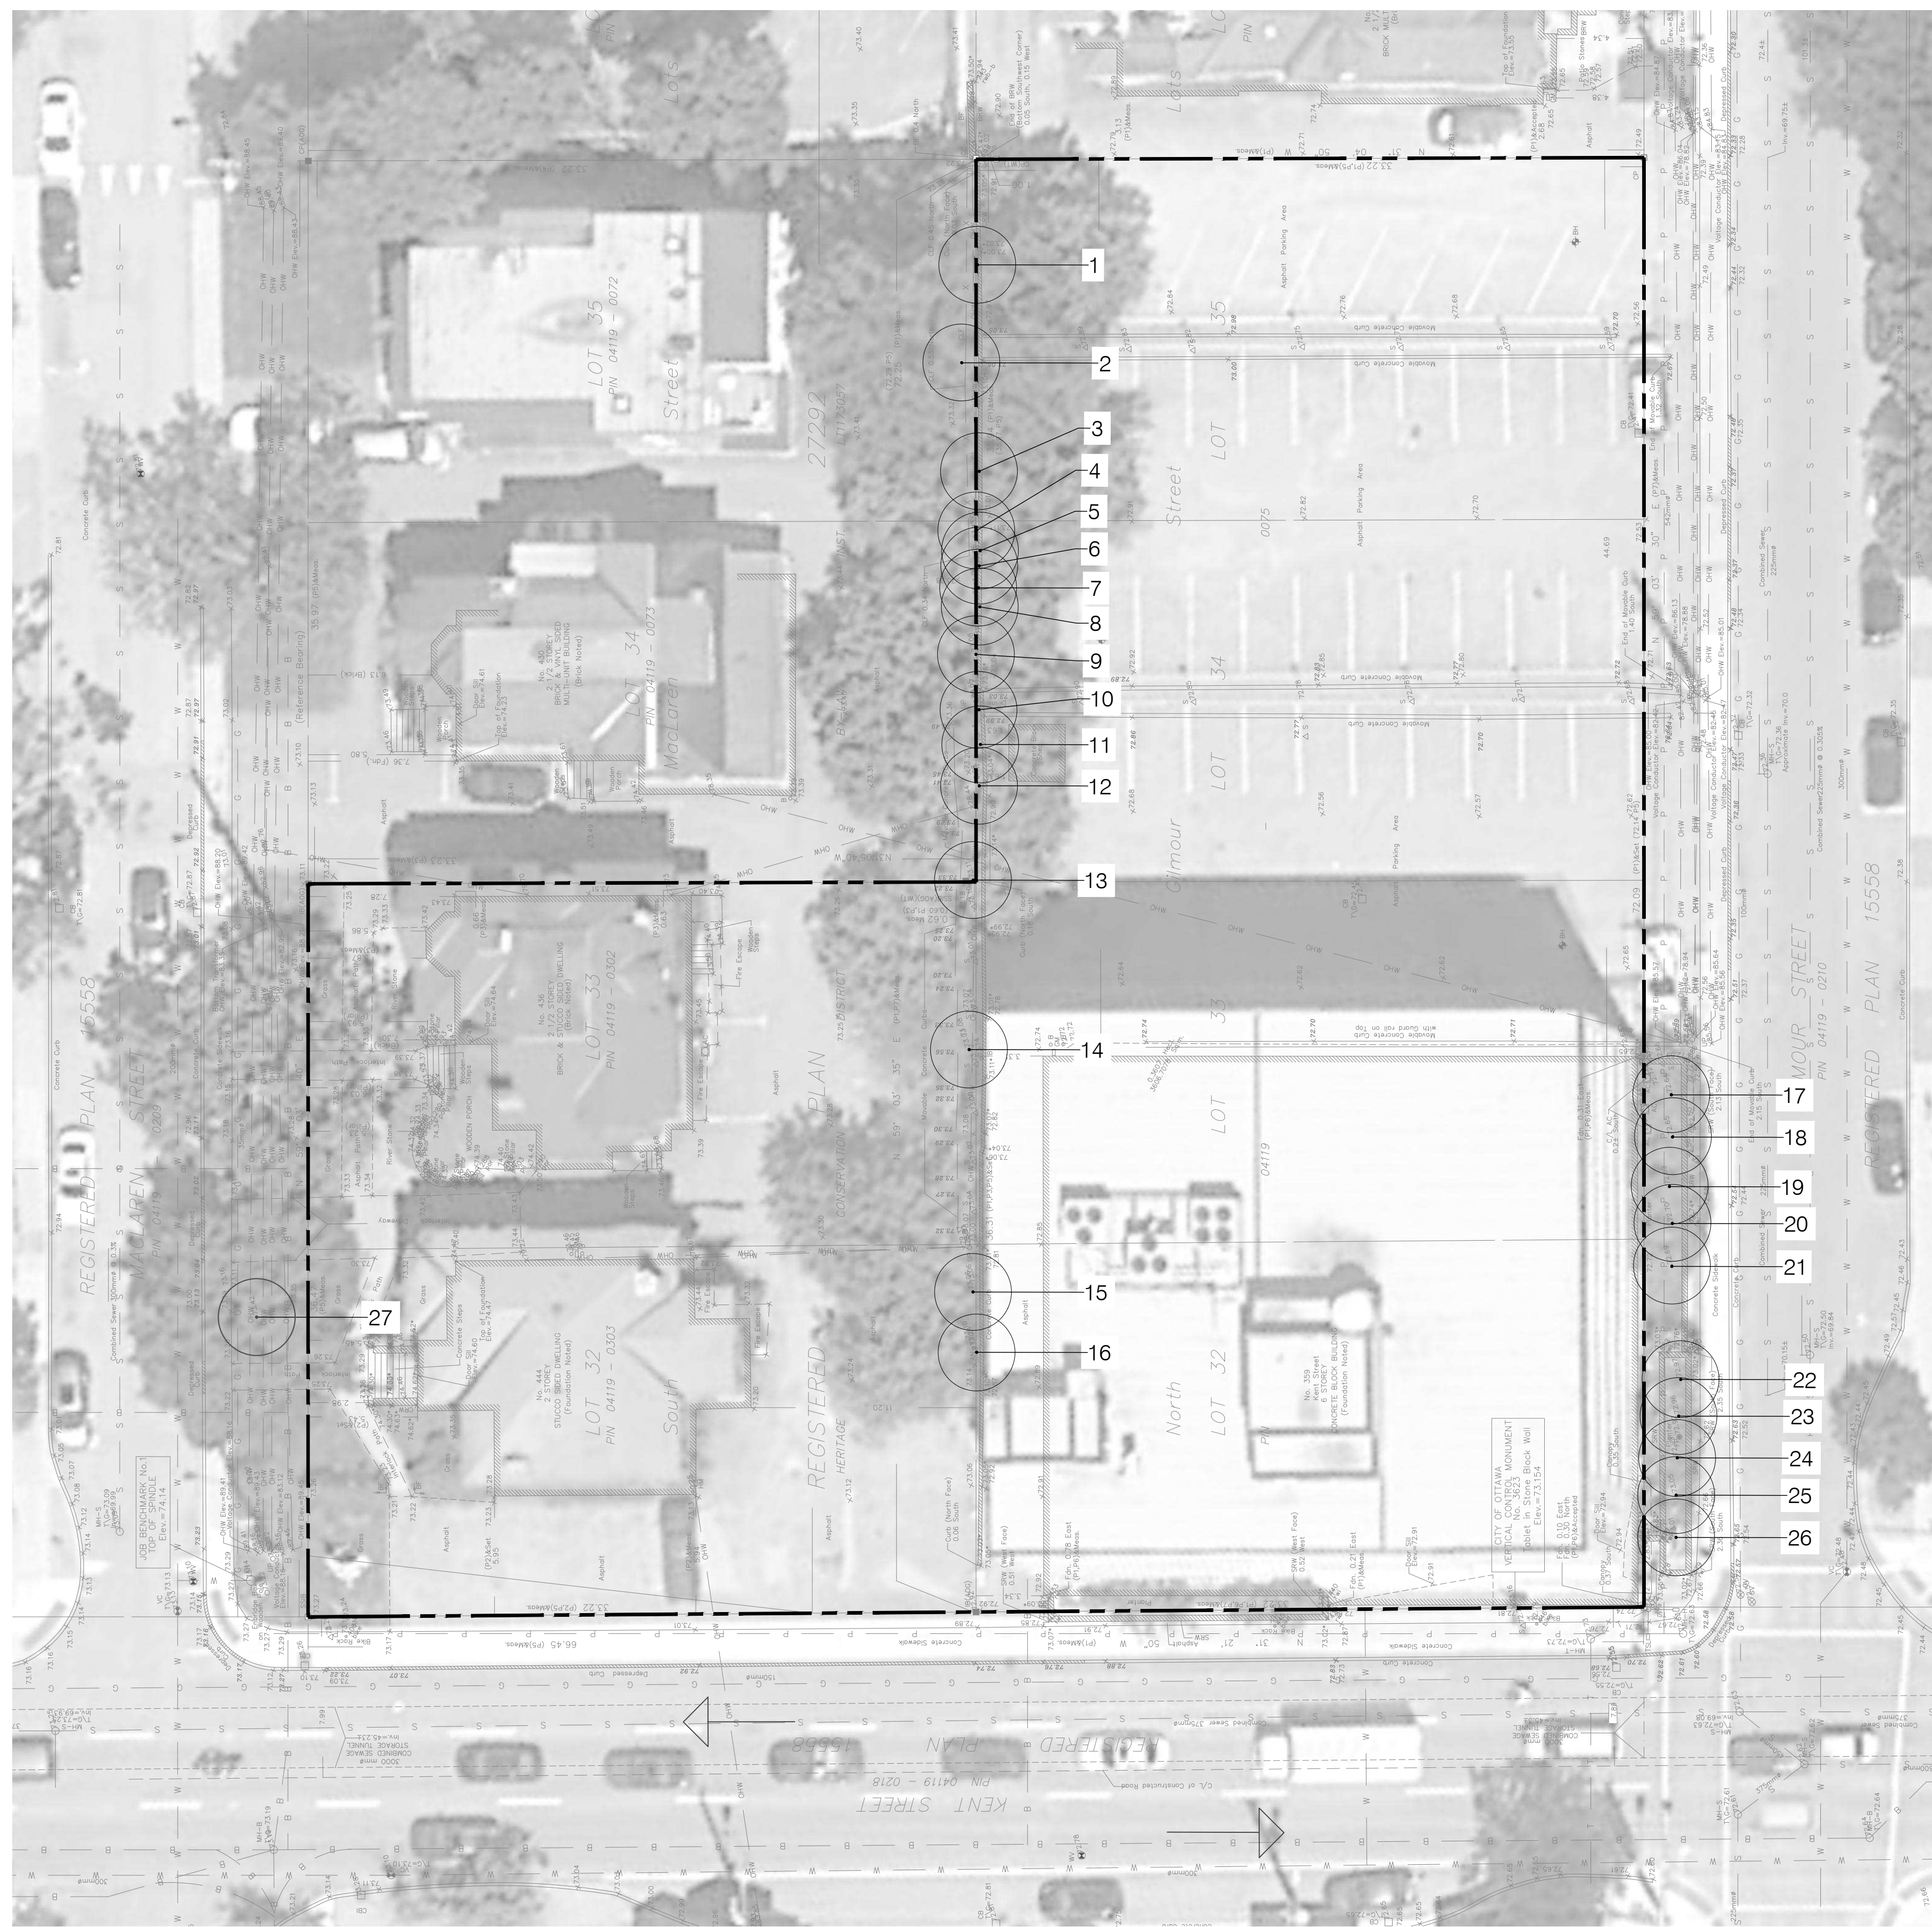
1 PRE DEVELOPMENT VEGETATION

| EXISTING TREES | | | | |
|---|---|---|---|--|
| 1 | Manitoba Maple / Acer negundo | 17, 35 | Poor | Trunk damage, wire conflict, 2 stems joined at base |
| 2 | Silver Maple / Acer saccharinum | 74 | Fair | Branch dieback, on adjacent property |
| 3 | Manitoba Maple / Acer negundo | 20, 24 | Poor | Included fence, trunk damage, 2 stems joined at base |
| 4 | Manitoba Maple / Acer negundo | 15 | Poor | Included fence, trunk damage |
| 5 | Manitoba Maple / Acer negundo | 19 | Poor | Included fence, trunk damage |
| 6 | Manitoba Maple / Acer negundo | 26 | Poor | Included fence, trunk damage |
| 7 | Manitoba Maple / Acer negundo | 29 | Poor | Included fence, trunk damage, internal rot |
| 8 | Manitoba Maple / Acer negundo | 23 | Poor | Included fence, trunk damage |
| 9 | Manitoba Maple / Acer negundo | 17, 17, 20 | Poor | Included fence, trunk damage, 3 stems joined at base |
| 10 | Manitoba Maple / Acer negundo | 25, 28 | Poor | Included fence, trunk damage, 2 stems joined at base |
| 11 | Manitoba Maple / Acer negundo | 17 | Poor | Included fence, trunk damage |
| 12 | Manitoba Maple / Acer negundo | 28 | Poor | Included fence, trunk damage |
| 13 | Manitoba Maple / Acer negundo | 25, 30 | Poor | Included fence, trunk damage, 2 stems joined at 1m |
| 14 | Manitoba Maple / Acer negundo | 41, 58 | Poor | Included fence, trunk damage, 2 stems joined at base, fungal fruiting bodies |
| 15 | Manitoba Maple / Acer negundo | 19, 27 | Fair | 2 stems joined at base |
| 16 | Manitoba Maple / Acer negundo | 31, 39 | Poor | 2 stems joined at base, longitudinal cracking |

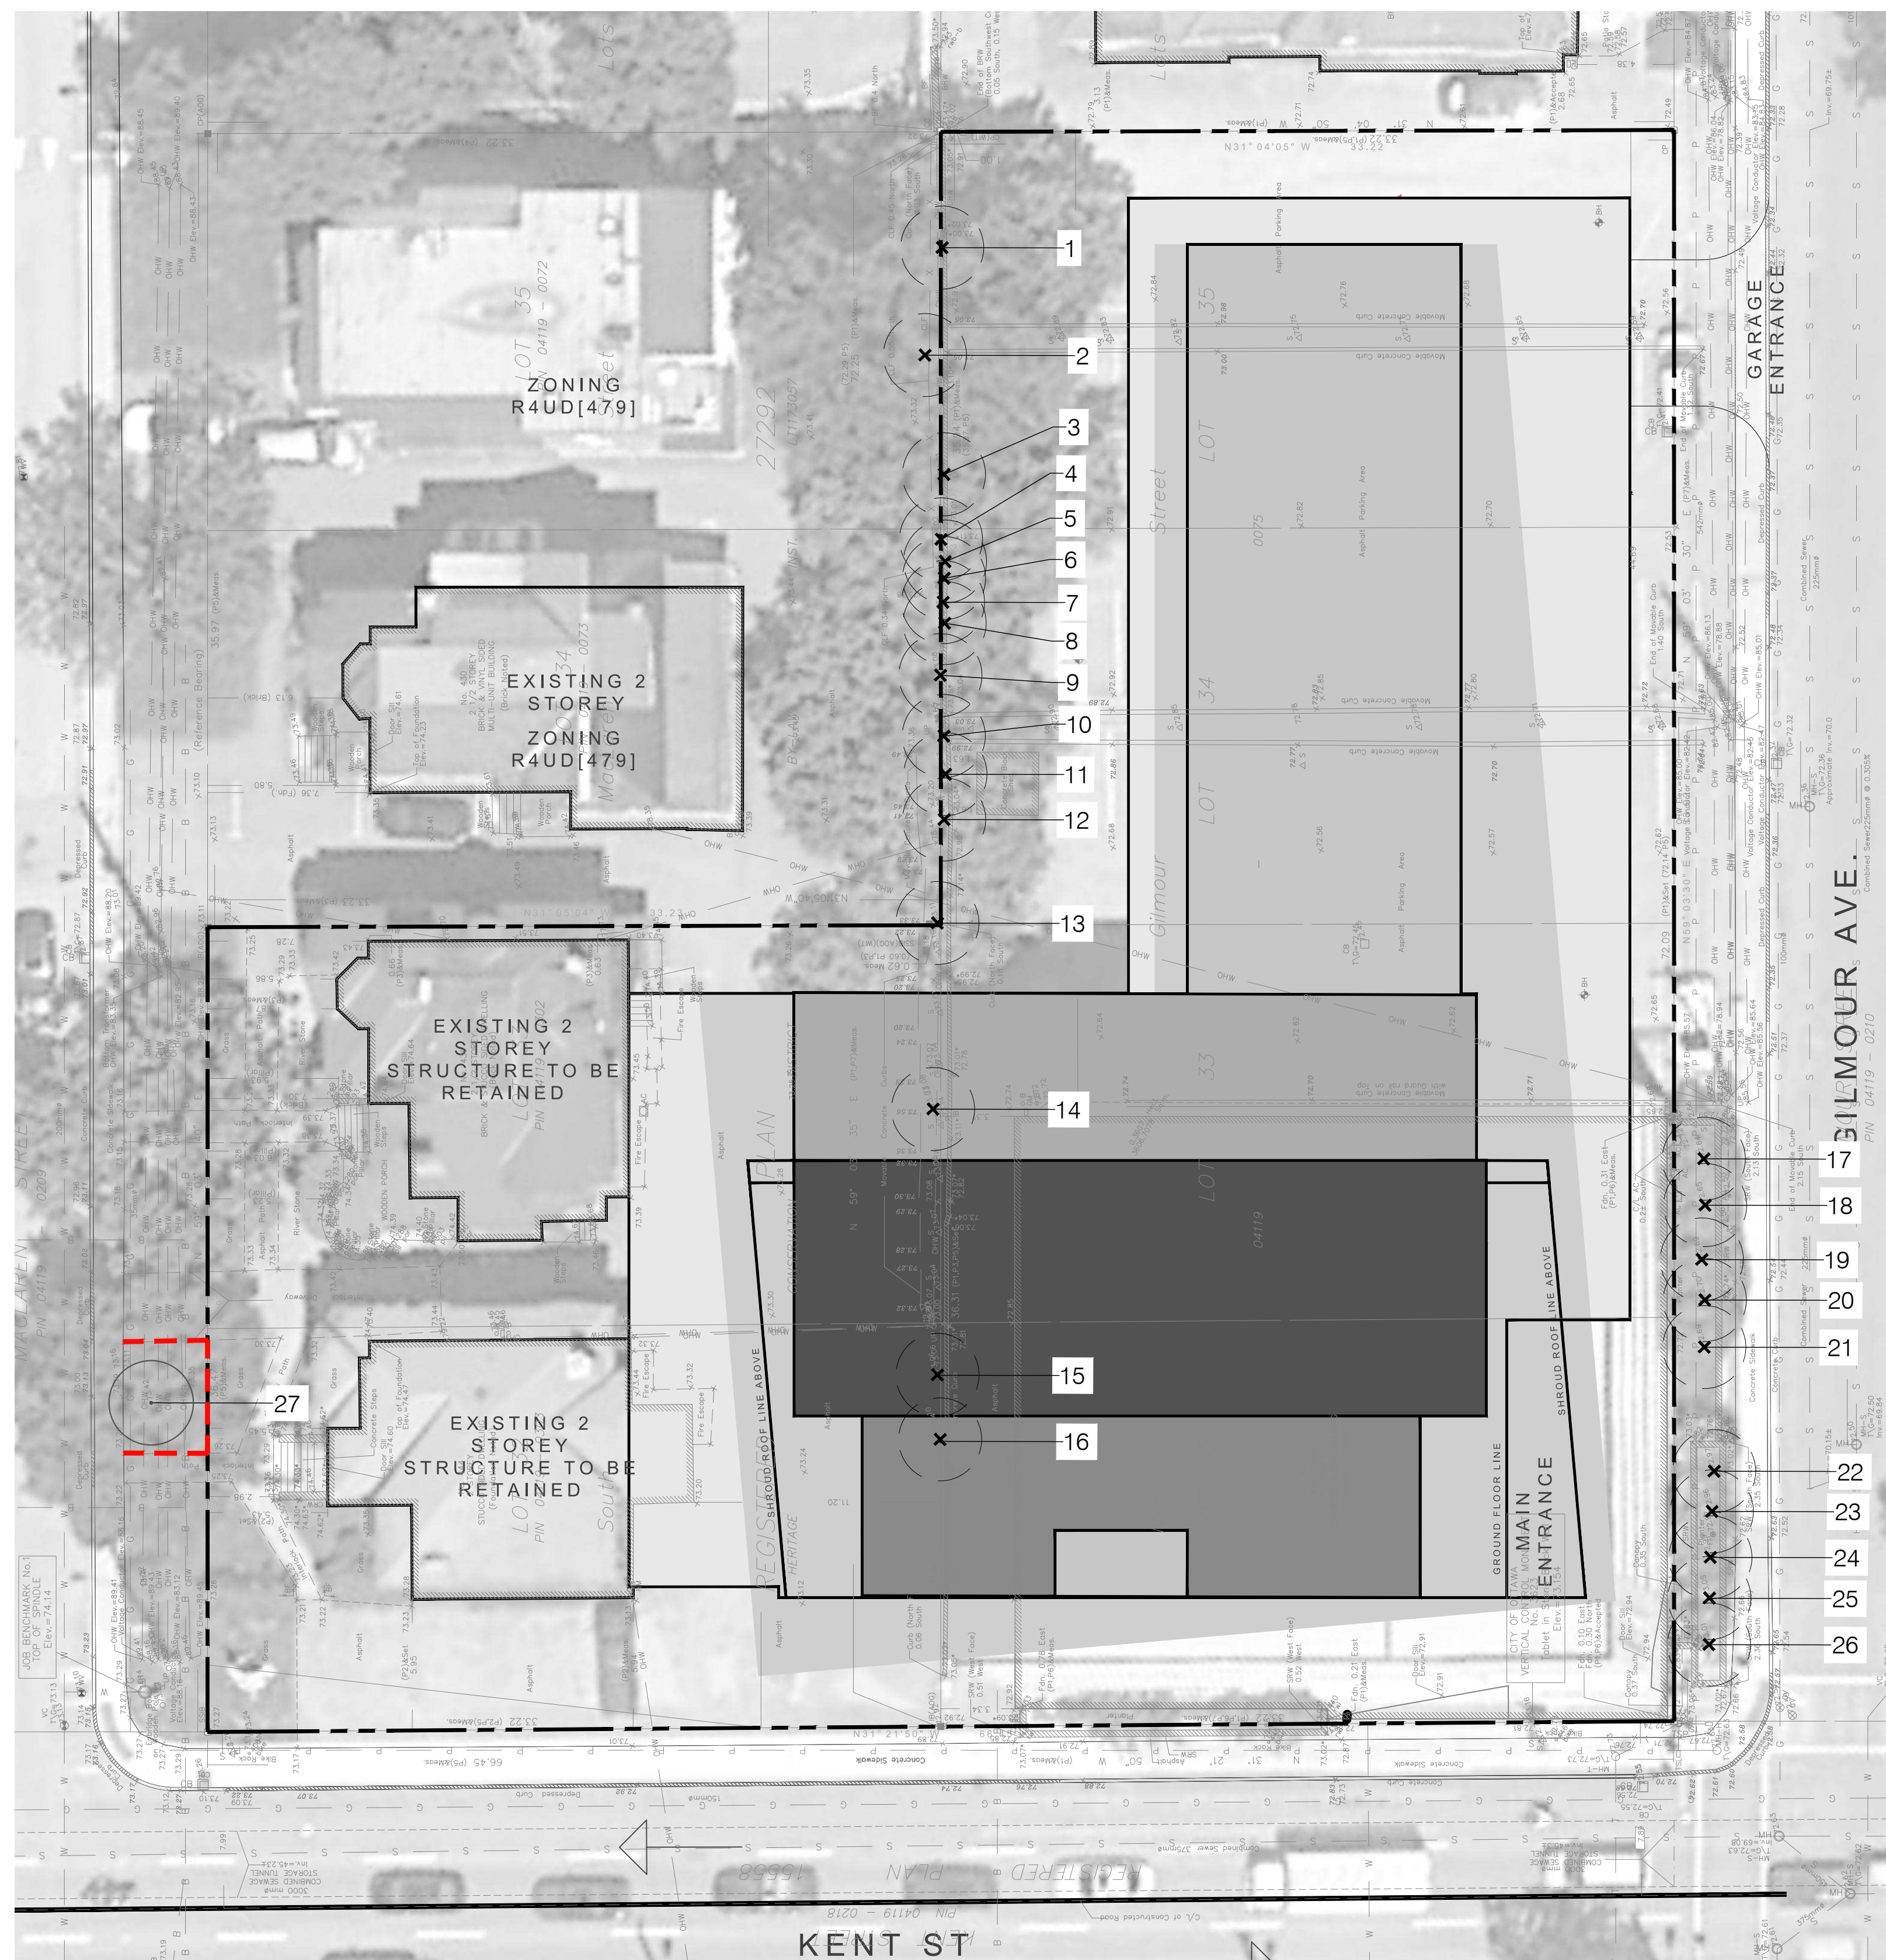
1 POST DEVELOPMENT VEGETATION

| EXISTING TREES TO BE REMOVED | | | | |
|---|---|---|---|--|
| 1 | Manitoba Maple / Acer negundo | 17, 35 | Poor | Trunk damage, wire conflict, 2 stems joined at base |
| 2 | Silver Maple / Acer saccharinum | 74 | Fair | Branch dieback |
| 3 | Manitoba Maple / Acer negundo | 20, 24 | Poor | Included fence, trunk damage, 2 stems joined at base |
| 7 | Manitoba Maple / Acer negundo | 29 | Poor | Included fence, trunk damage, internal rot |
| 14 | Manitoba Maple / Acer negundo | 41, 58 | Poor | Included fence, trunk damage, 2 stems joined at base, fungal fruiting bodies |
| 16 | Manitoba Maple / Acer negundo | 31, 39 | Poor | 2 stems joined at base, longitudinal cracking |

| EXISTING TREES TO BE RETAINED | | | | |
|---|---|---|---|---|
| 27 | Norway Maple / Acer platanoides | 38 | Good | City Tree |
