March 31, 2023

RE: TREE CONSERVATION REPORT FOR 1987 ROBERTSON ROAD

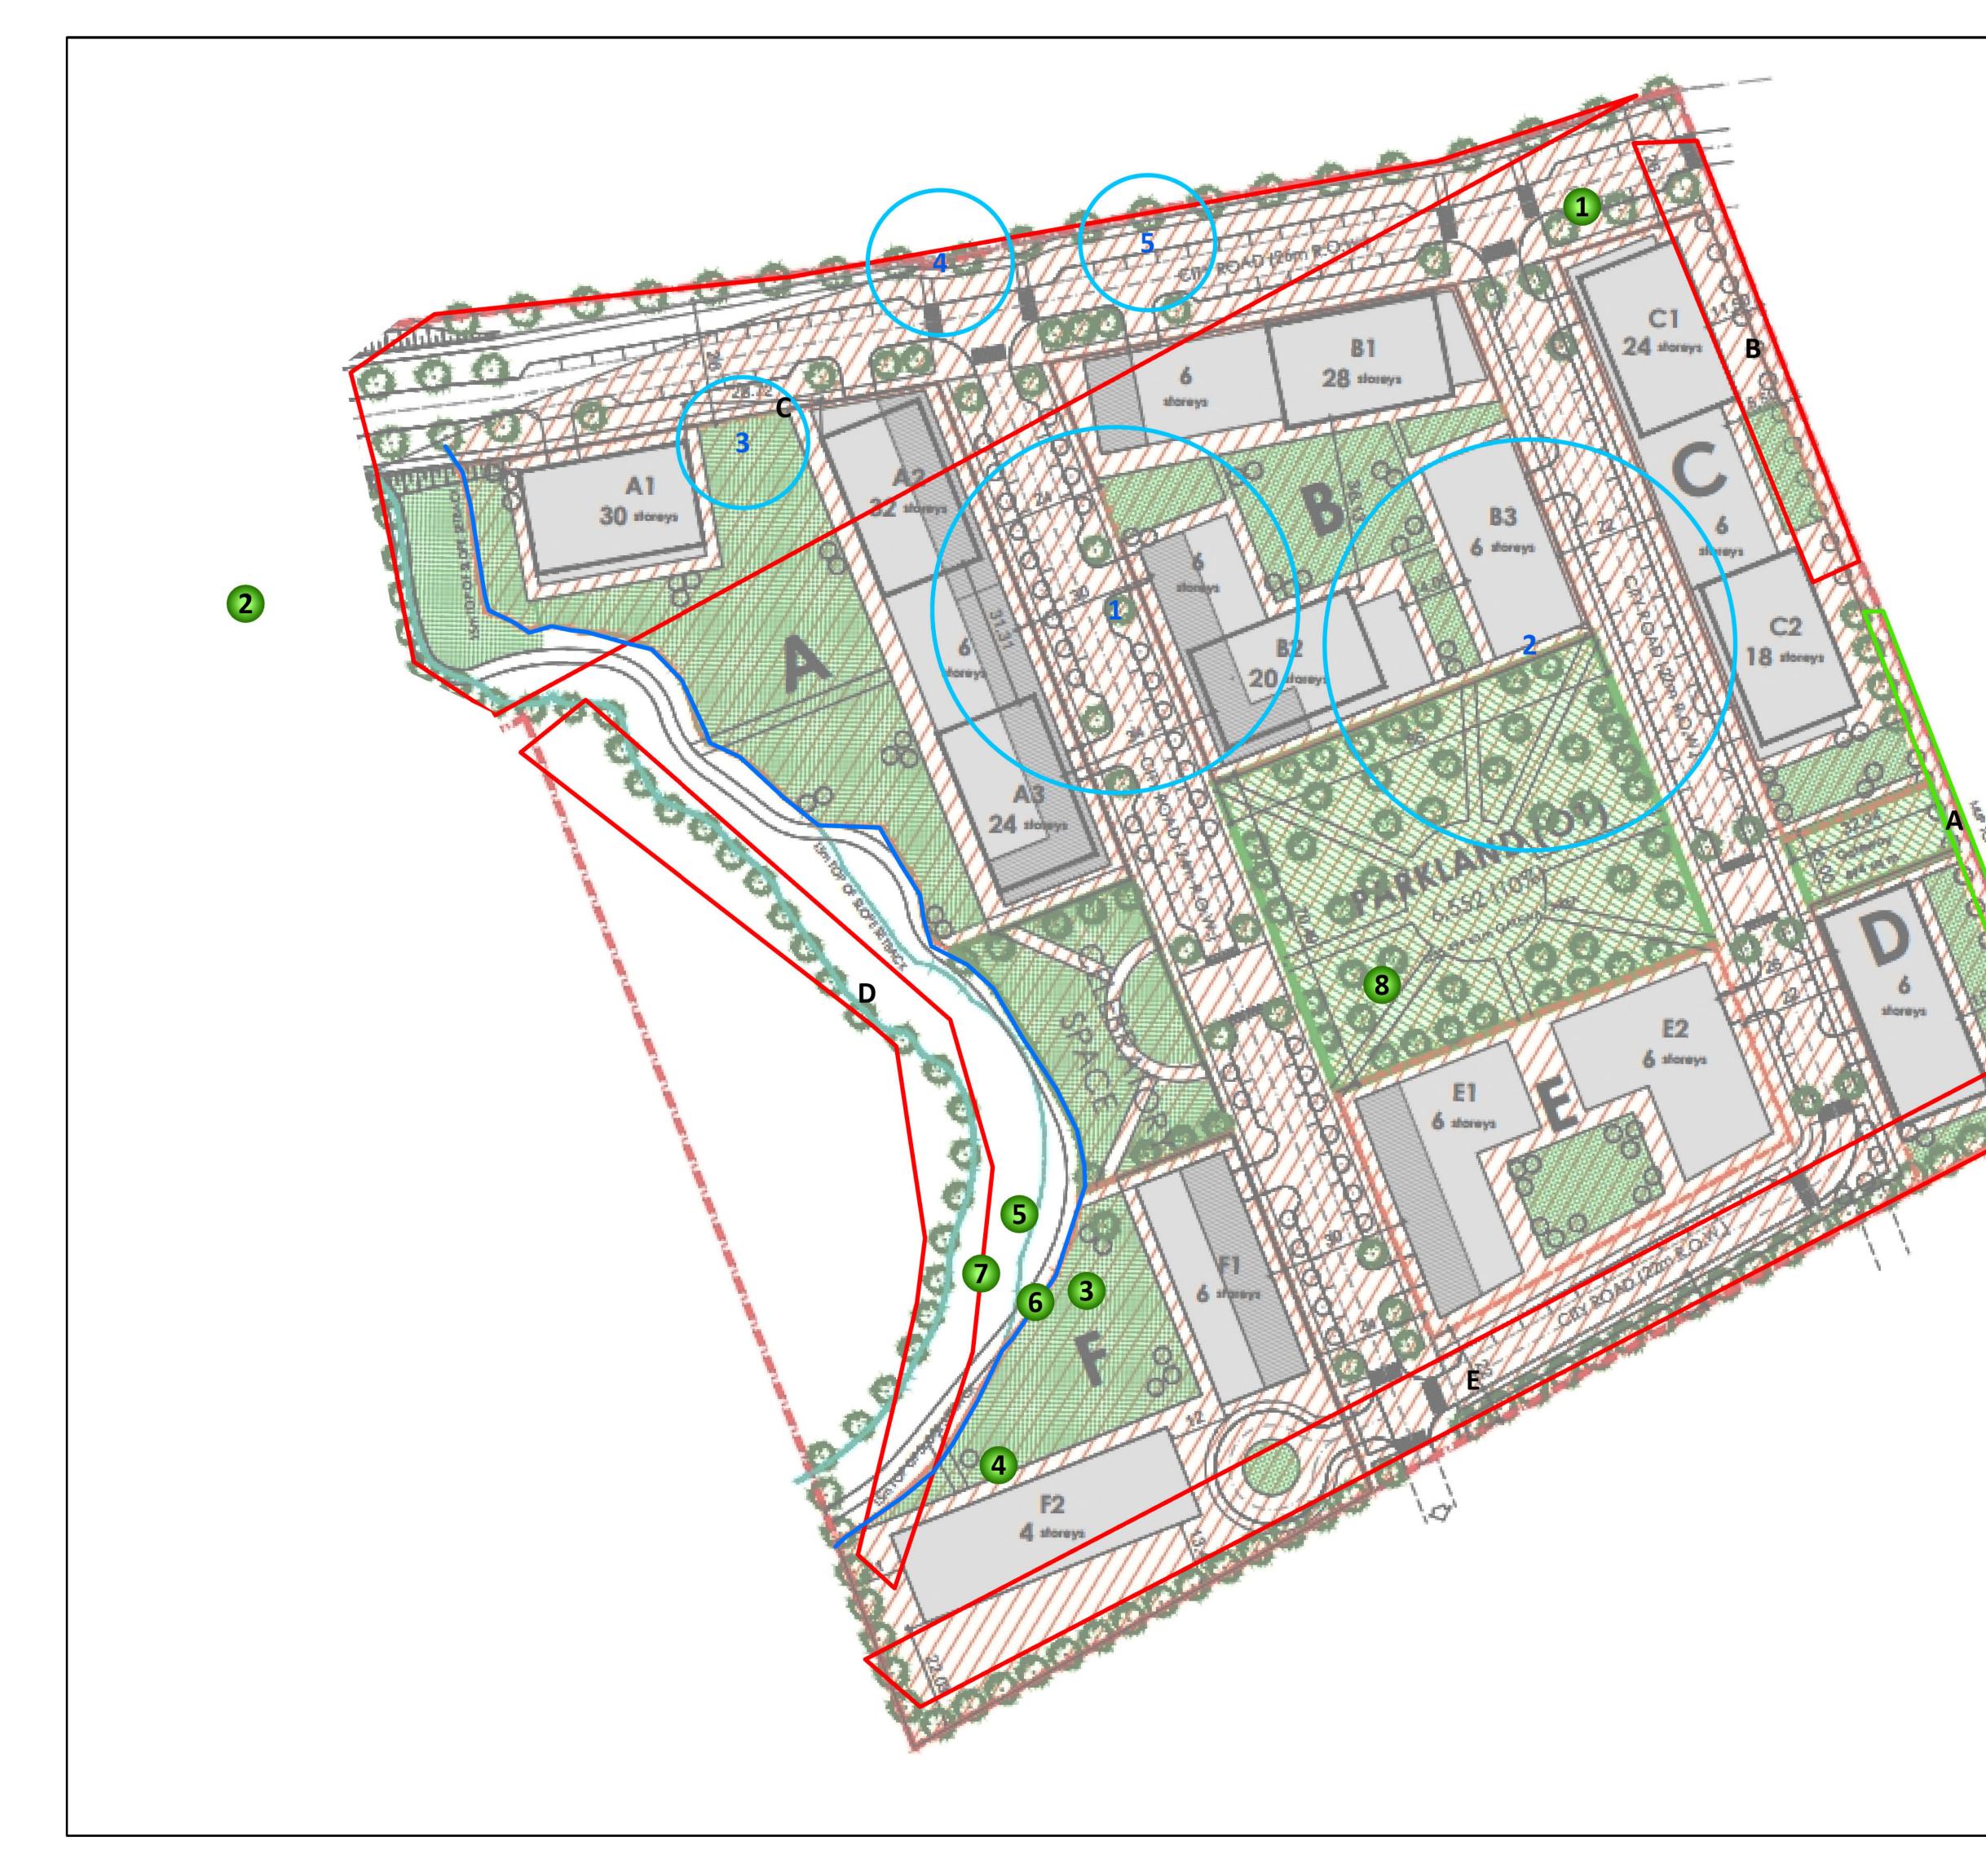
All current vegetation is shown on the tree conservation plan included on page 5 of this report. By the numbers and letters indicated on the plans, each tree and grouping of trees is detailed below:

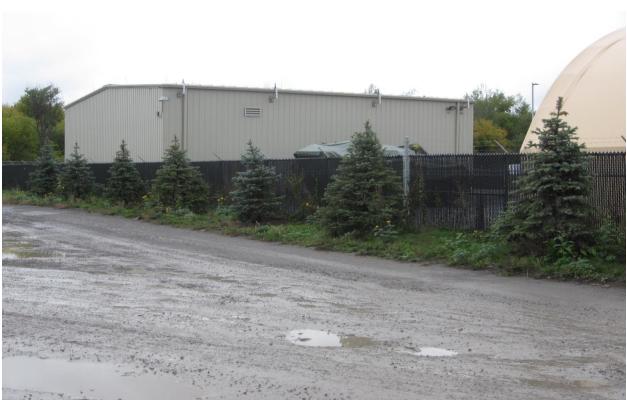
<u>Tree grouping A</u>: A line of nine planted Colorado spruce ranging in diameter from 5 to 9 cm which are in fair condition with the exception of one dead tree. Based on gaps in the line it appears other trees died and were removed in the past. This line of trees will be removed due to conflicts with construction. Transplanting elsewhere on the property may be an option for those trees in better health.

Picture 1. Tree grouping A at 1987 Robertson Road

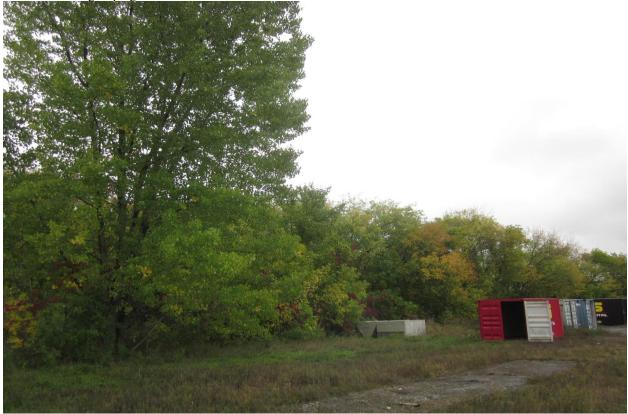
<u>Tree grouping B</u>: A group of Manitoba maples (*Acer negundo*) growing through the fence from the neighbouring property to the east. The largest tree is 19cm in diameter and in good condition. Being under the ownership of others these trees will be preserved and protected during construction (unless permission to remove is granted in writing by the adjacent landowner). However, the overhanging branches can be cut back to the property line.

Picture 2. Tree #1 (left) and grouping B at 1987 Robertson Road

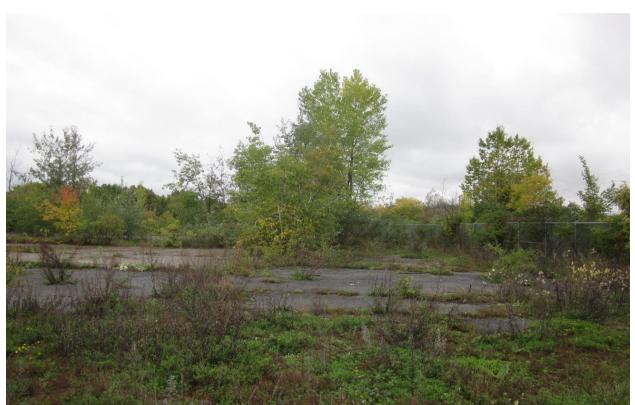
<u>Tree stand #1</u>: This stand is centered on a compacted area of stone, possibly a former parking lot. As with other areas on the property, all these trees arose from seed spread from elsewhere.

Tree Species	Average diameter (cm)	Percent occupancy
American elm	12	6
Ash species	12.5	2
Eastern cottonwood	15.1	28
Manitoba maple	12.1	28
Siberian elm		
(Ulmus pumila) ³	19.7	2
White poplar	16	2
Trembling aspen (Populus		
tremuloides)	15.1	32

Picture 3. Tree stand #1 at 1987 Robertson Road

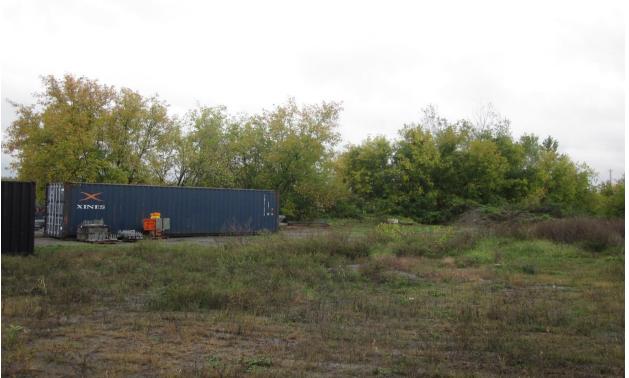
<u>Tree stand #2</u>: As with stand #1, this stand is centred on a heavily disturbed and compacted area.

Tree Species	Average diameter (cm)	Percent occupancy
Manitoba maple	16.3	43
White poplar	24.6	35
Trembling aspen	17.3	22

Picture 4. Tree stand #2 at 1987 Robertson Road

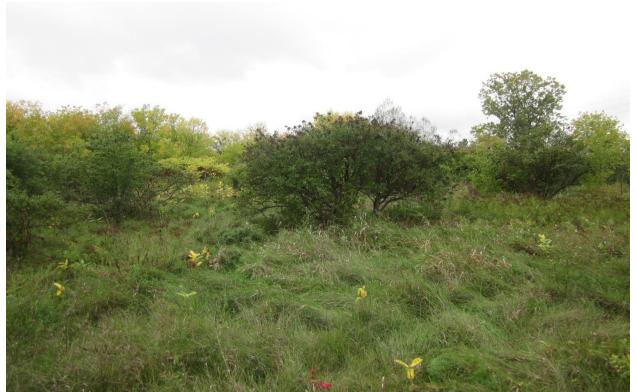
Tree Species	Average diameter (cm)	Percent occupancy
American elm		
(Ulmus americana)	15.4	21
Ash species		
$(Fraxinus \text{ spp.})^1$	15.2	13
Balsam poplar		
(Populus balsamifera)	14.6	18
Crab apple		
(Malus spp.)	17	2
Green ash		
(Fraxinus pennsylvanica var.		
subintegerrima) ¹	13	5
Manitoba maple		
(Acer negundo)	14.1	39
Willow species		
(Salix spp.)	19	2

<u>Tree grouping C</u>: A series of sample plots were taken in this area to determine general tree composition – species, average diameters and percent occupancy by stem count:

¹ all ash on the property are either dead or heavily infested with emerald ash borer (*Agrilus planipennis*)

Picture 5. Tree grouping C at 1987 Robertson Road

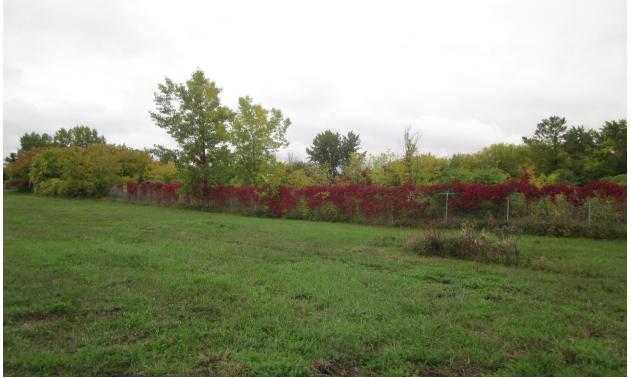
<u>Tree grouping D</u>: A series of sample plots were taken in this area to determine tree composition:

Tree Species	Average diameter (cm)	Percent occupancy	
American elm	15	6	
Eastern cottonwood (Populus deltoides)	27	6	
Manitoba maple	15.8	82	
Eastern redcedar (Juniperus virginiana)	6	6	A

Picture 6. Tree grouping D at 1987 Robertson Road

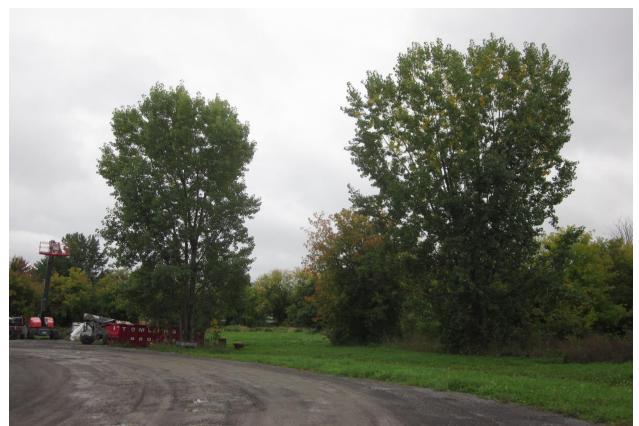
Tree	Tree	Diameter	Tree Condition,
No.	Species	(cm)	Condition Notes and Age
			Good; multi-stemmed (6) at grade; growing
1	Eastern cottonwood	27.5 avg.	through chain link fence; mature
			Good; basal wound; located on edge of hill,
2	Eastern cottonwood	60	near train tracks; mature
3	Eastern cottonwood	30 avg.	Good; multi-stemmed (3) at grade; maturing
	Crab apple		
4	(Malus spp.)	12.5 avg.	Good; multi-stemmed (7) at grade; maturing
			Good; multiple leaders at 1m from grade;
5	Eastern cottonwood	55	mature
			Good; double leader at 0.2m from grade with
6	Manitoba maple	27 avg.	inclusion ridge at union; maturing
7	Manitoba maple	21	Good condition; maturing
8	Balsam poplar	20	Fair; growing against building; maturing

Picture 7. Trees #3 and 5 at 1987 Robertson Road

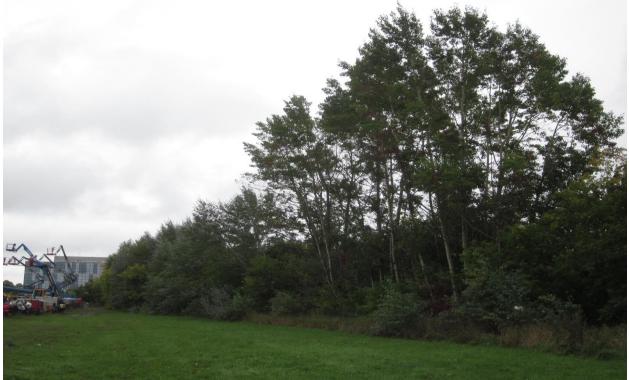
Tree Species	Average diameter (cm)	Percent occupancy
American elm	16	1
Manitoba maple	14	57
White poplar $(Populus \ alba)^2$	17.1	42

<u>Tree grouping E</u>: A series of sample plots were taken in this area to determine tree composition:

² white poplar is an introduced and invasive species in Ontario

Picture 8. Tree grouping E at 1987 Robertson Road
