April 18, 2023

## **1900 and 2000 CITYPARK DRIVE TREE INVENTORY AND RETENTION REVIEW**

project  
**1900 & 2000 CITY PARK DRIVE**

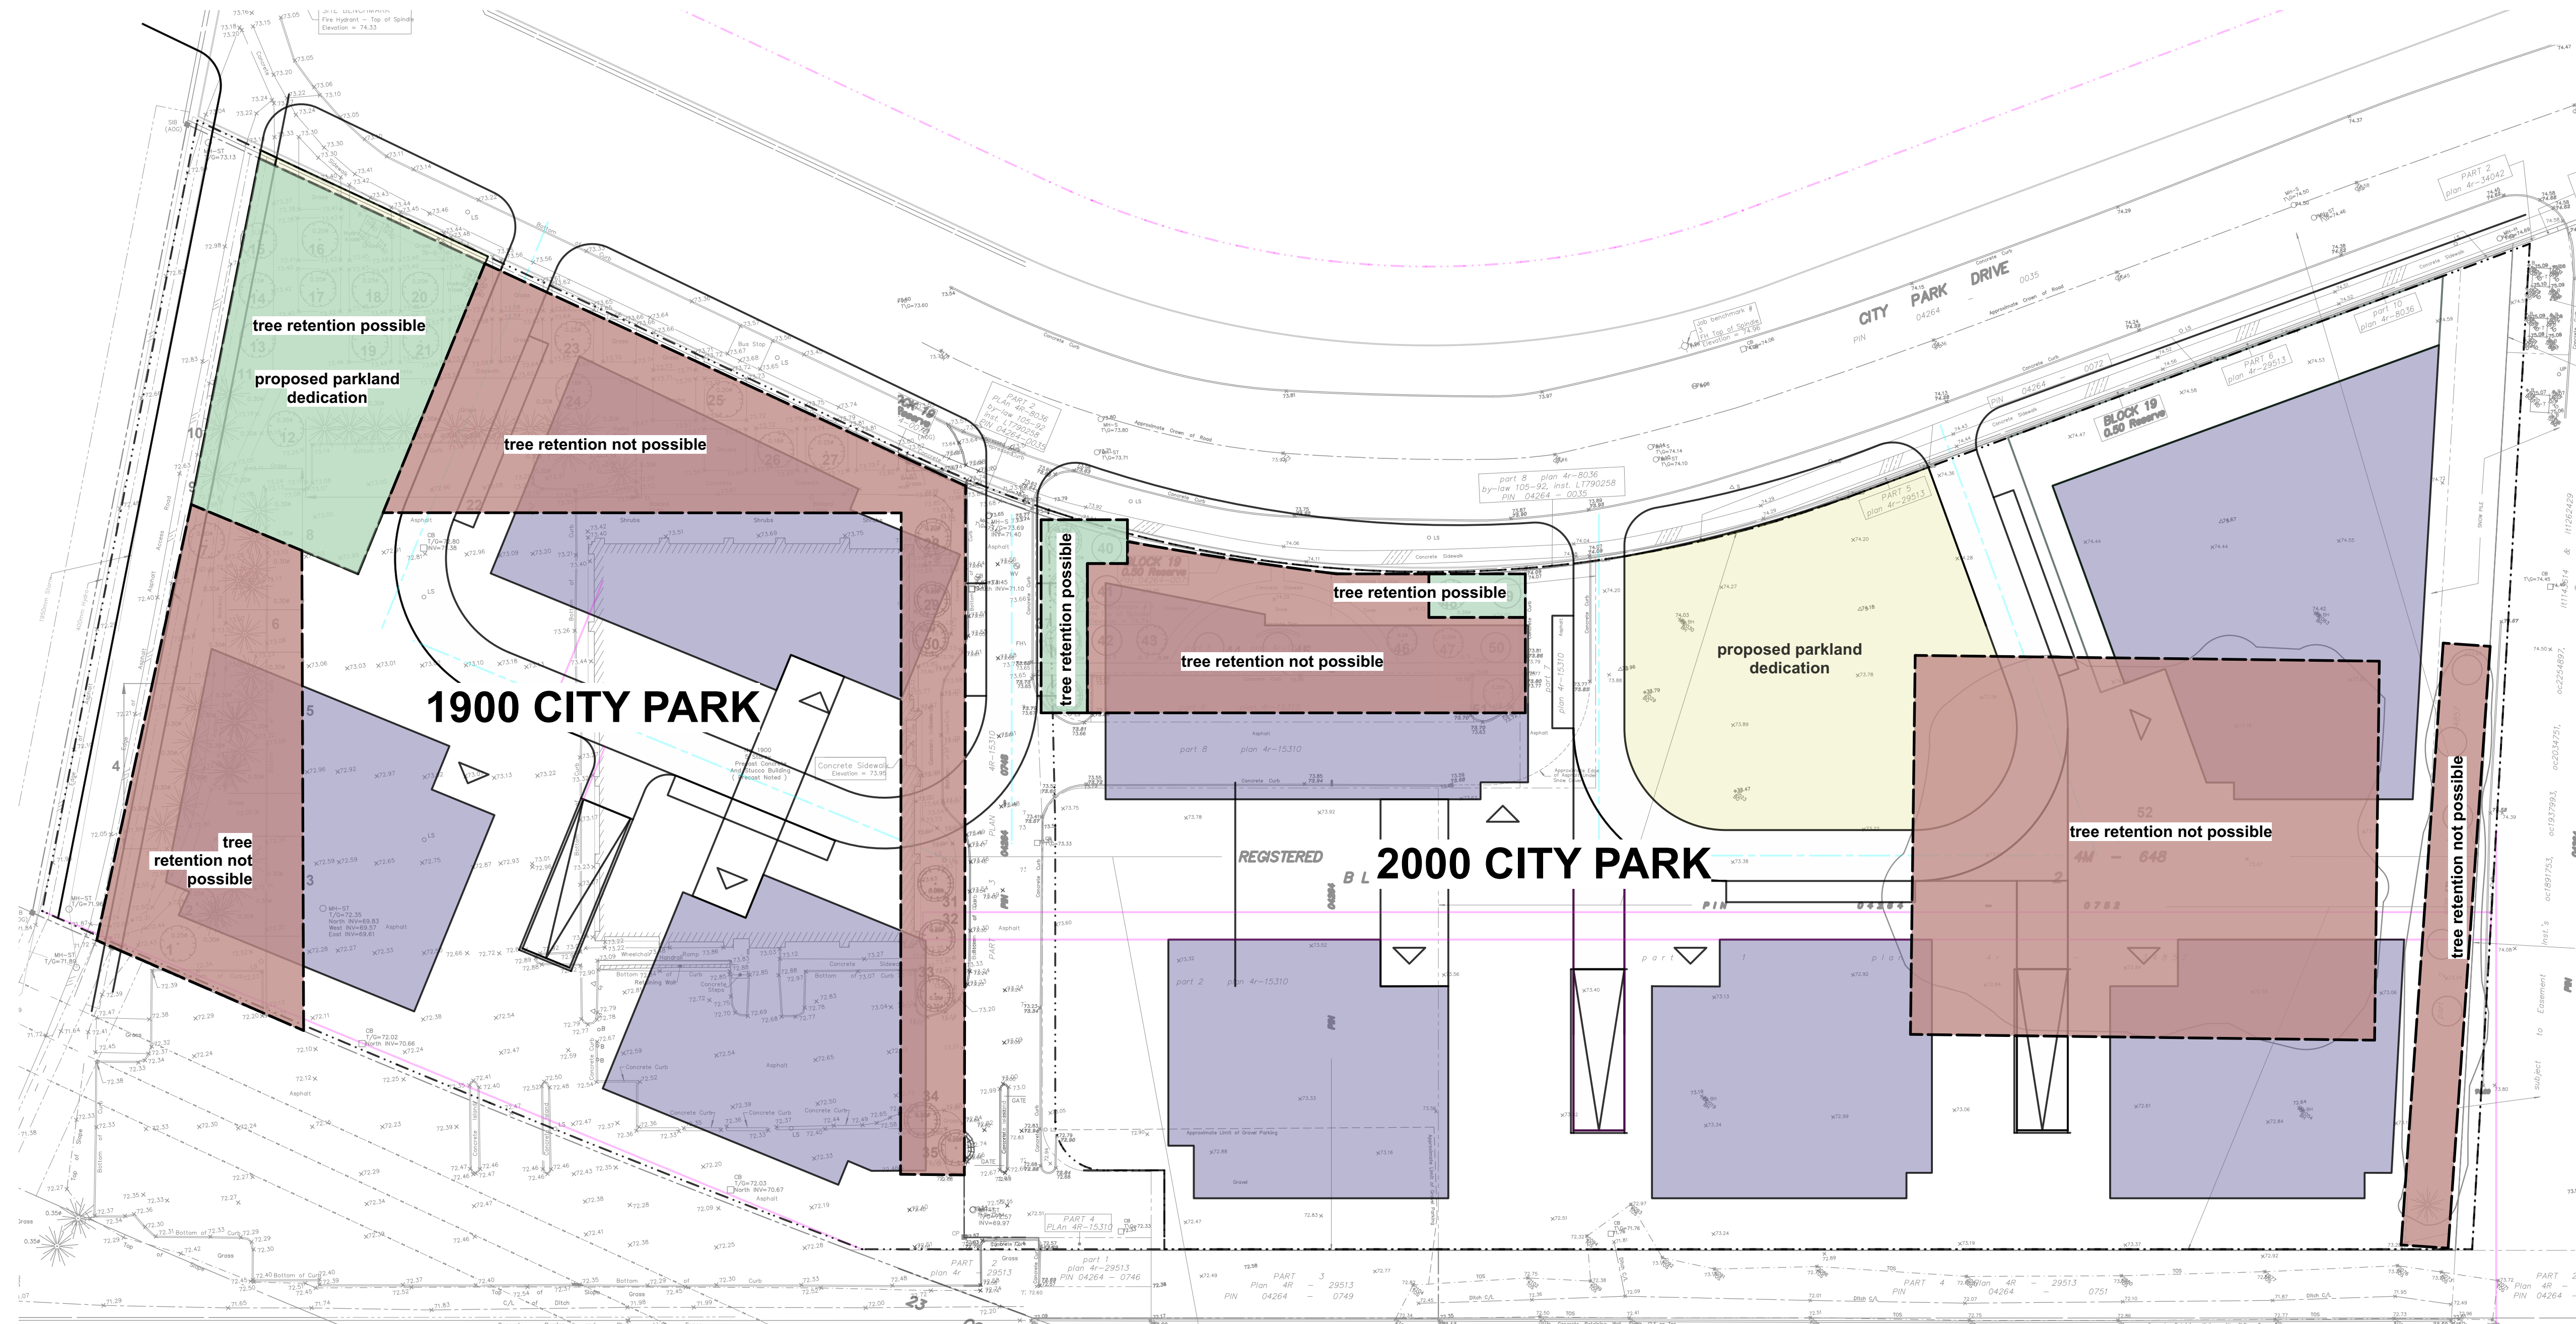
**RETENTION SCHEMATIC**

A high level desktop review of possible tree retention areas was undertaken using the existing schematic building layout for 1900 and 2000 City Park Drive. A retention plan is provided which is based on the existing surveys and proposed schematic site plan, refer to Retention Plan, R1 prepared by Ruhland & Associates.

**Tree Retention:** based on the current schematic site plan, preservation opportunities exist in the north west corner in the r.o.w. adjacent to the proposed entrance drive (trees #36-40, 48 & 49). The remainder of the trees would be removed. A final review of retention possibilities will be undertaken during the site plan control process with a final site plan layout. Refer to attached tree retention areas.

**Tree Retention:** Preservation opportunities exist in the north west corner (parkland dedication) (trees #8-21), depending on the future use. The remainder of the trees would be removed. A final review of retention possibilities will be undertaken during the site plan control process with a final site plan layout. Refer to attached tree retention areas.
