110394936 CANADA INC.

TREE CONSERVATION REPORT

8600 Jeanne-d'Arc Blvd N.

CIMA+ file number: A001295 May 23, 2023 – Review 000

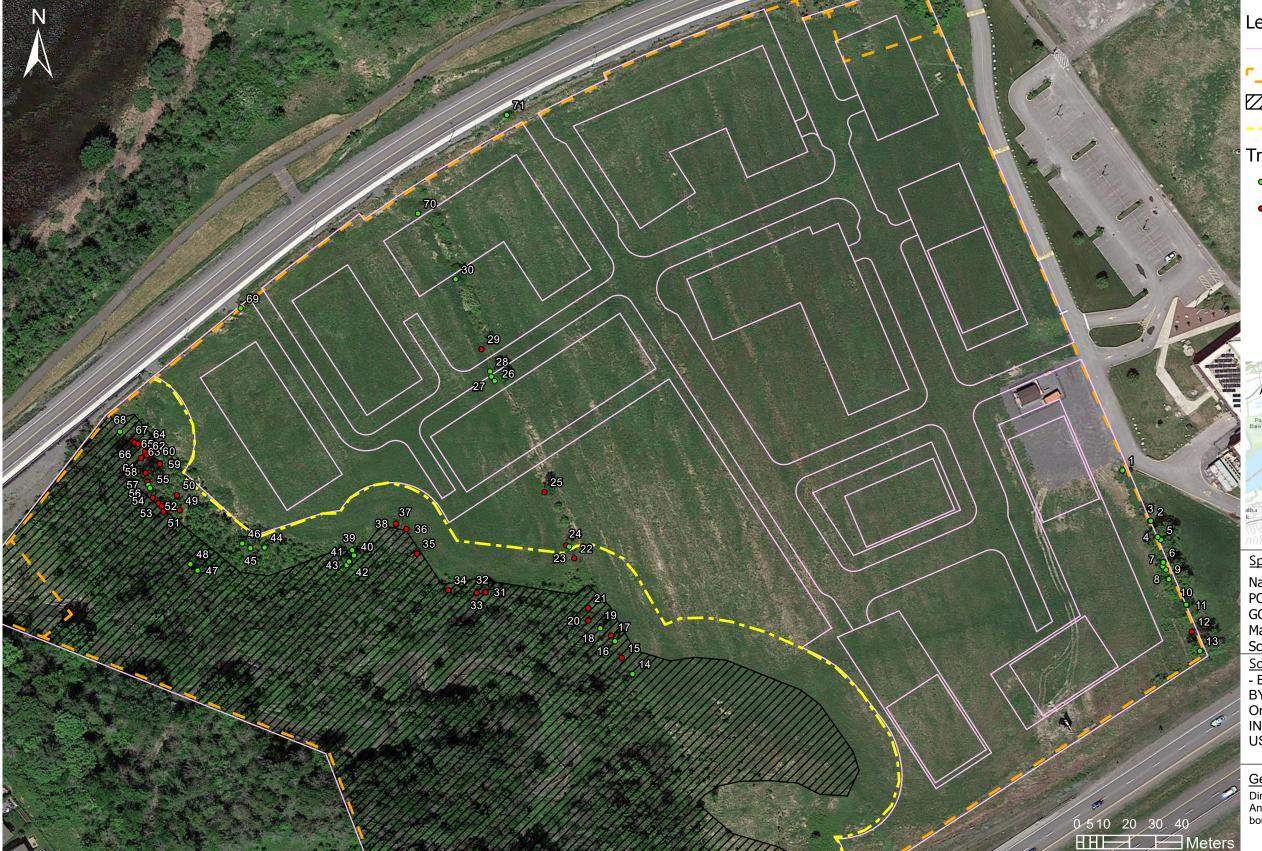
Figure 2 - Petrie III Study Area Tree Locations

A total of 71 trees with a DBH of 10 cm or greater were assessed as part of this inventory within the Site boundaries. Of these, 36 were alive, and 35 were dead. The most common living species were Bur Oak (15%), Green Ash (13%), and White Elm (13%), and majority of the dead trees were Green Ash.

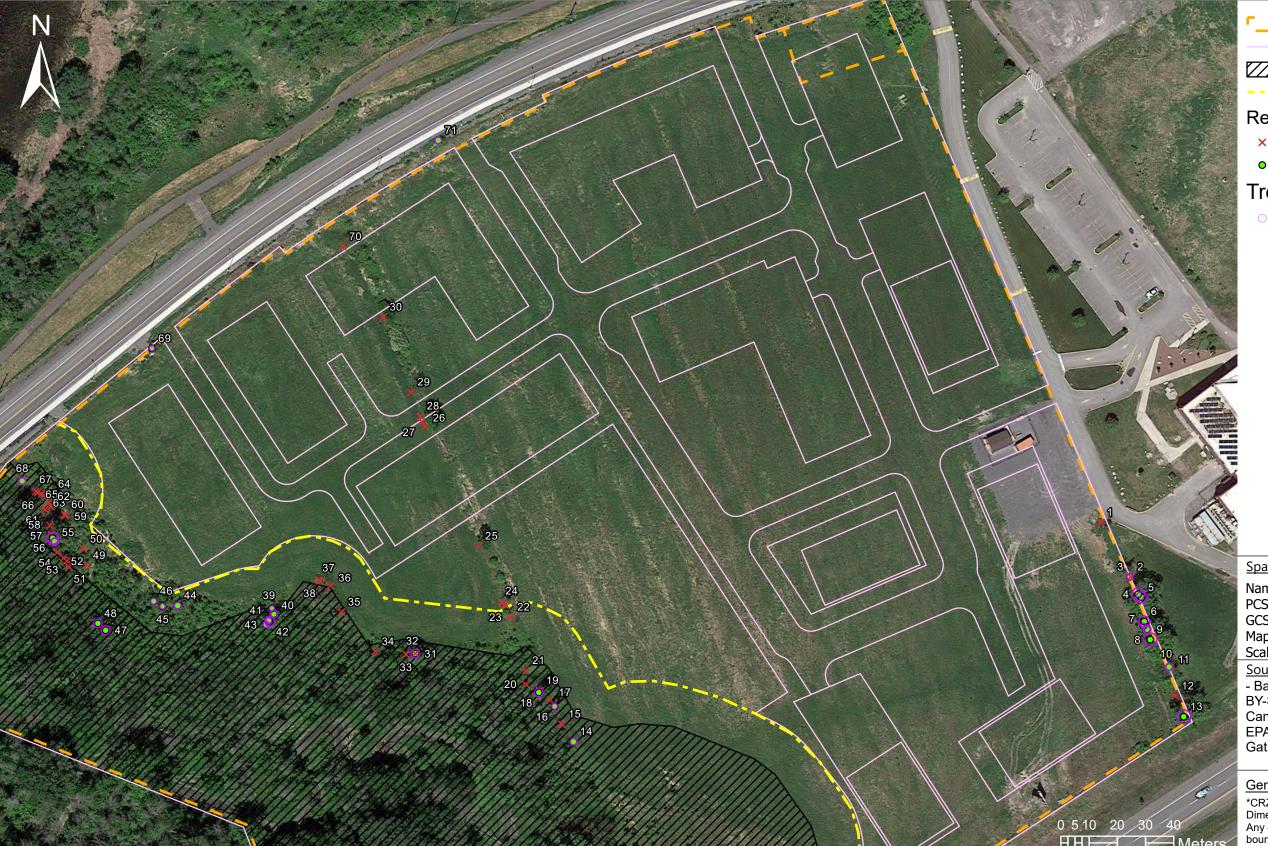
Figure 3 - Proposed Development & Conserved Vegetation

Based on the species and conditions of the trees located within the site and the extent of the grading limits of the proposed project design it is recommended to remove 43 trees and retain 28. Of the trees recommended for removal, 35 are dead ash and/or elm, two (2) are ash in poor condition, and the remaining six (6) individuals are directly within the impact area. The 28 trees recommended for retention are all living and are situated outside the limits of construction.

To successfully preserve trees that are recommended for on-site retention, as well as those identified as being impacted, the following series of mitigation measures is recommended. These recommended measures largely center on the minimum CRZ of trees, as defined by the City's Tree Conservation Report Guidelines. The following measures are being recommended to protect the CRZ of all trees slated for retention and/or impact:
