McKINLEY
ENVIRONMENTAL
SOLUTIONS

April 23rd, 2020

RE: Woodlot S-23 Large Tree Inventory – Minto Communities and Valecraft Homes Kanata North
Developments (Revised)

APPENDIX A – TREE PHOTOS

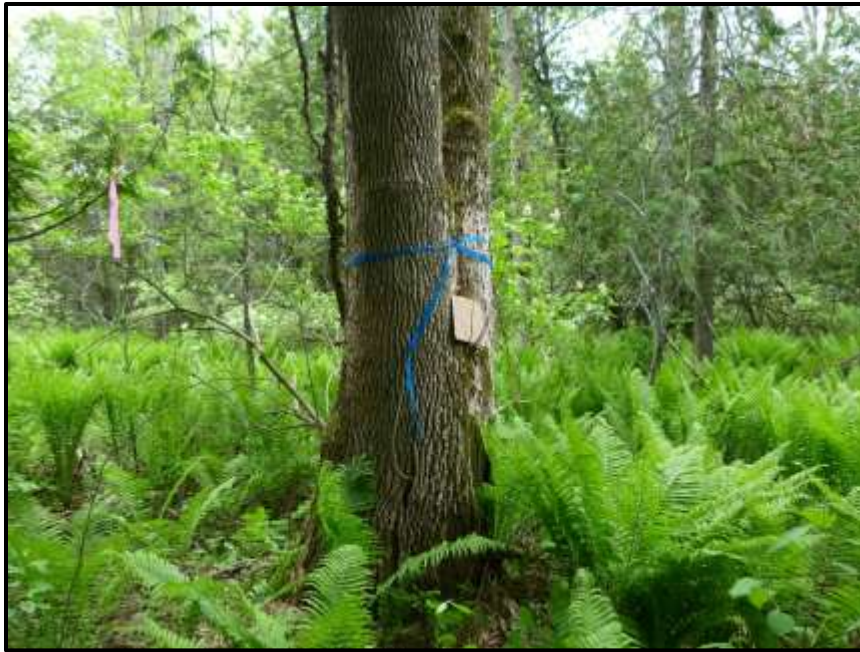
Photograph 7: Tree #8 – dead White Ash (May 27th, 2019).

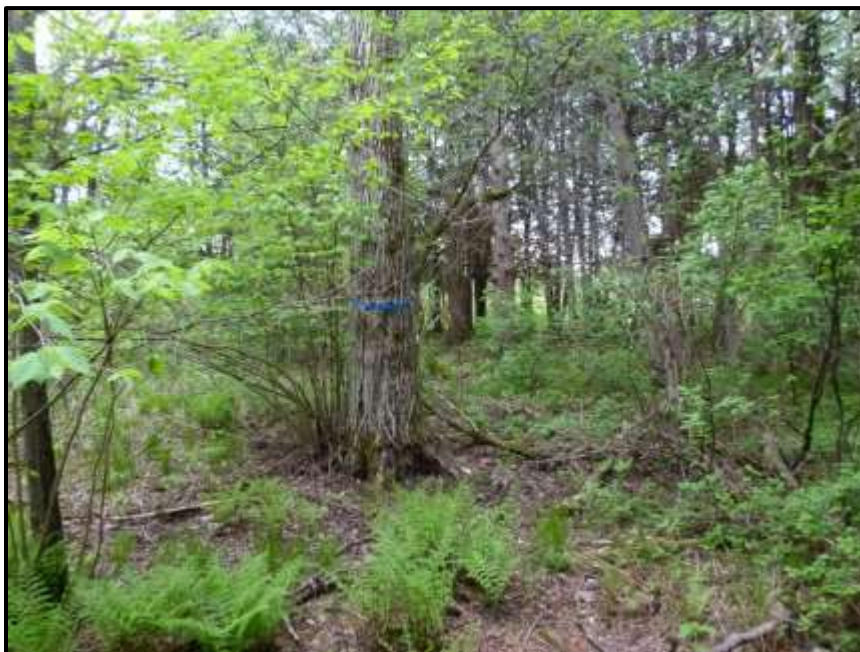
Photograph 12: Tree #13 – Category 3 Butternut (May 27th, 2019).

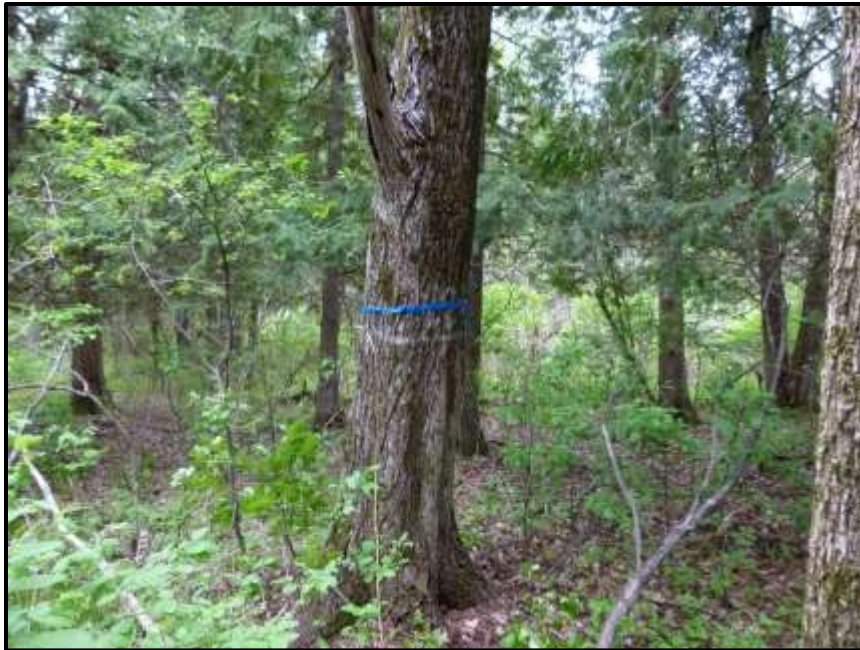
Photograph 15: Tree #16 - Category 1 Butternut (May 27th, 2019).

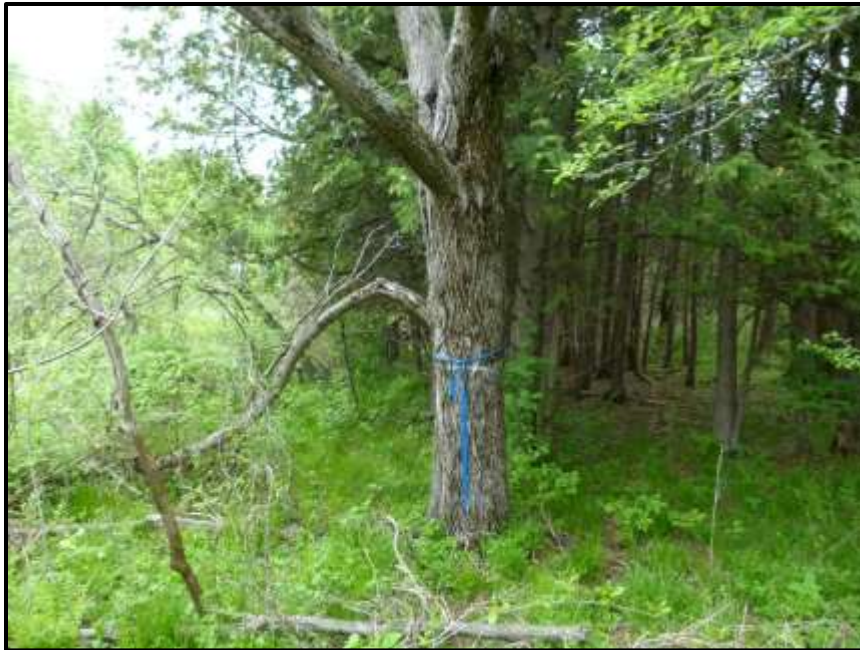
Photograph 17: Tree #18 – Category 2 Butternut (May 27th, 2019).

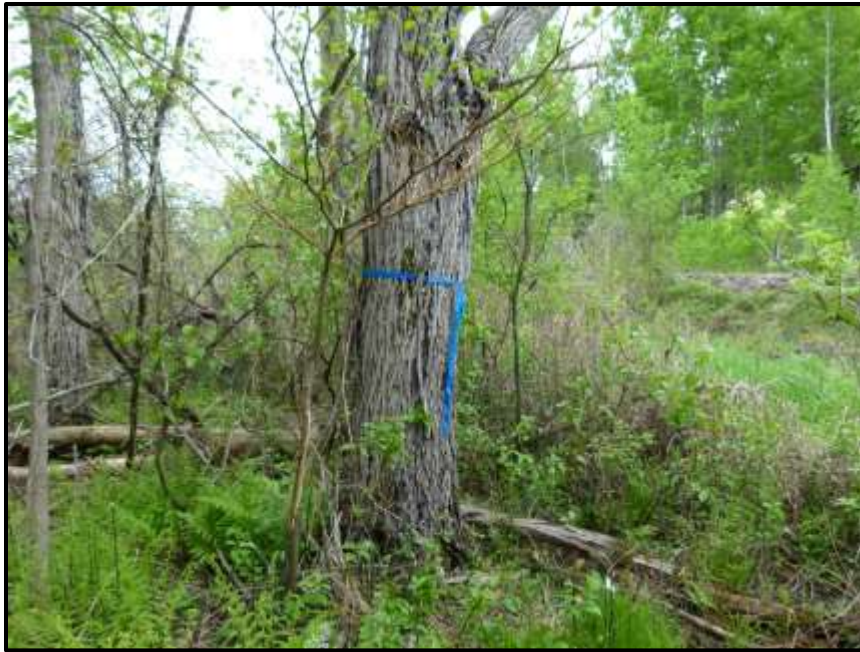
Photograph 19: Tree #20 – Category 1 Butternut (May 27th, 2019).

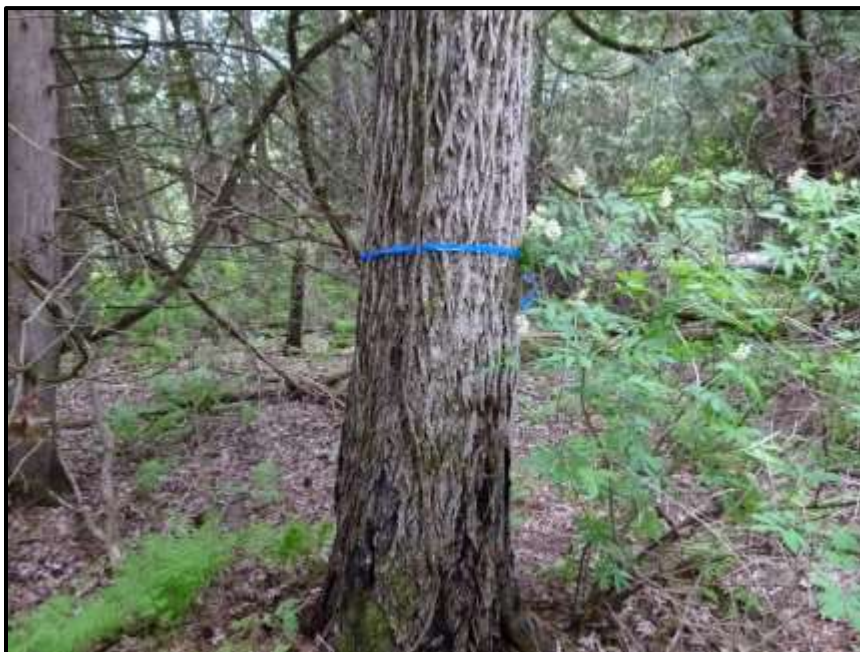
Photograph 24: Tree #25 – Category 3 Butternut Tree (May 27th, 2019).

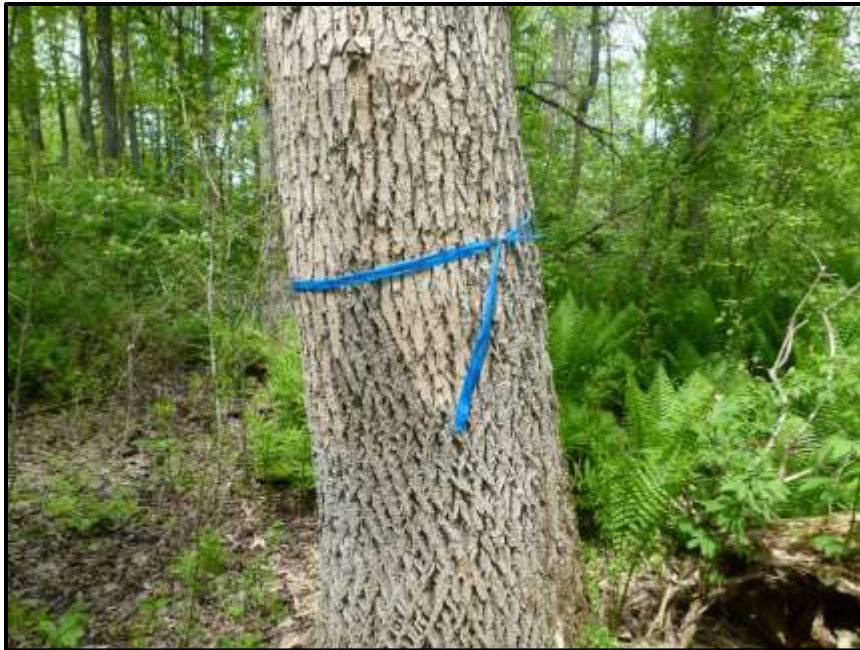
Photograph 31: Tree #32 – dead White Ash (May 27th, 2019).

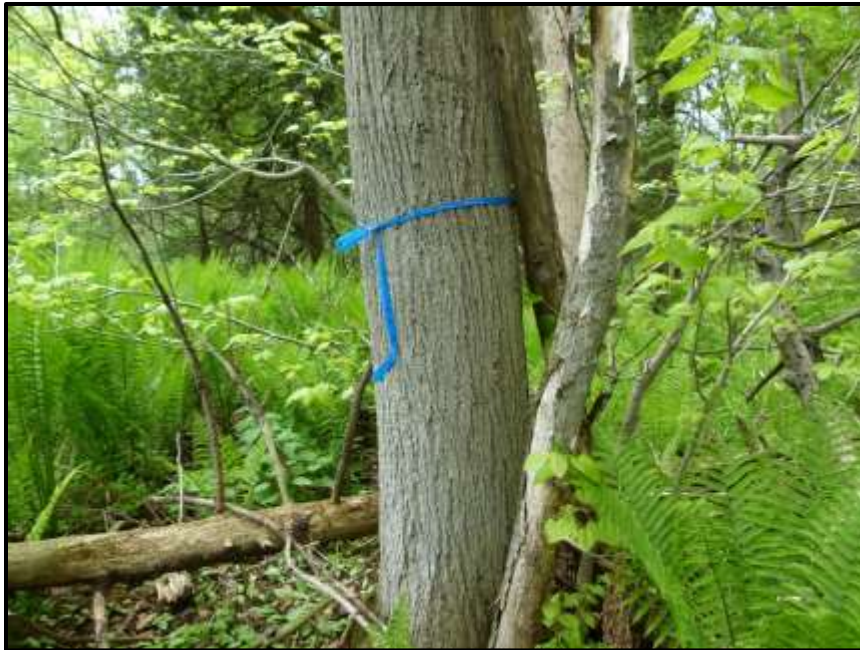
Photograph 33: Tree #34 – Basswood in good condition (May 27th, 2019).

Per the KNUEA EMP, it is recommended that all trees within the Study Area that occur outside of the limits of the future SWM pond should be preserved. In addition, wherever feasible, trees that occur along the edge of the retained area should also be preserved. Based on the estimated limits of the SWM pond shown above in Figures 1 to 3, the only potentially retainable trees (healthy) that currently occur along the edge of the SWM pond are Tree #34, which is a 51 cm diameter at breast height (dbh) Basswood, and Tree #74, which is a 74 cm dbh Butternut. If feasible and compatible with the requirements of the SWM pond, Tree #34 and Tree #74 should be preserved adjacent to the edge of the retained area during the construction of the SWM pond.

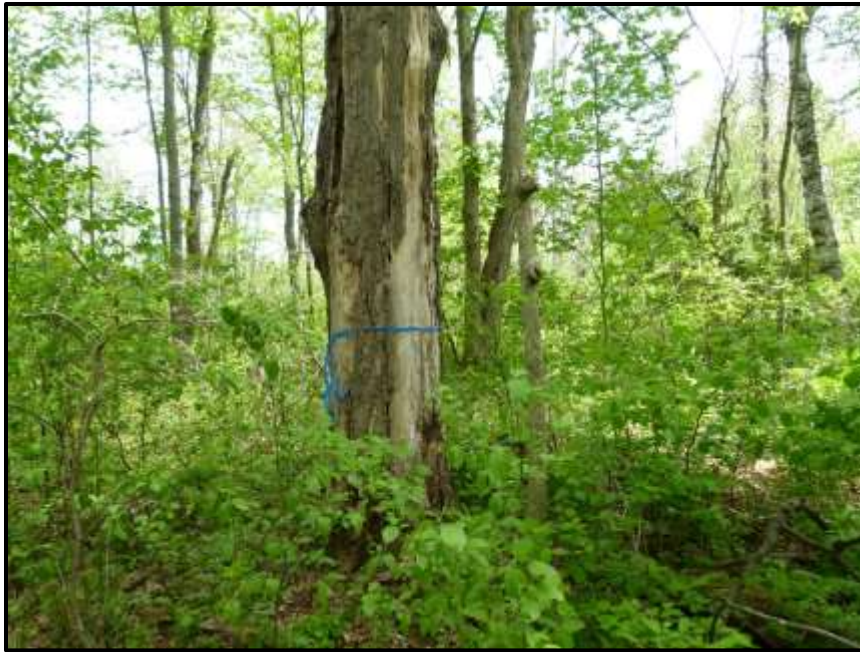
Photograph 37: Tree #38 – Sugar Maple in poor condition (May 27th, 2019).

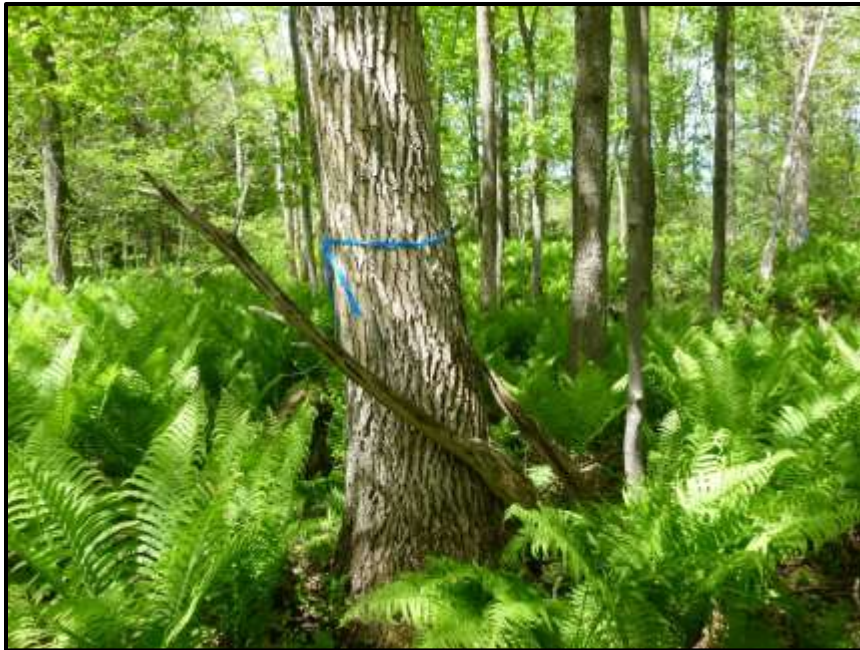
Photograph 47: Tree #48 – dead White Ash (May 27th, 2019).

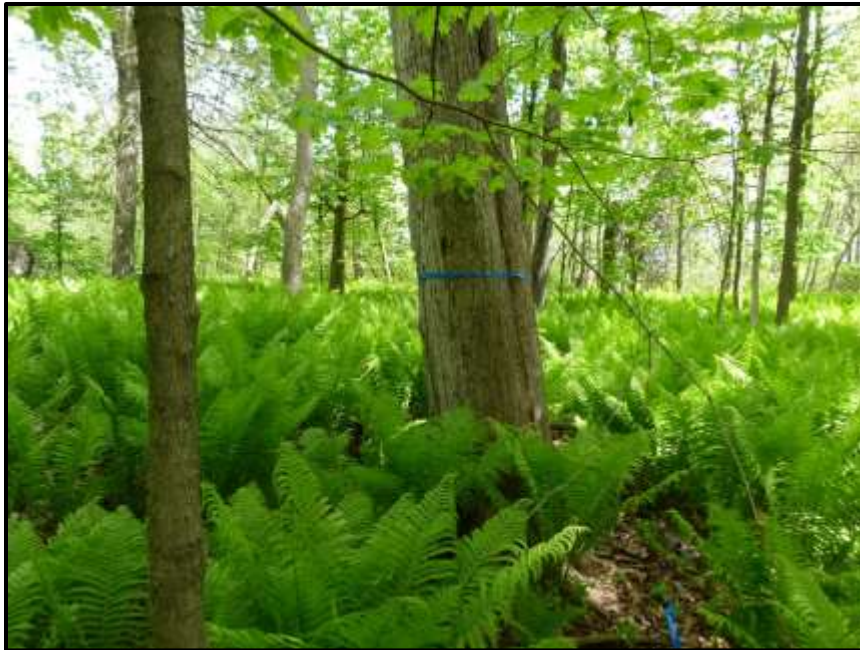
Photograph 49: Tree #50 – Basswood in poor condition (May 27th, 2019).

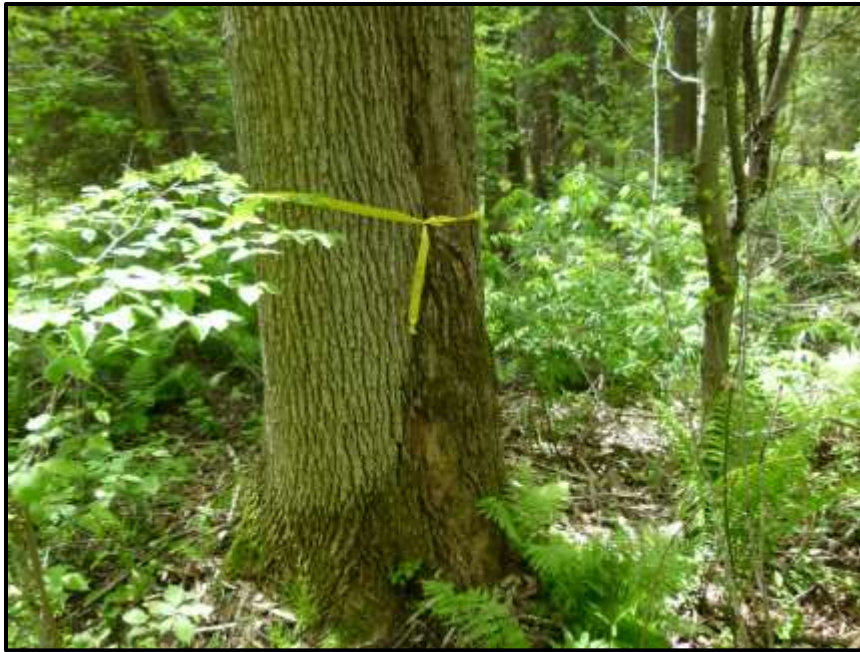
Photograph 51: Tree #52 – dead White Ash (May 27th, 2019).

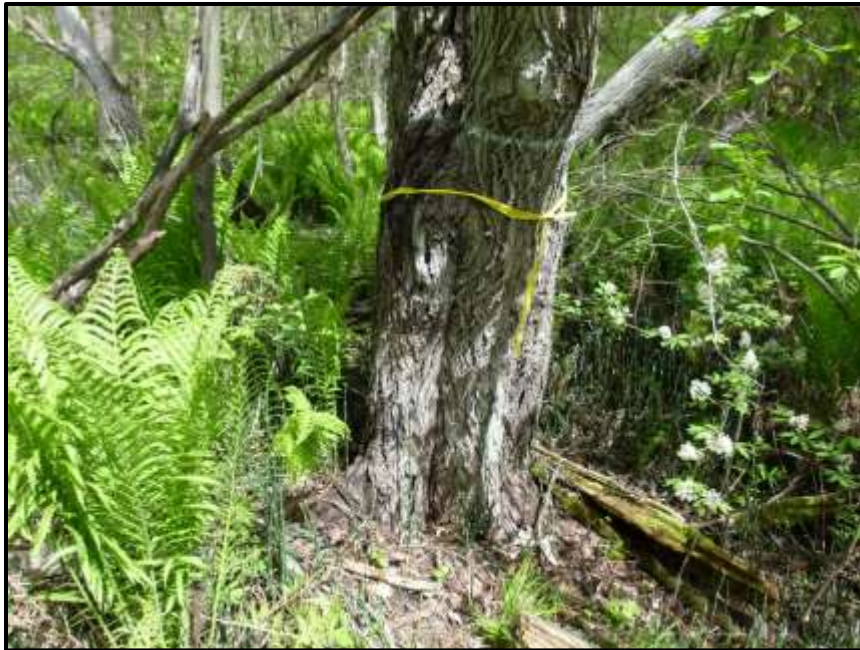
Photograph 55: Tree #56 – Category 3 Butternut (May 30th, 2019).

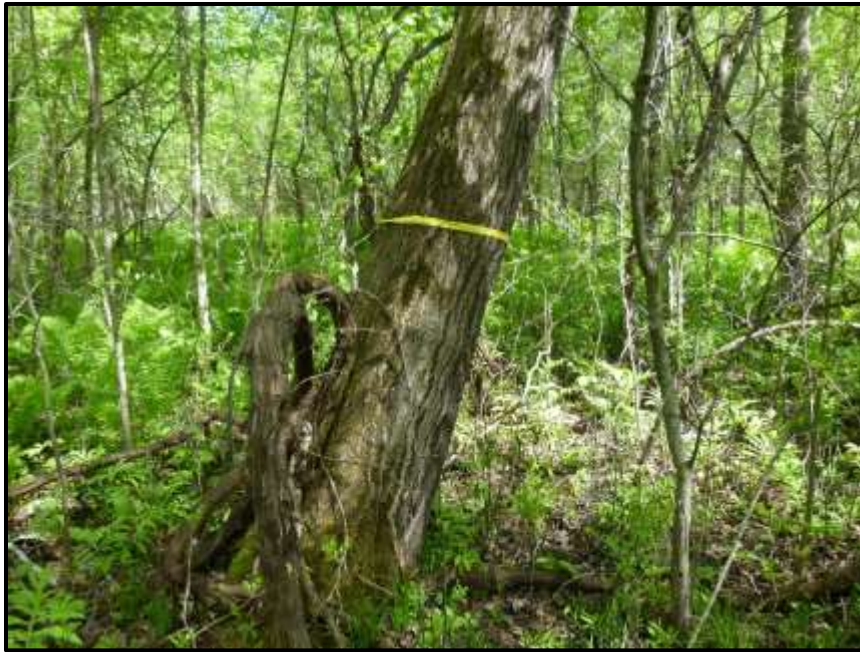
Photograph 57: Tree #58 – Trembling Aspen in poor condition (May 30th, 2019).
