December 15, 2020

RE: TREE CONSERVATION REPORT FOR 770-774 BRONSON AVENUE, OTTAWA

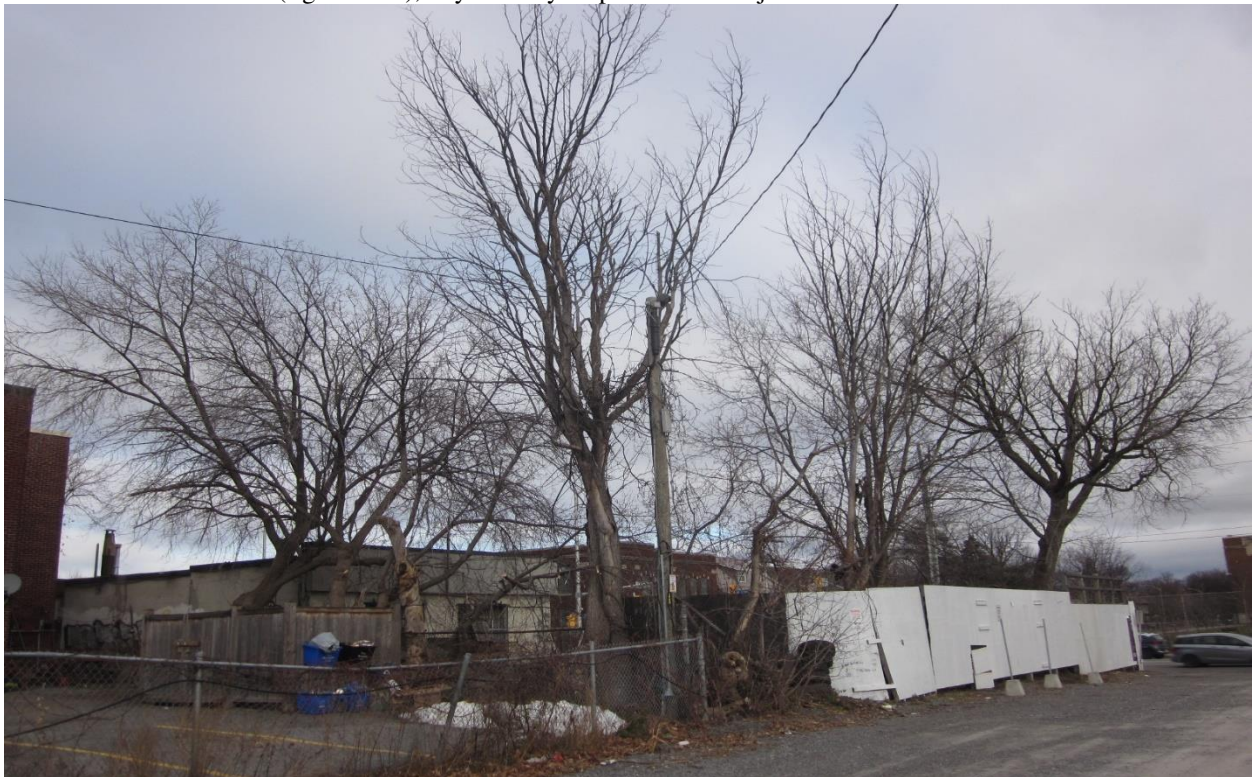
4	Manitoba maple	Dead	+/-15 avg.	Private	Maturing; coppice growth from old stump; to be removed
5	White elm (<i>Ulmus americana</i>)	Dead	+/-55	Shared	Mature; native species; likely killed by Dutch elm disease (<i>Ophiostoma ulmi/novo-ulmi</i>); to be removed (hazardous)
6	Manitoba maple	Poor	+/-25	Shared	Mature; coppice growth from old stump; embedded in fence; to be removed (due to poor condition)
7	Manitoba maple	Poor	+/-25	Shared	Mature; divergent form towards north; embedded in fence; to be removed (due to poor condition)

8	Manitoba maple	Poor	+/-60	Shared	Mature; topped at 4.5m – dense regrowth; very broad crown; embedded in fence; to be removed (due to poor condition)
9	Manitoba maple	Good	+/-30	Shared	Mature; central dominant stem; crown divergent towards east (over subject property); to be removed (conflicts with construction)
10	Hackberry (<i>Celtis occidentalis</i>)	Good	14.1	City	Maturing; dominant central stem for half height; co-dominant, divergent leaders at 3m; restricted rooting area; native species; to be preserved and protected
11	Hackberry	Good	13.7	City	Maturing; dominant central stem with competing laterals starting at 2m – broad crown; restricted rooting area; to be preserved and protected
12	Hackberry	Very good	13.9	City	Maturing; dominant central stem for most of height with parallel leaders at 4m – upright crown; restricted rooting area; to be preserved and protected
13	Manitoba maple	Good	+/-80	Private	Mature; generally upright form; core of crown in decline due to cluster of five laterals starting at 5m; to be removed (conflicts with construction)

Picture 2. Trees #5 (centre) through 13 (far right) shared or fully located on 770-774 Bronson Avenue
