March 1, 2022

RE: TREE CONSERVATION REPORT FOR 1987 ROBERTSON ROAD

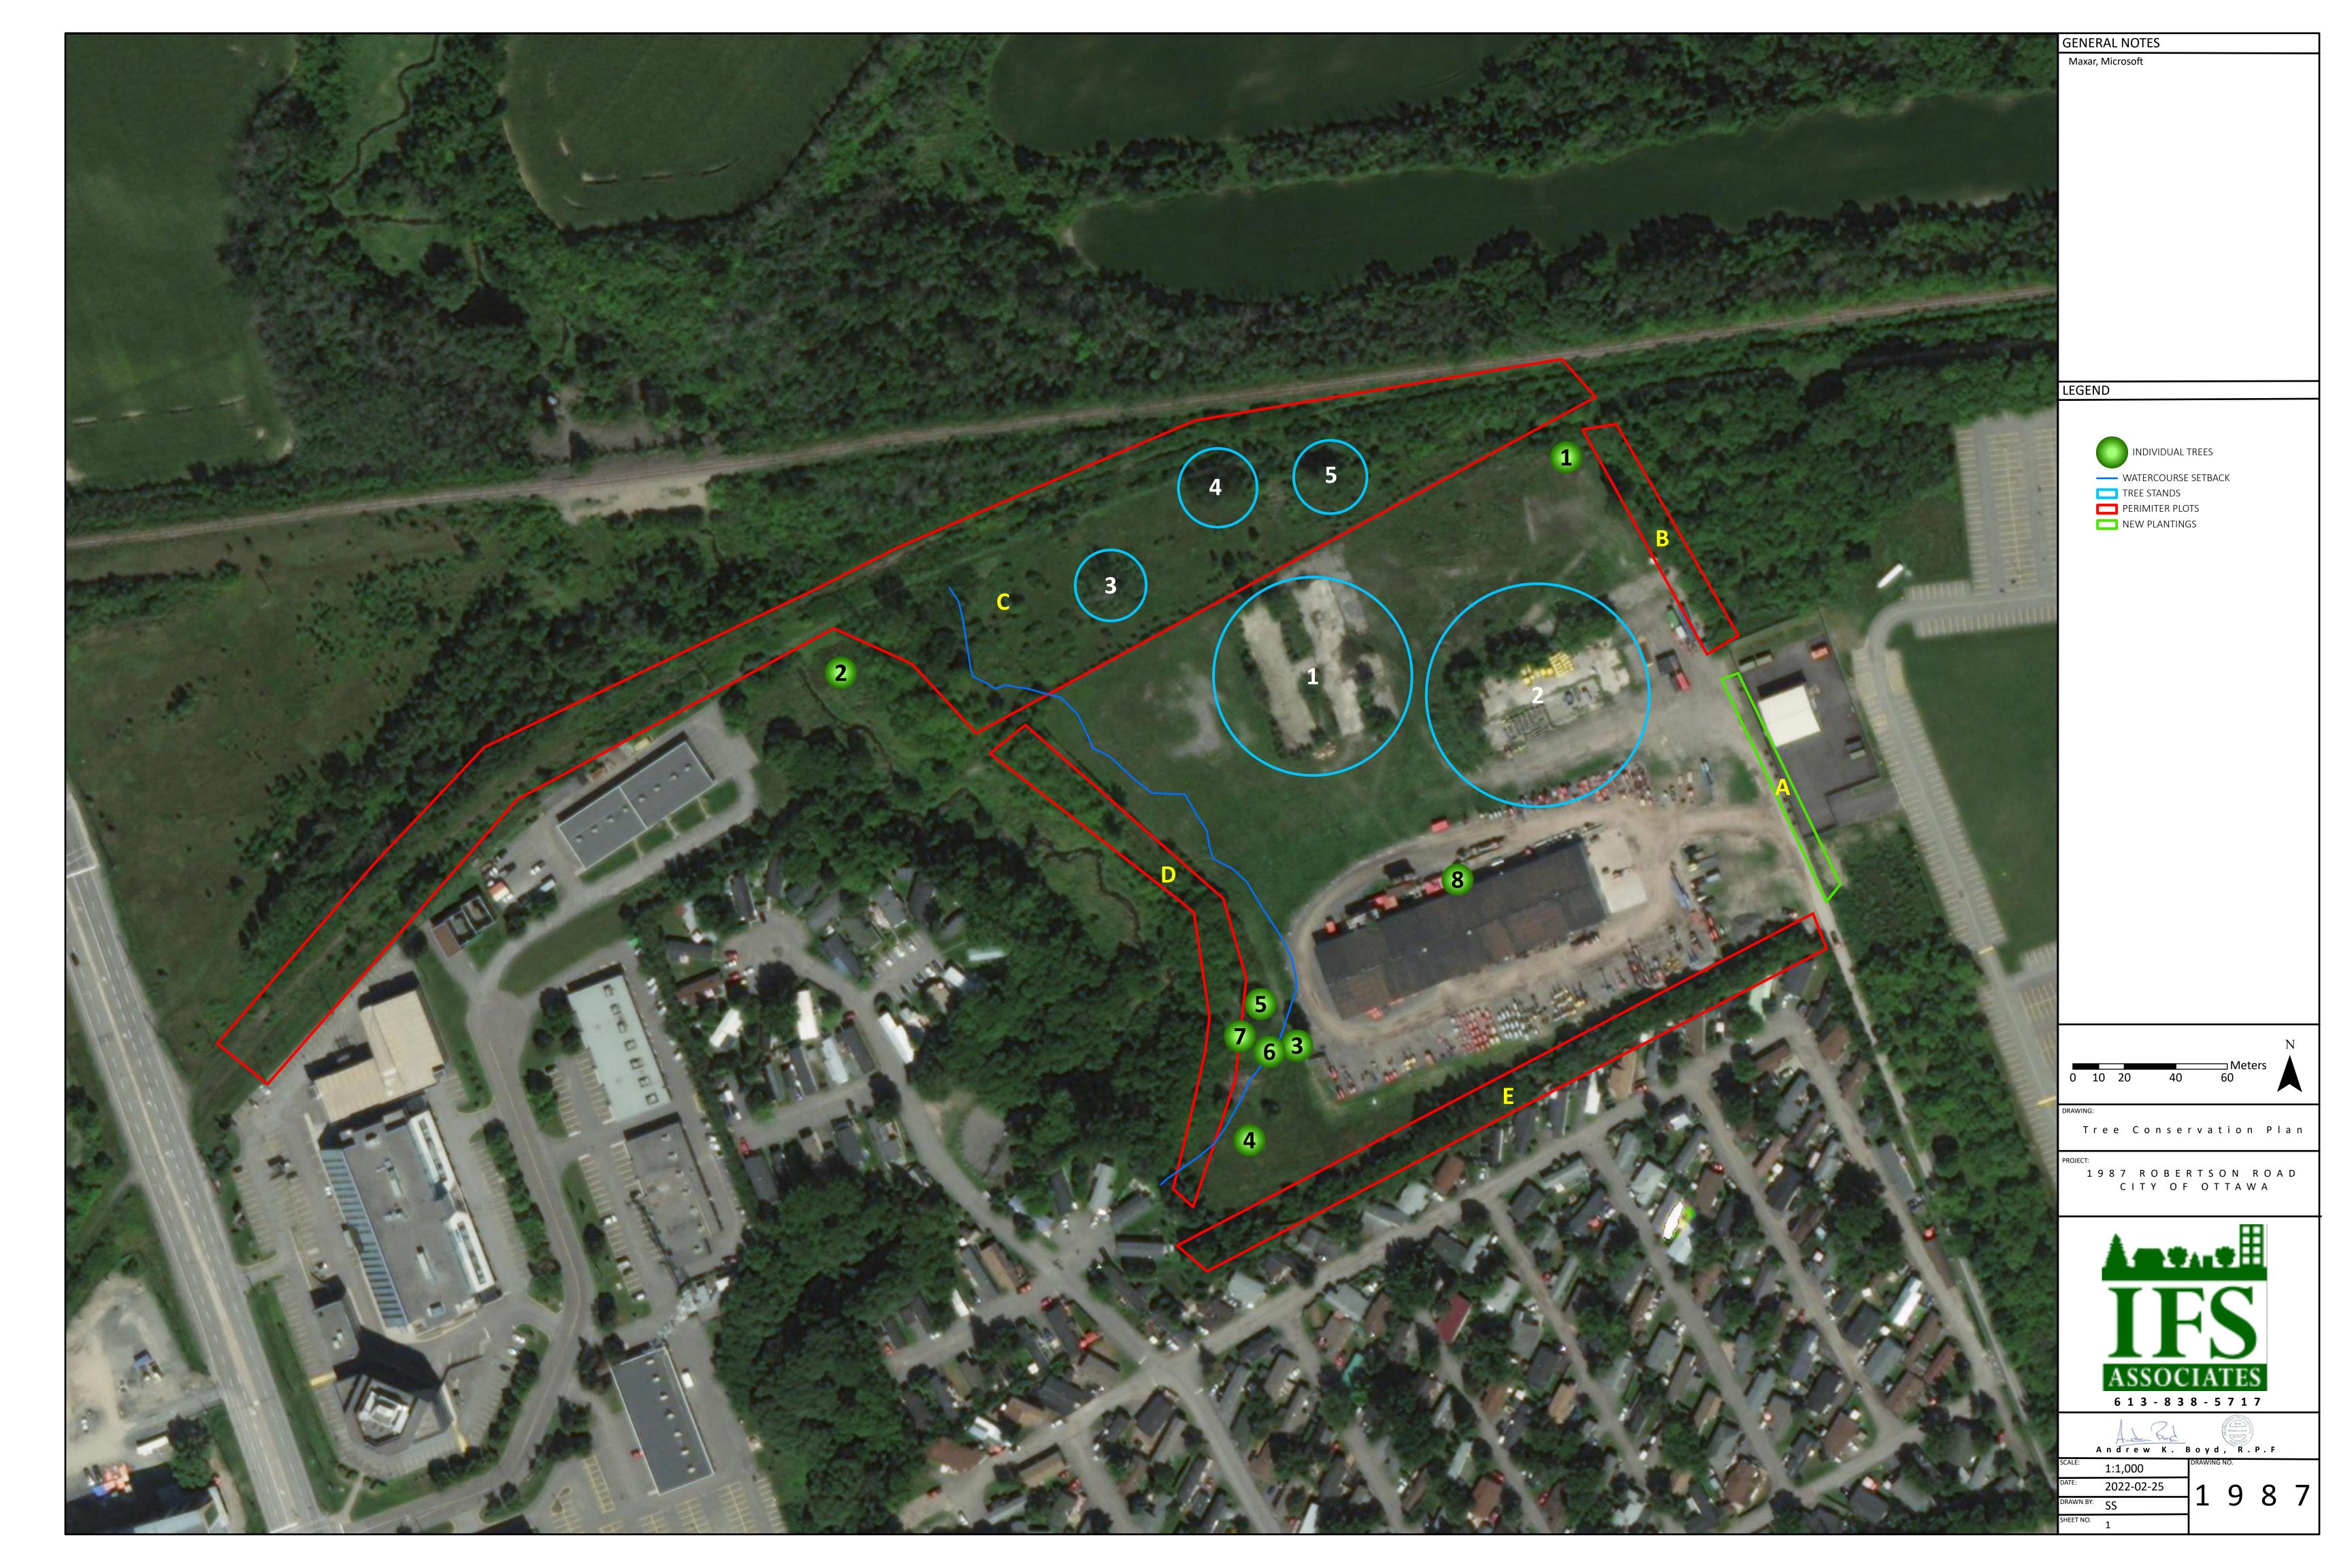
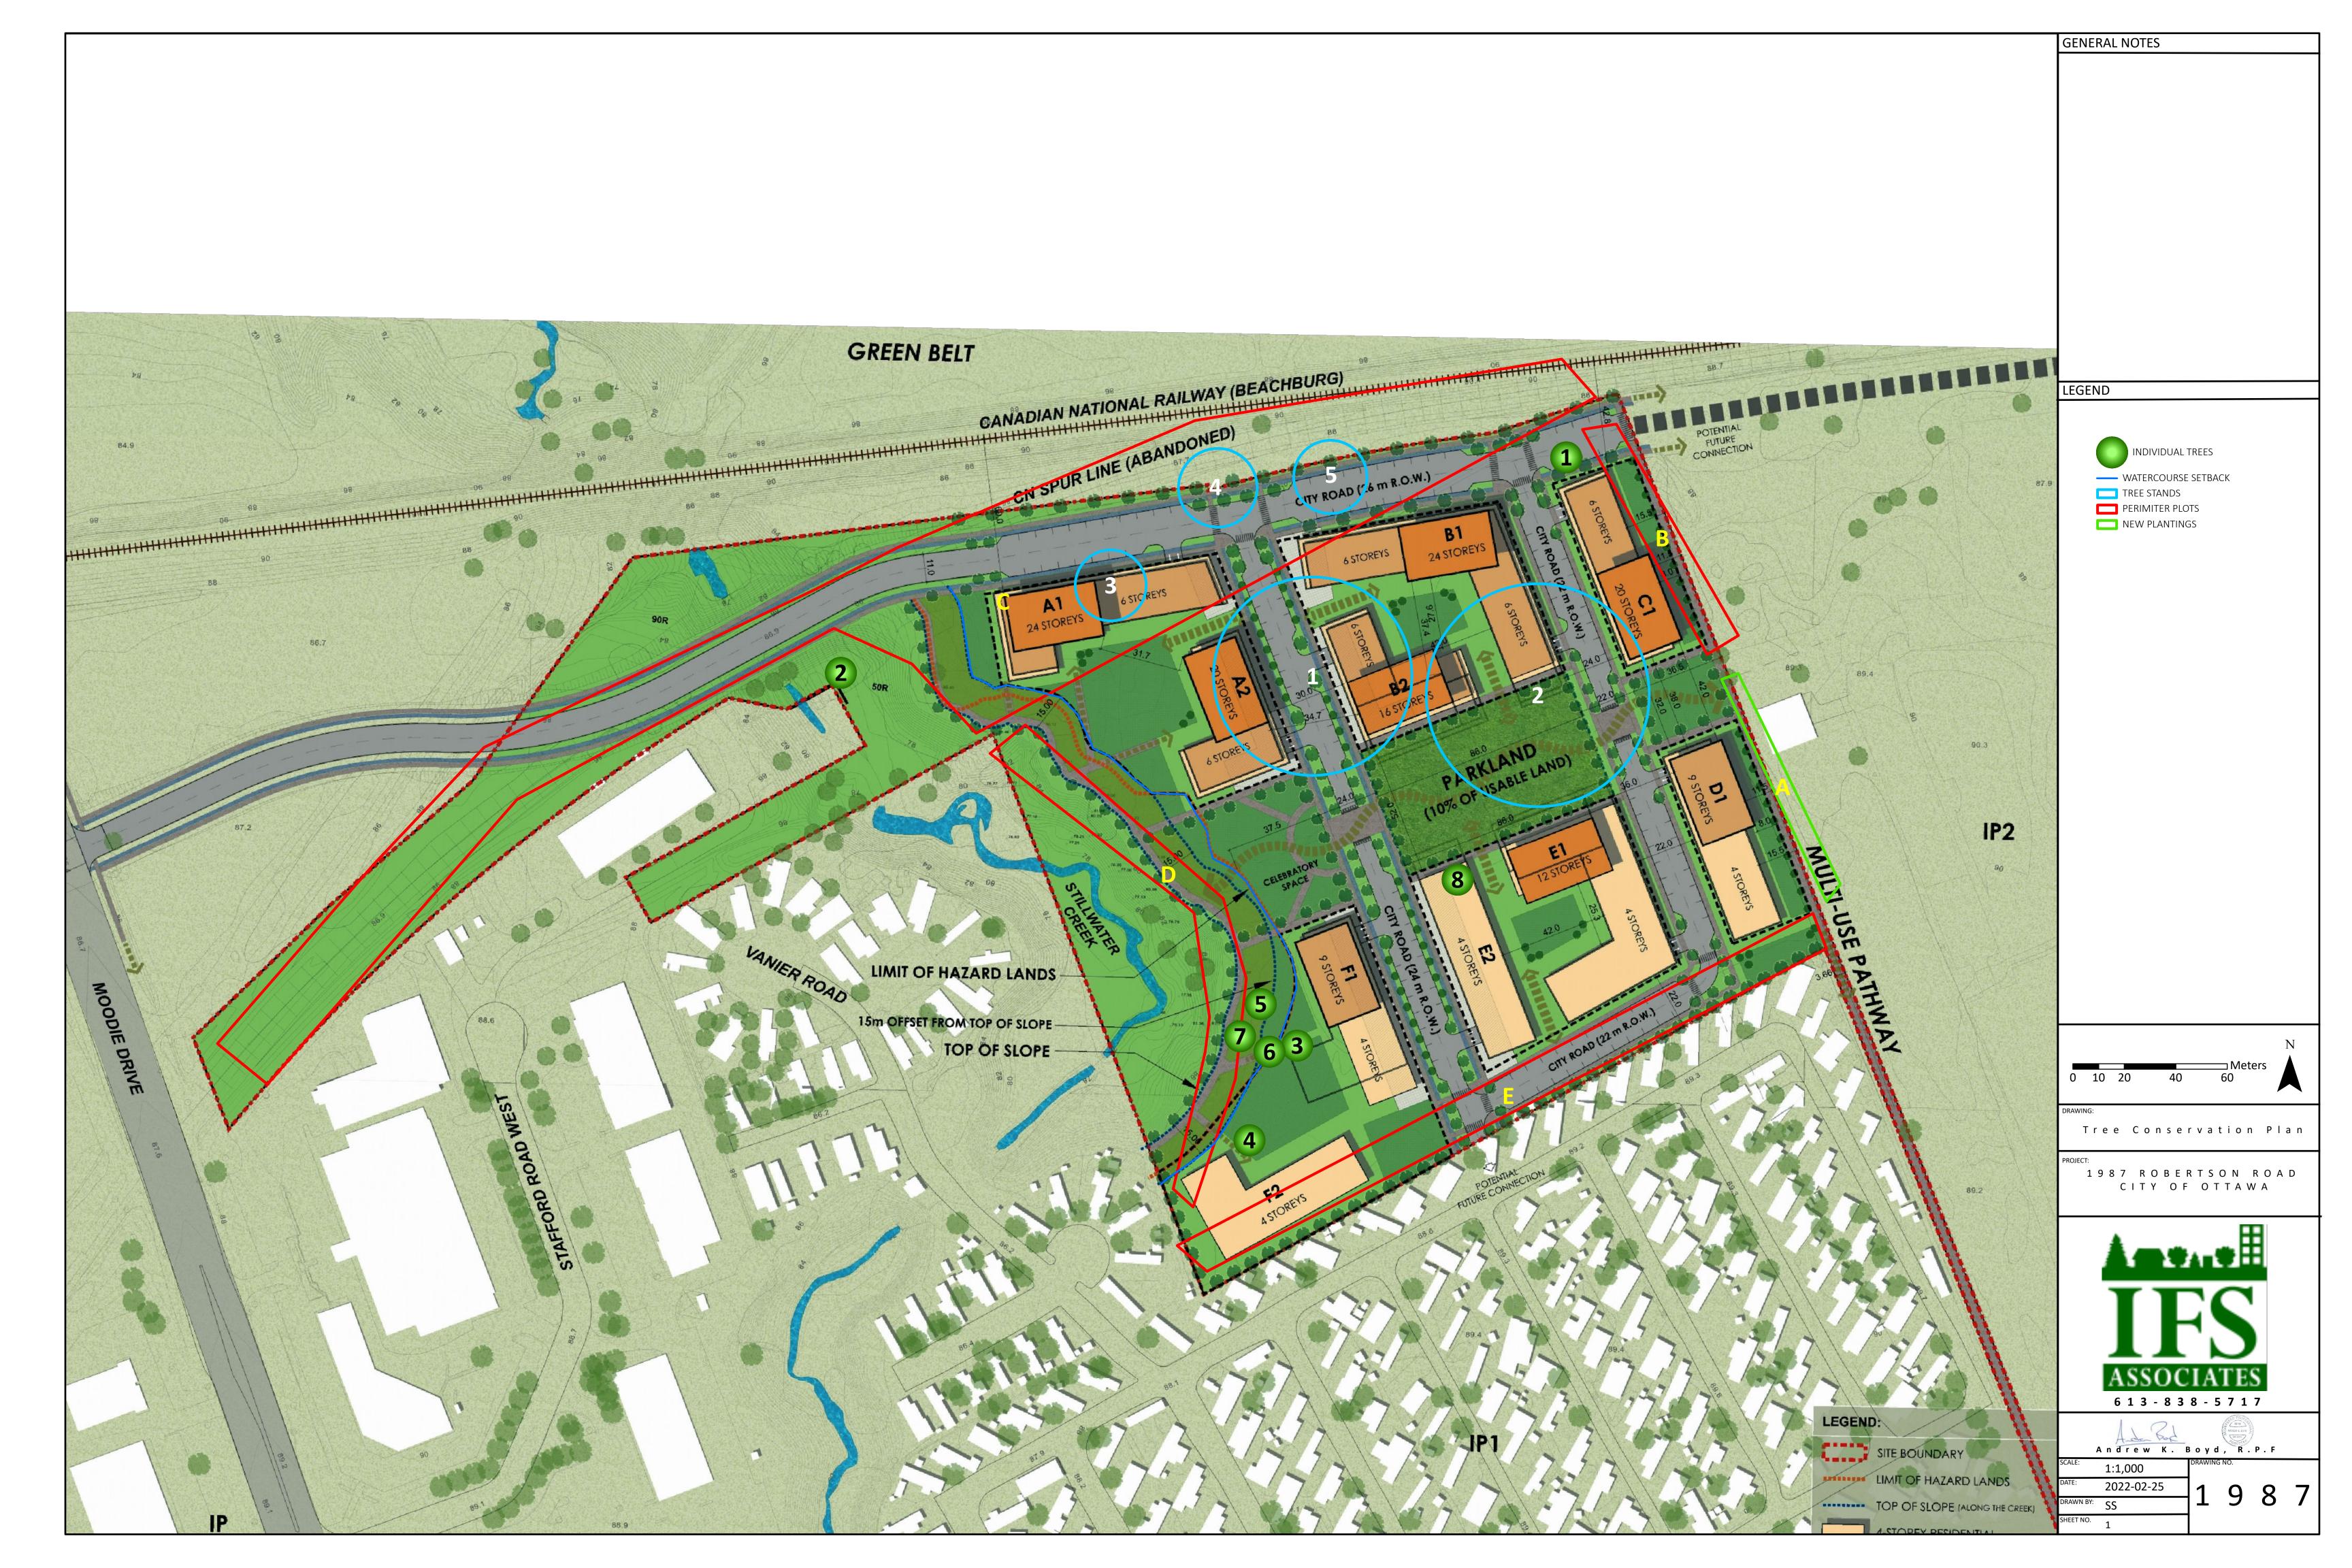
All current vegetation is shown on the tree conservation plans included on page 5 and 6 of this report. By the numbers and letters indicated on the plans, each tree and grouping of trees is detailed below:

- 1. Erect a fence at the critical root zone (CRZ¹) of trees;
- 2. Do not place any material or equipment within the CRZ of the tree;
- 3. Do not attach any signs, notices or posters to any tree;
- 4. Do not raise or lower the existing grade within the CRZ without approval;
- 5. Tunnel or bore when digging within the CRZ of a tree;
- 6. Do not damage the root system, trunk or branches of any tree;
- 7. Ensure that exhaust fumes from all equipment are NOT directed towards any tree's canopy.

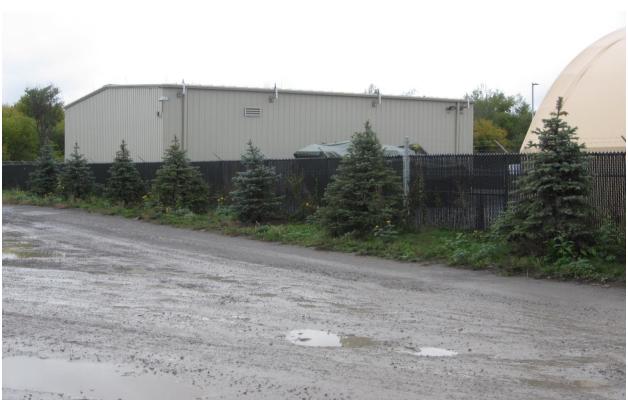
Picture 1. Tree grouping A at 1987 Robertson Road

<u>Tree grouping A</u>: A line of nine planted Colorado spruce ranging in diameter from 5 to 9 cm which are in fair condition with the exception of one dead tree. Based on gaps in the line it appears other trees died and were removed in the past. This line of trees will be removed due to conflicts with construction. Transplanting elsewhere on the property may be an option for those trees in better health.

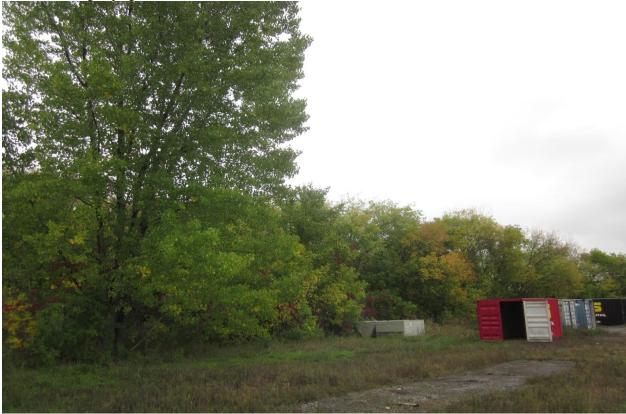
Picture 2. Tree #1 (left) and grouping B at 1987 Robertson Road

<u>Tree grouping B</u>: A group of Manitoba maples (*Acer negundo*) growing through the fence from the neighbouring property to the east. The largest tree is 19cm in diameter and in good condition. Being under the ownership of others these trees will be preserved and protected during construction (unless permission to remove is granted in writing by the adjacent landowner). However, the overhanging branches can be cut back to the property line.

Tree	Tree	Diameter	Tree Condition,
No.	Species	(cm)	Condition Notes and Age
			Good; multi-stemmed (6) at grade; growing
1	Eastern cottonwood	27.5 avg.	through chain link fence; mature
			Good; basal wound; located on edge of hill,
2	Eastern cottonwood	60	near train tracks; mature
3	Eastern cottonwood	30 avg.	Good; multi-stemmed (3) at grade; maturing
	Crab apple		
4	(Malus spp.)	12.5 avg.	Good; multi-stemmed (7) at grade; maturing
			Good; multiple leaders at 1m from grade;
5	Eastern cottonwood	55	mature
			Good; double leader at 0.2m from grade with
6	Manitoba maple	27 avg.	inclusion ridge at union; maturing
7	Manitoba maple	21	Good condition; maturing
8	Balsam poplar	20	Fair; growing against building; maturing

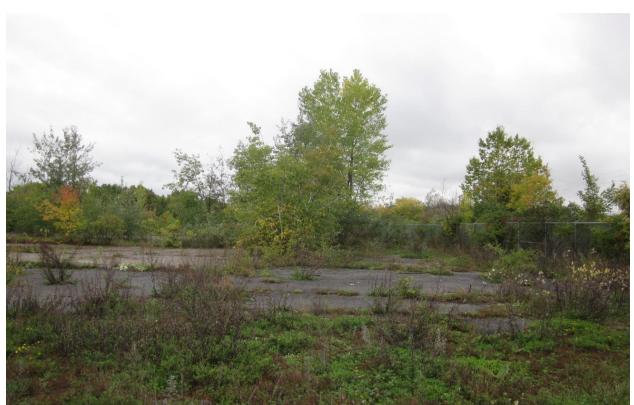
Picture 3. Tree stand #1 at 1987 Robertson Road

<u>Tree stand #1</u>: This stand is centered on a compacted area of stone, possibly a former parking lot. As with other areas on the property, all these trees arose from seed spread from elsewhere.

Tree Species	Average diameter (cm)	Percent occupancy	
American elm	12	6	
Ash species	12.5	2	
Eastern cottonwood	15.1	28	
Manitoba maple	12.1	28	
Siberian elm			
(Ulmus pumila) ³	19.7	2	
White poplar	16	2	
Trembling aspen (Populus			
tremuloides)	15.1	32

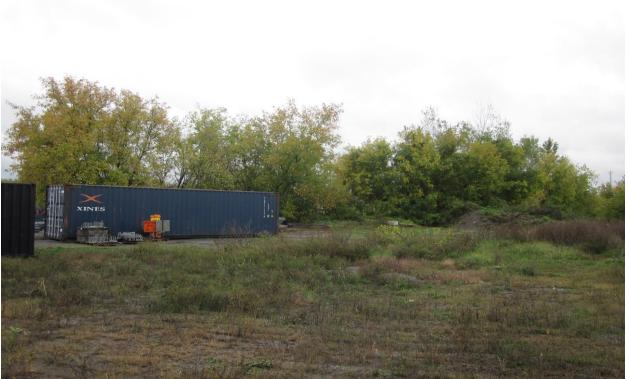
Picture 4. Tree stand #2 at 1987 Robertson Road

Tree stand #2: As with stand #1, this stand is centred on a heavily disturbed and compacted area.

Tree Species	Average diameter (cm)	Percent occupancy
Manitoba maple	16.3	43
White poplar	24.6	35
Trembling aspen	17.3	22

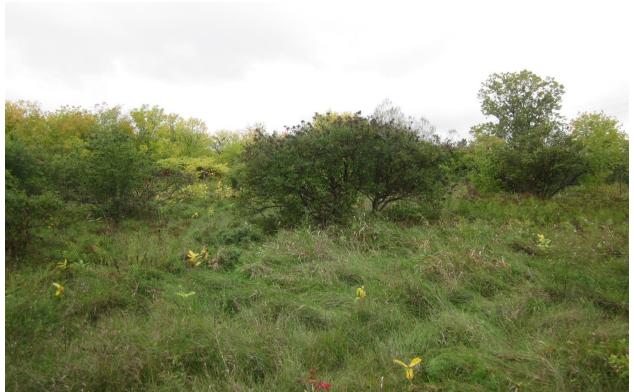
Picture 5. Tree grouping C at 1987 Robertson Road

Tree Species	Average diameter (cm)	Percent occupancy	
American elm			
(Ulmus americana)	15.4	21	
Ash species			
$(Fraxinus \text{ spp.})^1$	15.2	13	
Balsam poplar			
(Populus balsamifera)	14.6	18	
Crab apple			
(Malus spp.)	17	2	
Green ash			
(Fraxinus pennsylvanica var.			
subintegerrima) ¹	13	5	
Manitoba maple			
(Acer negundo)	14.1	39	
Willow species			
(Salix spp.)	19	2

<u>Tree grouping C</u>: A series of sample plots were taken in this area to determine general tree composition – species, average diameters and percent occupancy by stem count:

¹ all ash on the property are either dead or heavily infested with emerald ash borer (*Agrilus planipennis*)

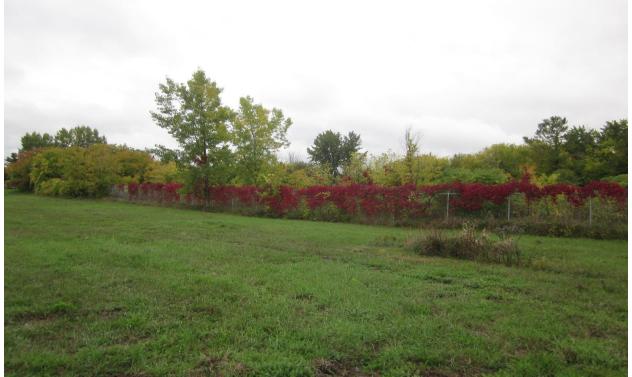
Picture 6. Tree grouping D at 1987 Robertson Road

<u>Tree grouping D</u>: A series of sample plots were taken in this area to determine tree composition:

Tree Species	Average diameter (cm)	Percent occupancy	
American elm	15	6	
Eastern cottonwood (Populus deltoides)	27	6	
Manitoba maple	15.8	82	
Eastern redcedar (Juniperus virginiana)	6	6	A

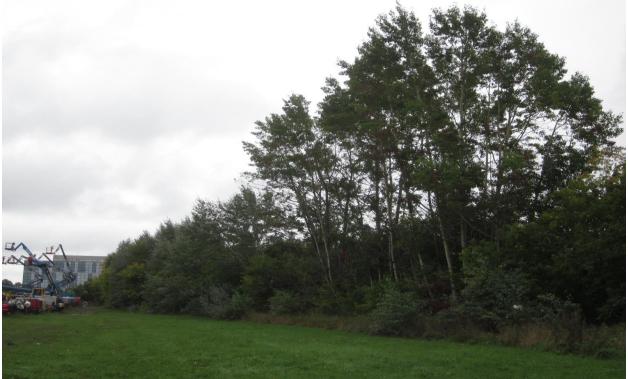
Picture 8. Tree grouping E at 1987 Robertson Road

Tree Species	Average diameter (cm)	Percent occupancy
American elm	16	1
Manitoba maple	14	57
White poplar $(Populus \ alba)^2$	17.1	42

<u>Tree grouping E</u>: A series of sample plots were taken in this area to determine tree composition:

² white poplar is an introduced and invasive species in Ontario
