URBAN FORESTRY & FOREST MANAGEMENT CONSULTING

October 1, 2021

RE: TREE CONSERVATION REPORT FOR 1987 ROBERTSON ROAD

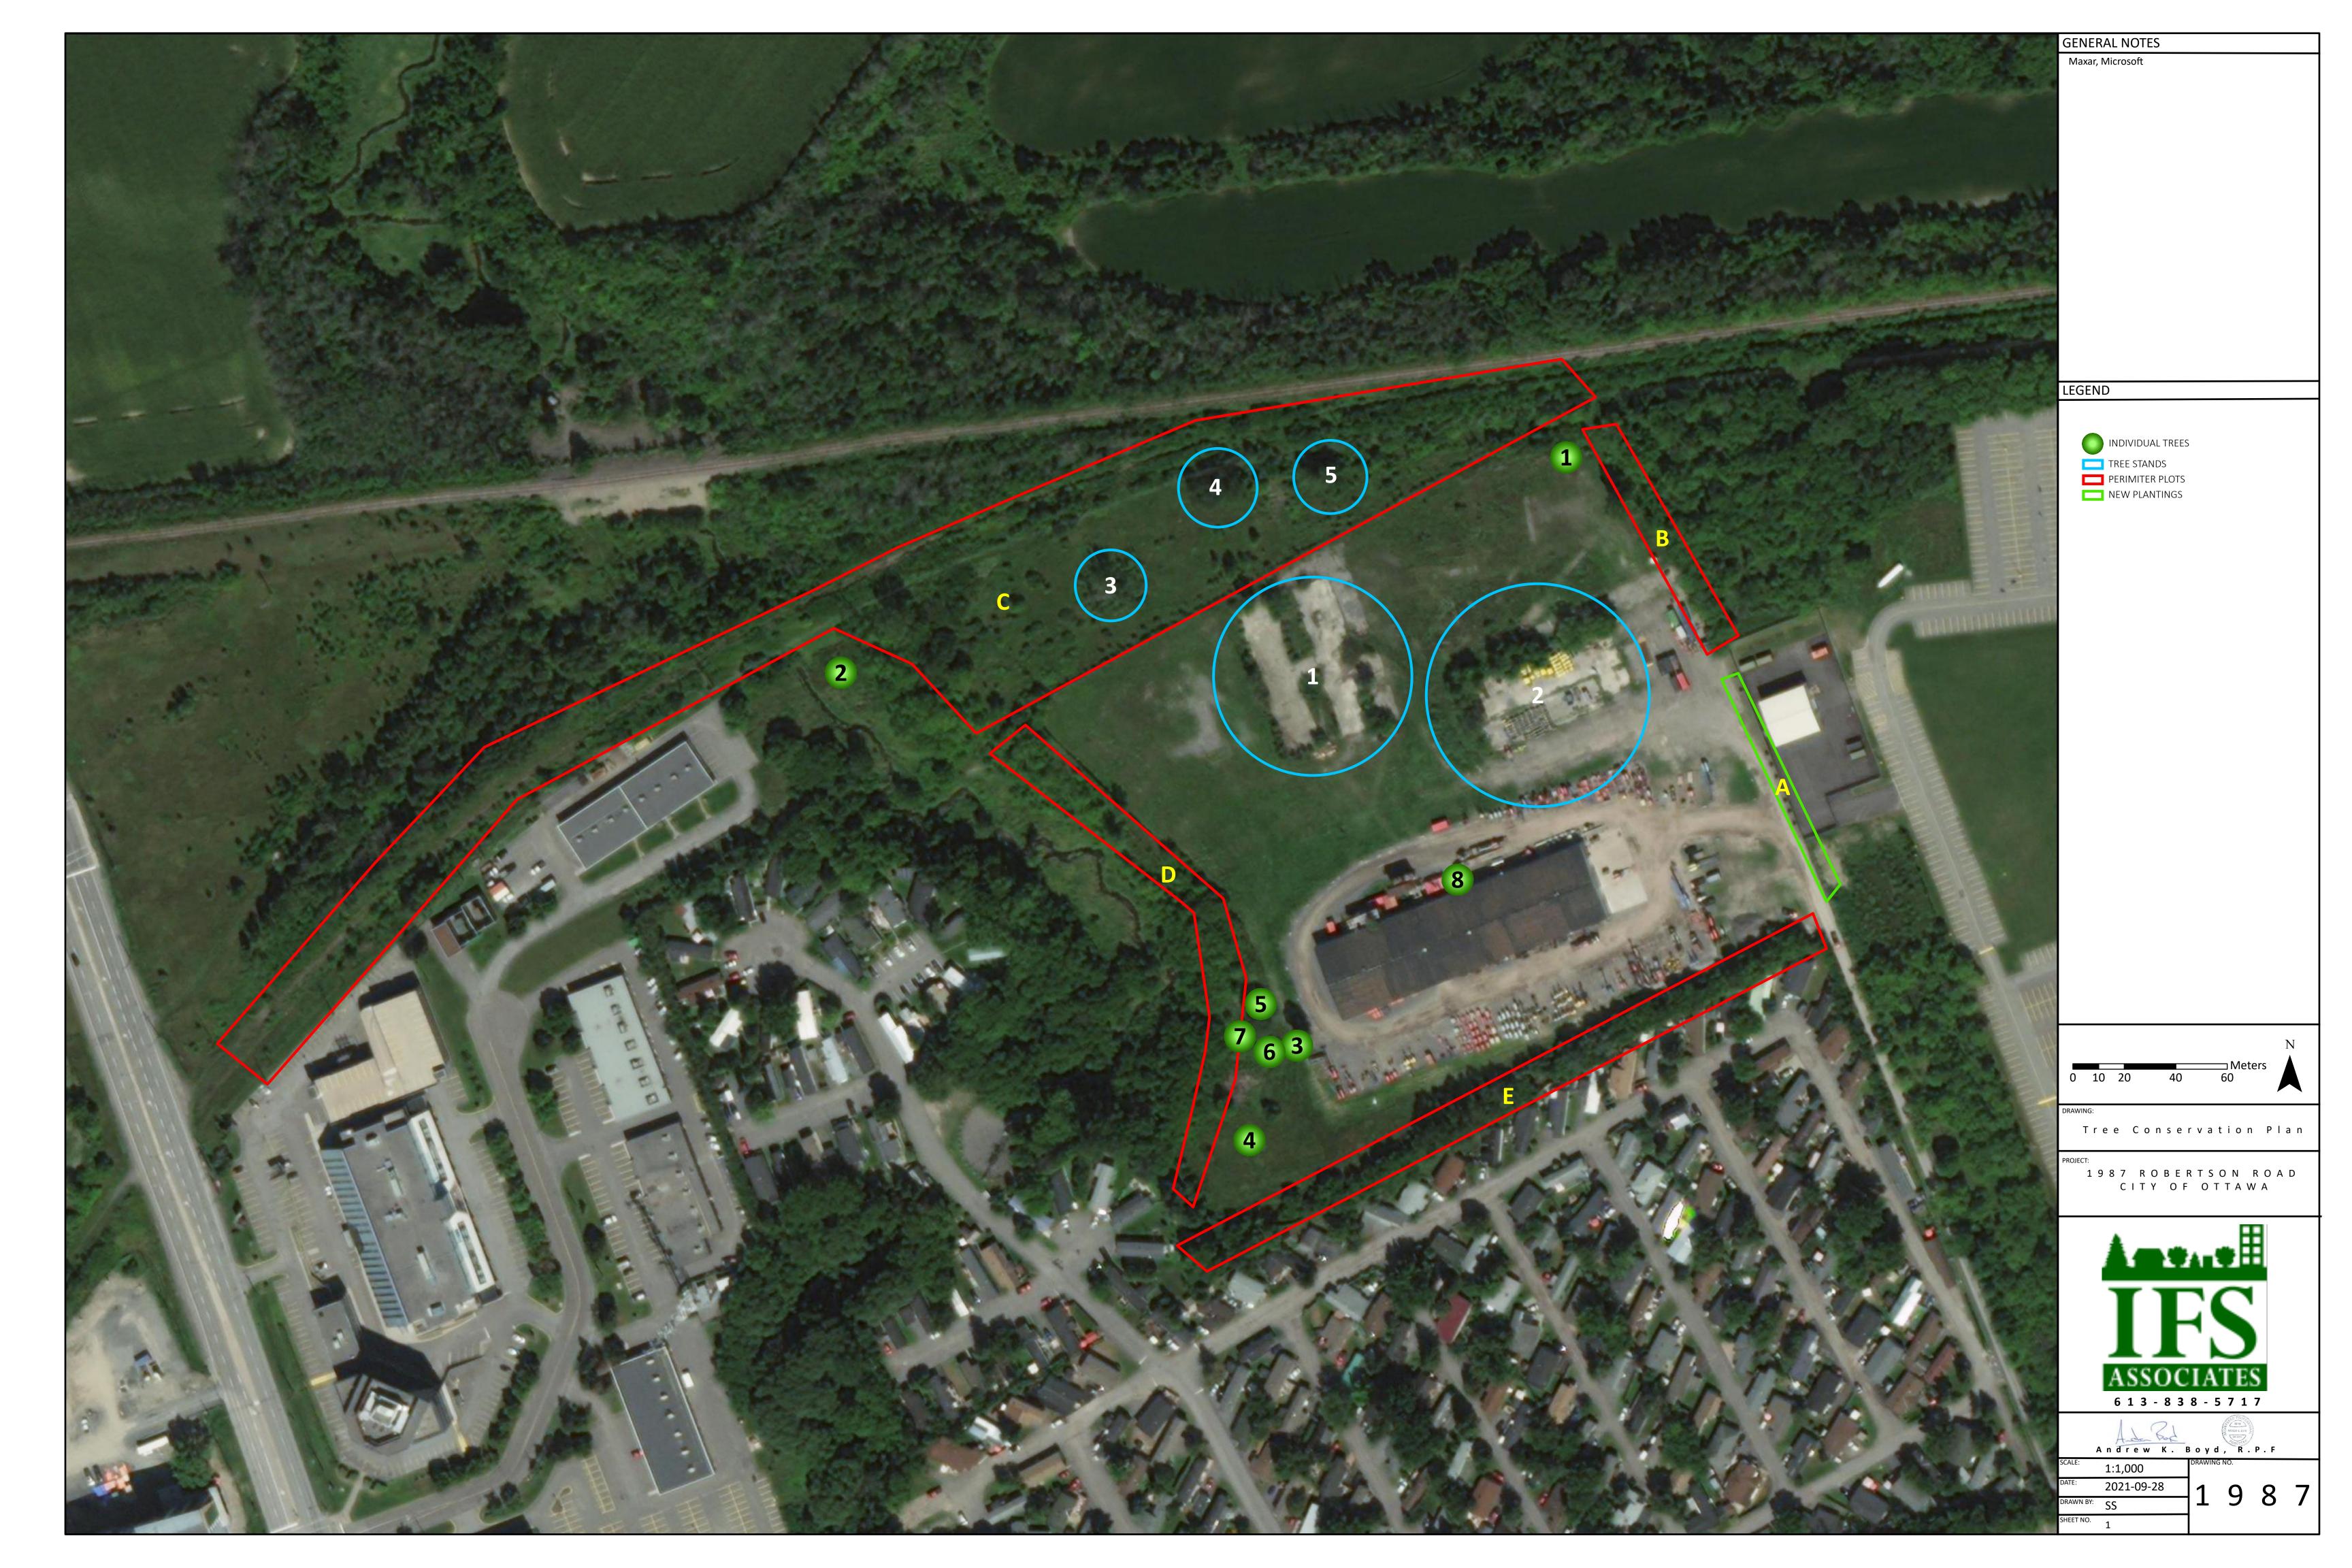
All current vegetation is shown on the tree conservation plan included on page 5 of this report. By the numbers and letters indicated on the plan, each tree and grouping of trees is detailed below:

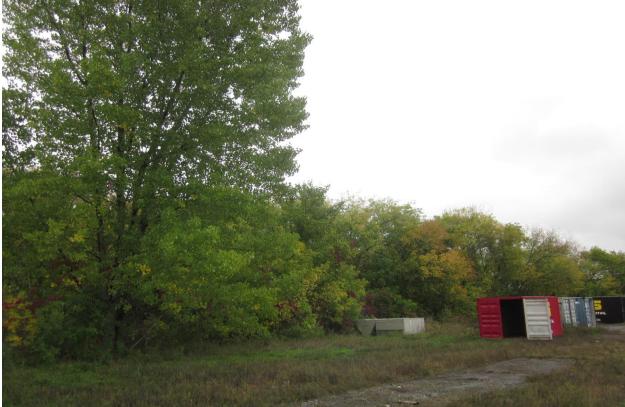
Picture 2. Tree #1 (left) and grouping B at 1987 Robertson Road

<u>Tree grouping B</u>: A group of Manitoba maples (*Acer negundo*) growing through the fence from the neighbouring property to the east. The largest tree is 19cm in diameter and in good condition. Being under the ownership of others these trees will be preserved and protected during construction (unless permission to remove is granted in writing by the adjacent landowner). However, the overhanging branches can be cut back to the property line.

Tree	Tree	Diameter	Tree Condition,
No.	Species	(cm)	Condition Notes and Age
1	Eastern cottonwood	27.5 avg.	Good; multi-stemmed (6) at grade; growing through chain link fence; mature
			Good; basal wound; located on edge of hill,
2	Eastern cottonwood	60	near train tracks; mature
3	Eastern cottonwood	30 avg.	Good; multi-stemmed (3) at grade; maturing
	Crab apple		
4	(Malus spp.)	12.5 avg.	Good; multi-stemmed (7) at grade; maturing
			Good; multiple leaders at 1m from grade;
5	Eastern cottonwood	55	mature
			Good; double leader at 0.2m from grade with
6	Manitoba maple	27 avg.	inclusion ridge at union; maturing
7	Manitoba maple	21	Good condition; maturing
8	Balsam poplar	20	Fair; growing against building; maturing

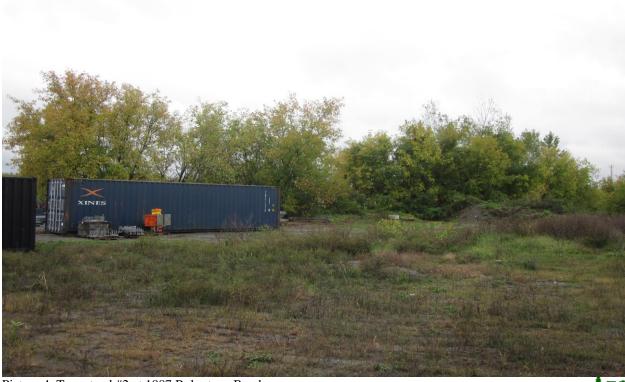
Picture 4. Tree stand #2 at 1987 Robertson Road

Tree stand #2: As with stand #1, this stand is centred on a heavily disturbed and compacted area.

Tree	Total	Total diameter	Average diameter	Percent
Species	trees	(cm)	(cm)	occupancy
Manitoba maple	17	277.3	16.3	43
White poplar	14	345	24.6	35
Trembling aspen	9	155.7	17.3	22

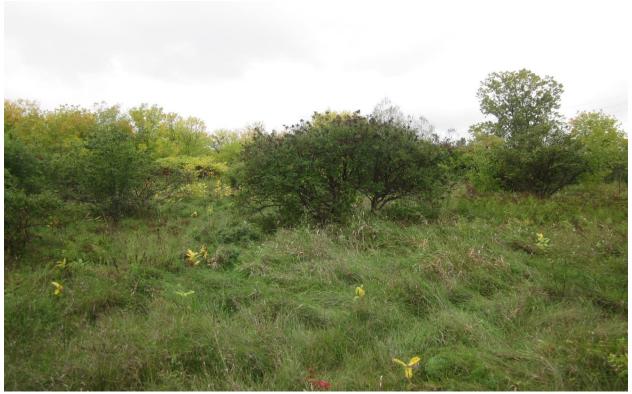
Picture 5. Tree grouping C at 1987 Robertson Road

<u>Tree grouping C</u>: A series of sample plots were taken in this area to determine general tree composition – species, average diameters and percent occupancy by stem count:

Tree Species	Average diameter (cm)	Percent occupancy
American elm		
(Ulmus americana)	15.4	21
Ash species		
$(Fraxinus \text{ spp.})^1$	15.2	13
Balsam poplar		
(Populus balsamifera)	14.6	18
Crab apple		
(Malus spp.)	17	2
Green ash		
(Fraxinus pennsylvanica var.		
subintegerrima) ¹	13	5
Manitoba maple		
(Acer negundo)	14.1	39
Willow species		
(Salix spp.)	19	2

¹ all ash on the property are either dead or heavily infested with emerald ash borer (*Agrilus planipennis*)

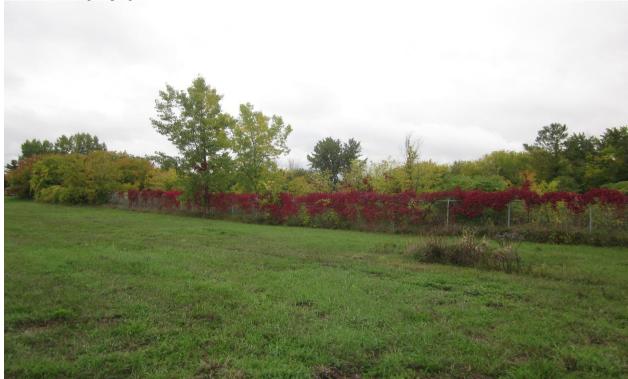
Picture 6. Tree grouping D at 1987 Robertson Road

<u>Tree grouping D</u>: A series of sample plots were taken in this area to determine tree composition:

Tree Species	Average diameter (cm)	Percent occupancy
American elm	15	6
Eastern cottonwood (Populus deltoides)	27	6
Manitoba maple	15.8	82
Eastern redcedar (Juniperus virginiana)	6	6

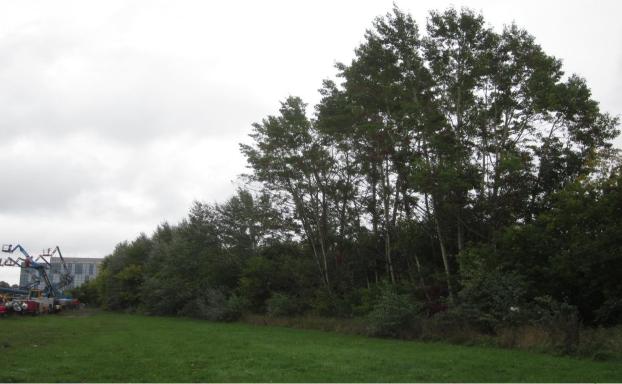
Picture 8. Tree grouping E at 1987 Robertson Road

<u>Tree grouping E</u>: A series of sample plots were taken in this area to determine tree composition:

Tree Species	Average diameter (cm)	Percent occupancy
American elm	16	1
Manitoba maple	14	57
White poplar (<i>Populus alba</i>) ²	17.1	42

white poplar is an introduced and invasive species in Ontario
