September 30, 2021

RE: TREE CONSERVATION REPORT FOR 249-255 RICHMOND ROAD & 372 TWEEDSMUIR AVENUE, OTTAWA

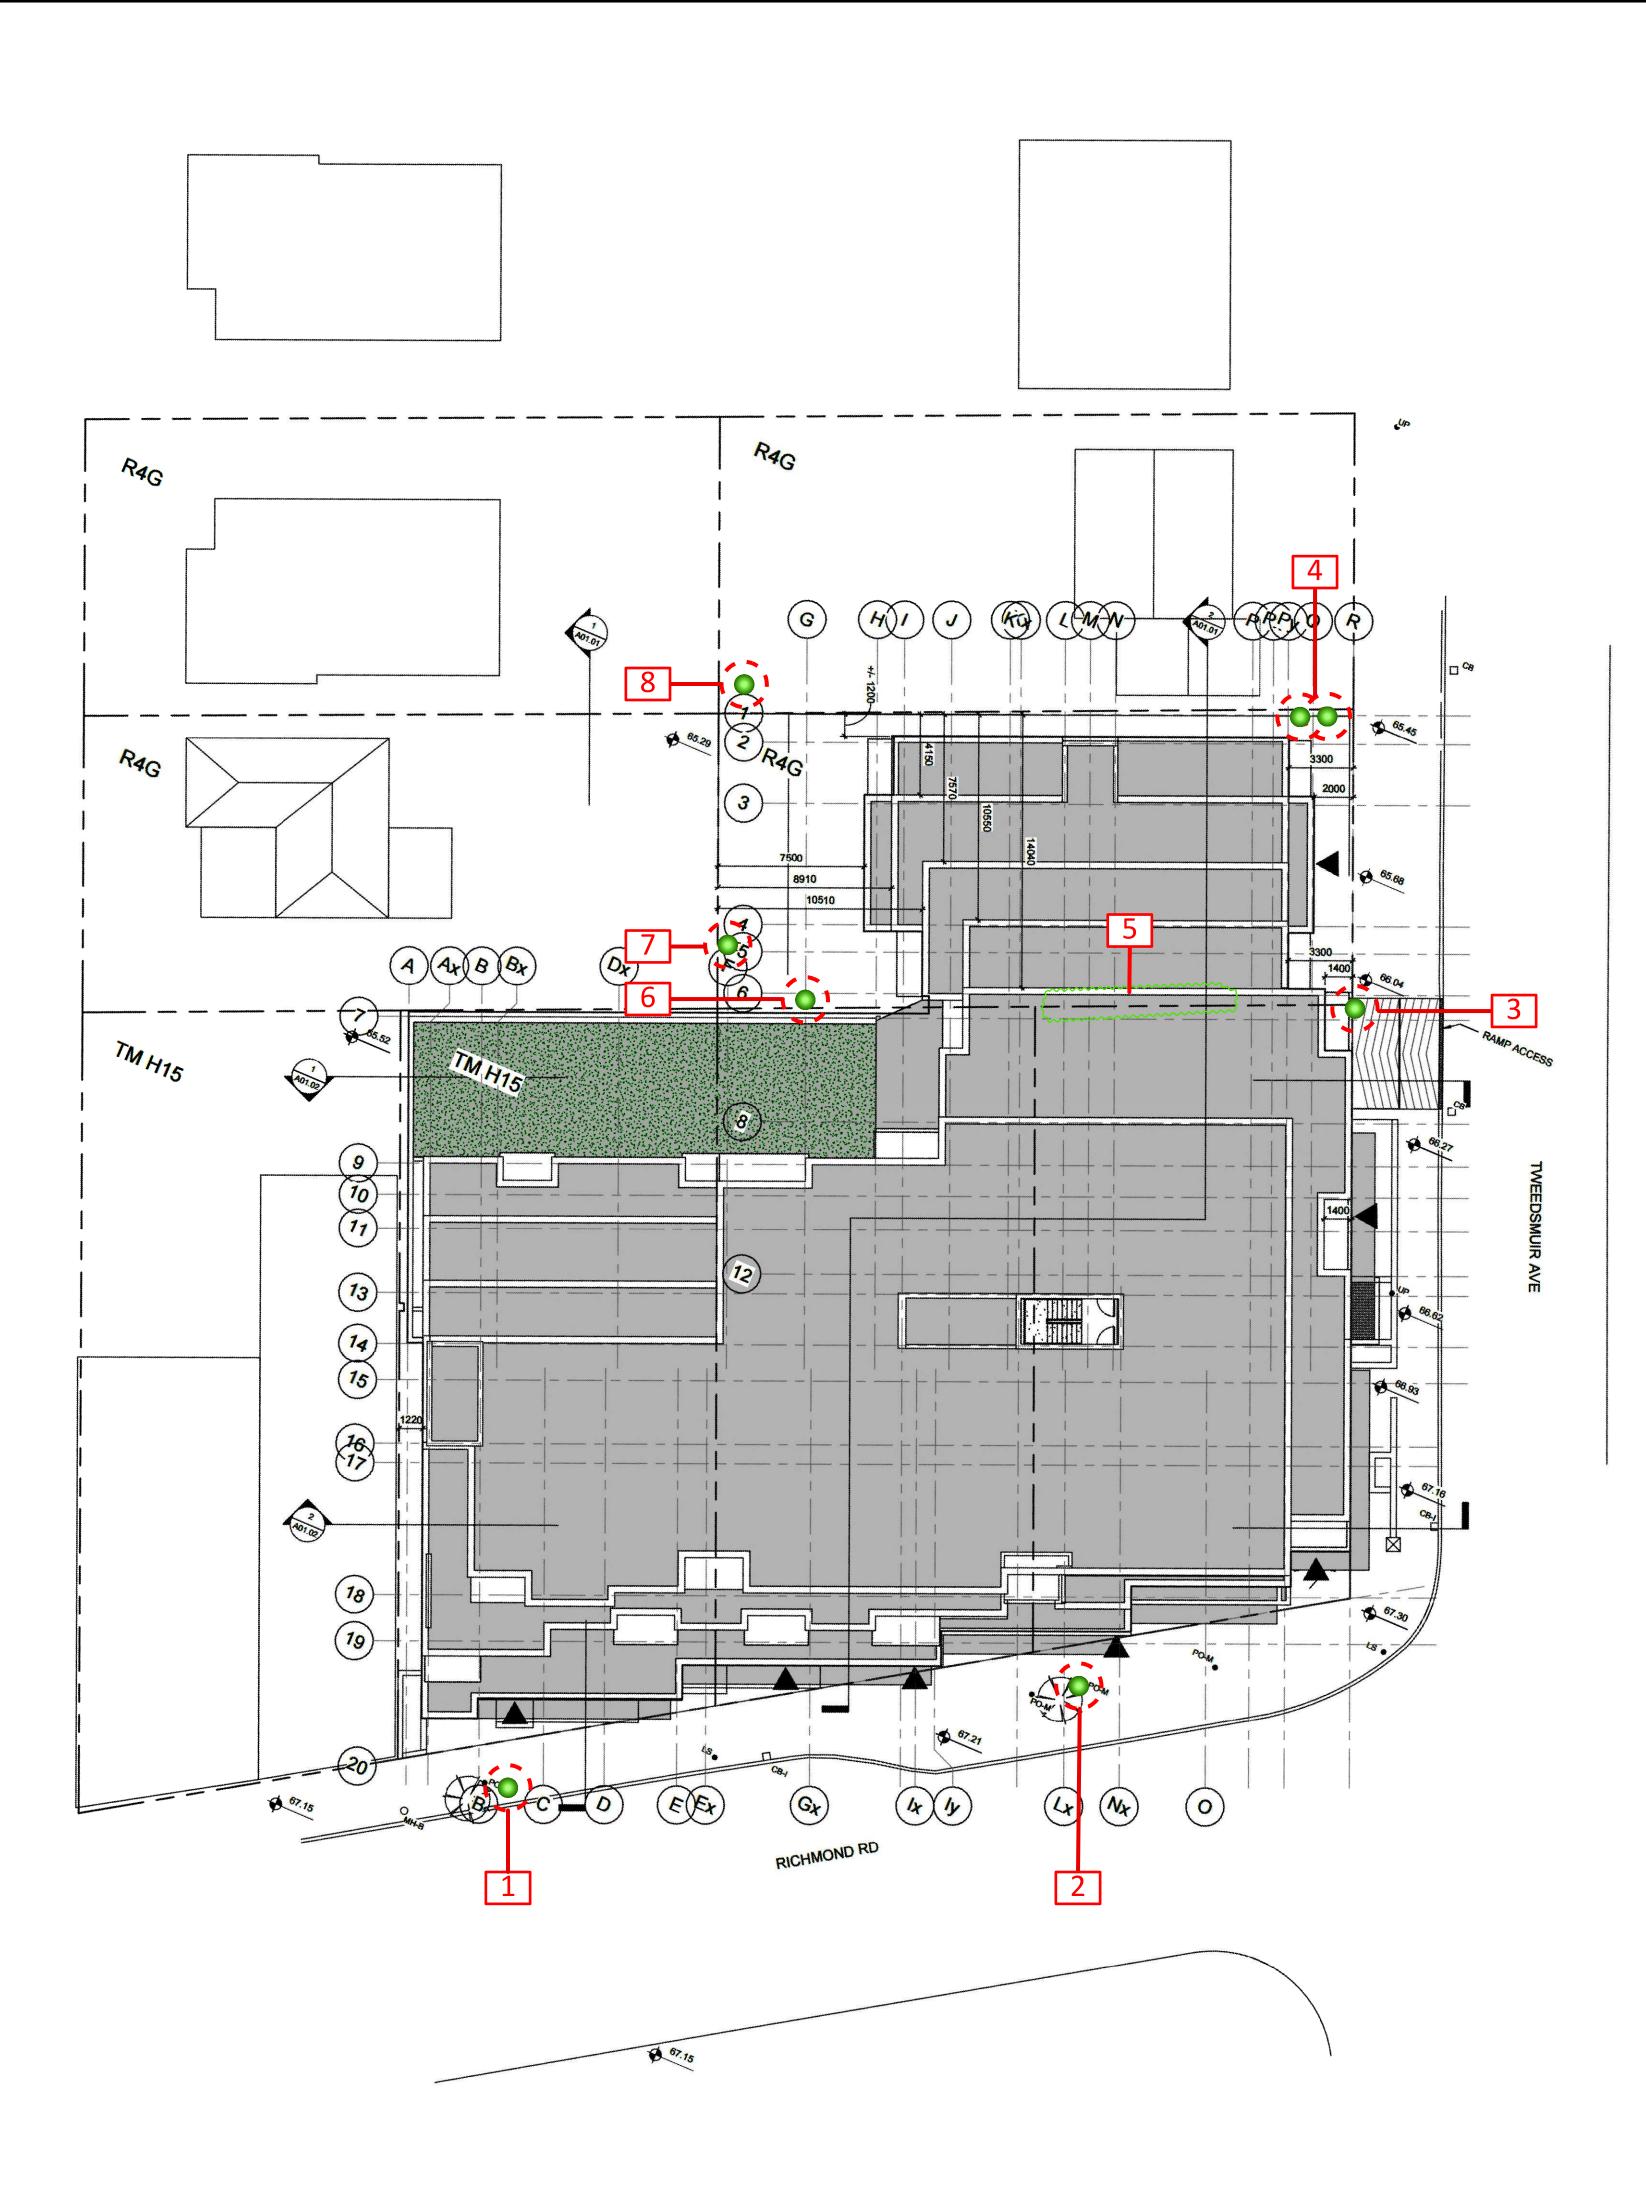
Table 1 on pages 2 and 3 of this report details the species, condition, size (diameter), ownership and preservation status of the individual trees on and adjacent to the subject property. Each of these trees is referenced by the numbers plotted on the tree conservation plan included on page 3 of this report. Pictures 1 through 4 on pages 5 to 8 show selected trees on and adjacent to the subject property.

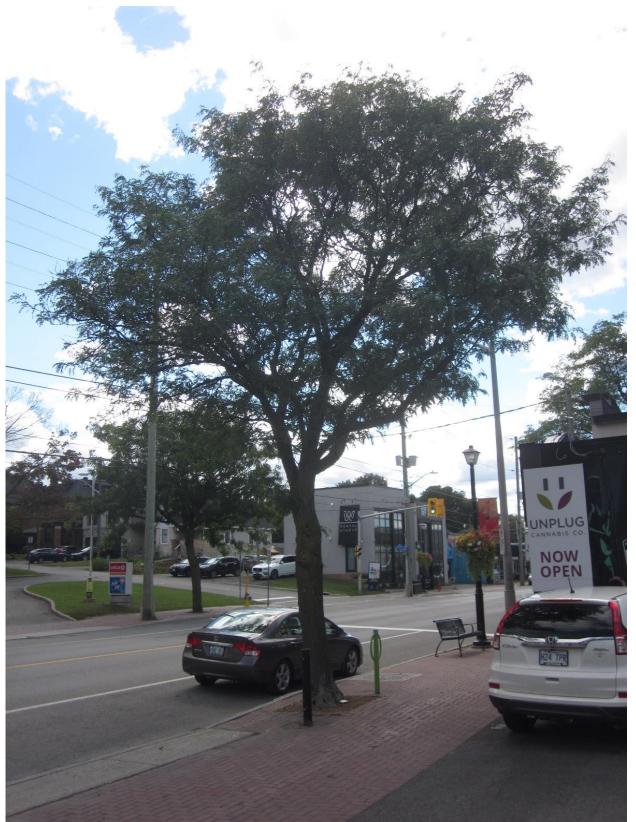
Picture 1. Tree #1 located on city property adjacent to 249-255 Richmond Road

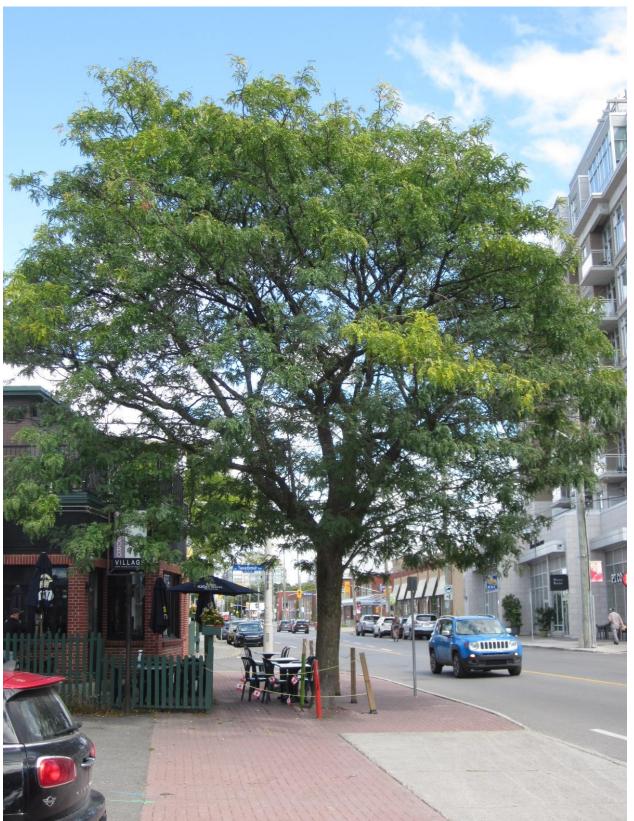
Picture 2. Tree #2 located on city property adjacent to 249-255 Richmond Road

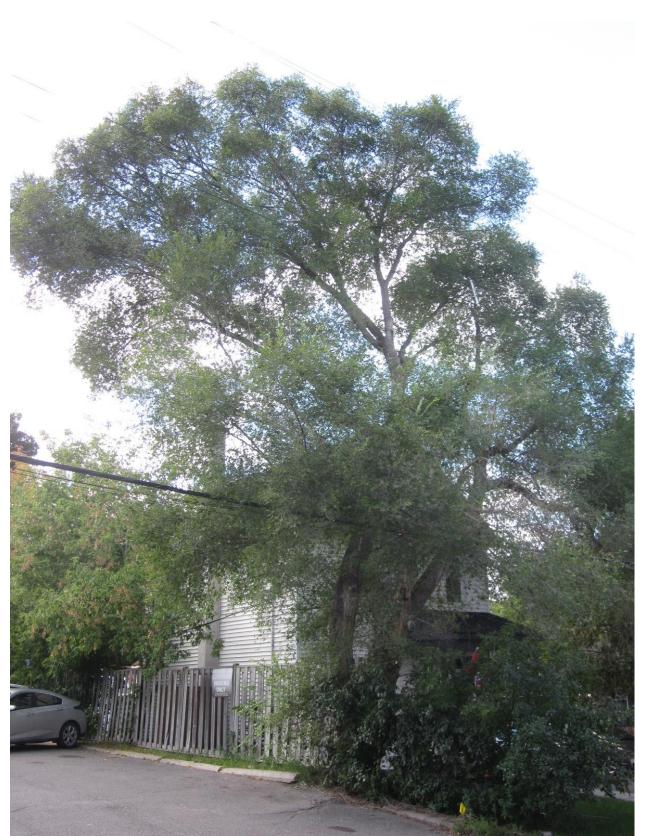
(Ulmus pumila)			with	Hydro at 4.5m, west stems moderately-heavily divergent towards east (over
				City	existing dwelling); introduced invasive species; to be removed (conflicts
					with construction both below and above ground)
4	White cedar	Good	16.5	Private	Mature; nine individual stems within hedge line; good crown density,
	(Thuja		avg.		growth increment and needle colour; native species; to be removed
	occidentalis)				(conflicts with construction)
5	Manitoba maple	Fair	+/-10	Private	Maturing; four multi-stemmed trees which originated from seed; all
	(Acer negundo)				divergent towards south (over commercial parking lot); naturalized species;
					to be removed (conflicts with construction)
6	Norway maple	Good	40.1	Private	Mature; single dominant stem for most of height; co-dominant leaders at
	(Acer				9.5m; lower crown asymmetric towards south and east due to influence of
	platanoides)				tree #7; introduced invasive species; to be removed (conflicts with

Picture 3. Tree #3 Siberian elm shared with 372 Tweedsmuir Avenue

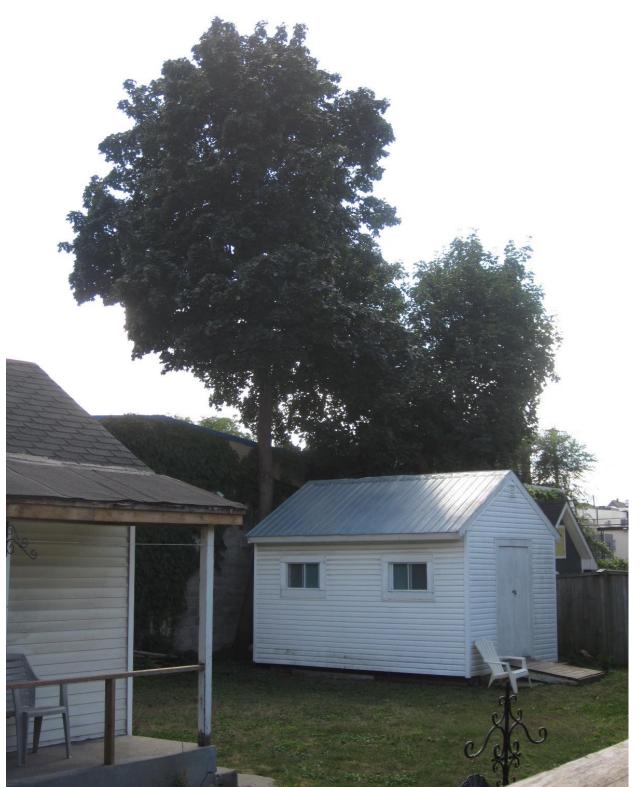
construction)
7	Norway maple	Very poor	38.5	Shared	Mature; co-dominant stems at 2.5m with inclusion ridge at union; east stem
					broken at 5m due to eutypella canker (Eutypella parasitica), west stem
					previously topped at 5m – now with sweep; introduced invasive species; to
					be removed (conflicts with construction)
8	Manitoba maple	Poor	+/-20	Neigh-	Mature; double stemmed from grade; larger stem divergent towards
			&	bour	southwest, smaller towards southeast; shear plane fractures in both stems;
			+/-40		introduced invasive species; to be preserved and protected
1 1	.1 .1 .1	4 6 1	(1 (1		issted), average dismeters indicate multi-stemmed trace

Picture 4. Trees #6 and 7 (left to right) located on or shared with 372 Tweedsmuir Avenue
