# TREE CONSERVATION REPORT

**1400 Bank Street**

Tree Conservation Report submitted as Partial  
Requirements for a Official Plan Amendment and  
Zoning By-law Amendment, dated August 9, 2021

**Date:** August 9, 2021

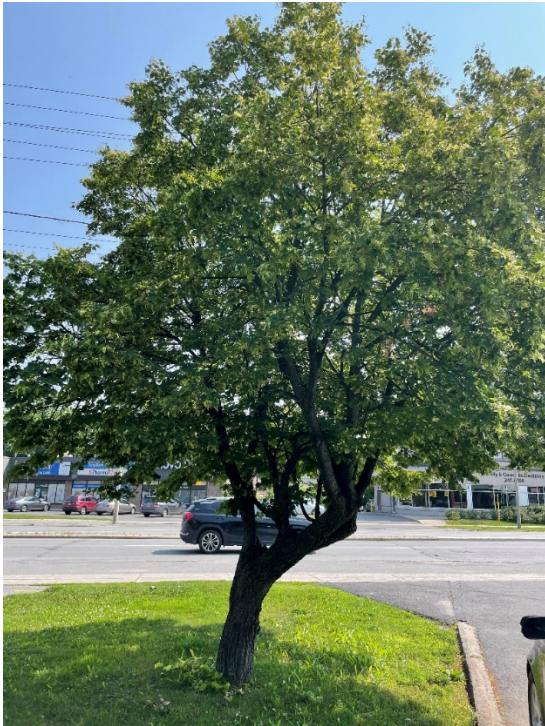
Tree <sup>1</sup>	Species	Diameter at breast height (dbh)	Ownership <sup>2,3</sup>	Condition	Action
1	Littleleaf linden ( <i>Tilia cordata</i> )	22, 27 cm (measured at 1 m)	Private	Fair; 70X 8 cm (8 cm deep) old branch attachment scar on trunk, lean towards adjacent property and asymmetric crown	Remove based on conflict with proposed building and underground parking garage
2	Littleleaf linden ( <i>Tilia cordata</i> )	23, 15, 16 cm	Private	Fair; original stem is in poor health; remaining stems are shoots	Remove based on conflict with proposed building and underground parking garage
3 <sup>4</sup>	Manitoba maple ( <i>Acer negundo</i> )	12, 12, 18 cm	Private	Fair; stump sprouts growing with a lean towards subject property	Remove based on proposed excavation for underground parking lot
4 <sup>4</sup>	American elm ( <i>Ulmus americana</i> )	30 cm	Private	Dead	Remove
5 <sup>4</sup>	American elm ( <i>Ulmus americana</i> )	26 cm	Private	Dead	Remove

Figure 1: Tree 1, little leaf linden to be removed

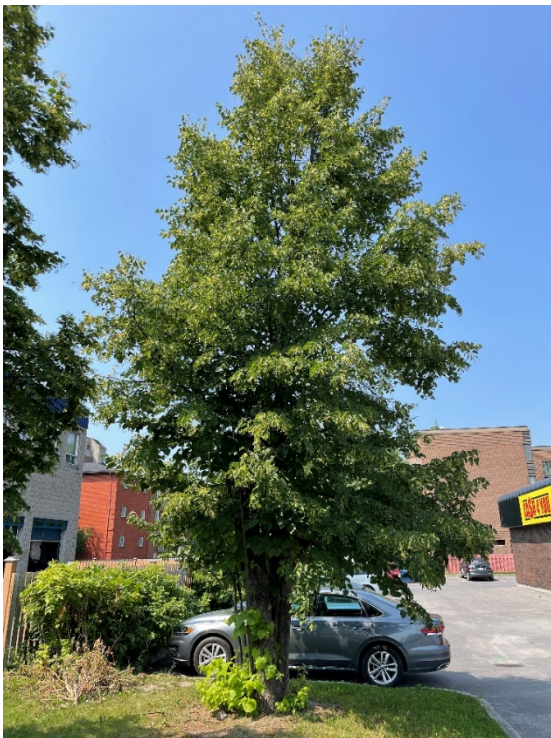
Figure 2: Tree 2, little leaf linden to be removed

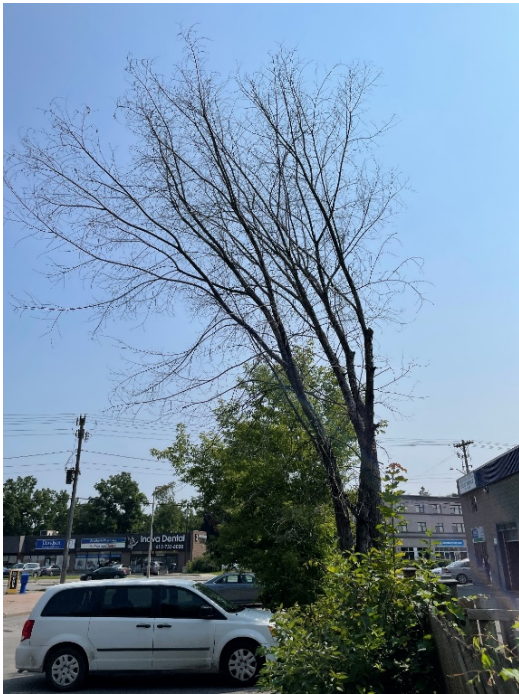
Figure 3: Trees 4&5, dead elms, and clump of Manitoba maple behind (tree 3)

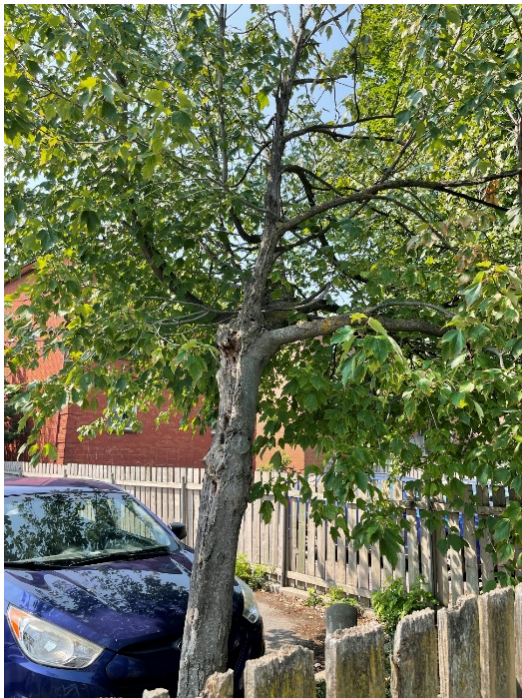
6	Red maple ( <i>Acer rubrum</i> )	16 cm	Adjacent property at 1177 Rockingham	Poor: dead main stem, lean towards adjacent property	No action required as far enough away from proposed construction
7 <sup>4</sup>	Manitoba maple ( <i>Acer negundo</i> )	~15 stems, 5-15 cm	Private	Fair; sprouts and lateral spreading	Remove based on proposed excavation for underground parking lot
8	Colorado spruce ( <i>Picea pungens</i> )	35 cm	Adjacent property at 1170 Belanger	Fair/good; suppressed growth	Retain and protect; recommend arborist to sever roots in advance of excavation to avoid tearing
9	Colorado spruce ( <i>Picea pungens</i> )	46 cm	Adjacent property at 1170 Belanger	Good	Retain and protect; recommend arborist to sever roots in advance of excavation to avoid tearing
10	Red oak ( <i>Quercus rubra</i> )	44 cm	Adjacent property at	Good; small roots beginning to girdle trunk	Retain and protect; recommend arborist to sever roots in advance of

Figure 4: Tree 6 - Red maple on adjacent property

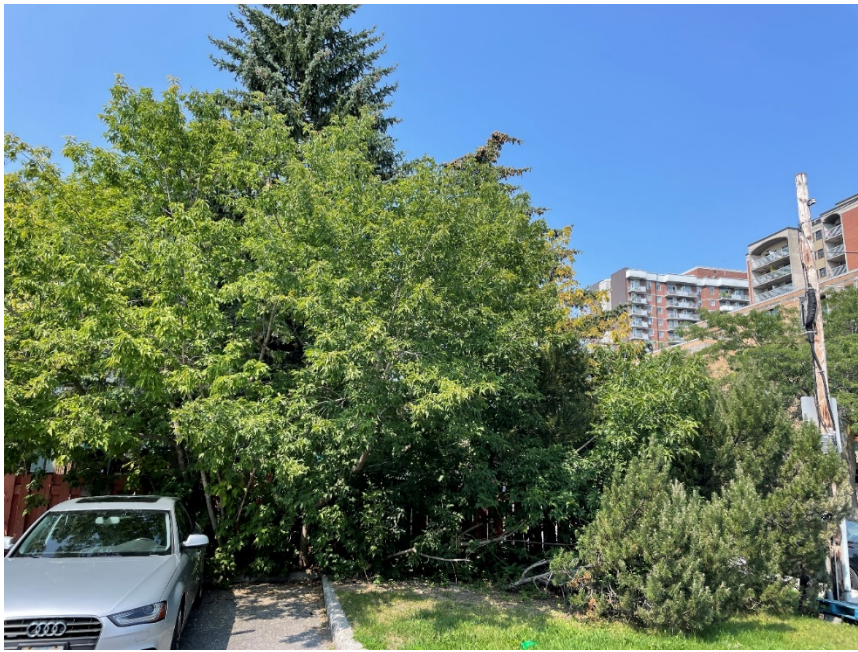
Figure 5: tree 7 - clump of Manitoba maple and Mugho pine shrub

1170 Belanger		excavation to avoid tearing
11 <sup>4</sup>	Mugho pine ( <i>Pinus mugo</i> )	Shrub - Multiple stems 8- 15 cm	City	Fair	Retain and protect <i>or</i> discuss removal and replacement with city Parks, Forestry and Stormwater Services and incorporate into landscape plan

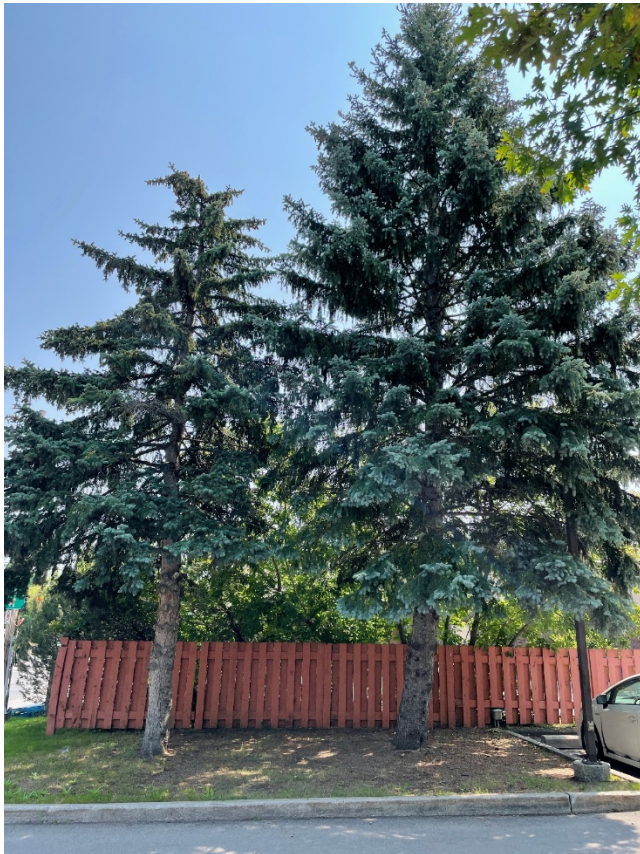
This development will involve excavation to the property line along the south and west side which will require the removal of all trees on the subject site. There will be some root loss of trees on adjacent property to the west, specifically trees 8 – 10. To reduce the impact of the root loss, it is recommended that the following mitigation measures be applied:

Figure 6: Trees 8 (left) and 9 (right) - Colorado blue spruce on adjacent property

- Arborist to pre-sever roots prior to excavation to avoid tearing of the roots and promote quick sealing and reduce the risk of pathogens from entering
- Roots should not be left exposed and be covered with soil as quickly as possible, or temporarily with a moist, organic material such as mulch and/or burlap

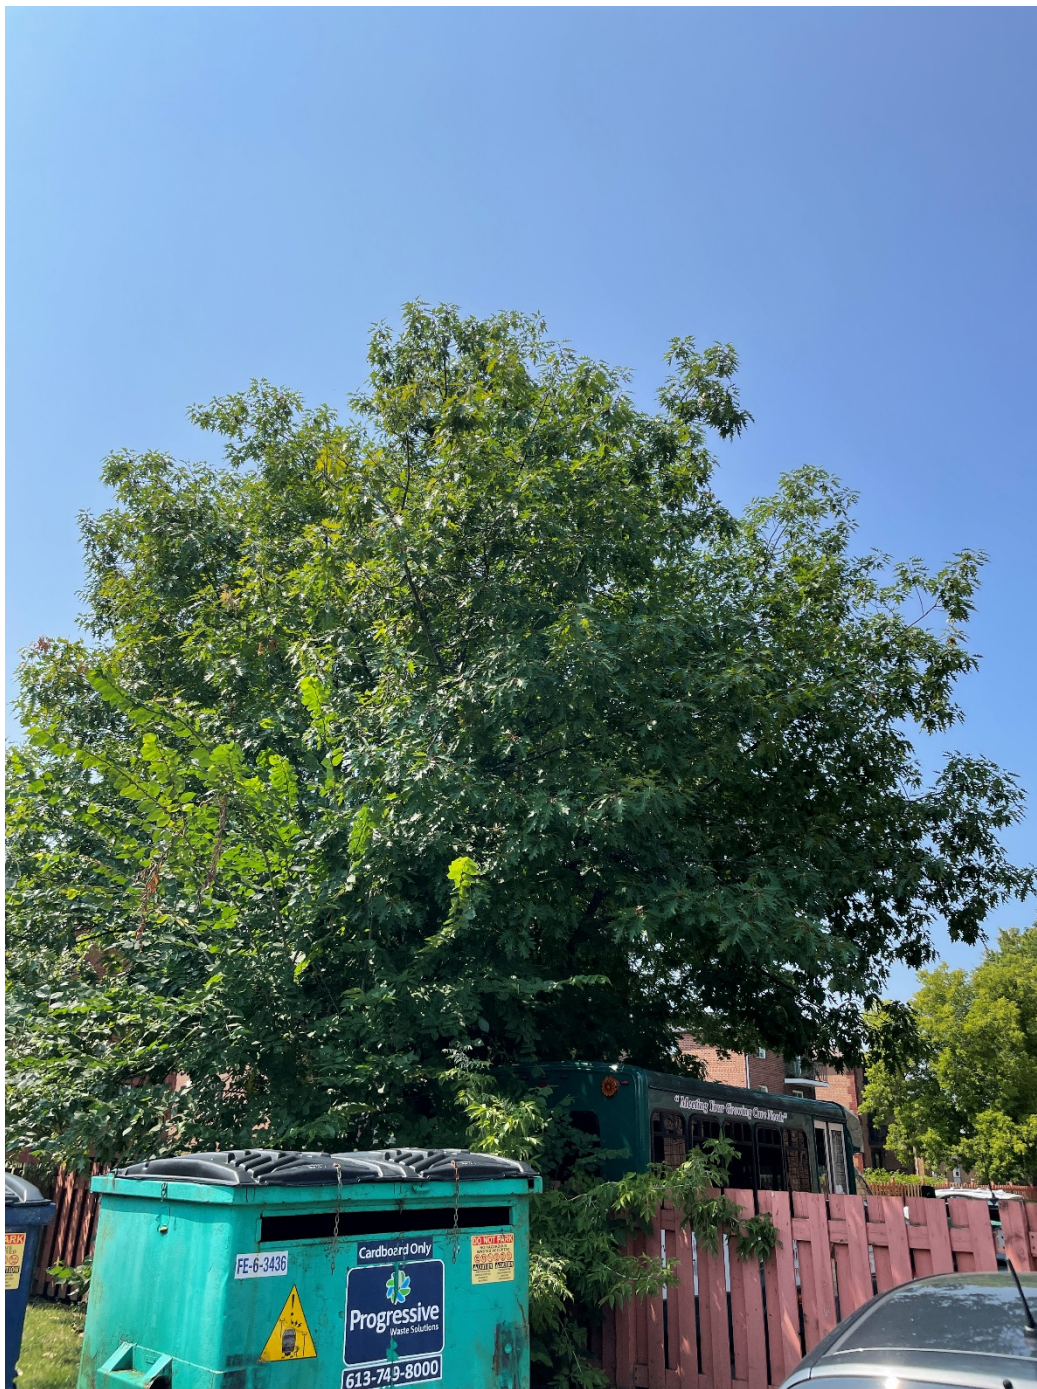
Figure 7: Tree 10 - red oak on adjacent property

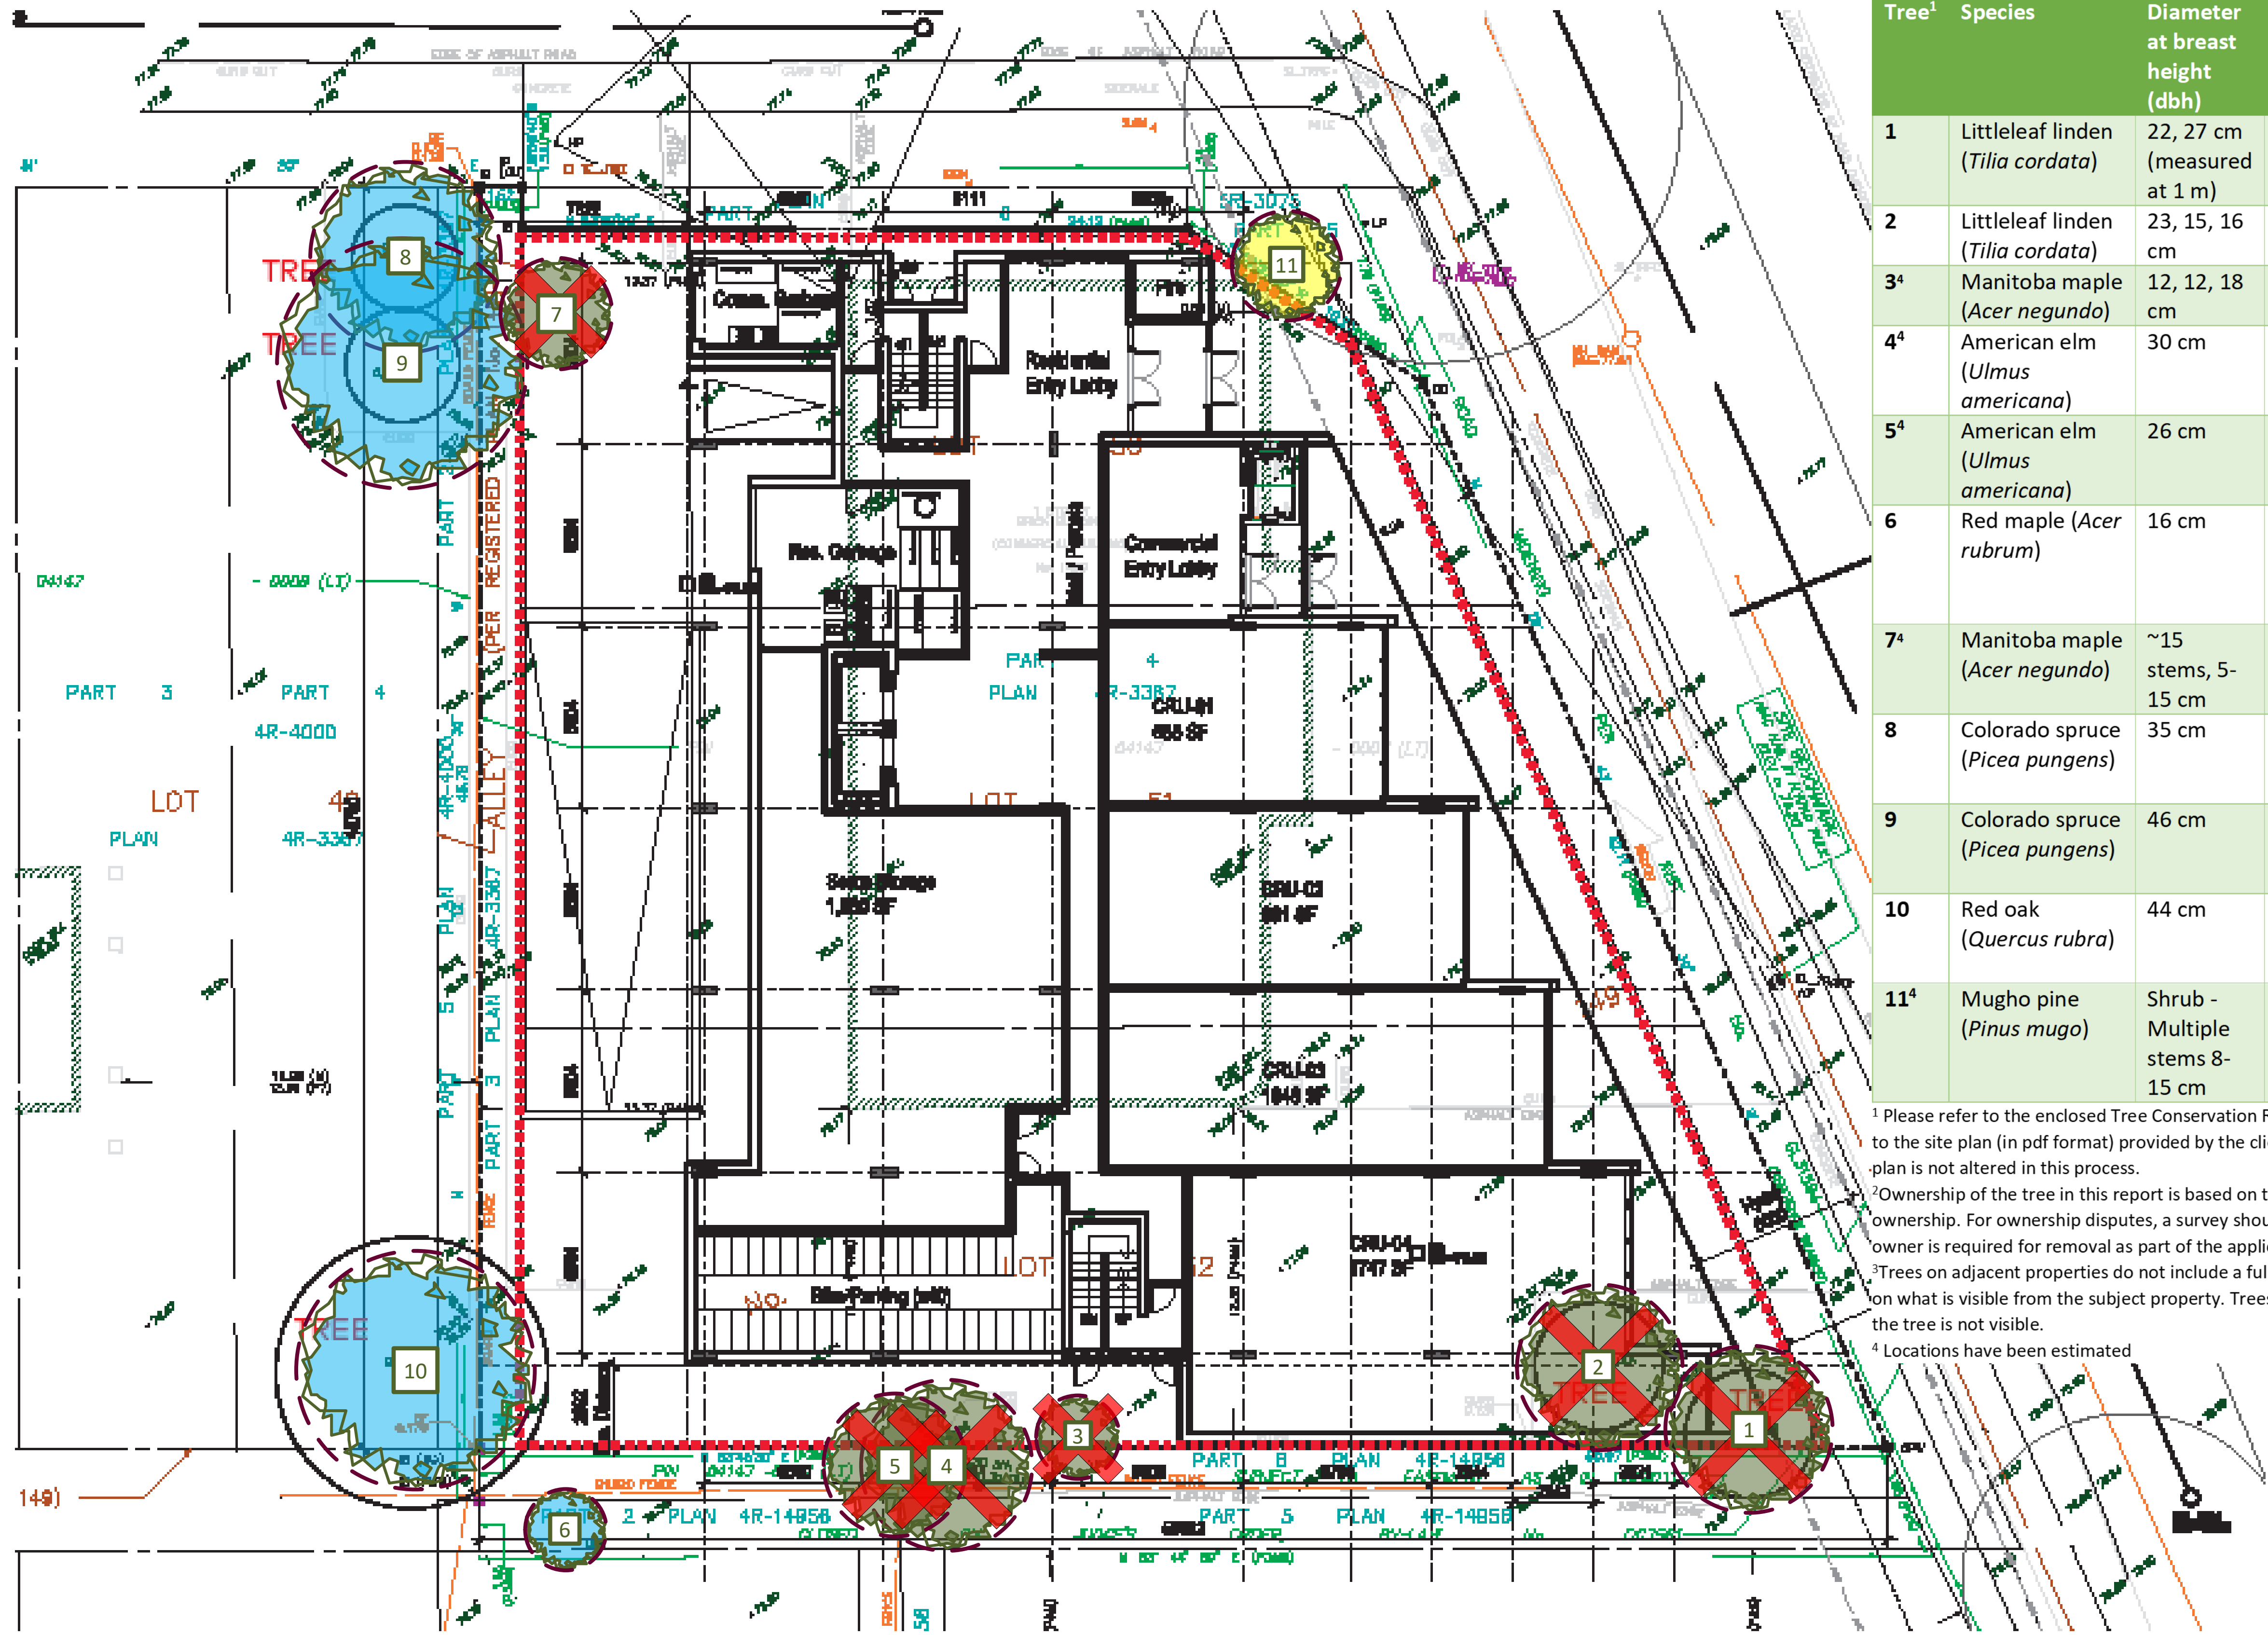
### 1400 Bank St. | Ottawa Redevelopment Proposal

Tree <sup>1</sup>	Species	Diameter at breast height (dbh)	Ownership <sup>2,3</sup>	Action
1	Littleleaf linden ( <i>Tilia cordata</i> )	22, 27 cm (measured at 1 m)	Private	Remove based on conflict with proposed building and underground parking garage
2	Littleleaf linden ( <i>Tilia cordata</i> )	23, 15, 16 cm	Private	Remove based on conflict with proposed building and underground parking garage
3 <sup>4</sup>	Manitoba maple ( <i>Acer negundo</i> )	12, 12, 18 cm	Private	Remove based on proposed excavation for underground parking lot
4 <sup>4</sup>	American elm ( <i>Ulmus americana</i> )	30 cm	Private	Remove
5 <sup>4</sup>	American elm ( <i>Ulmus americana</i> )	26 cm	Private	Remove
6	Red maple ( <i>Acer rubrum</i> )	16 cm	Adjacent property at 1177 Rockingham	No action required as far enough away from proposed construction
7 <sup>4</sup>	Manitoba maple ( <i>Acer negundo</i> )	~15 stems, 5-15 cm	Private	Remove based on proposed excavation for underground parking lot

8	Colorado spruce ( <i>Picea pungens</i> )	35 cm	Adjacent property at 1170 Belanger	Retain and protect; recommend arborist to sever roots in advance of excavation to avoid tearing
9	Colorado spruce ( <i>Picea pungens</i> )	46 cm	Adjacent property at 1170 Belanger	Retain and protect; recommend arborist to sever roots in advance of excavation to avoid tearing
10	Red oak ( <i>Quercus rubra</i> )	44 cm	Adjacent property at 1170 Belanger	Retain and protect; recommend arborist to sever roots in advance of excavation to avoid tearing
11 <sup>4</sup>	Mugho pine ( <i>Pinus mugo</i> )	Shrub - Multiple stems 8-15 cm	City	Retain and protect <i>or</i> discuss removal and replacement with city Parks, Forestry and Stormwater Services and incorporate into landscape plan

Note that the locations of trees 3, 4, 5, 7 and 11 have been estimated
